**RE: Whitestown Municipal Landfill, NYSDEC Site No. 633013****FILE: 1087908/1940102347**

Date January 31, 2023

This Periodic Review Report (PRR) is being provided by Ramboll Americas Engineering Solutions, Inc. (Ramboll) on behalf of the Town of Whitestown (Town) for the reporting period January 1, 2022, to December 31, 2022.

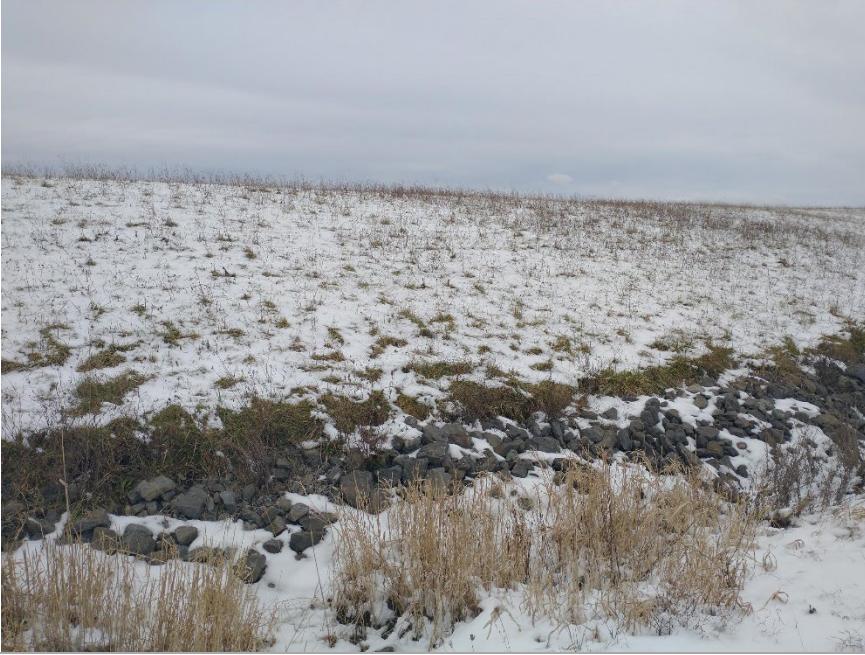
<b>CLIENT NAME:</b> Town of Whitestown		<b>SITE LOCATION:</b> Whitestown Landfill, Oriskany, New York	<b>PROJECT NO.</b> 1940102347
<b>PHOTO NO.</b> 1	<b>DATE:</b> 12/15/2022

<b>DESCRIPTION</b> Looking northeast across side slope and drainage swale along perimeter road.			
<b>CLIENT NAME:</b> Town of Whitestown		<b>SITE LOCATION:</b> Whitestown Landfill, Oriskany, New York	<b>PROJECT NO.</b> 1940102347
<b>PHOTO NO.</b> 2	<b>DATE:</b> 12/15/2022

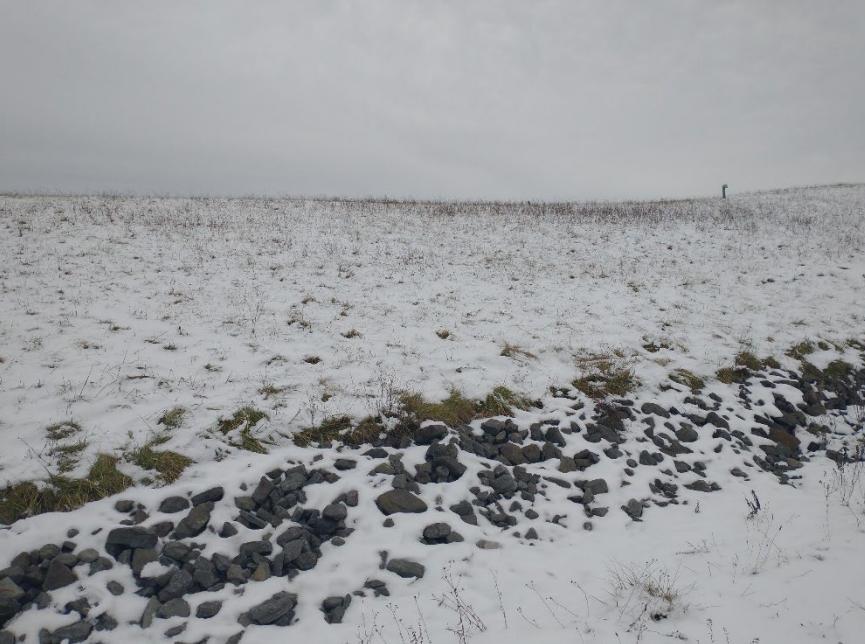
<b>DESCRIPTION</b> Side slope with monitoring well visible just right of center, cap in place.

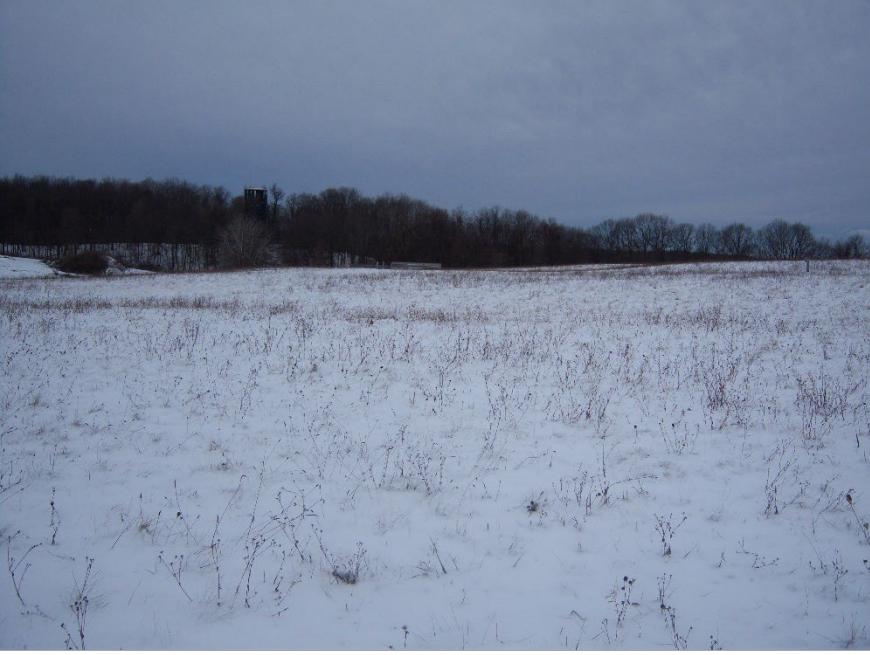
<b>CLIENT NAME:</b> Town of Whitestown		<b>SITE LOCATION:</b> Whitestown Landfill, Oriskany, New York	<b>PROJECT NO.</b> 1940102347
<b>PHOTO NO.</b> 3	<b>DATE:</b> 12/15/2022

<b>DESCRIPTION</b> Looking west to Maintenance Garage over potential settlement area, no ponding observed.			
<b>CLIENT NAME:</b> Town of Whitestown		<b>SITE LOCATION:</b> Whitestown Landfill, Oriskany, New York	<b>PROJECT NO.</b> 1940102347
<b>PHOTO NO.</b> 4	<b>DATE:</b> 12/15/2022

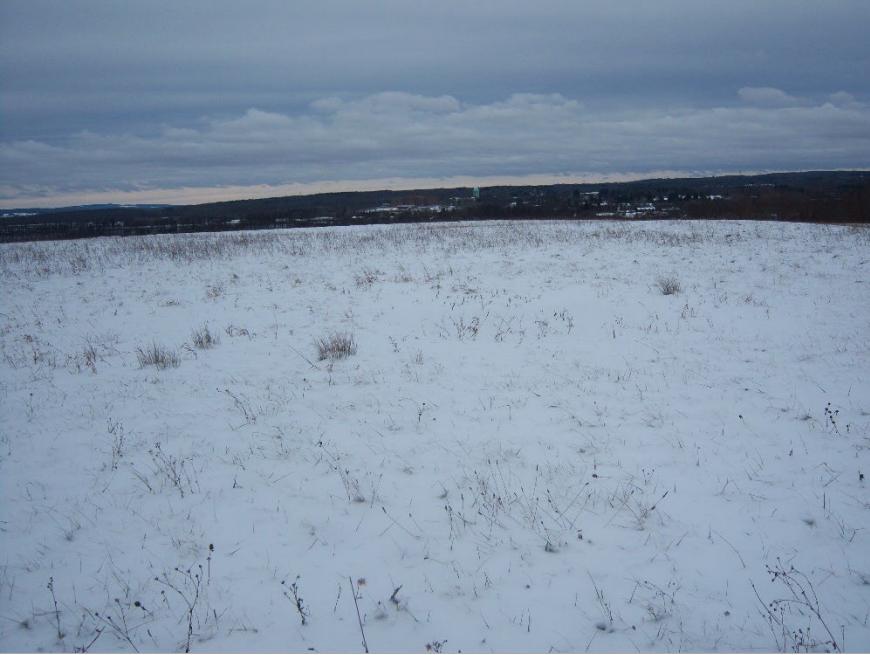
<b>DESCRIPTION</b> Panoramic view looking north across cap; ponding area previously observed appears stable, some ice crust below snow was noted here.

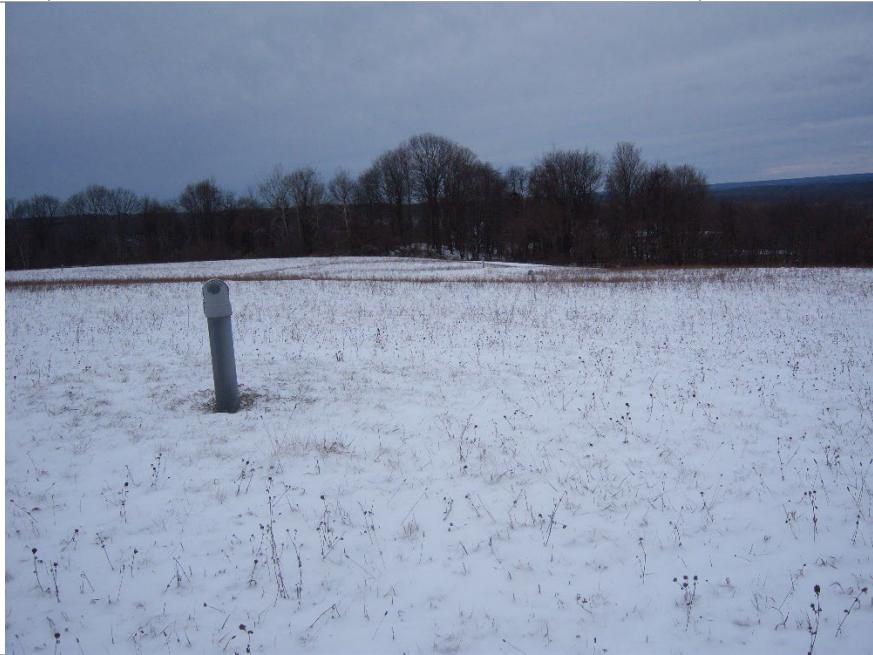
<b>CLIENT NAME:</b> Town of Whitestown		<b>SITE LOCATION:</b> Whitestown Landfill, Oriskany, New York	<b>PROJECT NO.</b> 1940102347
<b>PHOTO NO.</b> 5	<b>DATE:</b> 12/15/2022

<b>DESCRIPTION</b> Looking northwest toward original settlement area that has HDPE underdrain pipe previously installed in soil cover and discharged to perimeter road stone-lined ditch.			
<b>CLIENT NAME:</b> Town of Whitestown		<b>SITE LOCATION:</b> Whitestown Landfill, Oriskany, New York	<b>PROJECT NO.</b> 9140102347
<b>PHOTO NO.</b> 6	<b>DATE:</b> 12/15/2022

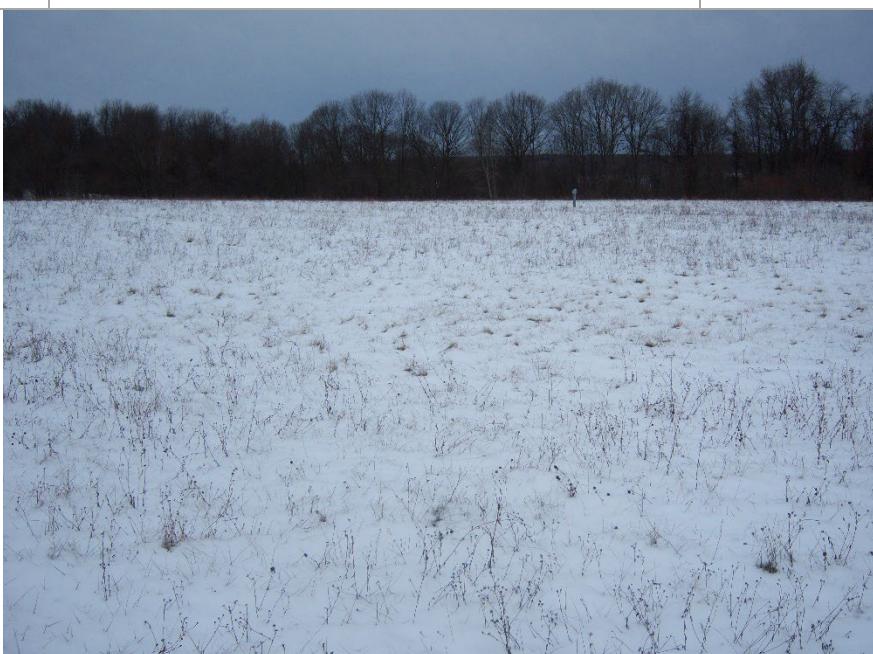
<b>DESCRIPTION</b> Original settlement area, no ice or evidence of ponding observed.

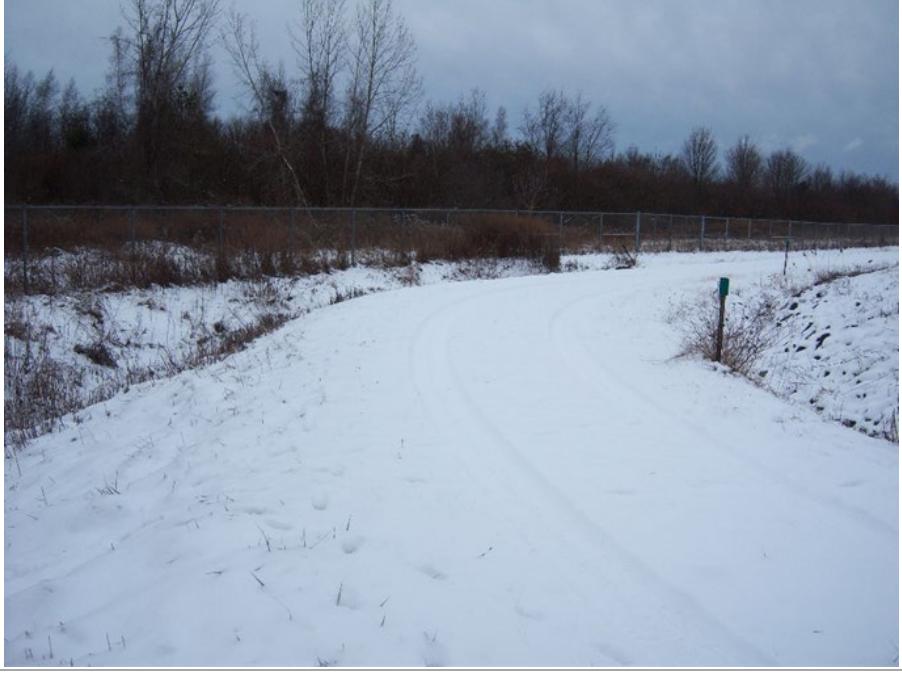
<b>CLIENT NAME:</b> Town of Whitestown		<b>SITE LOCATION:</b> Whitestown Landfill, Oriskany, New York	<b>PROJECT NO.</b> 1940102347
<b>PHOTO NO.</b> 7	<b>DATE:</b> 12/15/2022

The northeast end of the stone-lined swale along the perimeter road had water ponding in several locations during last year's inspection. Several areas of vegetation growth and sedimentation were noted as causing water to back up in the ditch. In addition, small trees and brush were noted at the drainage ditch outlet, i.e., northeast culvert headwall and concrete apron. In June 2022, the Town performed clearing and additional stone lining work on the perimeter swale and in these areas. Ramboll conducted an inspection to evaluate the completed work. The cap drainage system appears to be functioning properly but should be monitored closely, and organic material cleaned out if overtopping is noted. These facilities must remain cleared to prevent future drainage issues.

<b>DESCRIPTION</b> Northeast corner of perimeter road, drainage swale cleared of heavy brush.			
<b>CLIENT NAME:</b> Town of Whitestown		<b>SITE LOCATION:</b> Whitestown Landfill, Oriskany, New York	<b>PROJECT NO.</b> 9140102347
<b>PHOTO NO.</b> 8	<b>DATE:</b> 12/15/2022

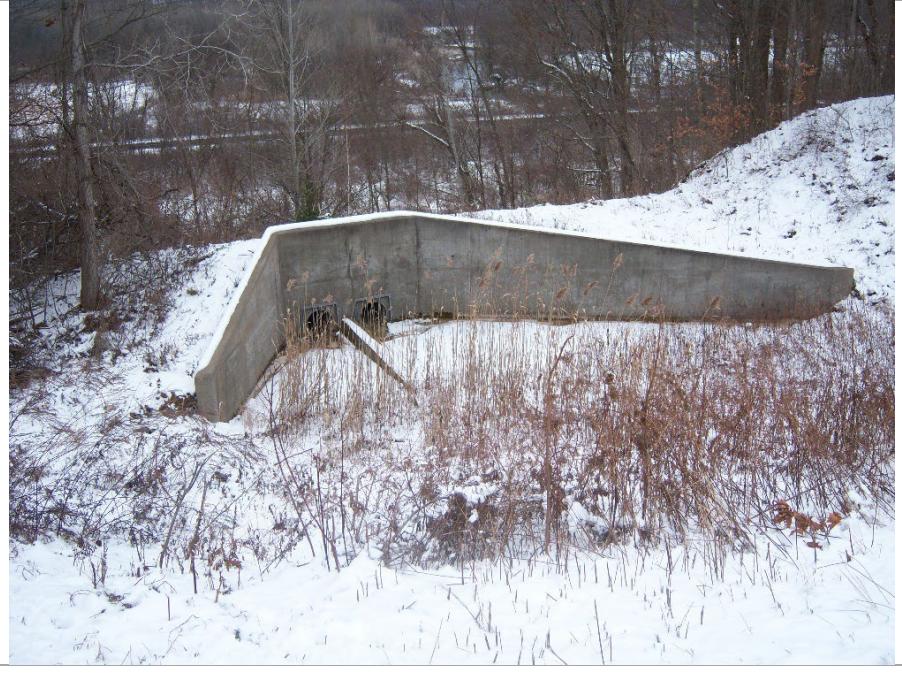
<b>DESCRIPTION</b> Storm inlet structure in good condition with no debris on apron.

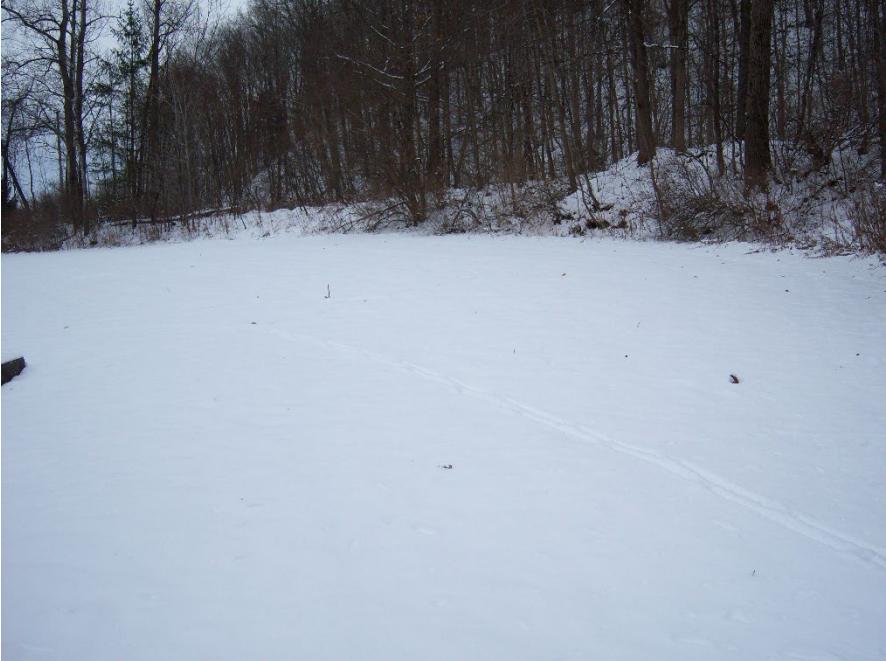
<b>CLIENT NAME:</b> Town of Whitestown		<b>SITE LOCATION:</b> Whitestown Landfill, Oriskany, New York	<b>PROJECT NO.</b> 1940102347
<b>PHOTO NO.</b> 9	<b>DATE:</b> 12/15/2022

<b>DESCRIPTION</b> Location of capped Seep #7 along embankment behind Groundwater Collection Treatment site looking east.			
<b>CLIENT NAME:</b> Town of Whitestown		<b>SITE LOCATION:</b> Whitestown Landfill, Oriskany, New York	<b>PROJECT NO.</b> 9140102347
<b>PHOTO NO.</b> 10	<b>DATE:</b> 12/15/2022

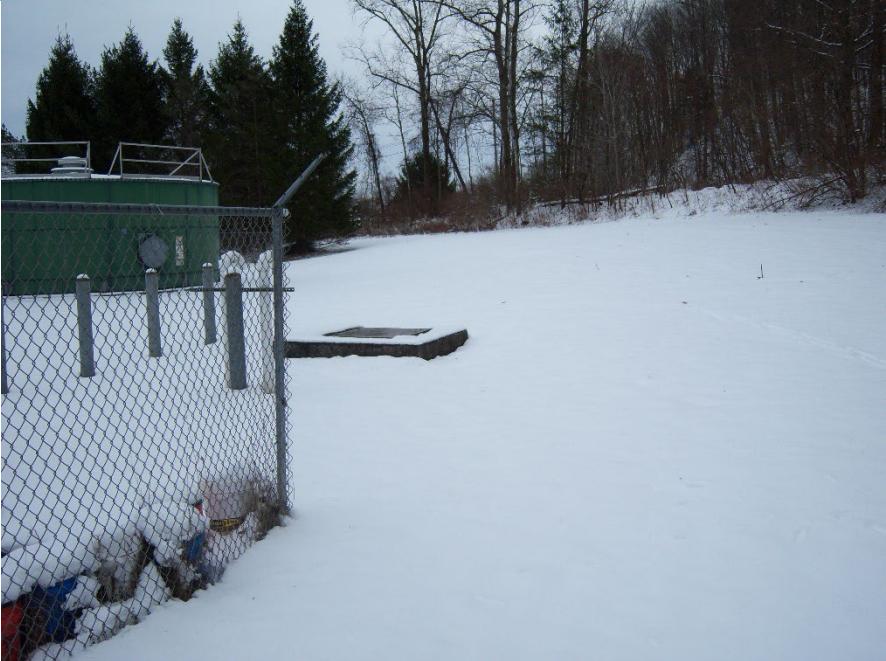
<b>DESCRIPTION</b> Groundwater Treatment site, not in use. No evidence of breakout from previously capped area.

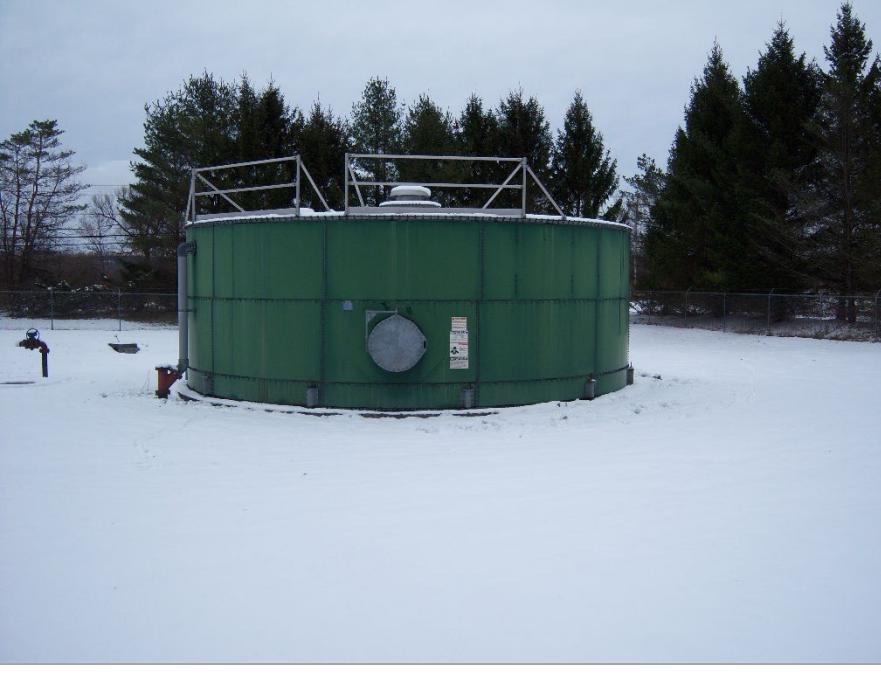
<b>CLIENT NAME:</b> Town of Whitestown		<b>SITE LOCATION:</b> Whitestown Landfill, Oriskany, New York	<b>PROJECT NO.</b> 1940102347
<b>PHOTO NO.</b> 11	<b>DATE:</b> 12/15/2022

<b>DESCRIPTION</b> Groundwater storage tank not in use.			
<b>CLIENT NAME:</b> Town of Whitestown		<b>SITE LOCATION:</b> Whitestown Landfill, Oriskany, New York	<b>PROJECT NO.</b> 9140102347
<b>PHOTO NO.</b> 12	<b>DATE:</b> 12/15/2022

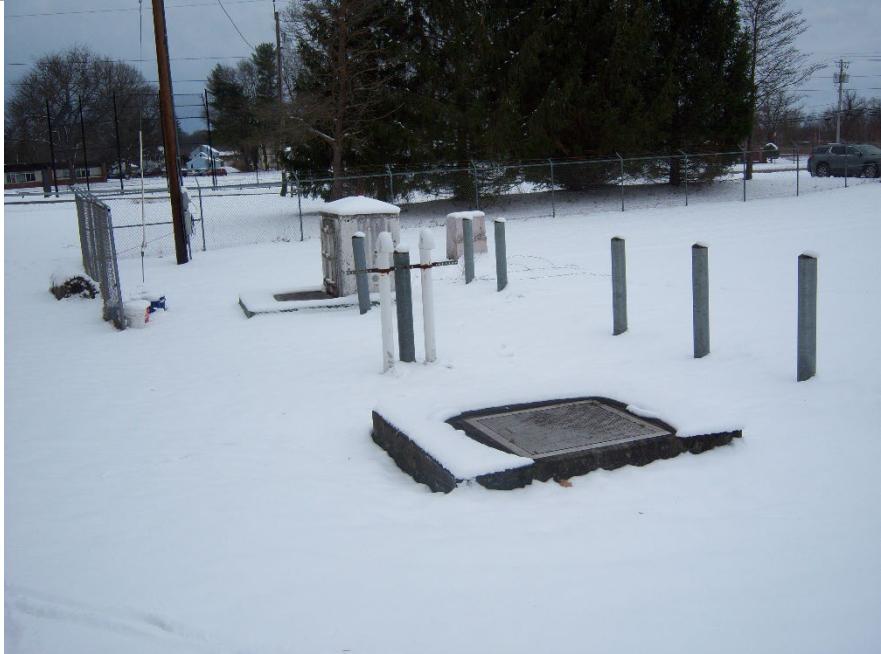
<b>DESCRIPTION</b> Groundwater settling chamber access hatch and pump station, inlet pipe capped and system is not in use.
