# Primoshield: Verizon Repair

DER Site Management, 12/29/2011

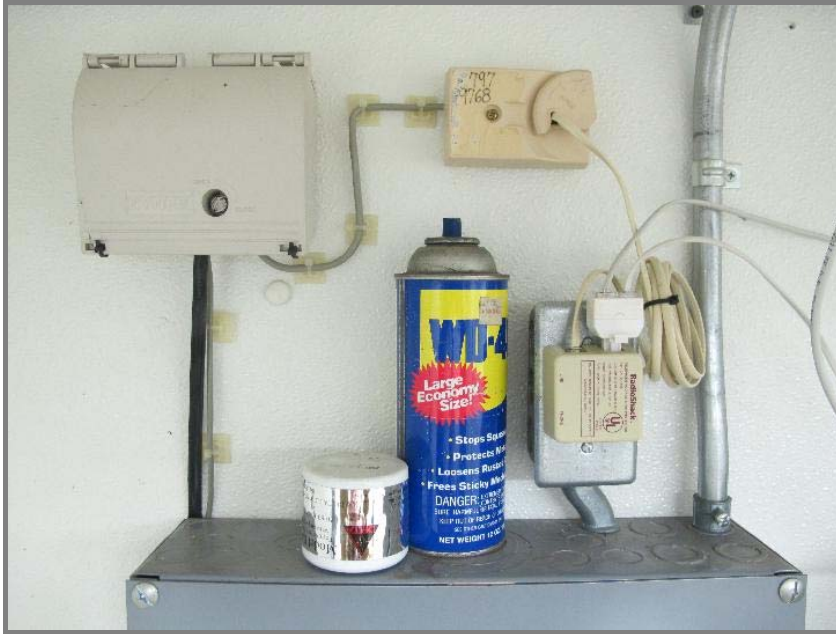
We have had intermittent phone service since the end of summer. Verizon was called on 9/22/11, 11/4/11 and 12/28/11 because the phone line was dead. This time I met the technician on December 29th. at 10:00 AM, onsite.

Photo of the interface box made on 12/28.

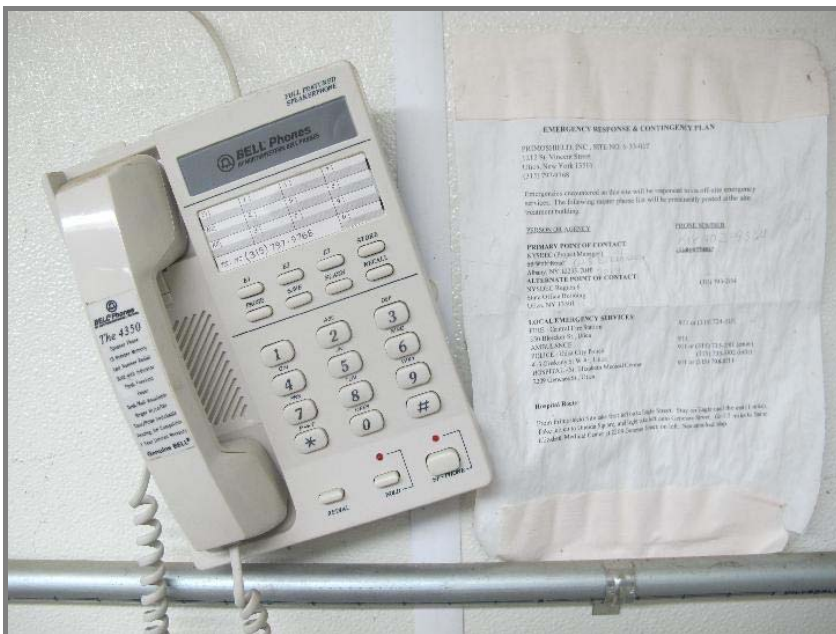
Photo taken 12/28. It turned out that the technician determined that there was a short in the phone somewhere. There also was a short in the line outside.

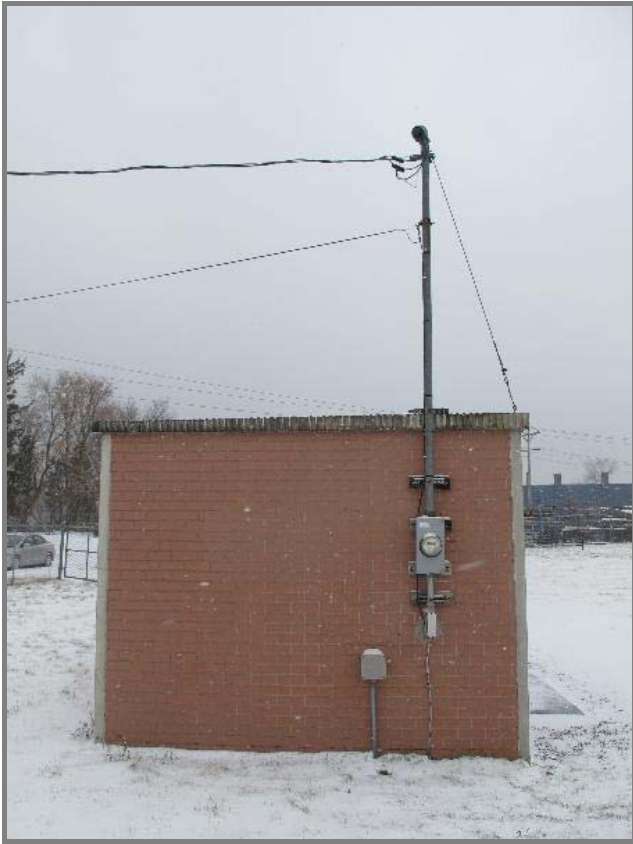
Photo 1 of 6 showing the way the phone line enters our plant.

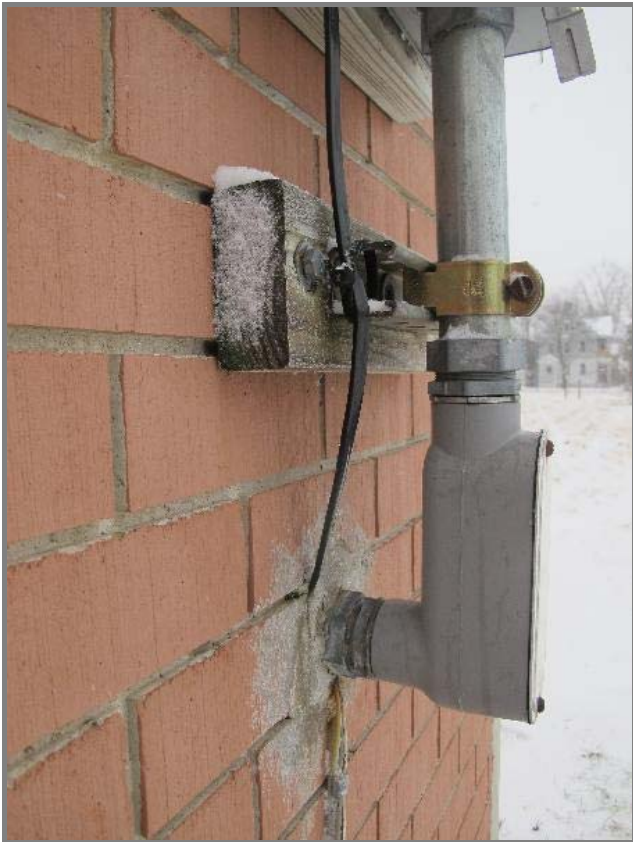
Photo 2 of 6 showing the way the phone line enters our plant.

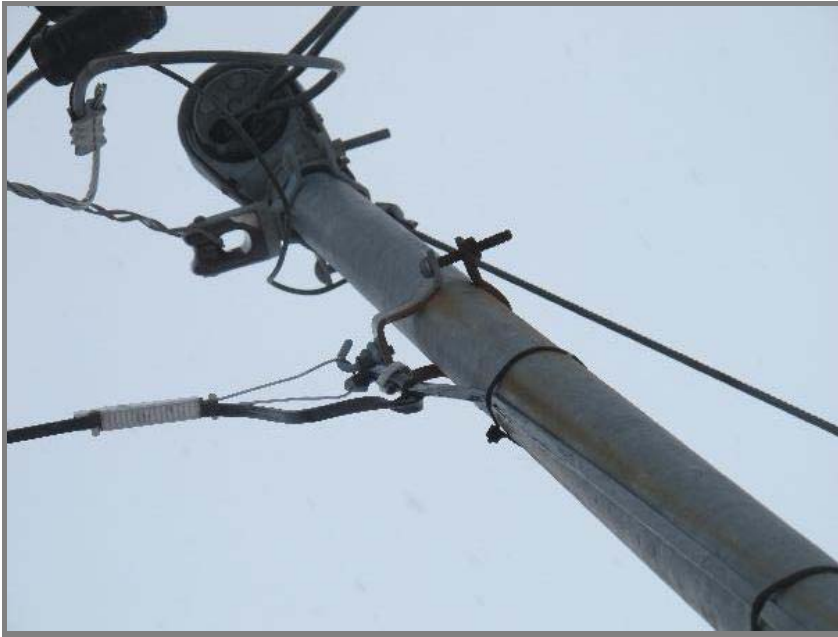
Photo 3 of 6 showing the way the phone line enters our plant.

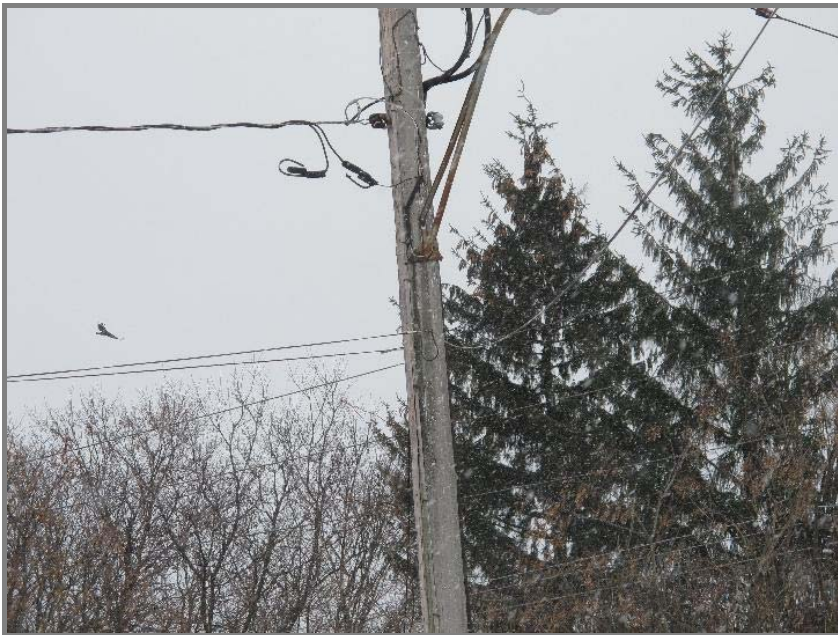
Photo 4 of 6 showing the way the phone line enters our plant.

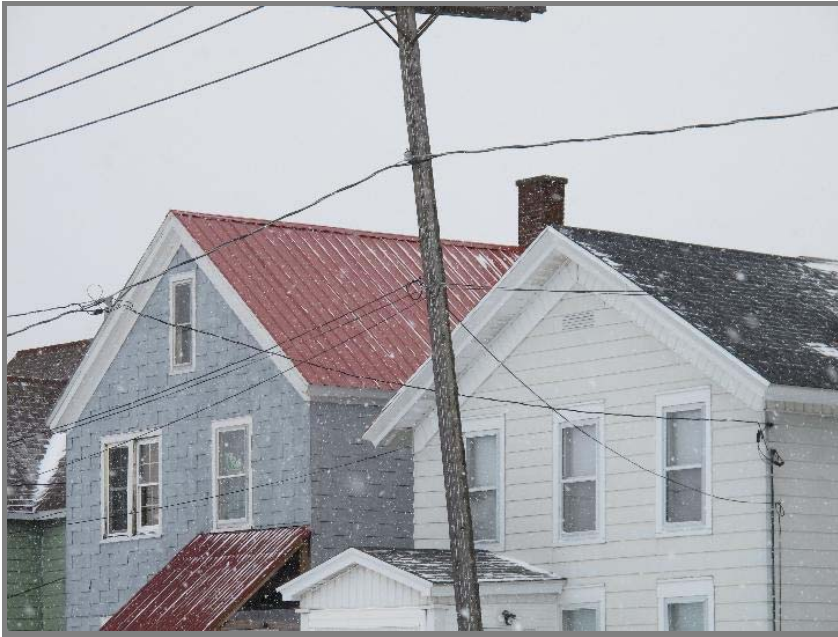
Photo 5 of 6 showing the way the phone line enters our plant.

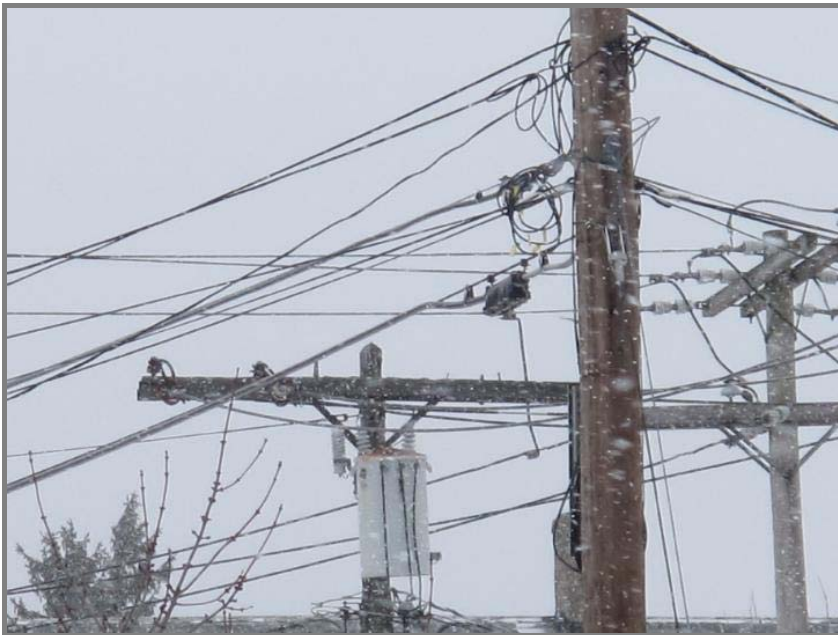
Photo 6 of 6 showing the way the phone line enters our plant.

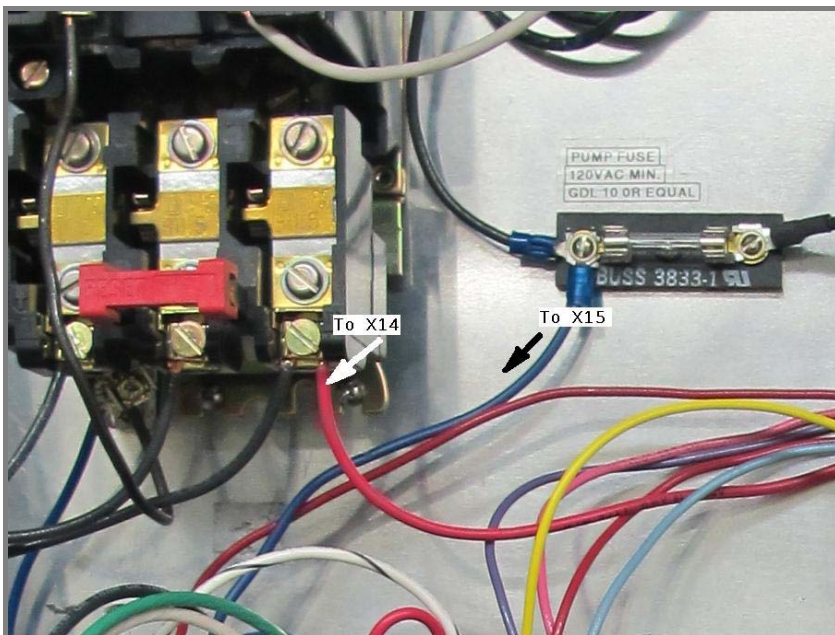
Close-ups of the wiring additions

I wired two more circuits to the PLC. the first new circuit goes from the third (lower-right) terminal on the motor starter to X14. The second goes from the left-hand side of the fuse bus to X15. I wired C3 to the terminal on the same block where C1 and C2 connect. I updated the program by adding two rungs on the ladder for these two inputs and outputs - Y14 and Y15 - I wired nothing to these however, only put the connections in the program as normally open contacts. This can be revised.
