# MACTEC

**Subject:        Semiannual Discharge Monitoring and Site  
                    Inspection Report - March 2013  
                    Primoshield Incorporated Site, Site No. 633027  
                    MACTEC Engineering & Consulting, P.C., Project No. 3612122251**

New York Department of Environmental Conservation  
Inactive Hazardous Waste Site  
Inspection Form-Treatment Systems

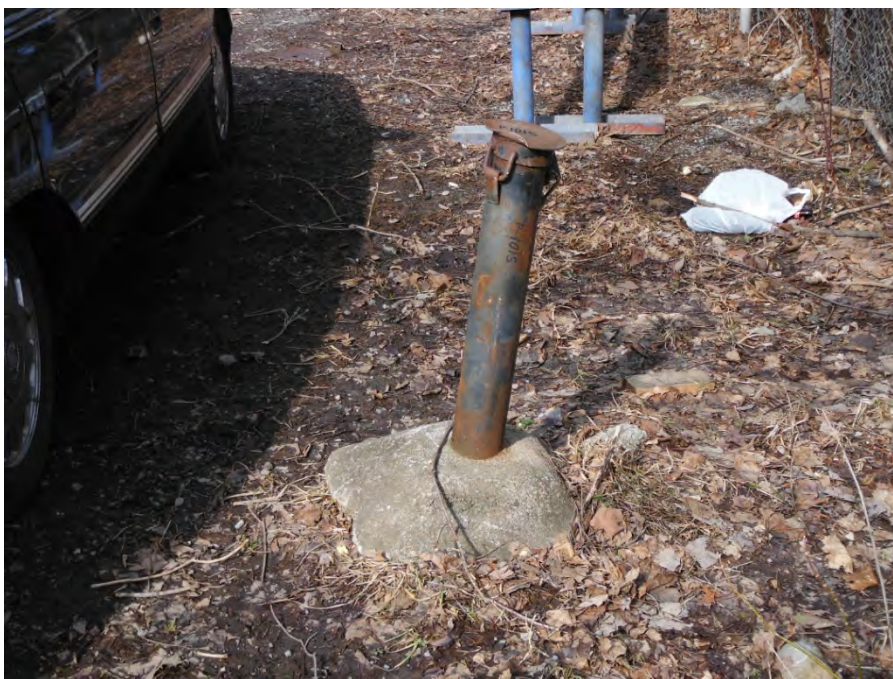
wells 1075 - concrete pad heaved, casing very loose.  
1015 - casing bent.

Photo 1: Monitoring Well P101S damage view

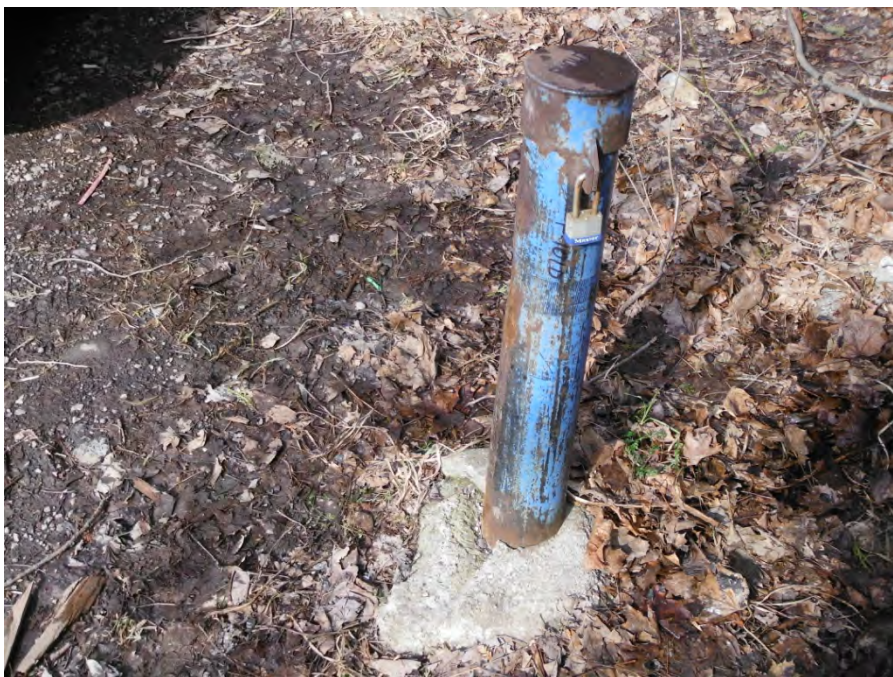
Photo 2: Monitoring Well P-101D cracked concrete, tilted possibly from snow plowing.

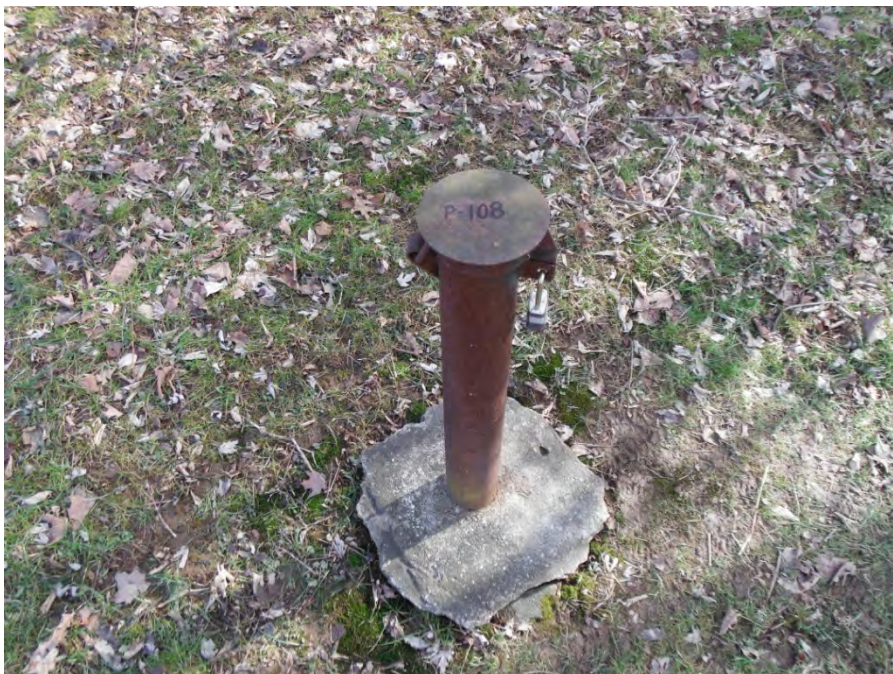
Photo 4: Monitoring Well P-108 slight heaving of concrete pad (view 1)

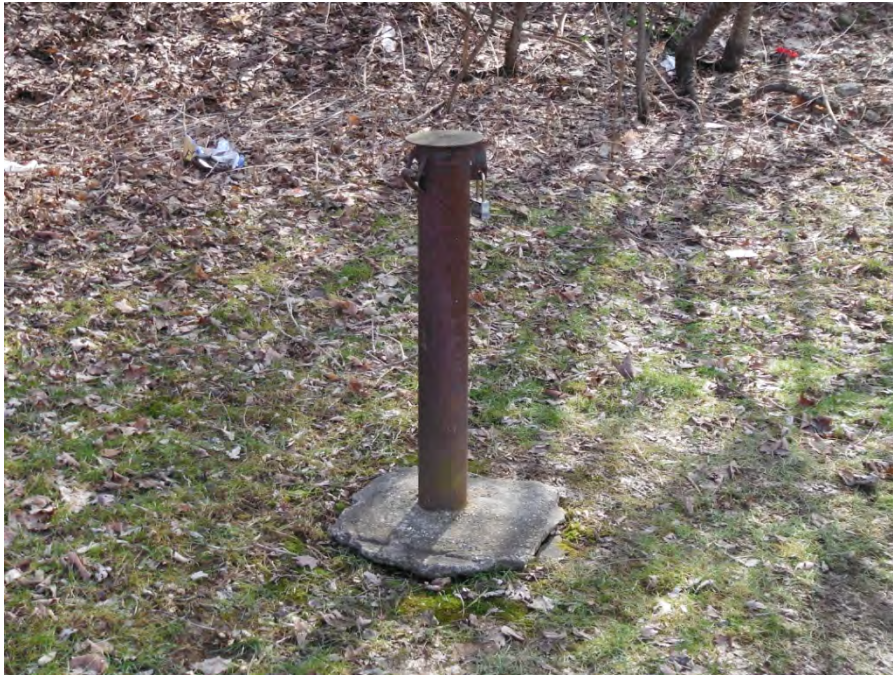
Photo 5: Monitoring Well P-108 slight heaving of concrete pad (view 2)

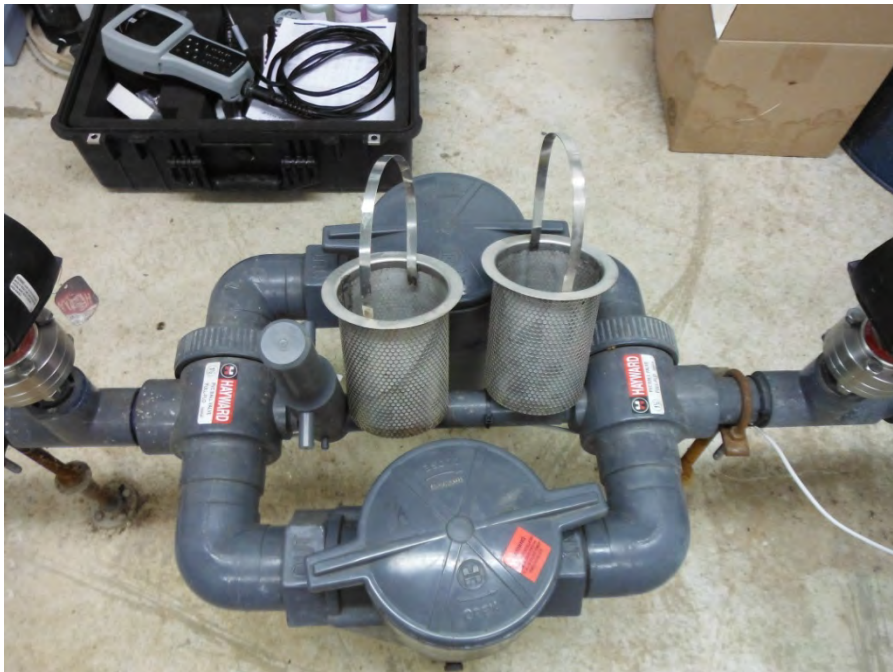
The treatment system was observed to be operating upon arrival. Consistent with previous inspections, the basket strainers were observed to be clogged with fine silt and grass clippings potentially hindering system performance. The basket strainers were removed from the system and the grass directly around the collection manhole was replaced with gravel in order to minimize the amount of grass clippings entering the treatment system. System flow was observed to be approximately 30 gallons per minute (gpm) (after cleaning the strainer).

Photo 6: Basket strainers from the Treatment system

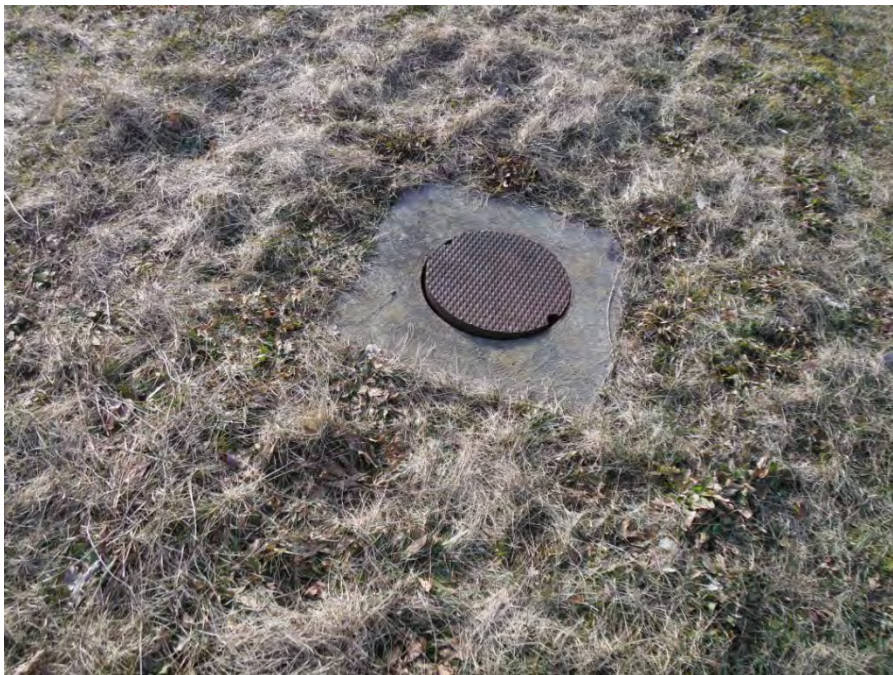
Photo 14: Slightly heaved cleanout cap near P-106S/D

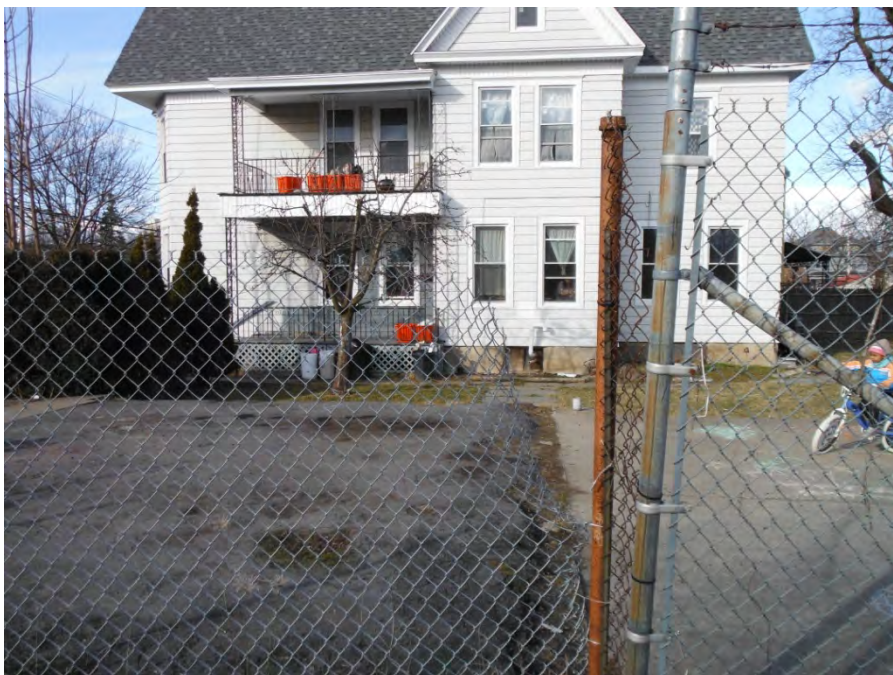
- The perimeter fence is upright; the 2 locations that were found to be compromised during previous inspections were repaired (one temporarily – see photos in Attachment 1). One additional fence was noted to need vendor repair (awaiting cost estimate from vendor).

Photo 16: Gap in fence near P-106S/D

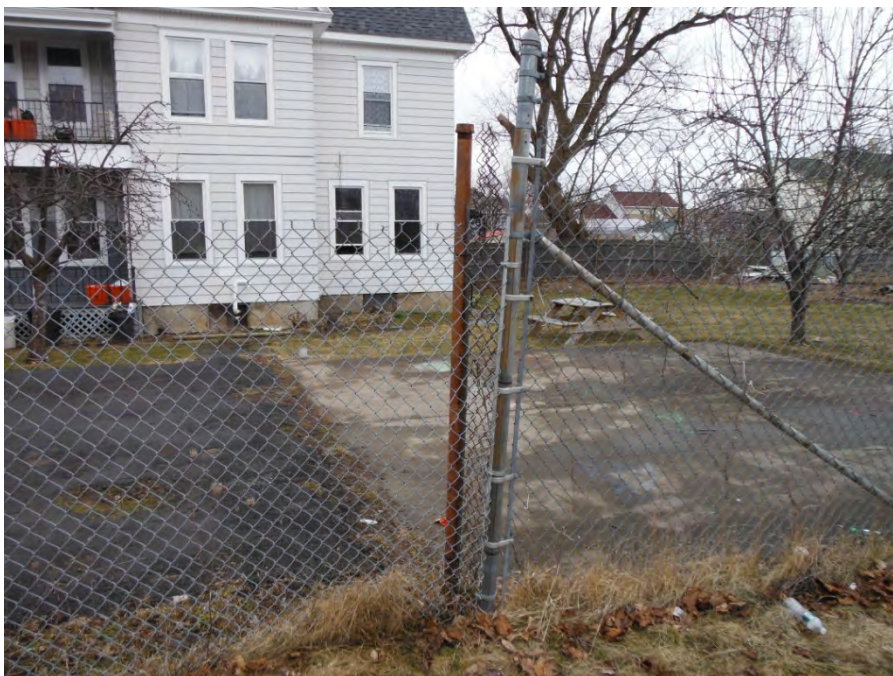
Photo 17: Fence after repair

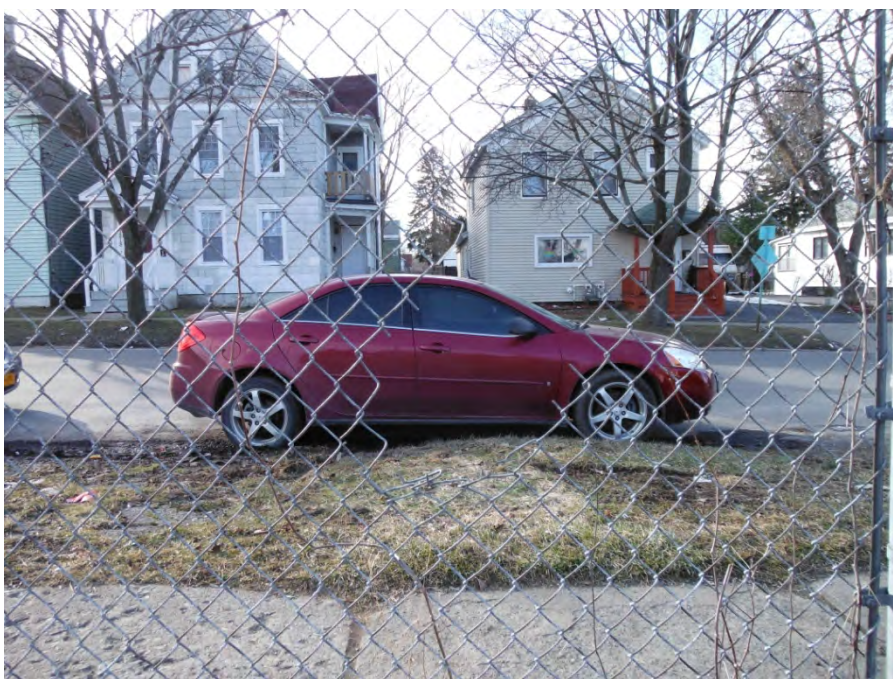
Photo 18: Hole in fence near northwest corner, Conkling Avenue

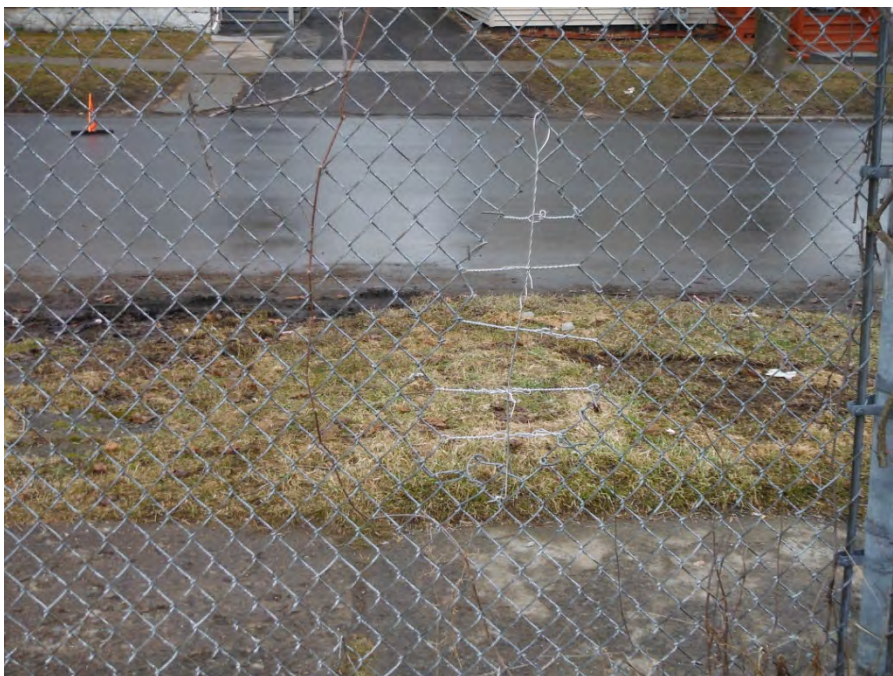
Photo 19: Fence after repair (temporary)

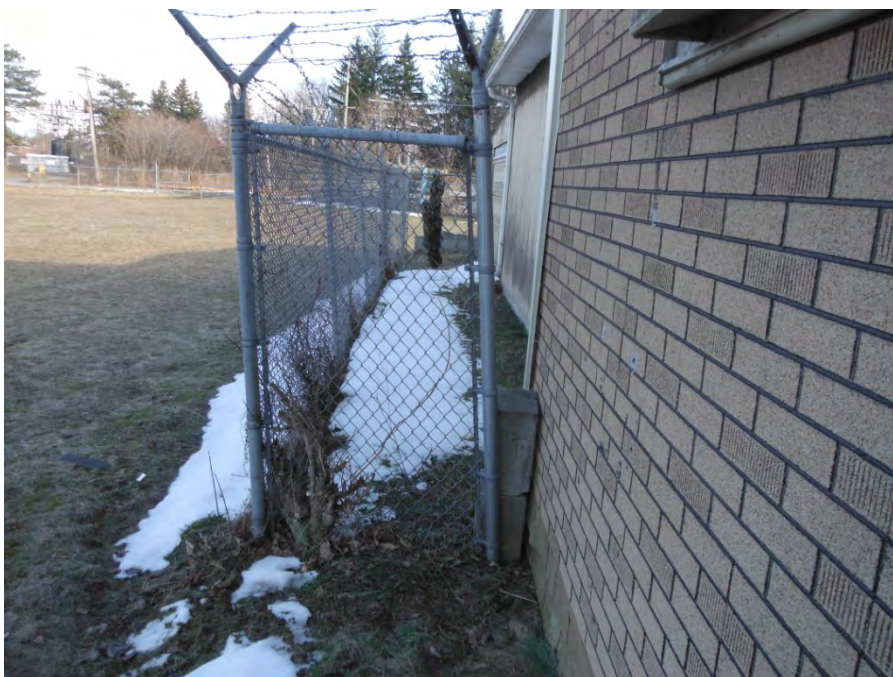
Photo 20: Loose fence post against building and southern perimeter of site (repair pending)

- Continue inspections and performance monitoring on a semi-annual basis.
- Subcontract with a fencing company to complete the fence repairs.
