**2025 Annual Site  
Management Report**

**APPENDIX B:  
Cover System  
Performance Report**

**Former Lockheed Martin  
French Road Facility  
Utica, New York**

**March 2026**

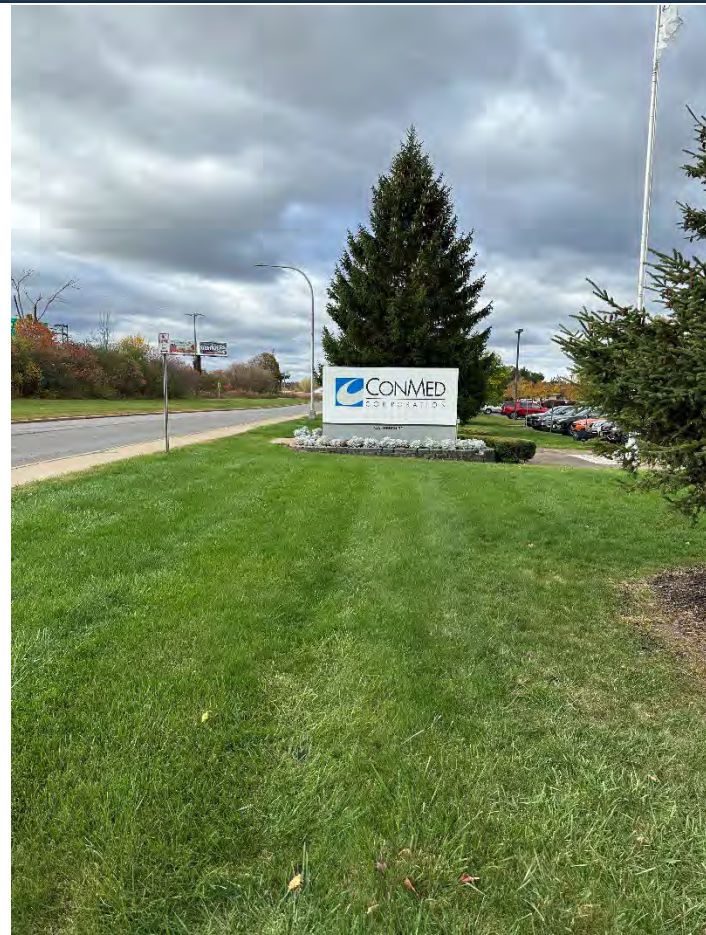
Photograph No.: 001

Comments: South side opposite front entrance to building – looking West.

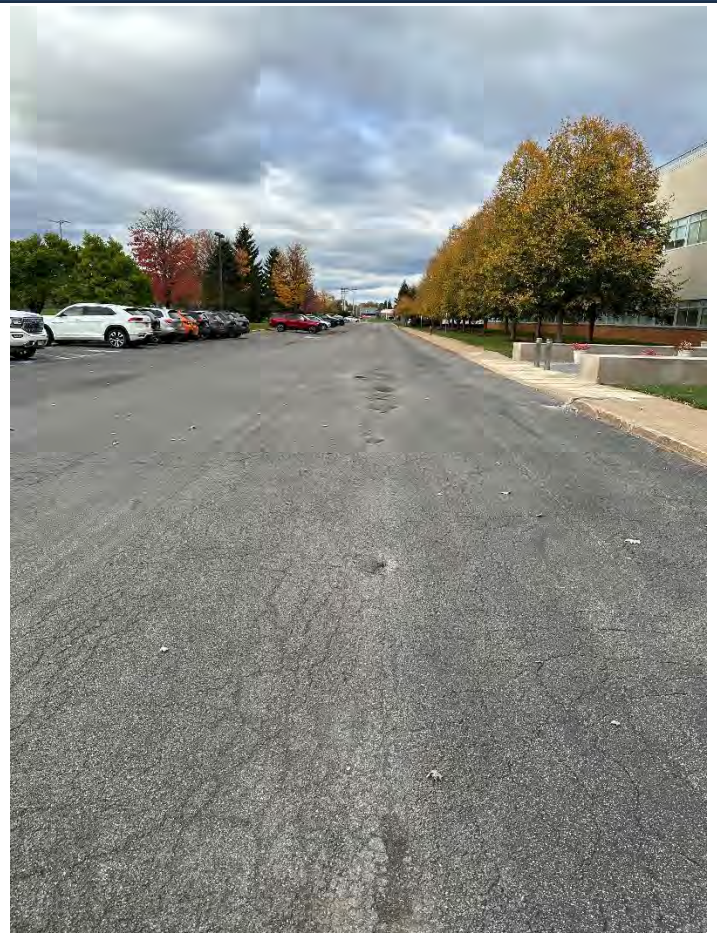
Photograph No.: 002

Comments: South side showing drive and landscaped area along front of building – looking West.

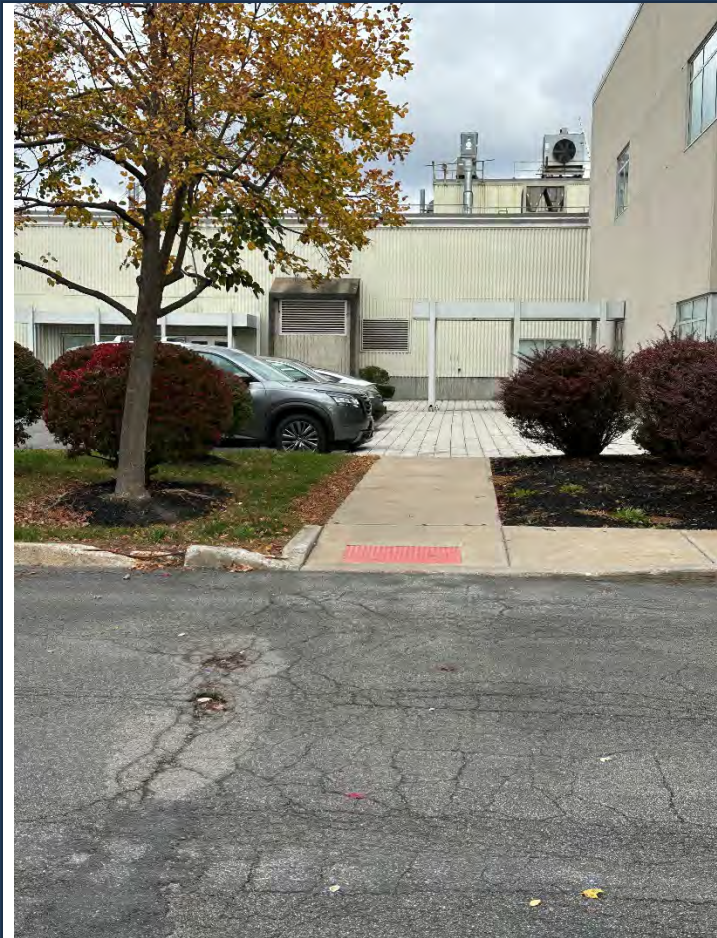
Photograph No.: 003  
Comments: West side with sidewalk – looking North.  
Note minor pot holes.

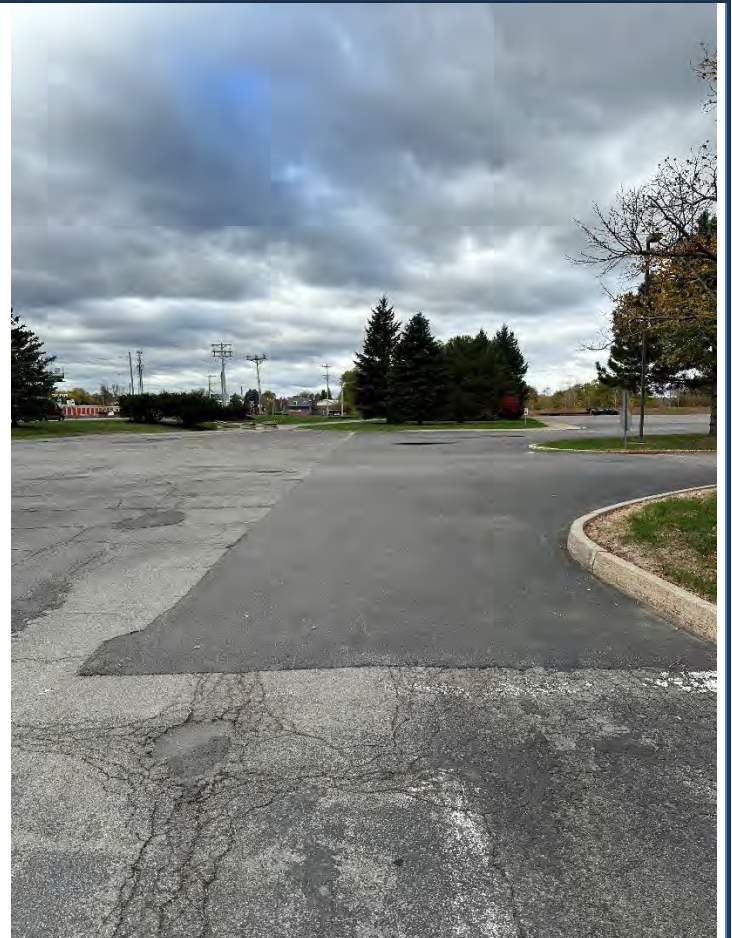
Photograph No.: 004  
Comments: South side – West end showing paved area –  
looking Southwest. Note asphalt pavement repair.

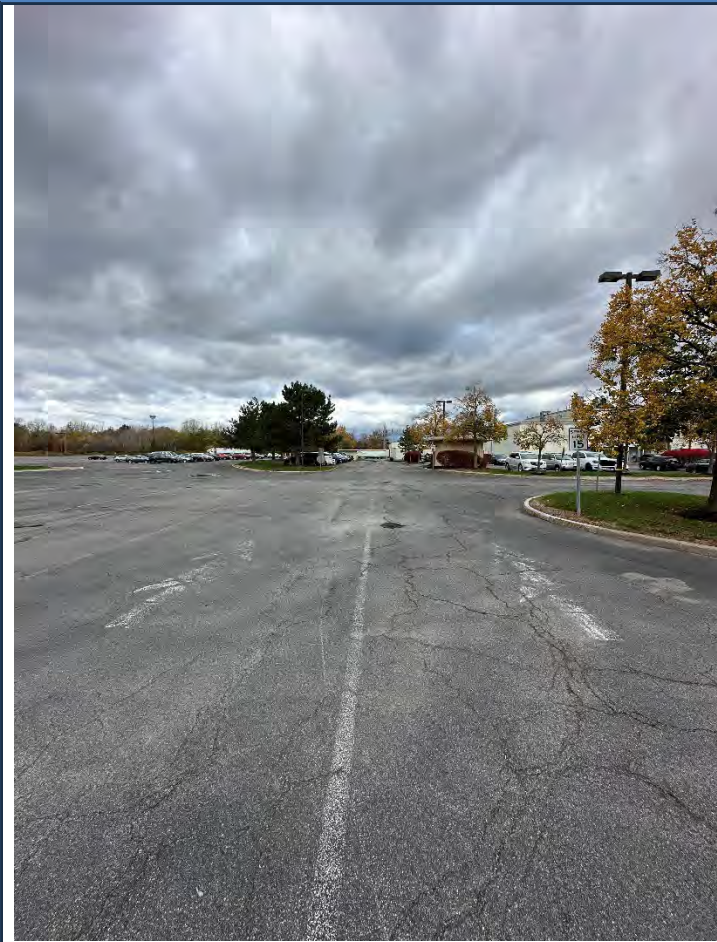
Photograph No.: 005  
Comments: West side, typical parking pavement – looking North.

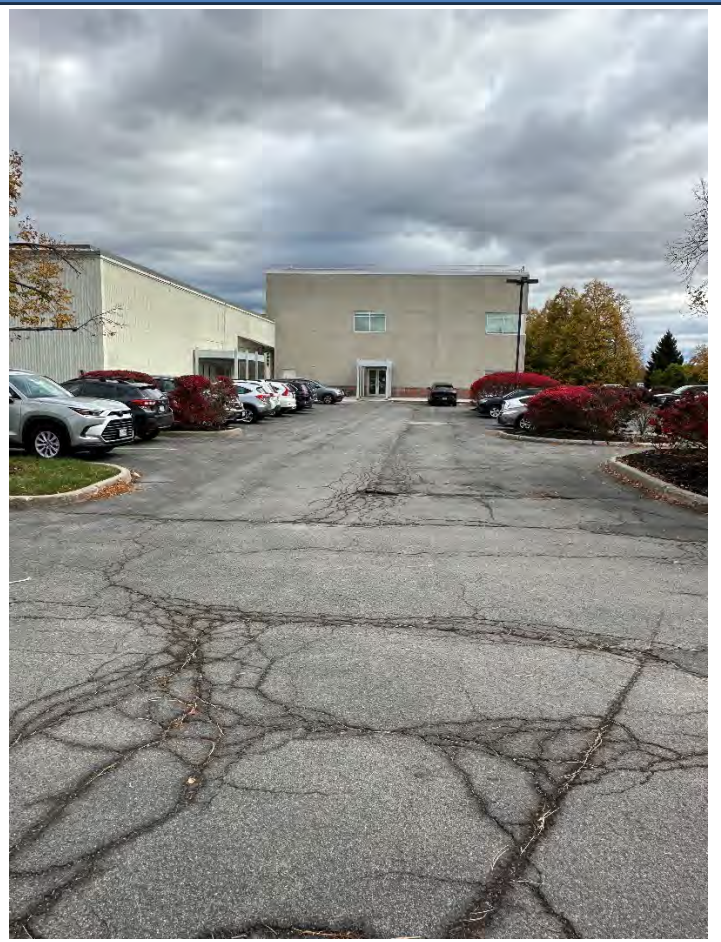
Photograph No.: 006  
Comments: West side, typical parking area pavement – looking East. Note cracking of pavement.

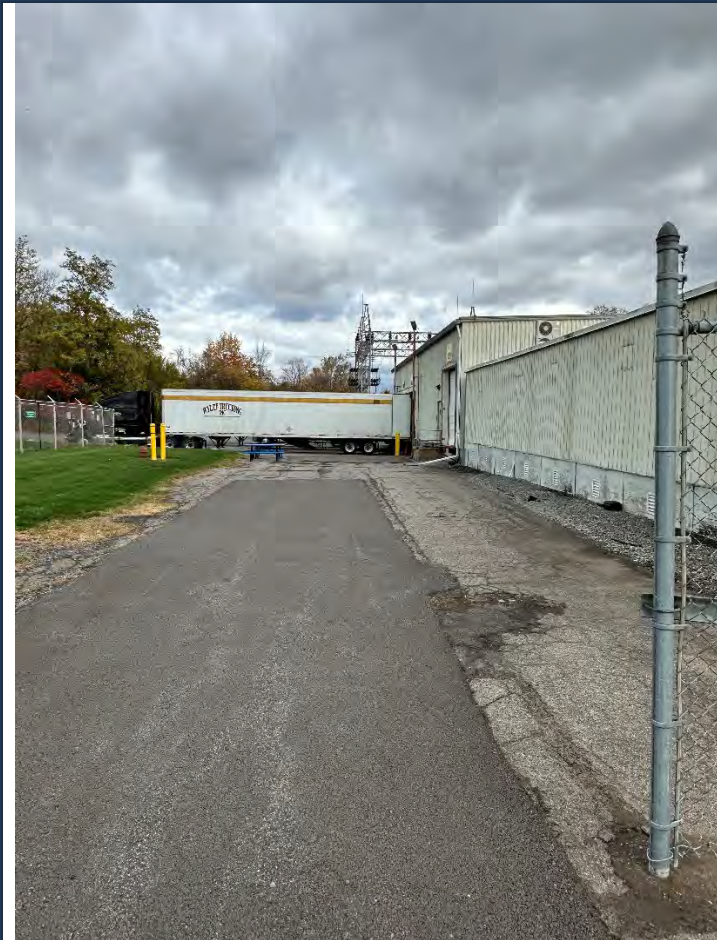
Photograph No.: 007

Comments: West side, paved area along building looking North toward loading docks. Note pavement repair.

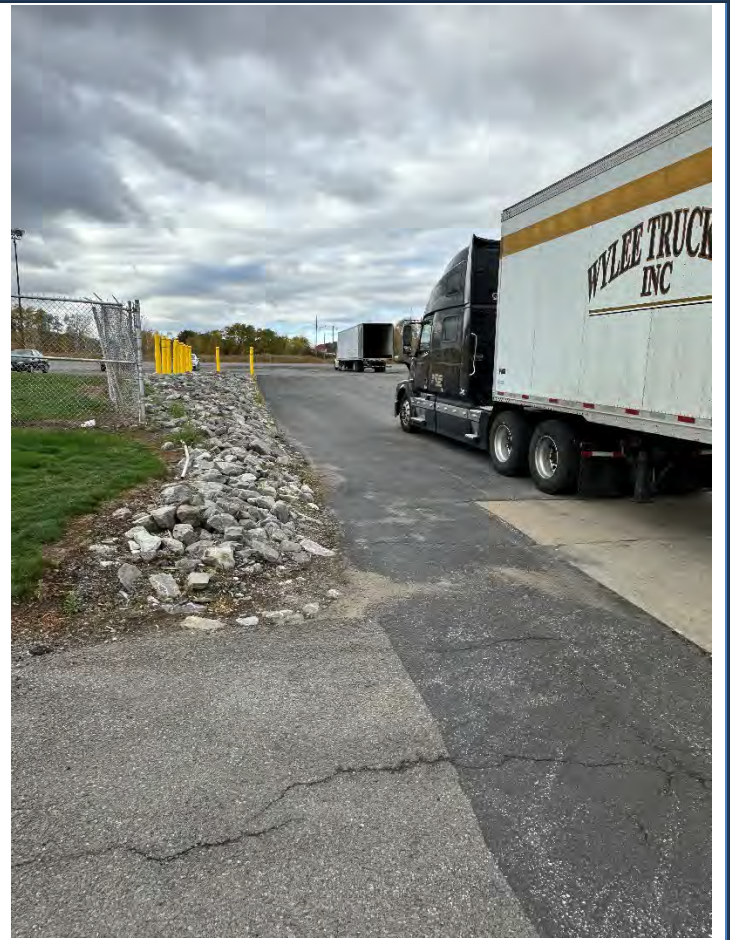
Photograph No.: 008

Comments: West side, paved area of entrance to back of main building – looking West.

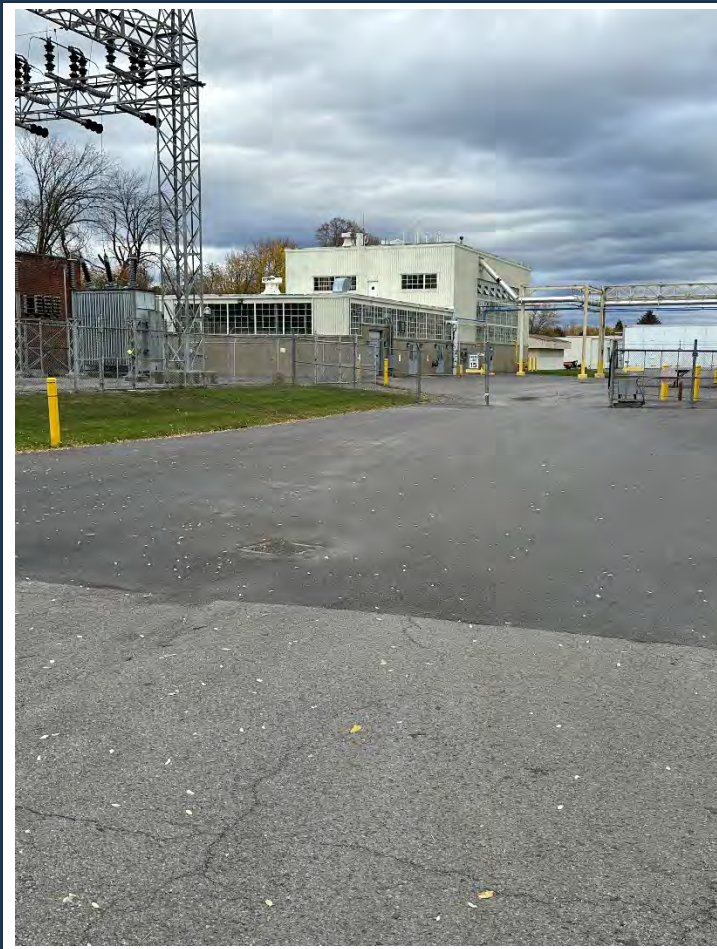
Photograph No.: 009  
Comments: North side - West end showing electrical substation - looking Northeast.

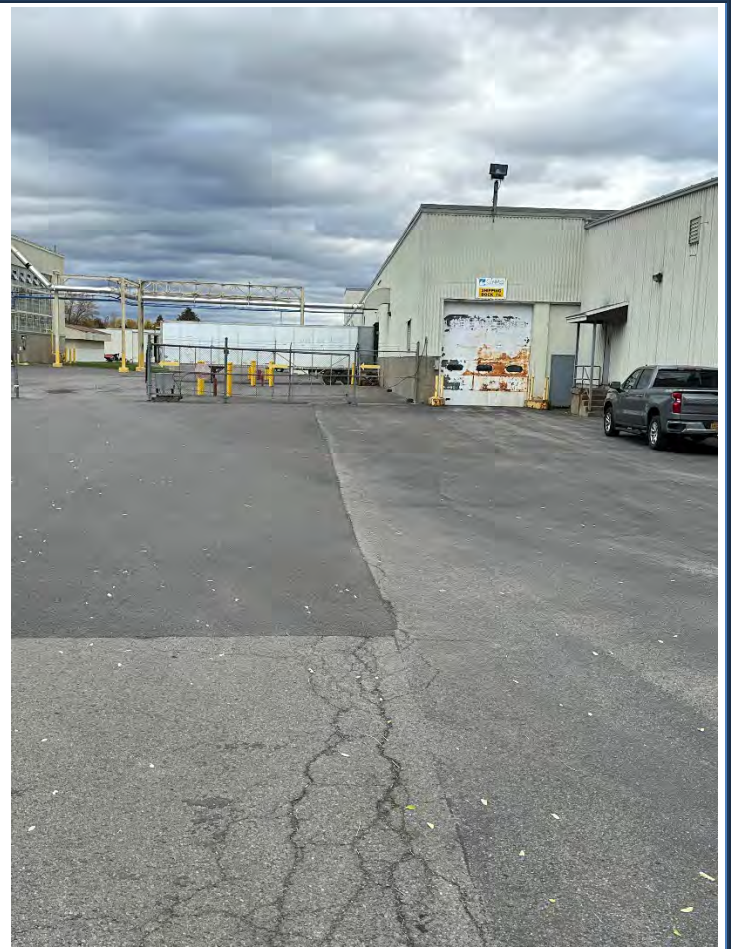
Photograph No.: 010  
Comments: North side - West end, overview of paved access drive - looking East.

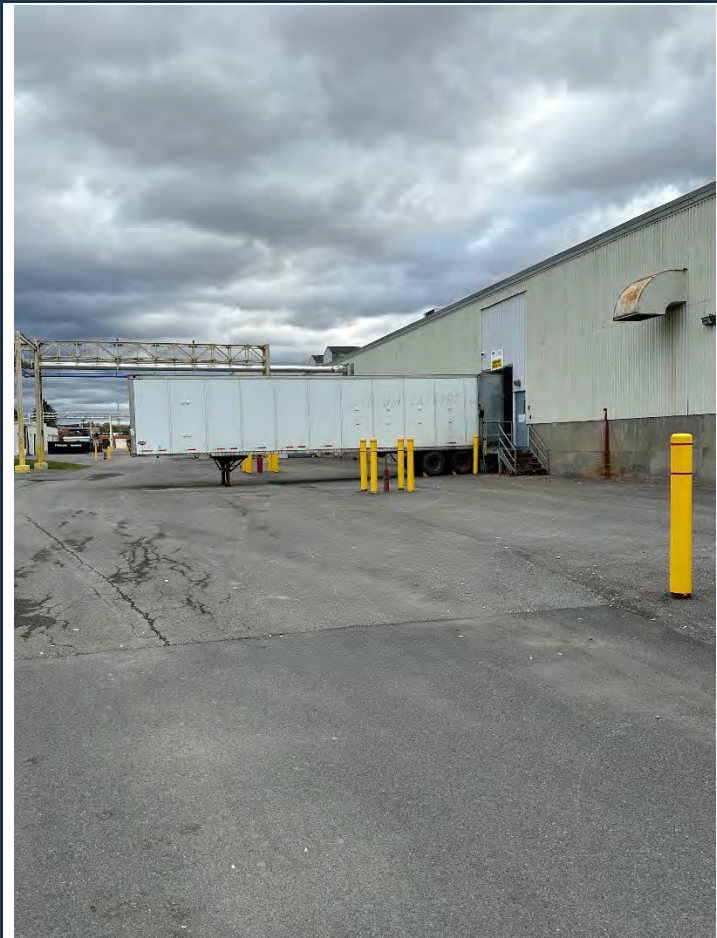
Photograph No.: 011  
Comments: North side, West end of building – looking East.

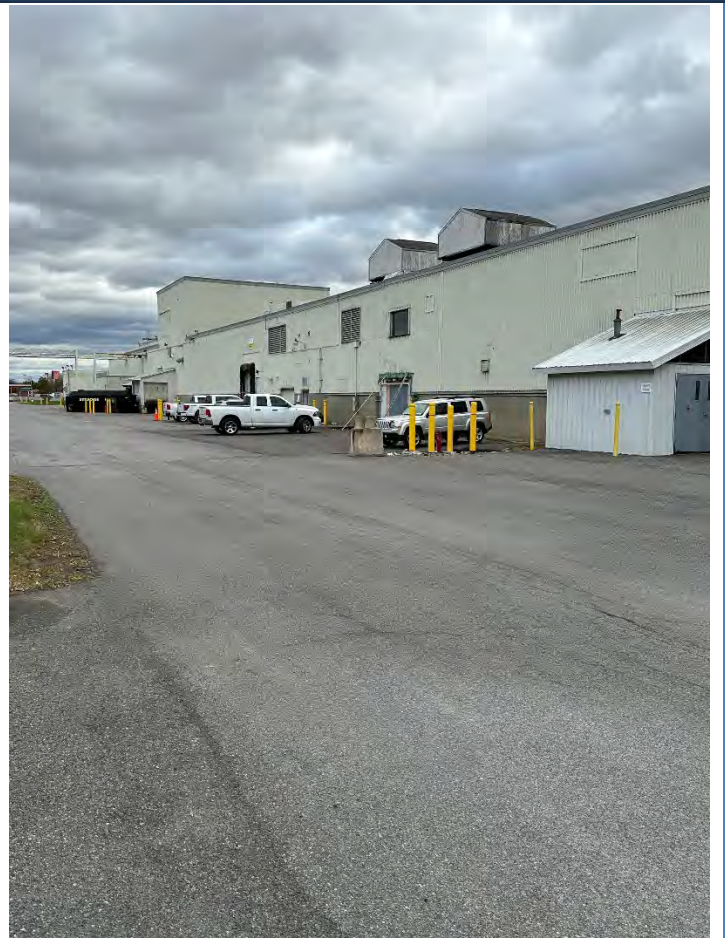
Photograph No.: 012  
Comments: North side of West end of building showing March 2022 waterline repair area – looking West. Note asphalt pavement repair in area of water line repair.

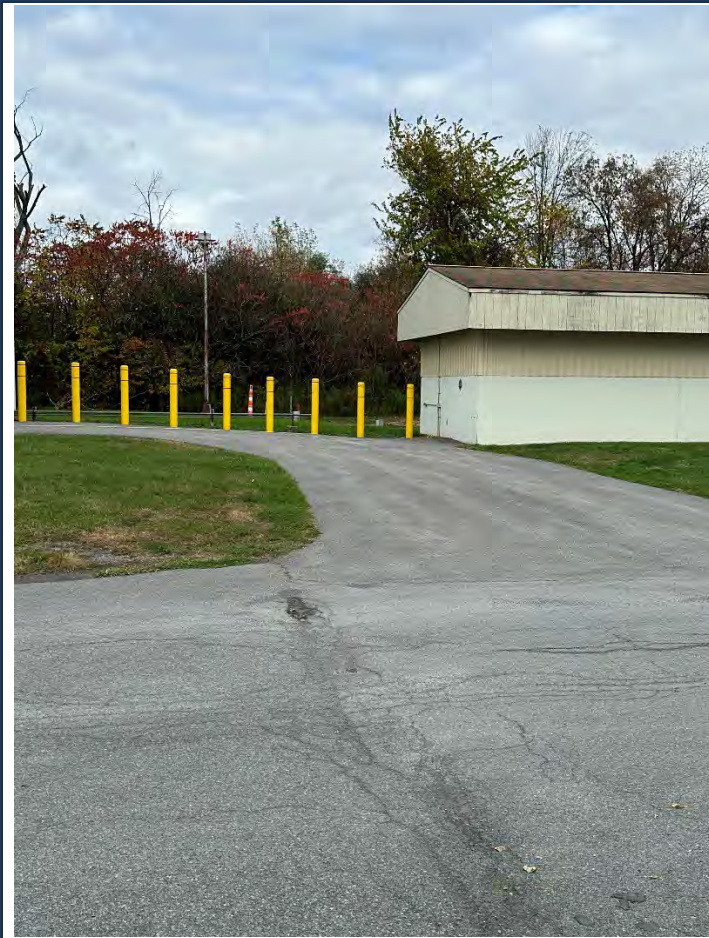
Photograph No.: 013  
Comments: North side, looking Northwest.

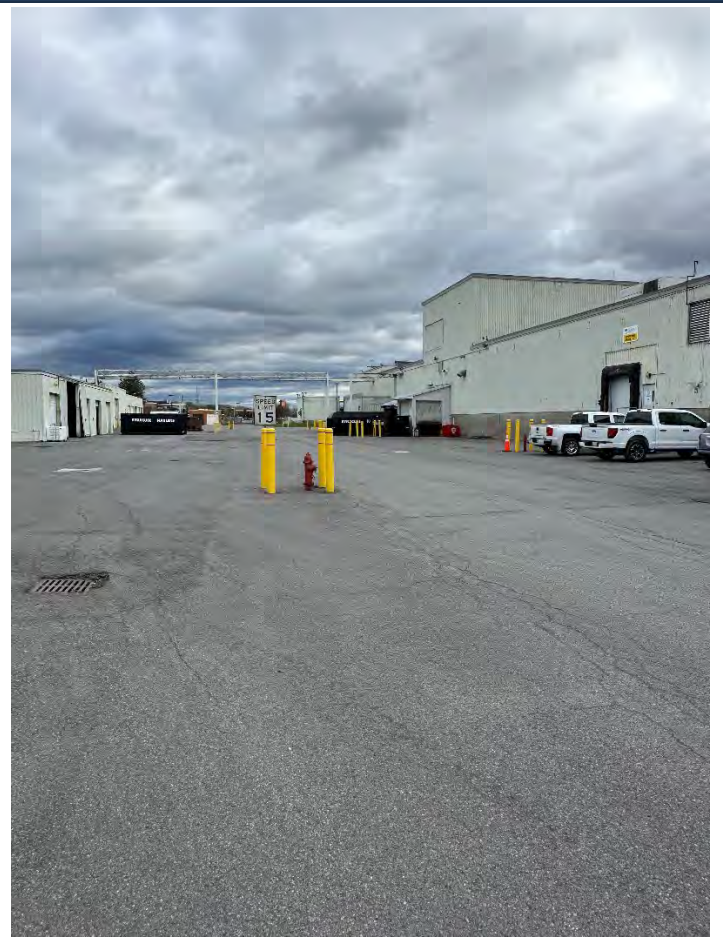
Photograph No.: 014  
Comments: North side - Central area main building - looking East.

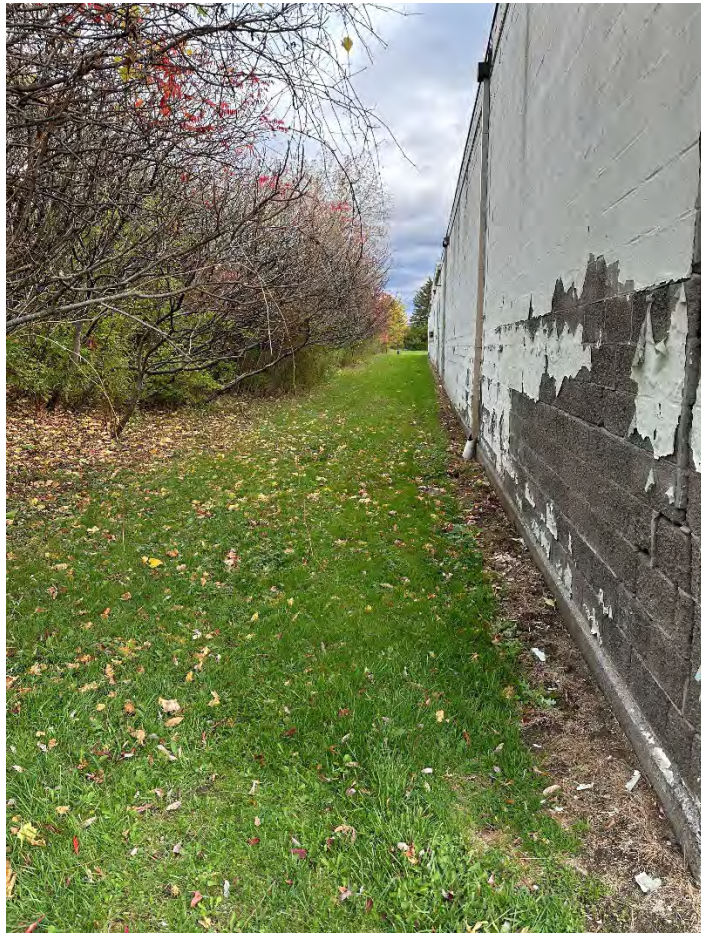
Photograph No.: 015  
Comments: Northside area, North of maintenance building – looking East.

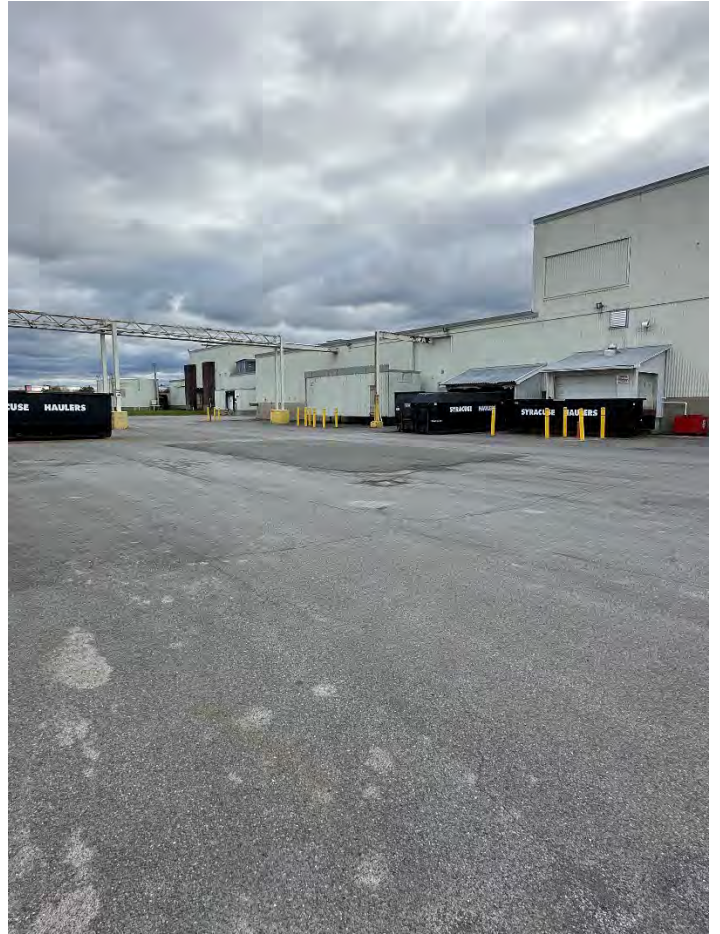
Photograph No.: 016  
Comments: North side – Central area, looking Southeast. Note asphalt pavement repair.

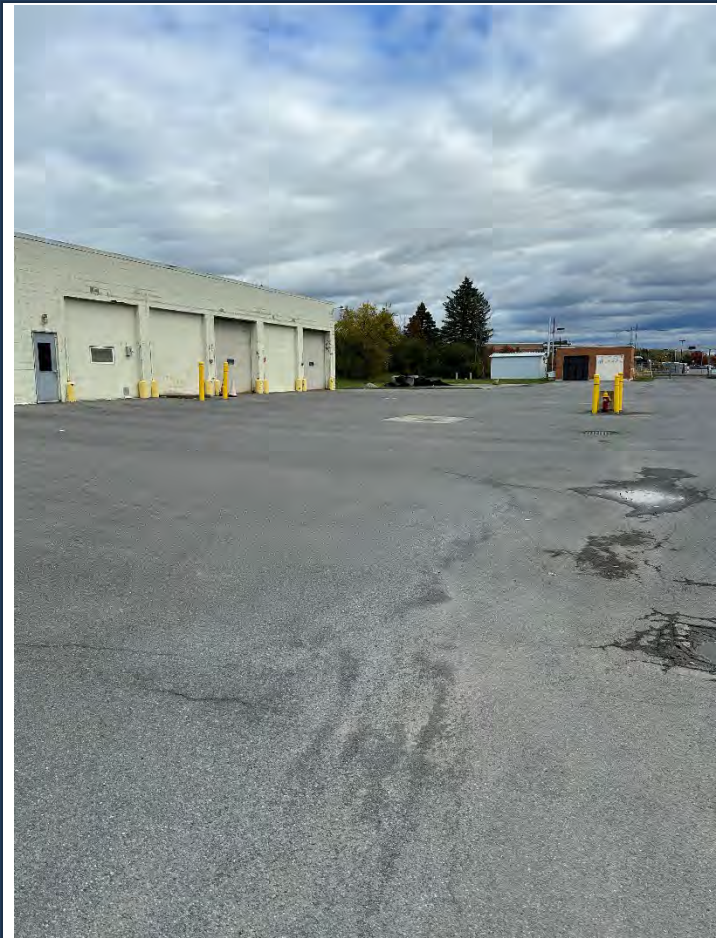
Photograph No.: 017  
Comments: North side – loading dock area – looking Northeast.

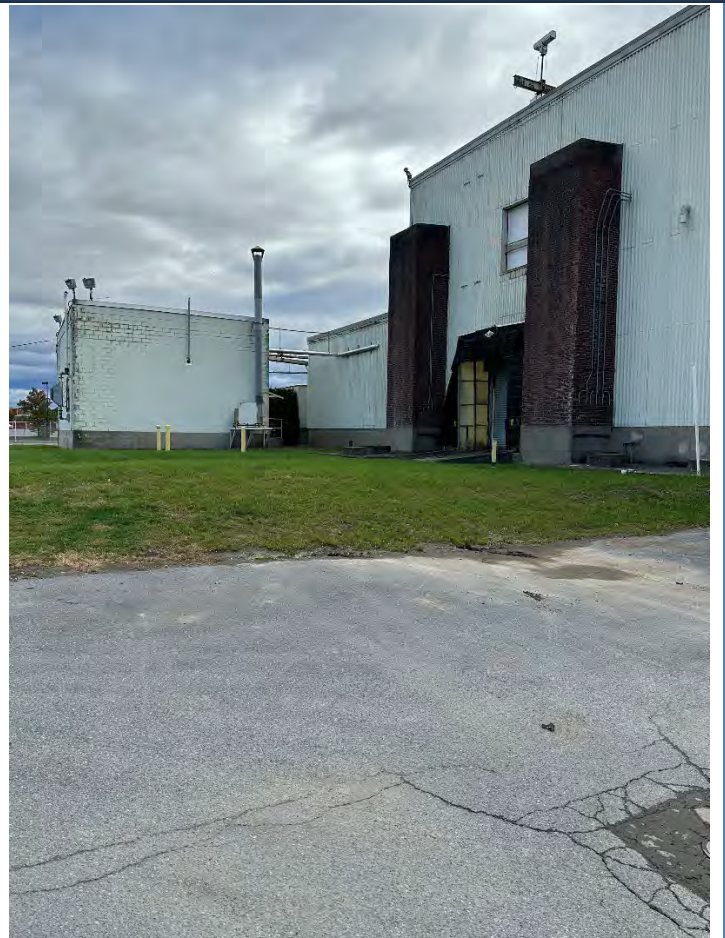
Photograph No.: 018  
Comments: North side, recently restored area from waterline repair in January 2025. – looking East.

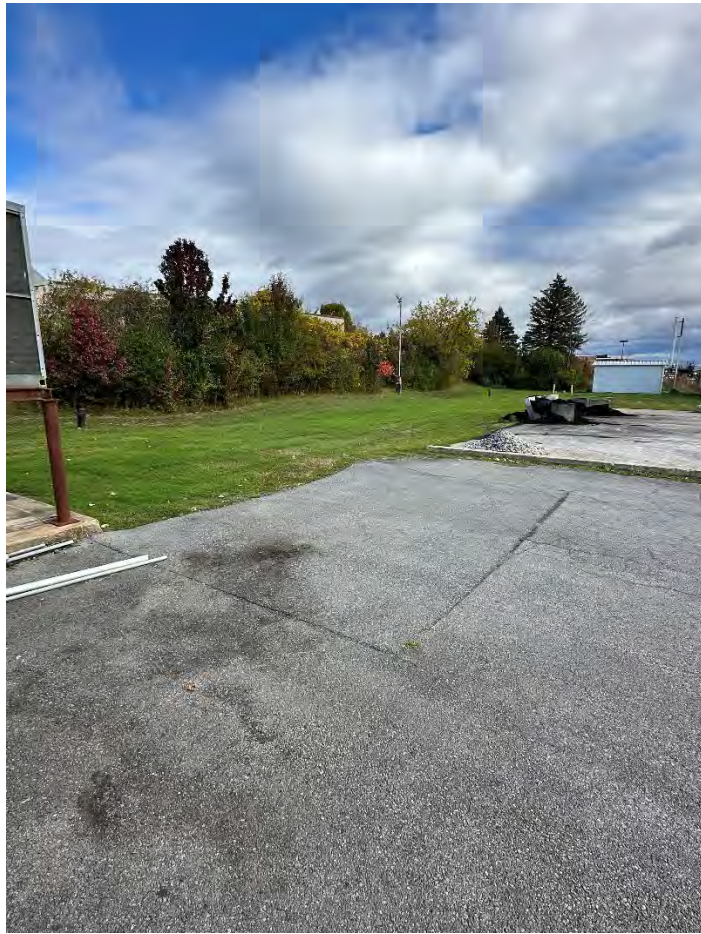
4. Former Pole Barn Concrete Slab – The concrete slab-on-grade remains for the former pole barn (see photo log location 19).

Photograph No.: 019  
Comments: North side, showing East side of former pole barn concrete slab – looking Northeast.

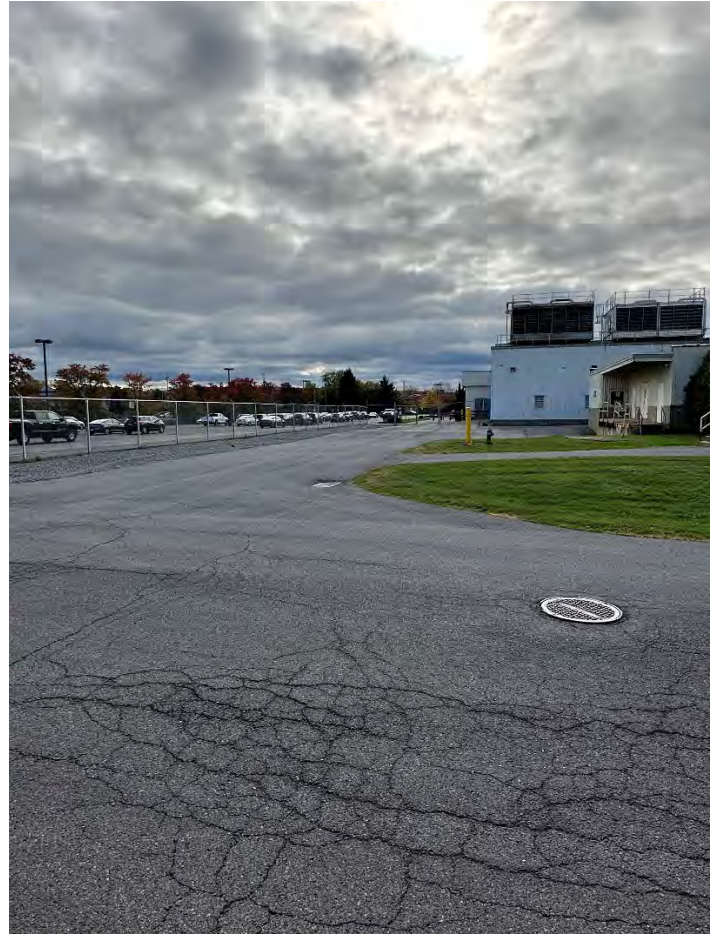
Photograph No.: 020  
Comments: East side, along security fence line – looking South.

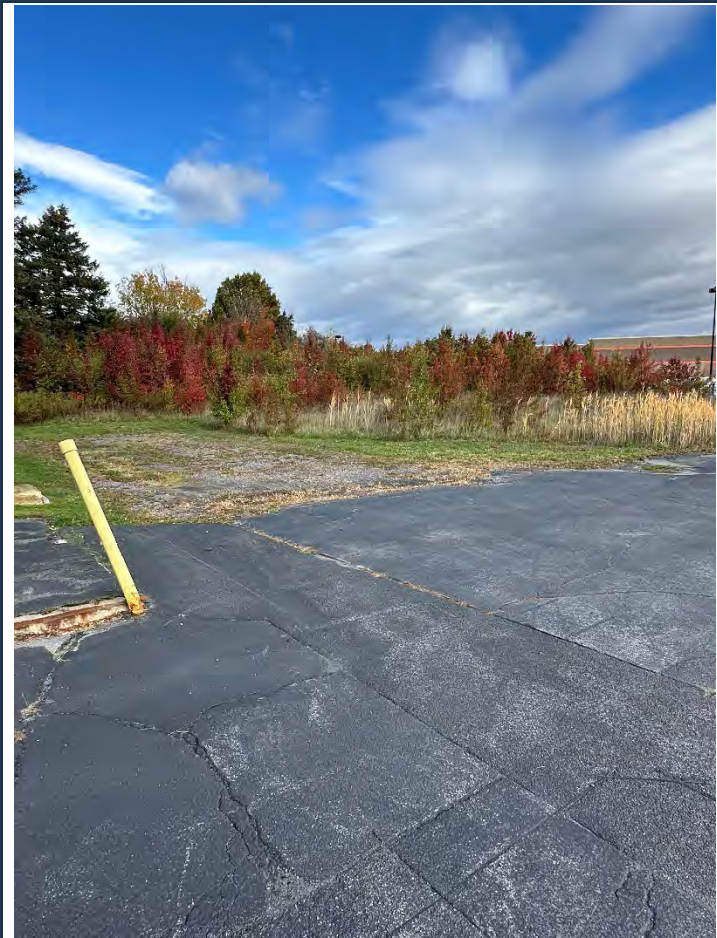
Photograph No.: 021  
Comments: East side – Northeast corner showing grass covered area – looking North.

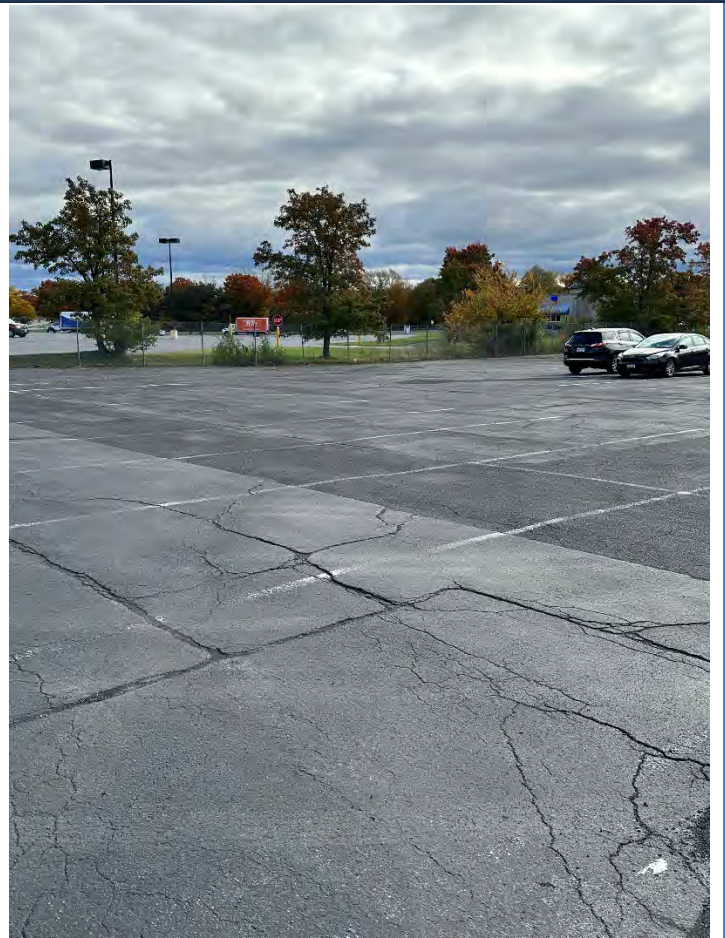
Photograph No.: 022  
Comments: East side – looking South along eastern fence line. Note cracking of asphalt pavement.

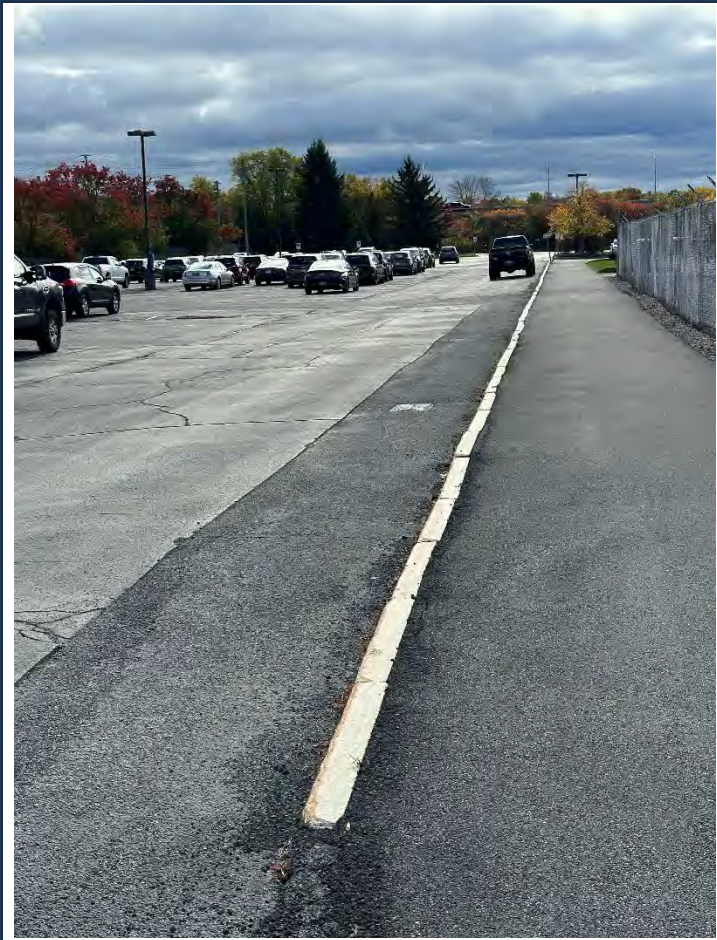
Photograph No.: 023  
Comments: East side – showing parking/pavement area – looking South.

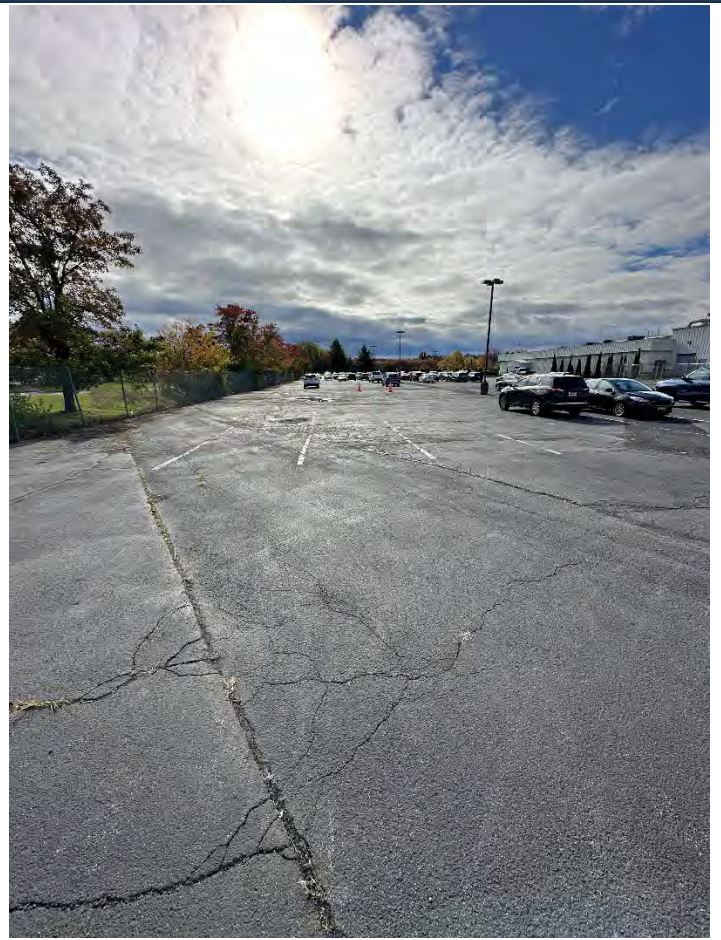
Photograph No.: 024  
Comments: East side – looking South along eastern fence line. Note minor pavement cracking.

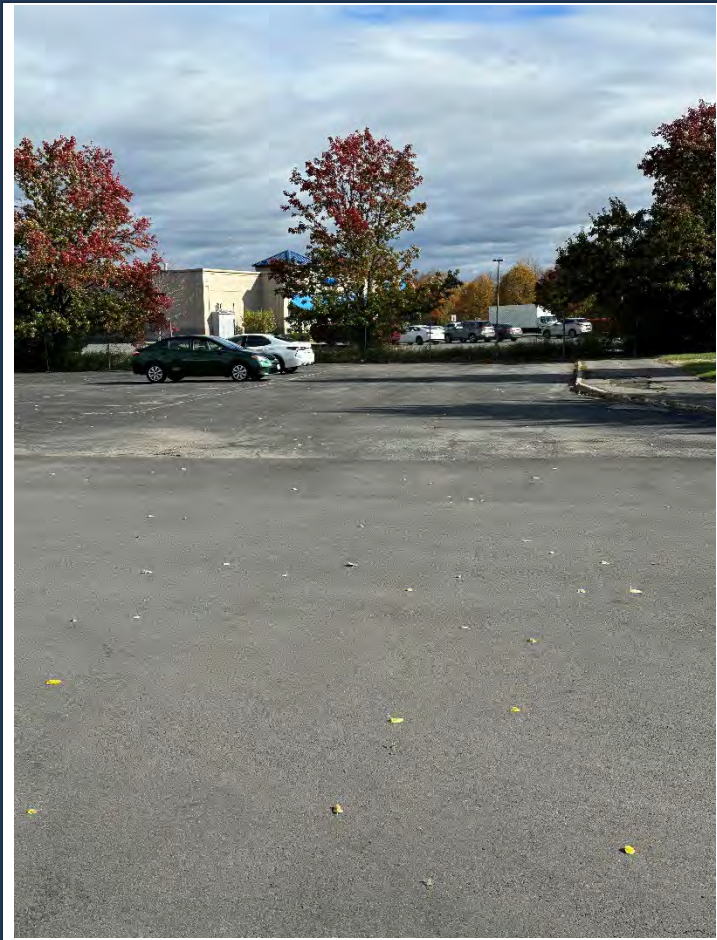
Photograph No.: 025  
Comments: East side – showing parking/pavement area – looking East.

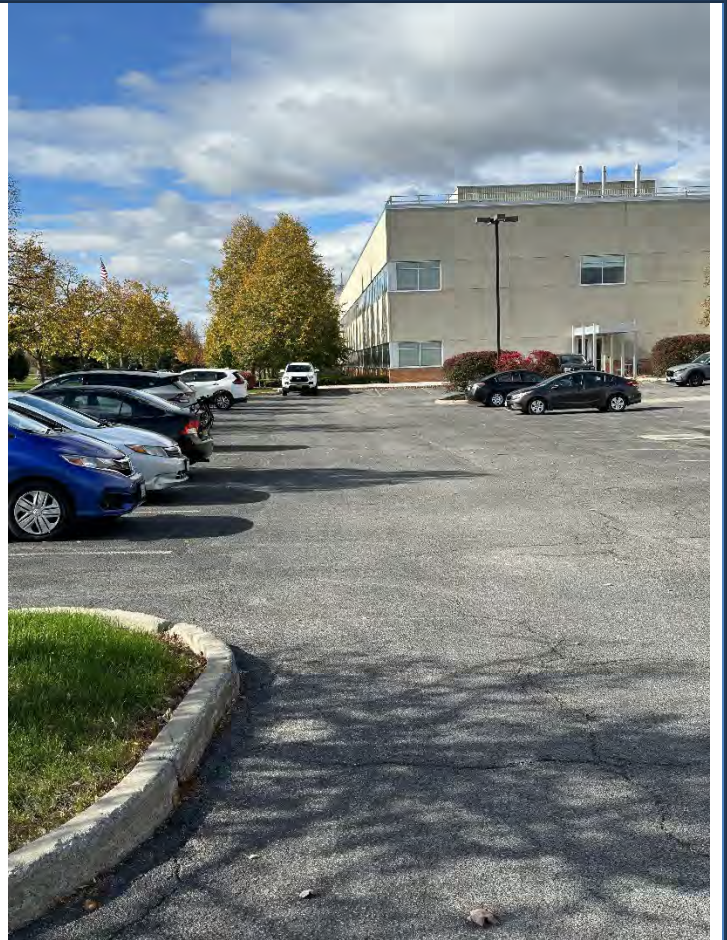
Photograph No.: 026  
Comments: East side – showing parking/pavement area and main building – looking West.

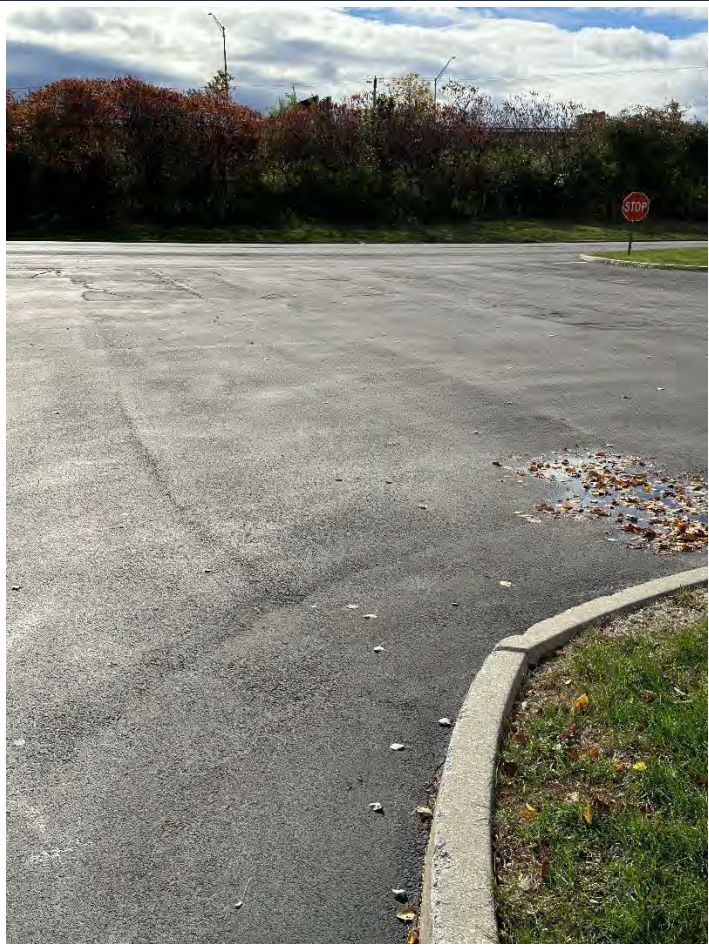
Photograph No.: 027  
Comments: East side – showing parking/pavement area – looking South.

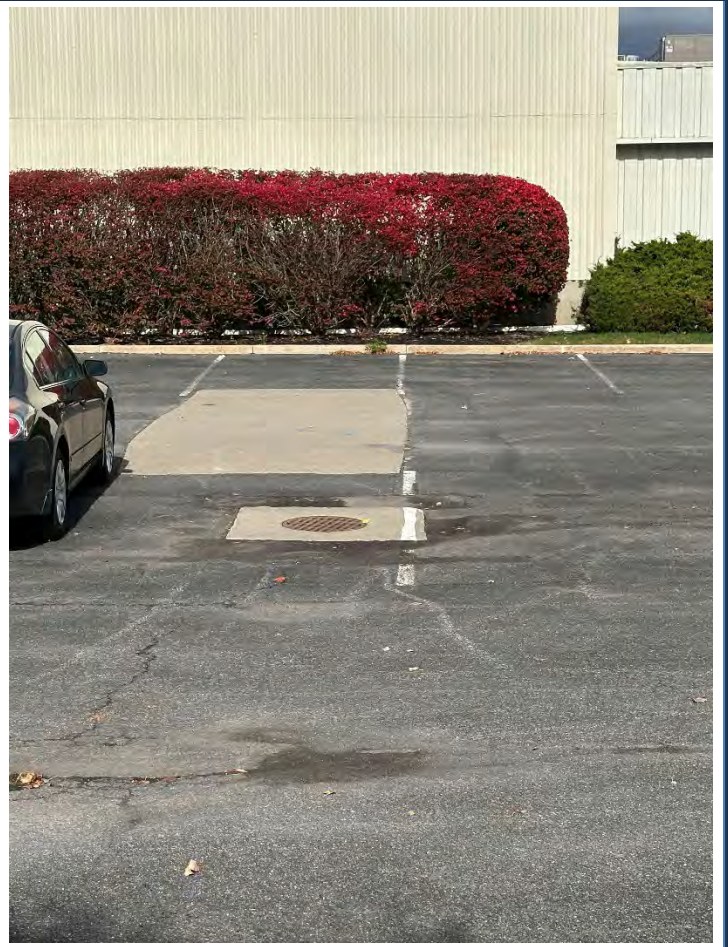
Photograph No.: 028  
Comments: East side – showing water main repair/concrete patch – looking North.

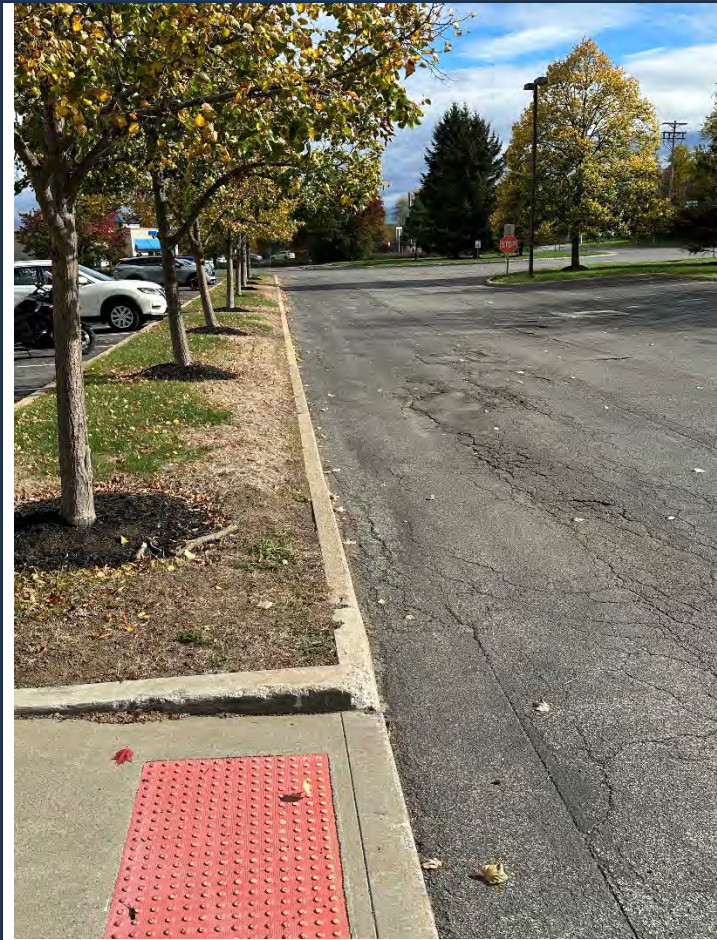
Photograph No.: 029  
Comments: South side - East end showing typical pavement/landscaping - looking East.

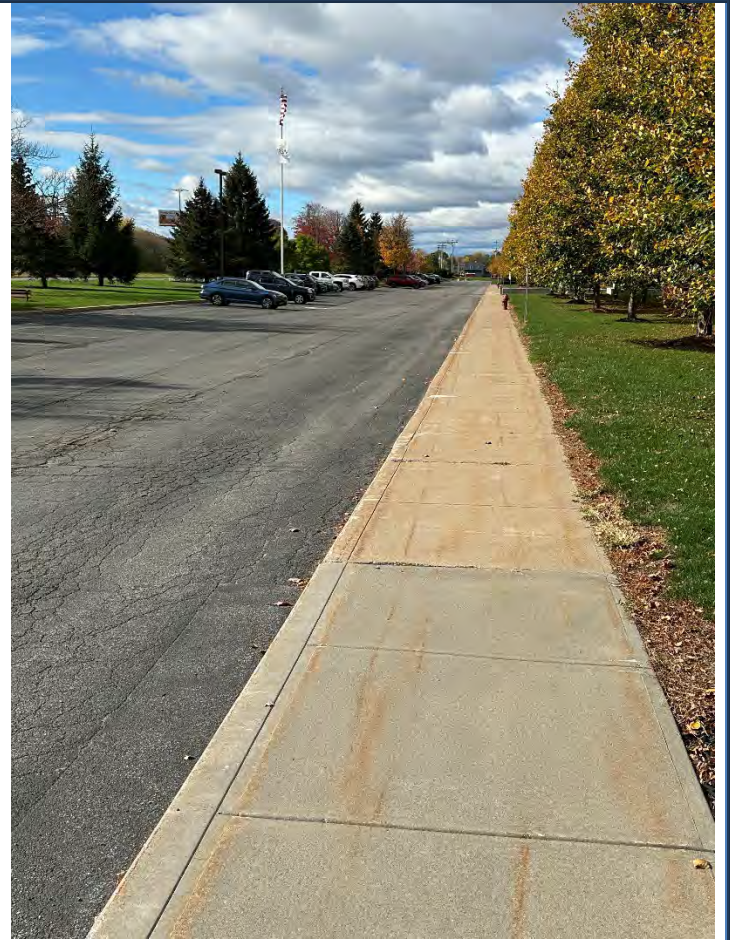
Photograph No.: 030  
Comments: South side - East end showing typical pavement/landscaping - looking West.
