**Re: Site Photo Logs  
Former Matt/Grace Petroleum  
201 Leland Avenue  
Utica, New York (Oneida County)  
NYSDEC Spill# 88-09026**

**Photo Logs**

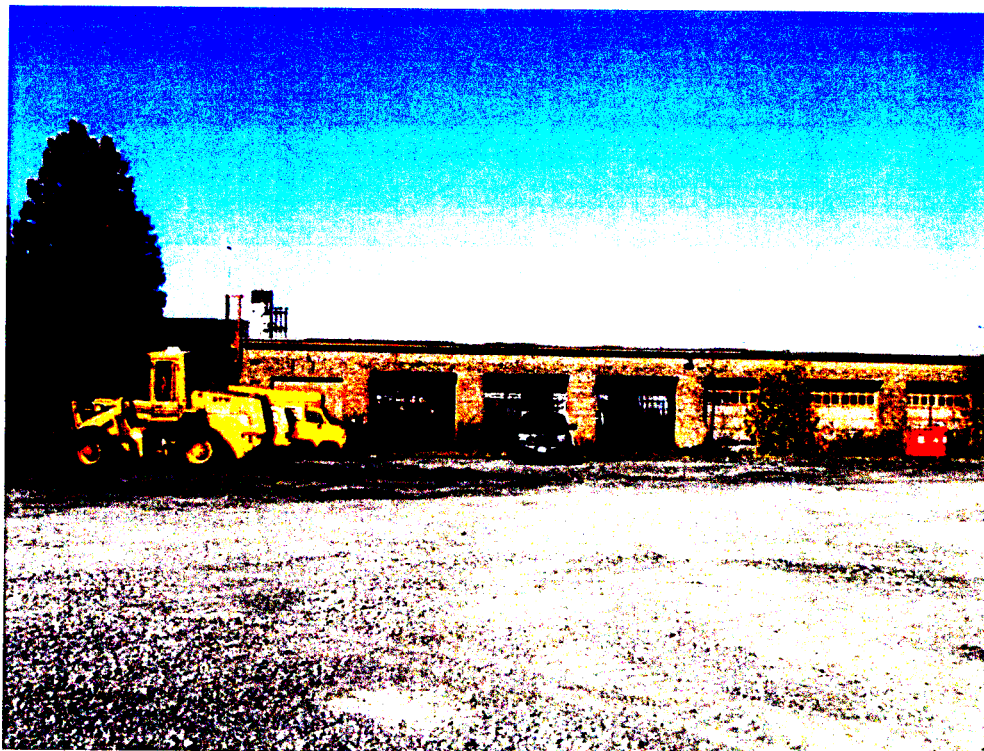
Photo #1: October 10, 2011 – Vacant brick building.

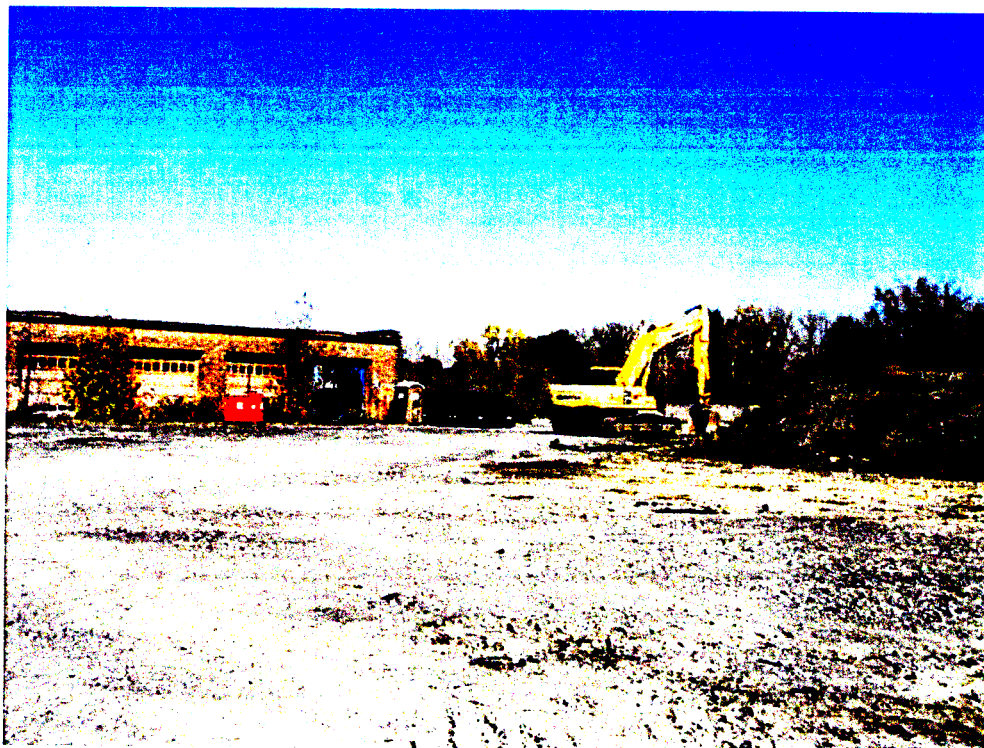
Photo #2: October 10, 2011 – Pre-excavation site photo.

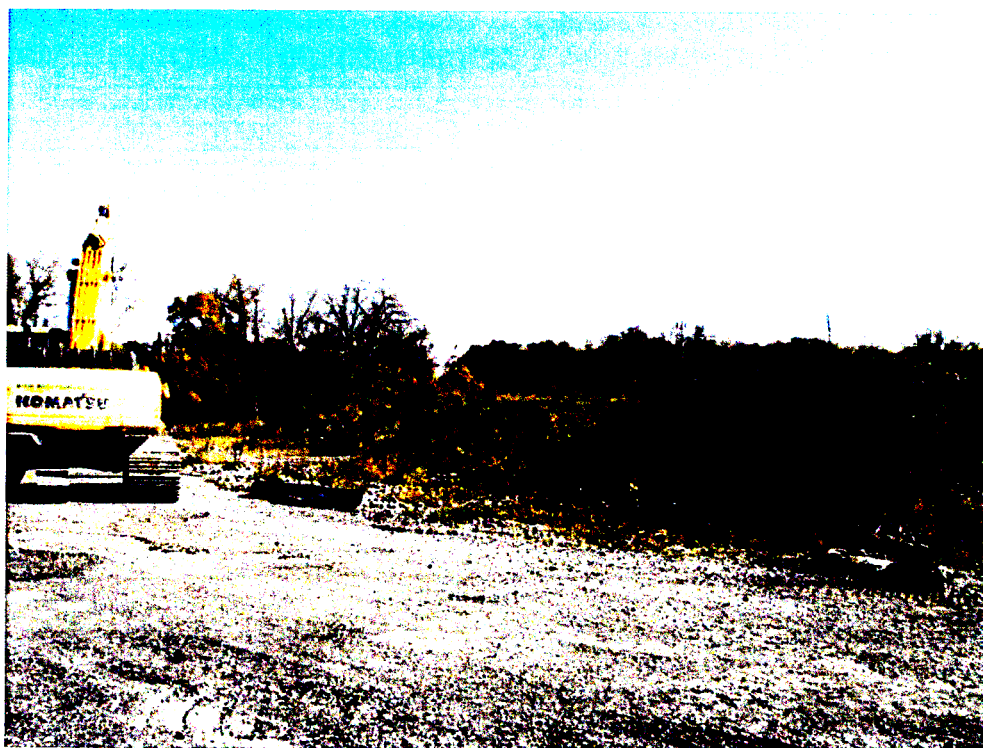
Photo #4: October 10, 2011 – Pre-excavation site photo, three staged soil piles.

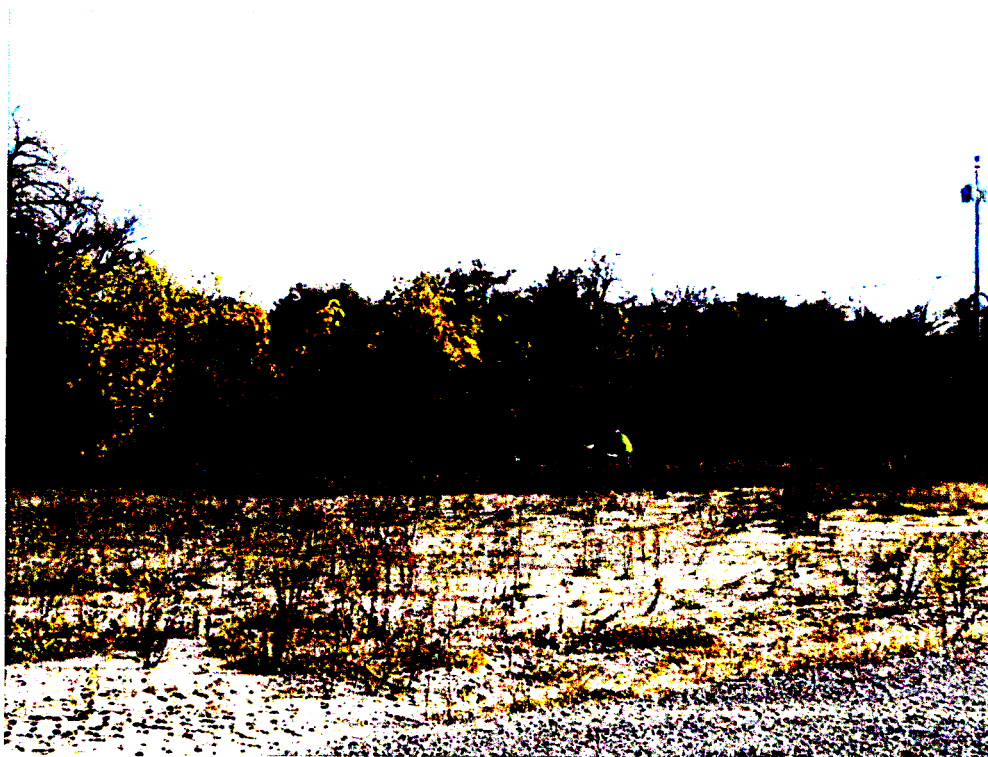
Photo #7: October 10, 2011 – Installation of silt fencing along northern property line.

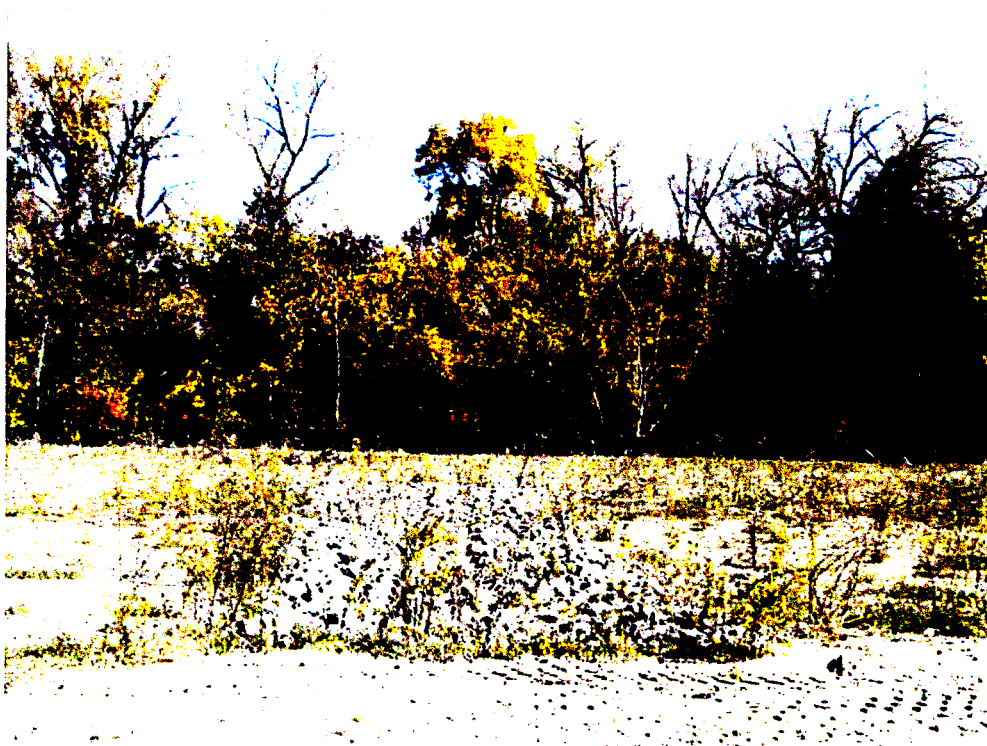
Photo #8: October 10, 2011 – Installation of silt fencing along northern property line.

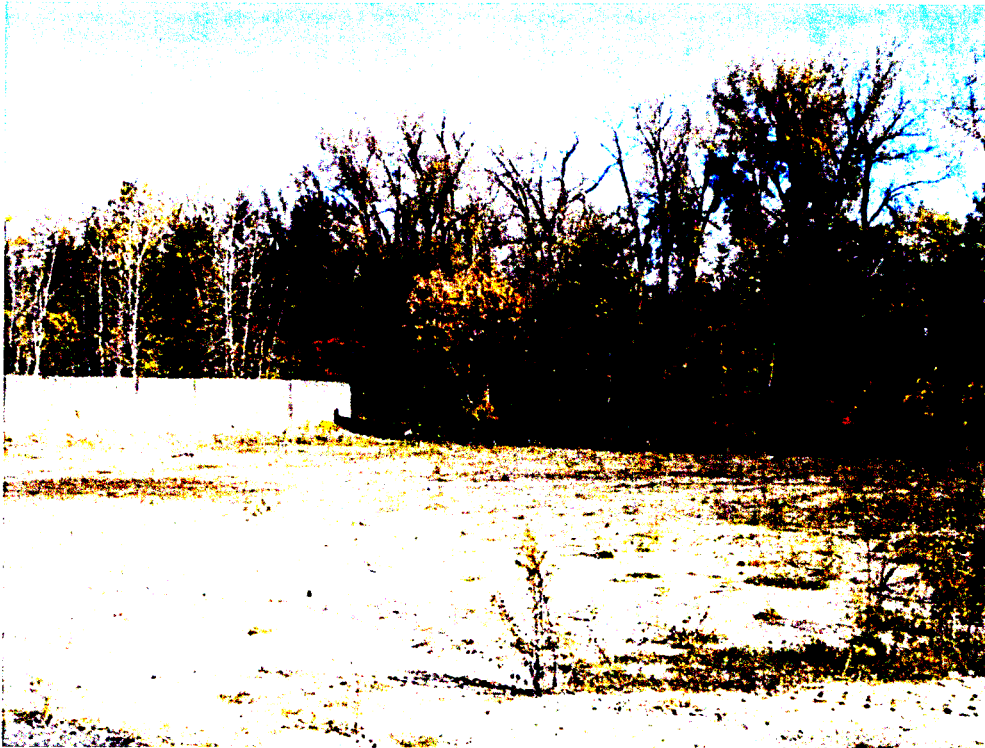
Photo #9: October 10, 2011 – Installation of silt fencing along northern property line.

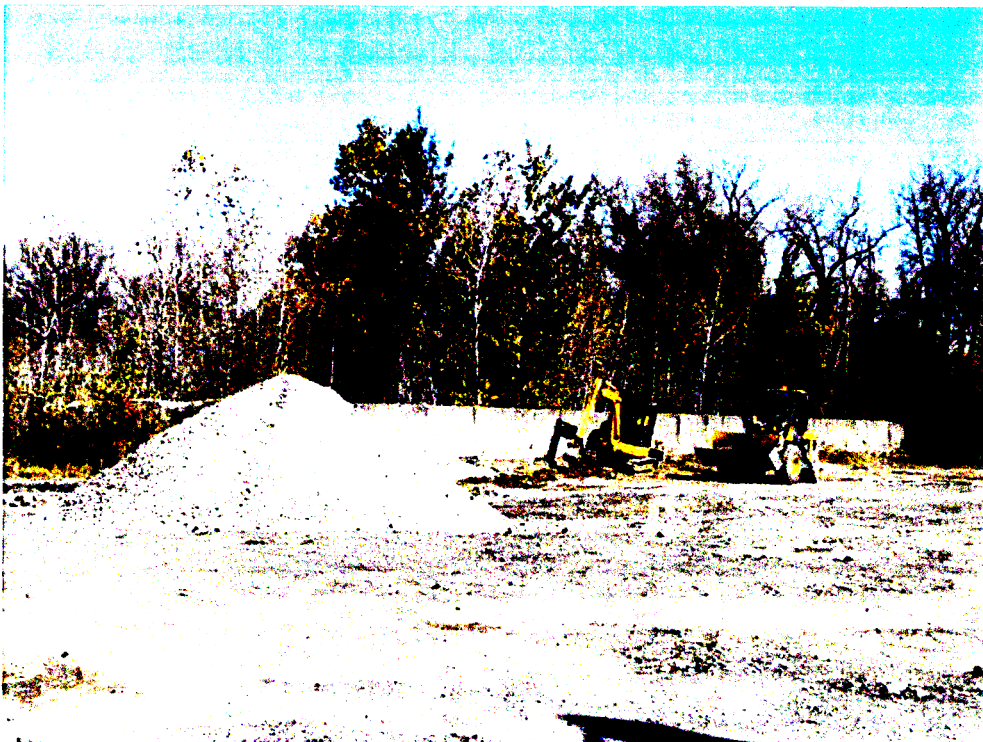
Photo #10: October 10, 2011 – Trenching drainage ditch around northern property line.

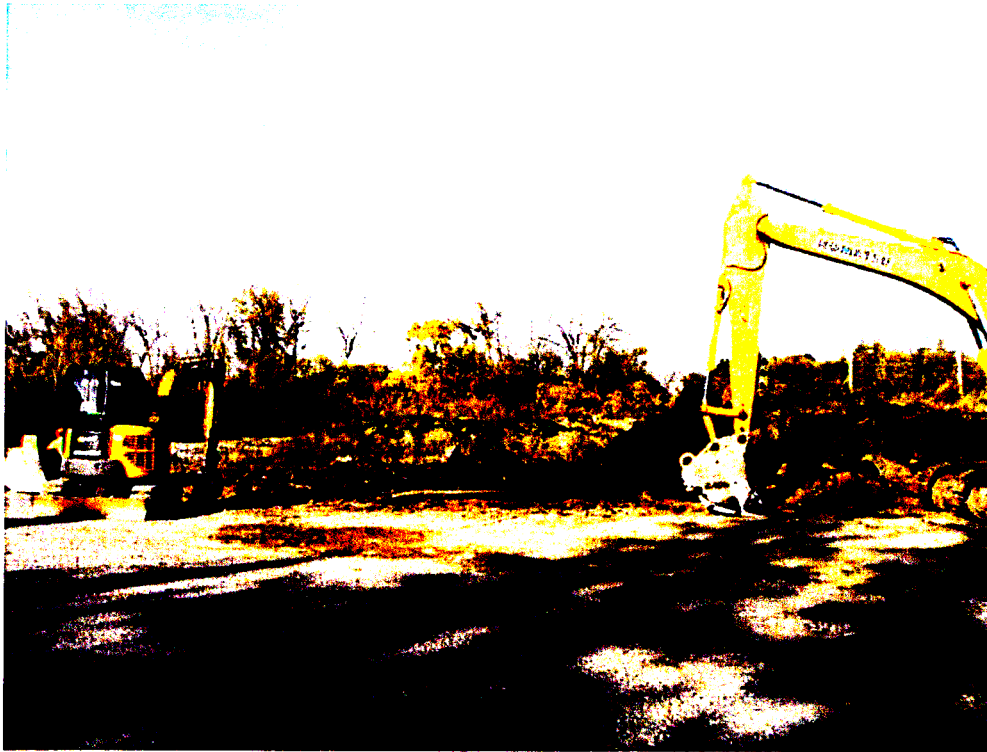
Photo #11: October 10, 2011 – Beginning Phase I: Moving staged soil to new windrows.

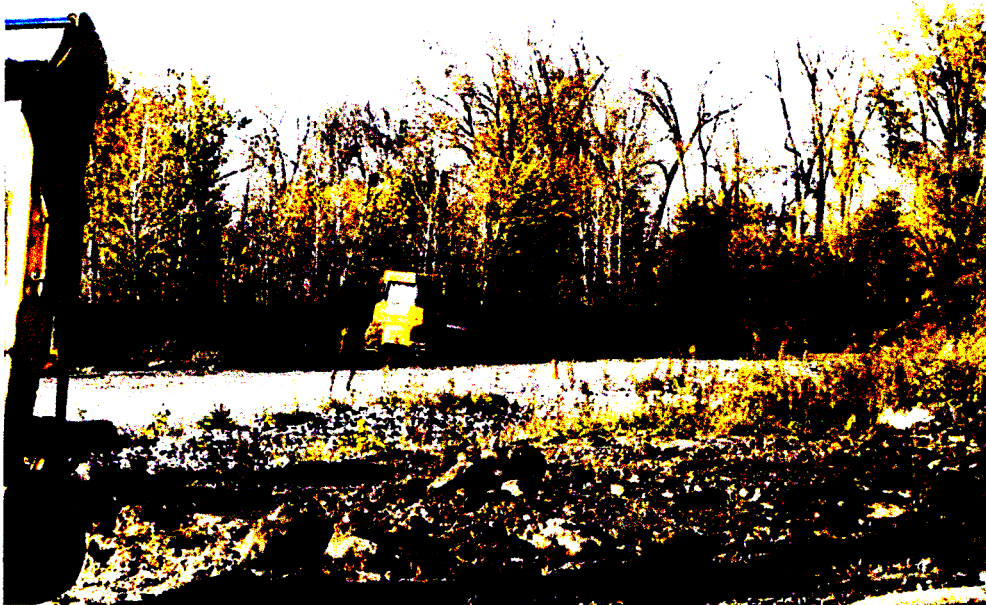
Photo #12: October 10, 2011 – Phase I: Staging new windrows in northwest corner of property.

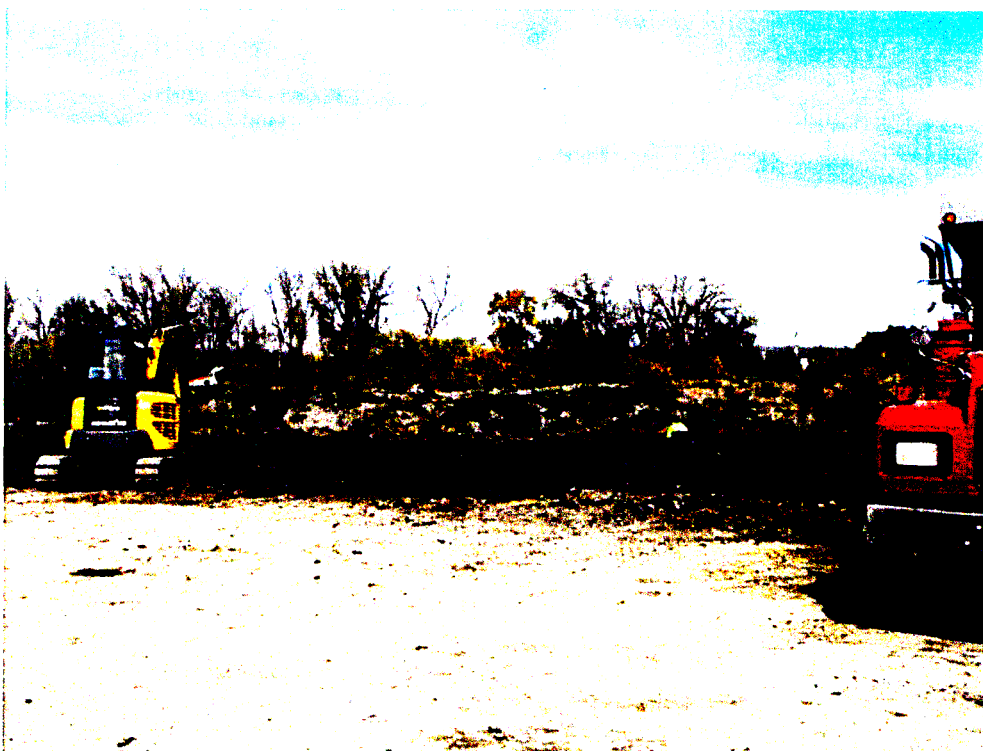
Photo #13: October 11, 2011 – Phase I: Building a road across proposed excavation area to load dump trucks.

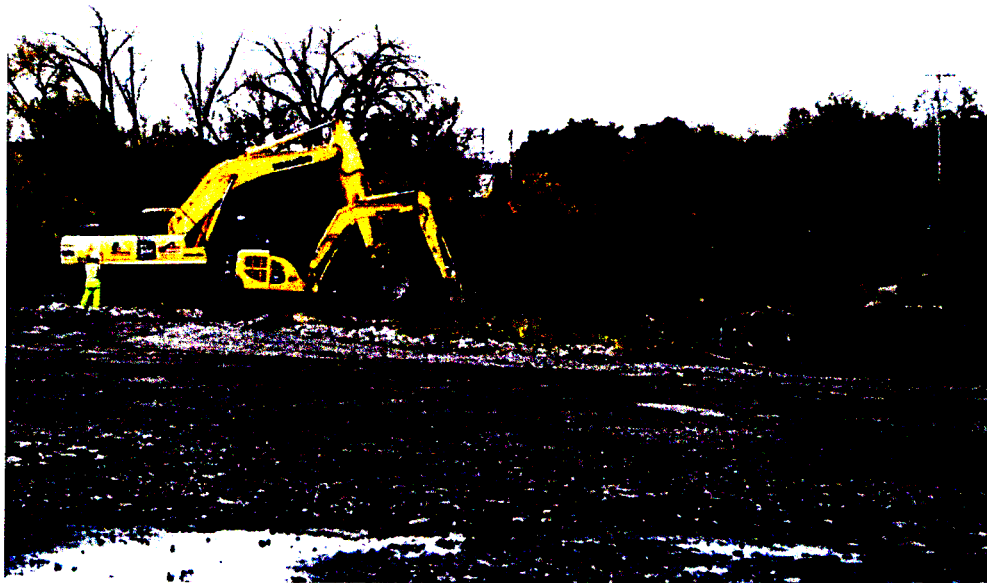
Photo #18: October 13, 2011 – Phase I: Excavating the 3<sup>rd</sup> staged soil pile, excavated ~1062 yd<sup>3</sup> to date.

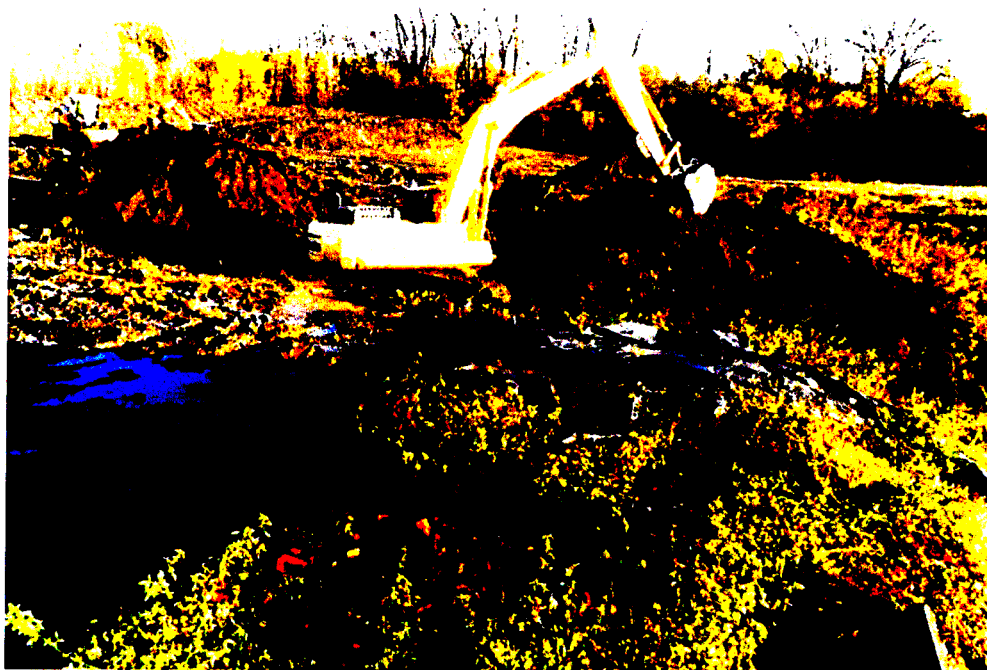
Photo #19: October 17, 2011 – Phase I: Excavating the 3<sup>rd</sup> staged soil pile.

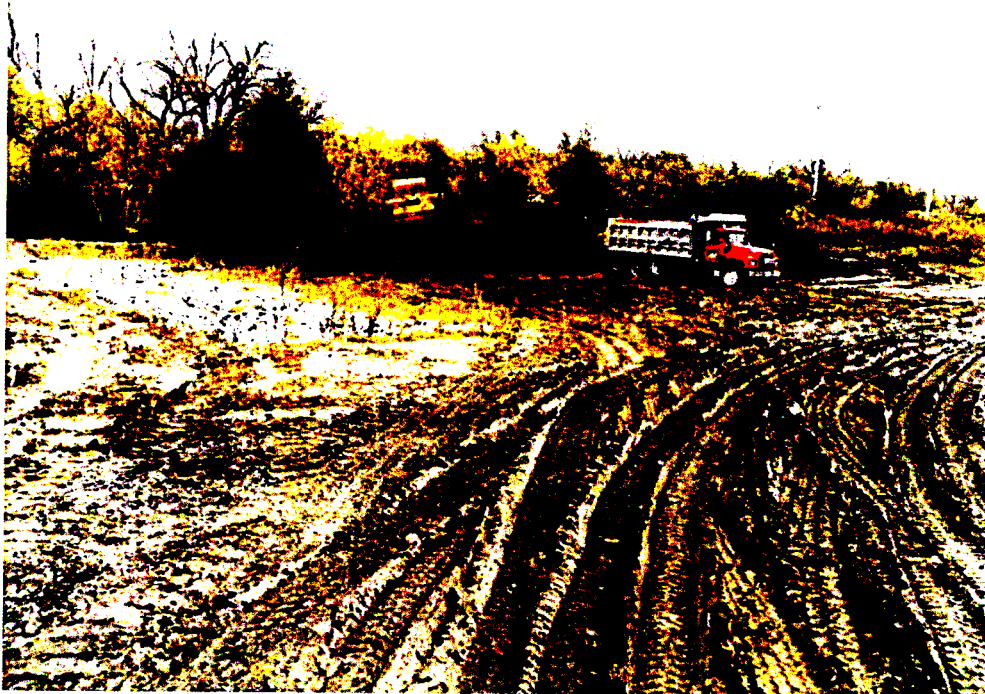
Photo #21: October 17, 2011 – Phase I: Loaded dump truck moving stage soil to new windrows.

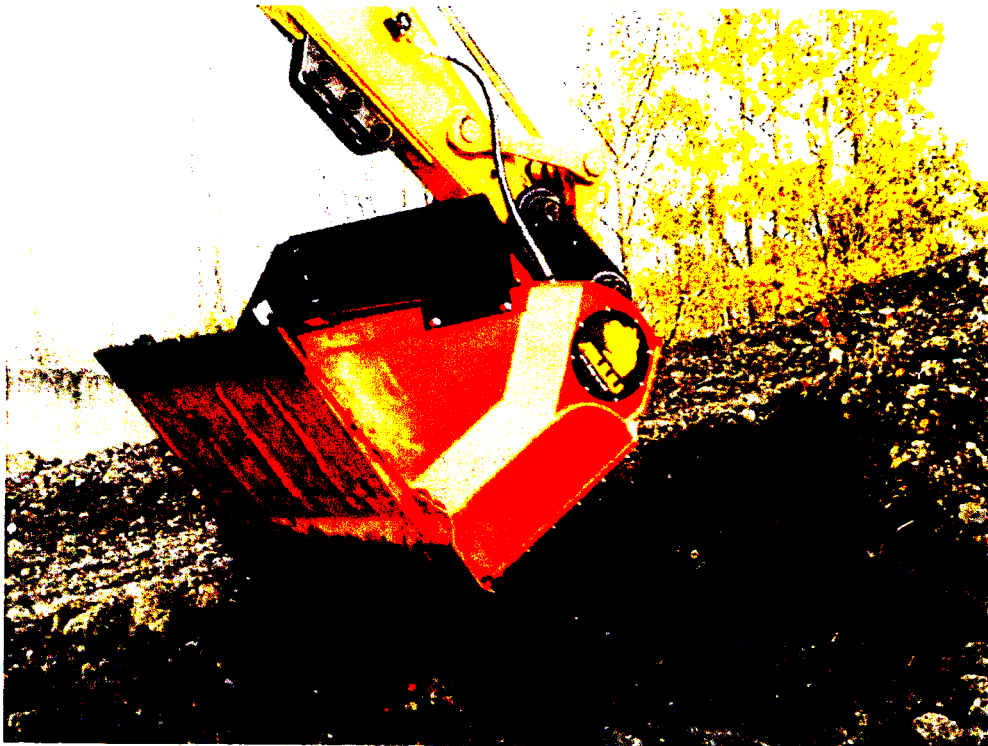
Photo #24: October 19, 2011 – Beginning of Phase II: Aeration of Windrow 1 via Allu excavator.

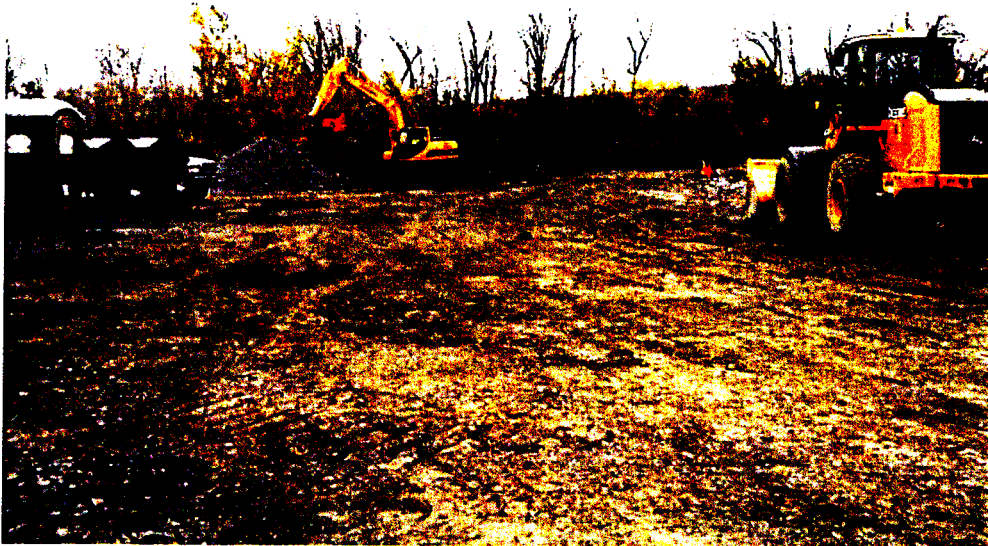
Photo #25: October 19, 2011 –Phase II: Aeration of Windrow 1 via Allu excavator.

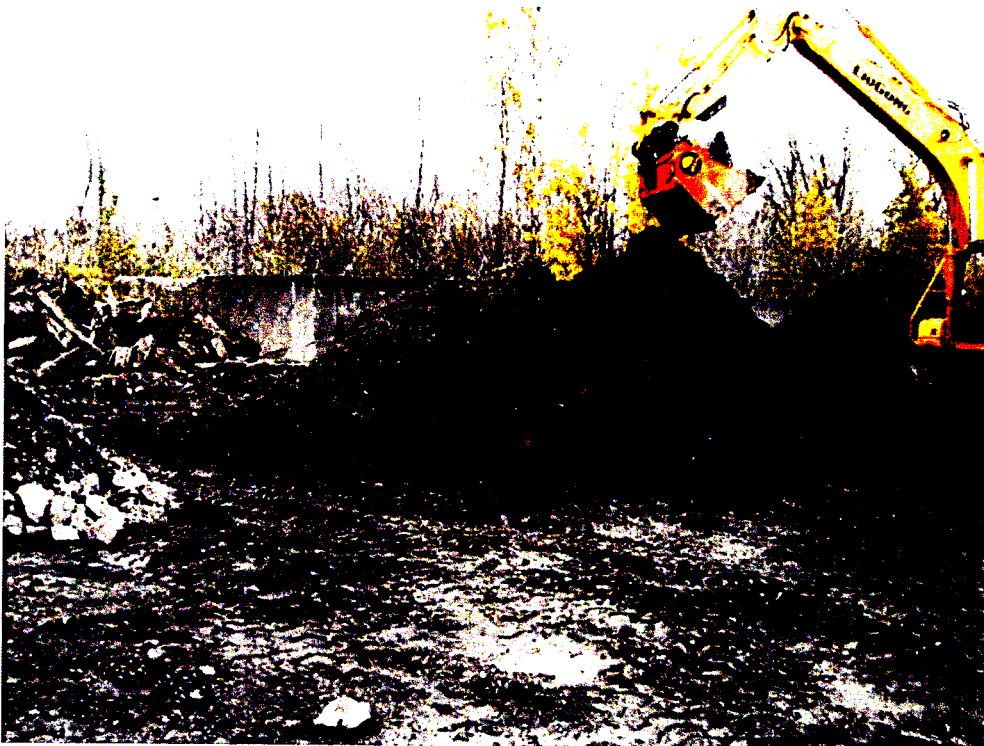
Photo #26: October 20, 2011 –Phase II: Aeration of Windrow 1 via Allu excavator.

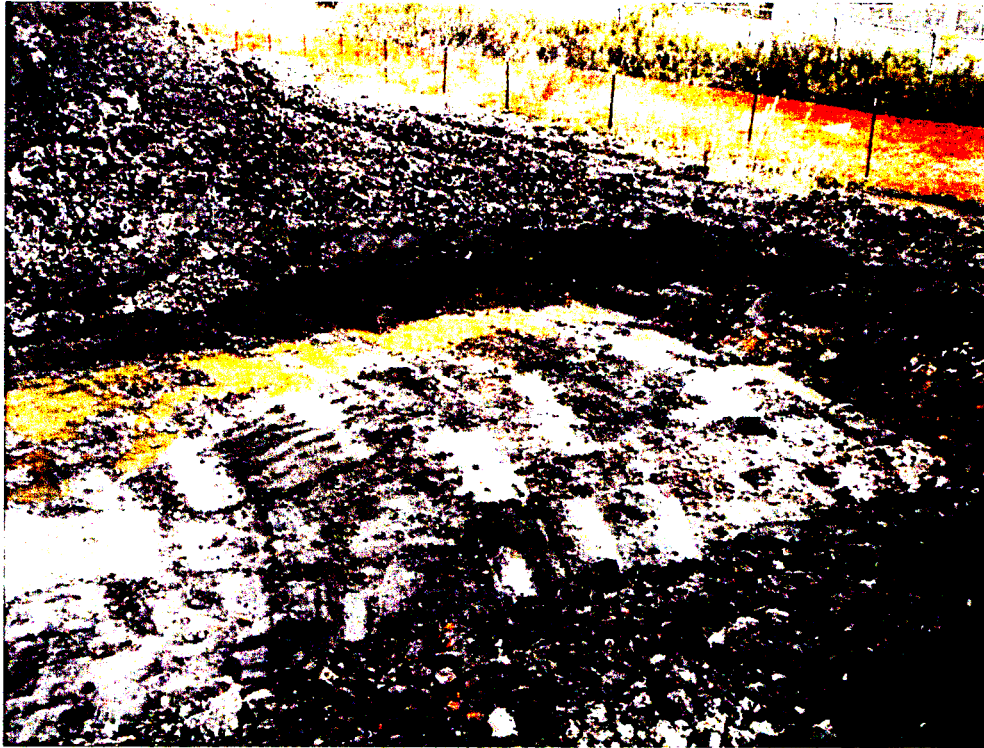
Photo #31: October 21, 2011 –Phase I: Completion of Excavation 2.

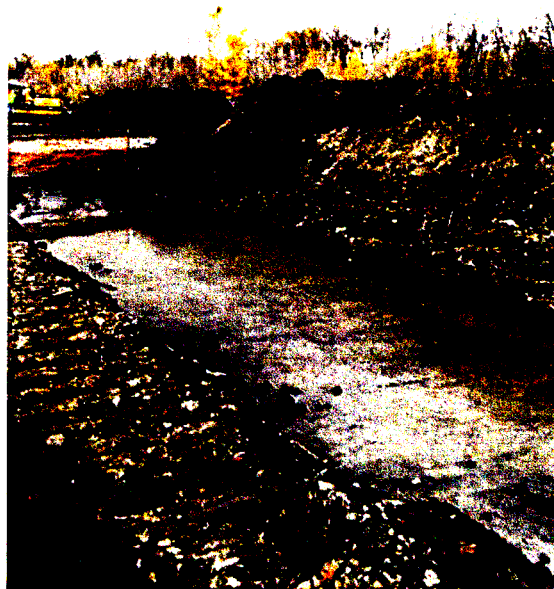
Photo #32: October 21, 2011 –Phase I: Completion of Excavation 2.

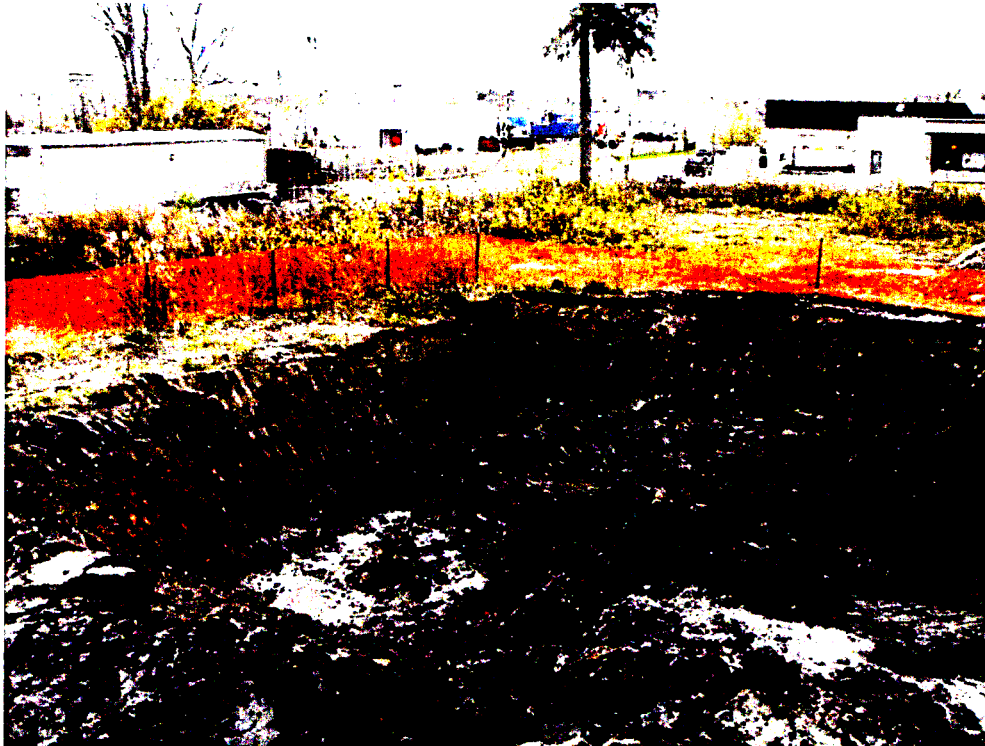
Photo #33: October 21, 2011 –Phase I: Beginning of Excavation 3.

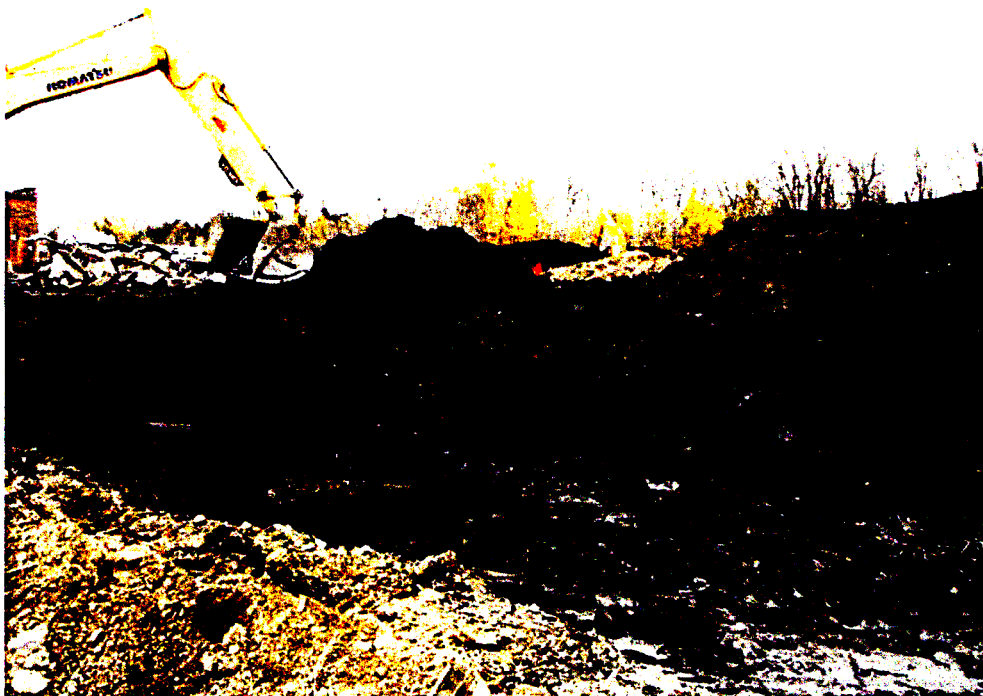
Photo #34: October 24, 2011 –Phase I: Continuation of Excavation 3.

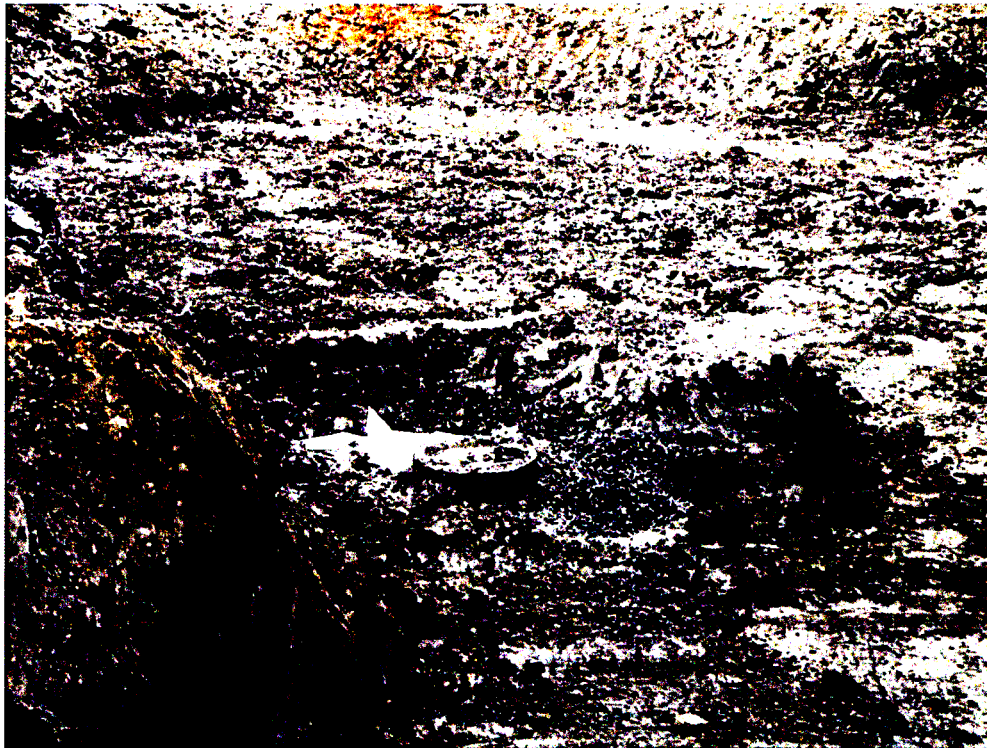
Photo #35: October 24, 2011 –Phase I: Uncovered a former in-active drain within Excavation 3.

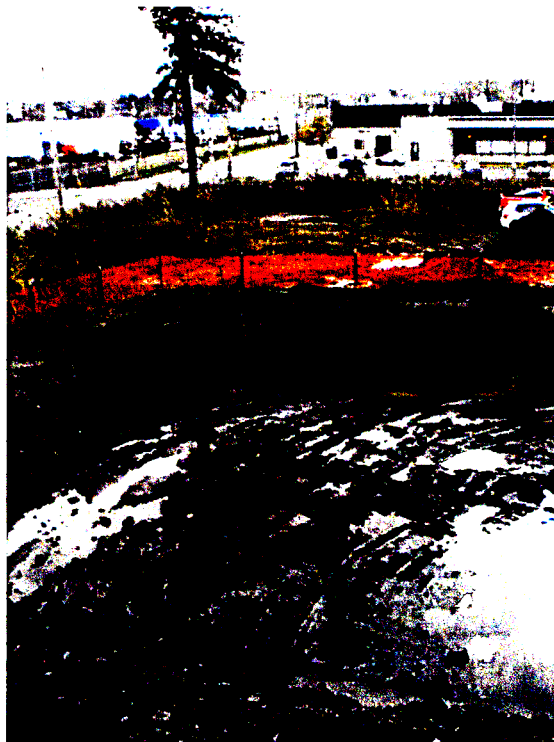
Photo #36: October 28, 2011 –Phase I: Completion of Excavation 3, ~4.5 to 5 fbg.

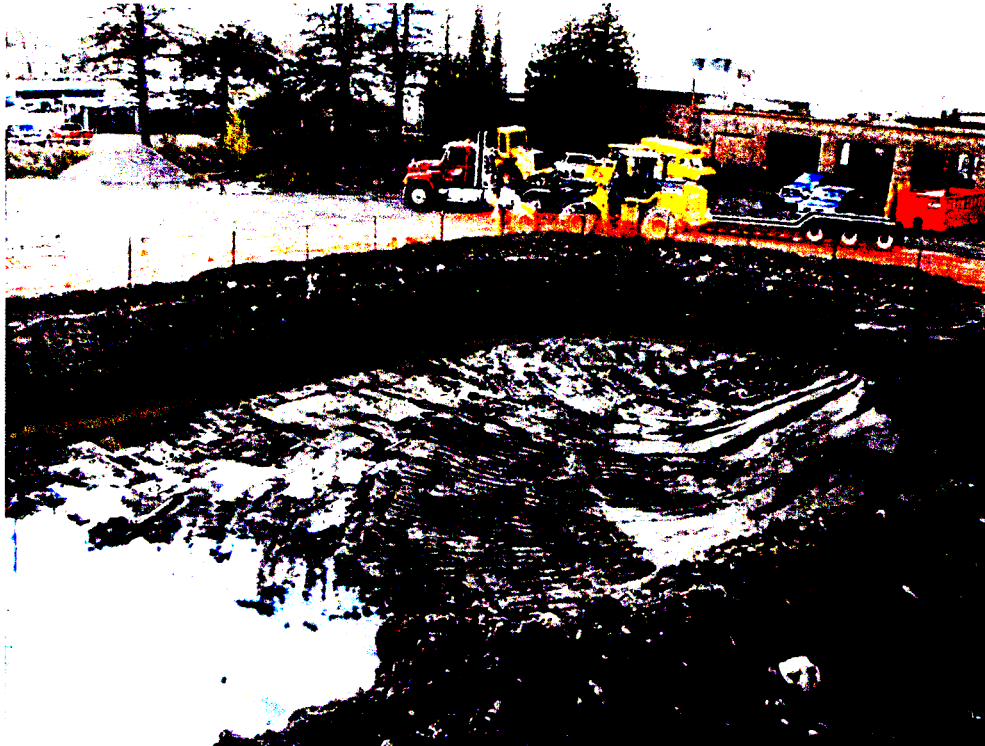
Photo #37: October 28, 2011 –Phase I: Completion of Excavation 3.

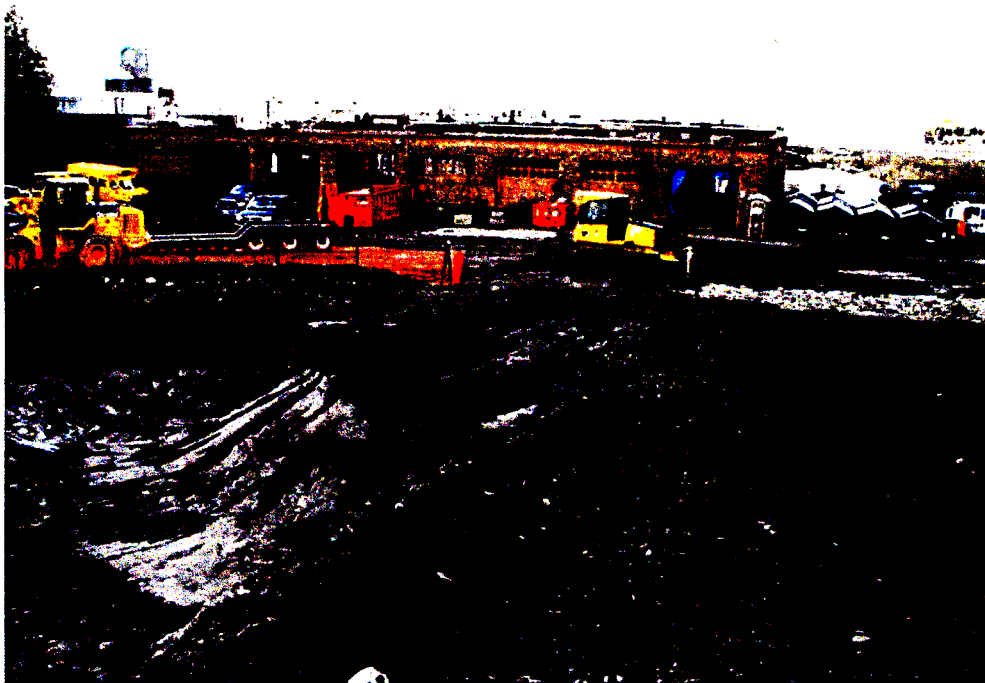
Photo #38: October 28, 2011 –Phase I: Completion of Excavation 3, and Windrow 5.

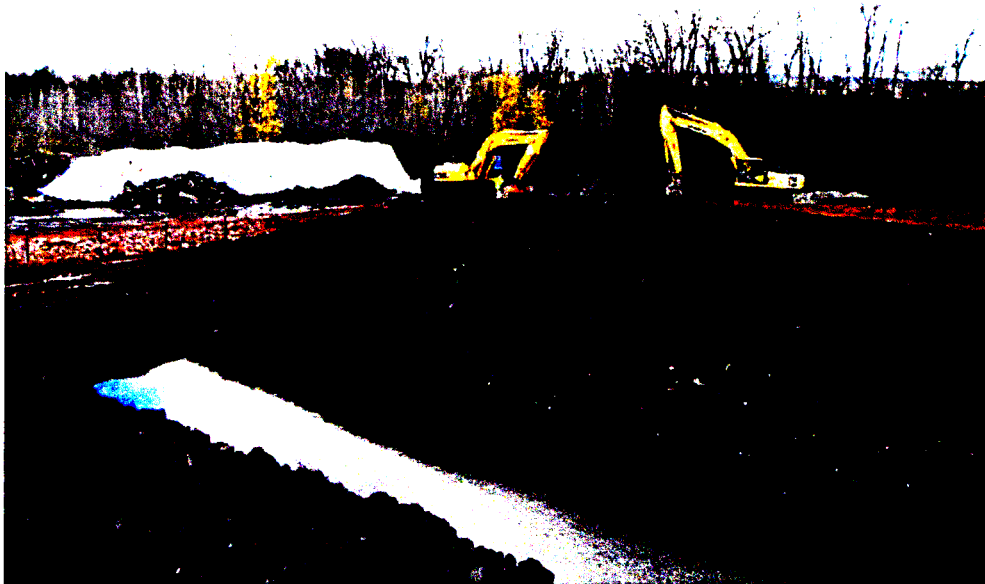
Photo #39: October 28, 2011 –Phase I: Completion of dressing Windrow 4, covering Allu soil pile 1 and dressing Windrows 1 and 2.

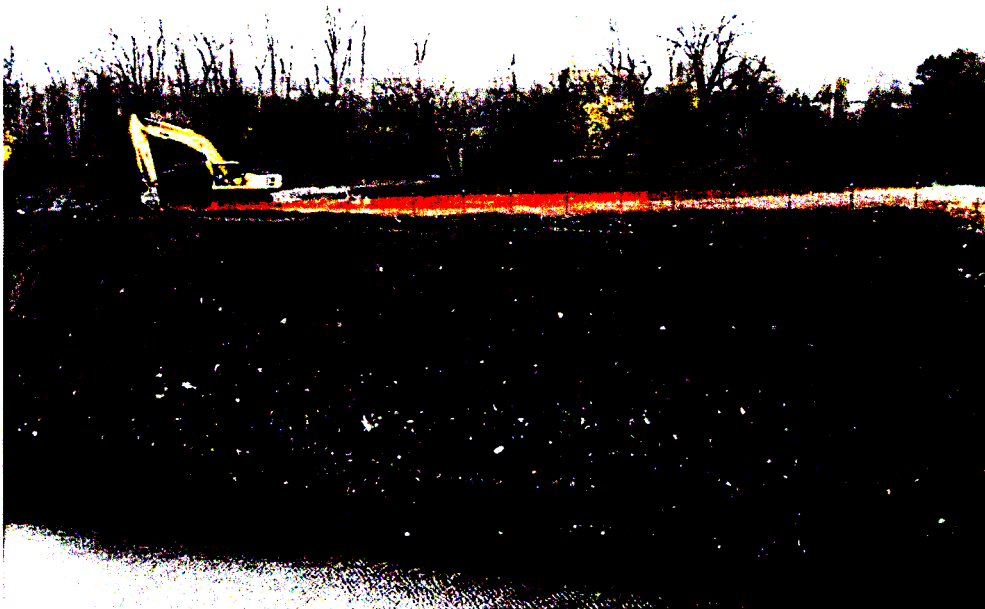
Photo #40: October 28, 2011 –Phase I: Completion of dressing Windrow 3.

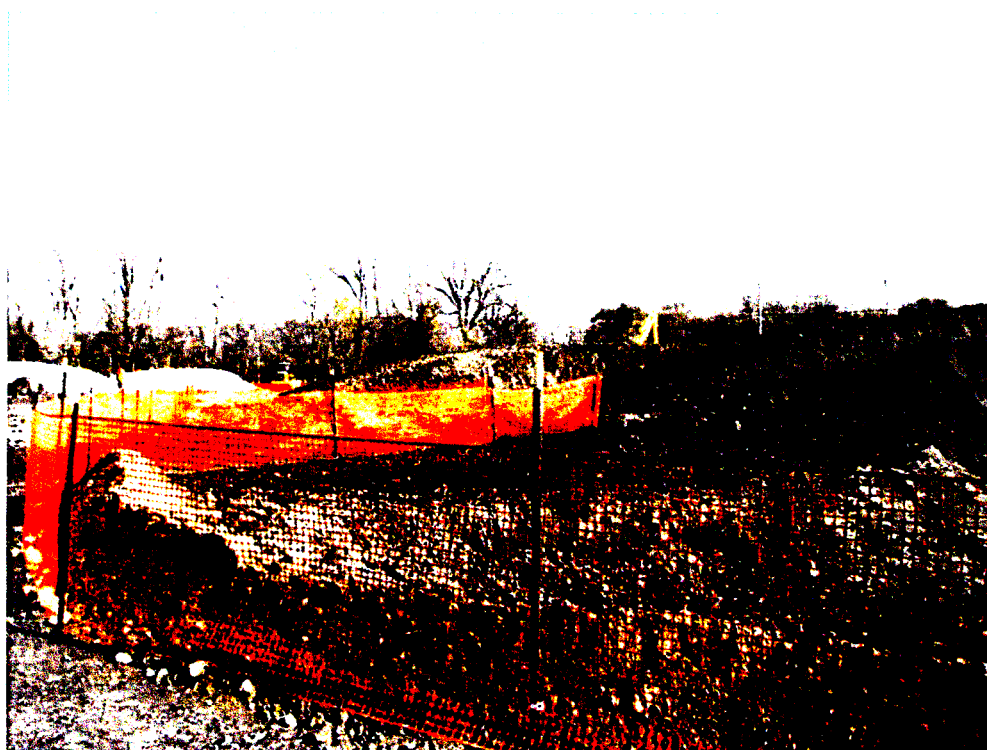
Photo #42: November 1, 2011 –Phase I: Completion of excavations and windows, winterization of site with orange snow fencing.

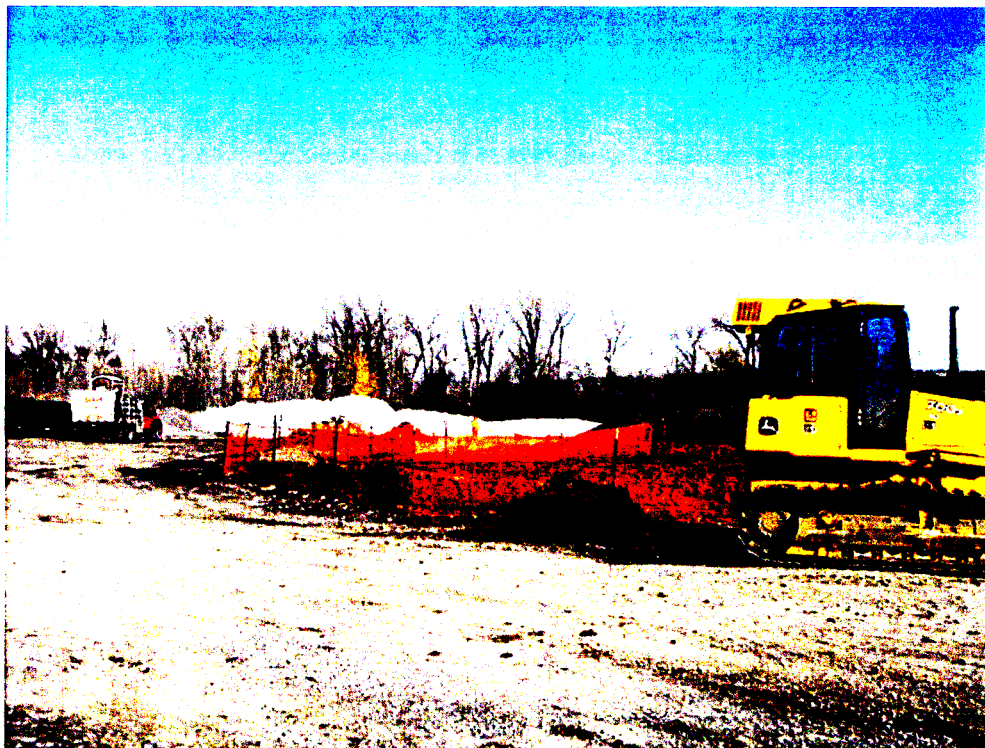
Photo #43: November 1, 2011 –Phase I: Completion of excavations and windows, winterization of site with orange snow fencing.

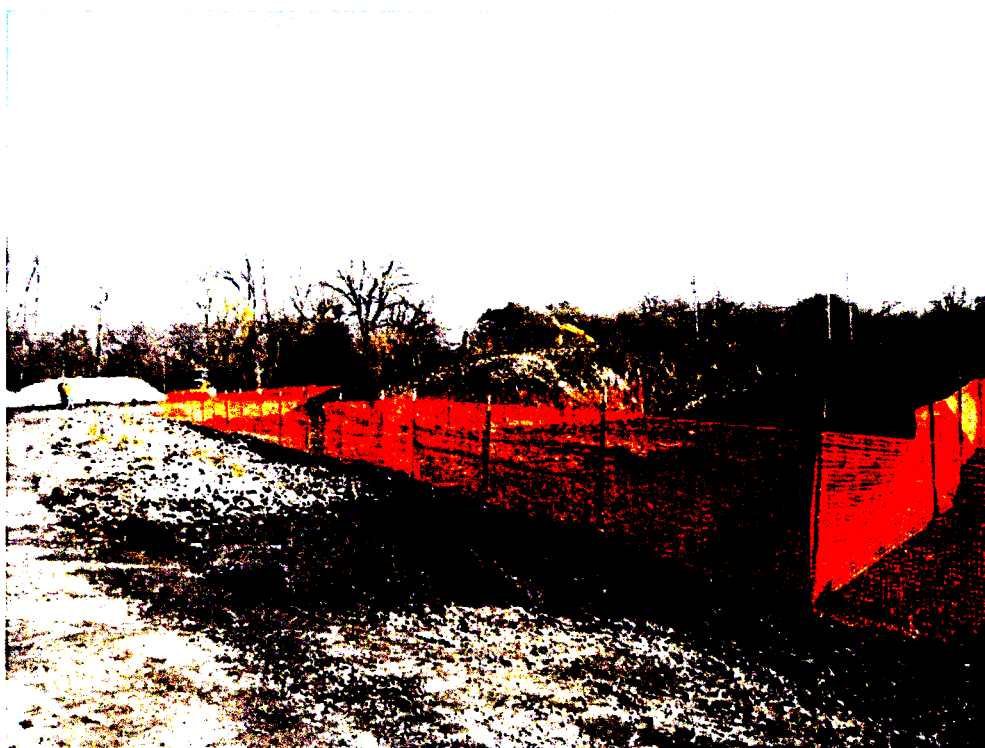
Photo #44: November 1, 2011 –Phase I: Completion of excavations and windows, winterization of site with orange snow fencing.

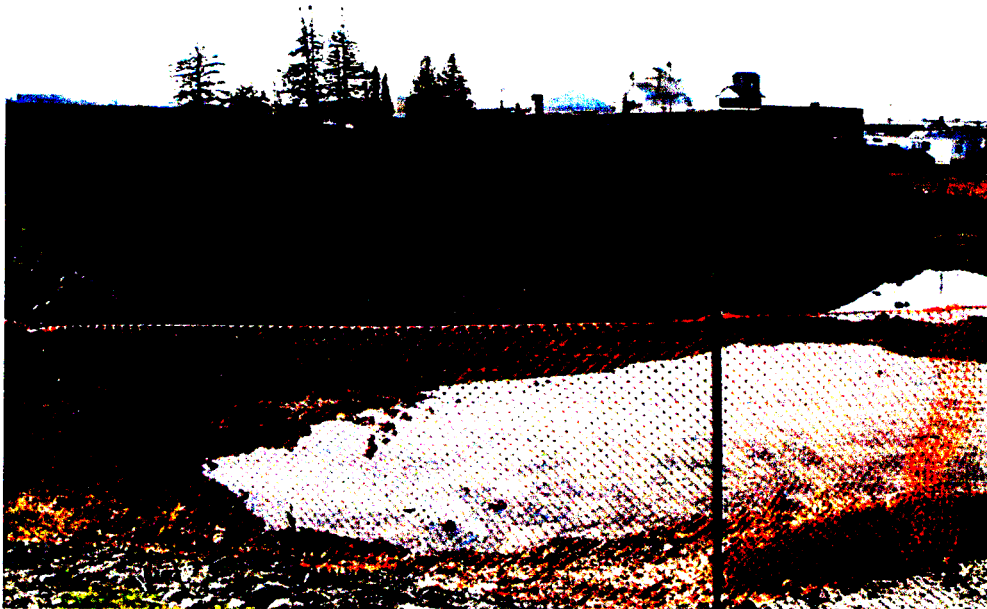
Photo #46: November 1, 2011 –Phase I: Completion of excavations and windows, winterization of site with orange snow fencing.

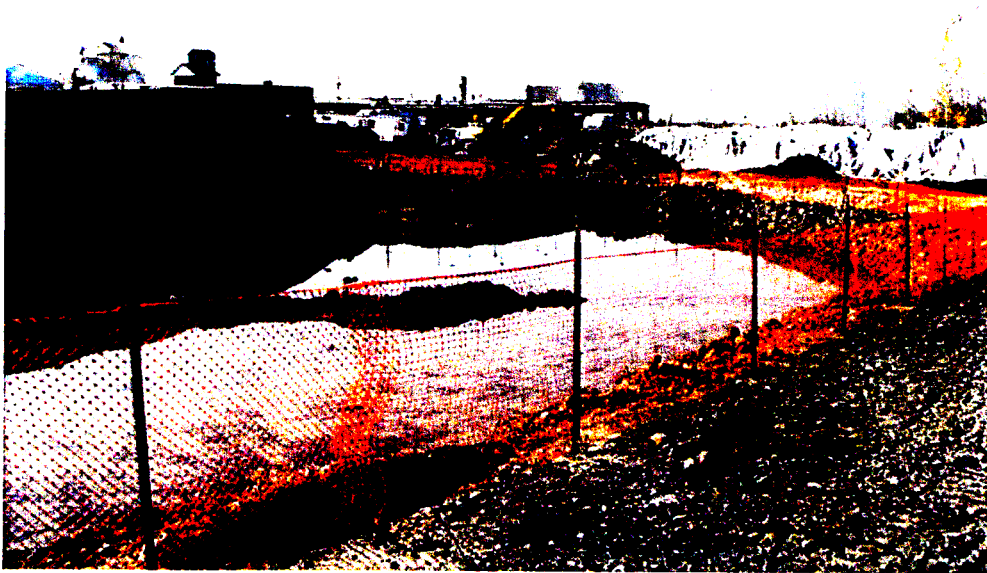
Photo #47: November 1, 2011 –Phase I: Completion of excavations and windows, winterization of site with orange snow fencing.

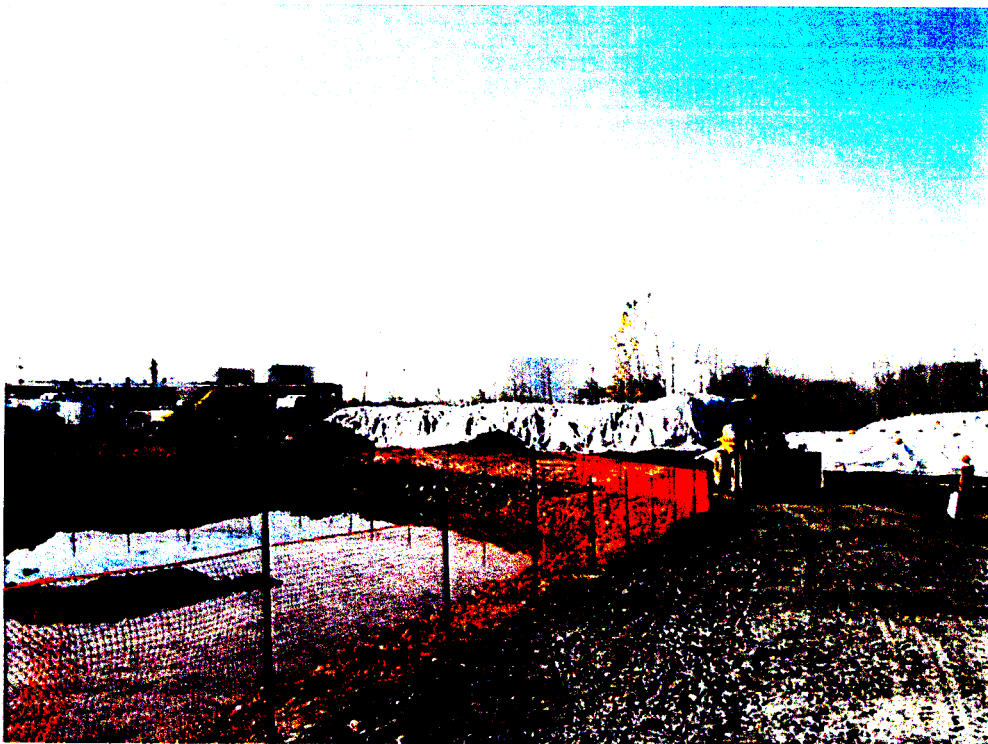
Photo #48: November 1, 2011 –Phase I: Completion of excavations and windows, winterization of site with orange snow fencing.

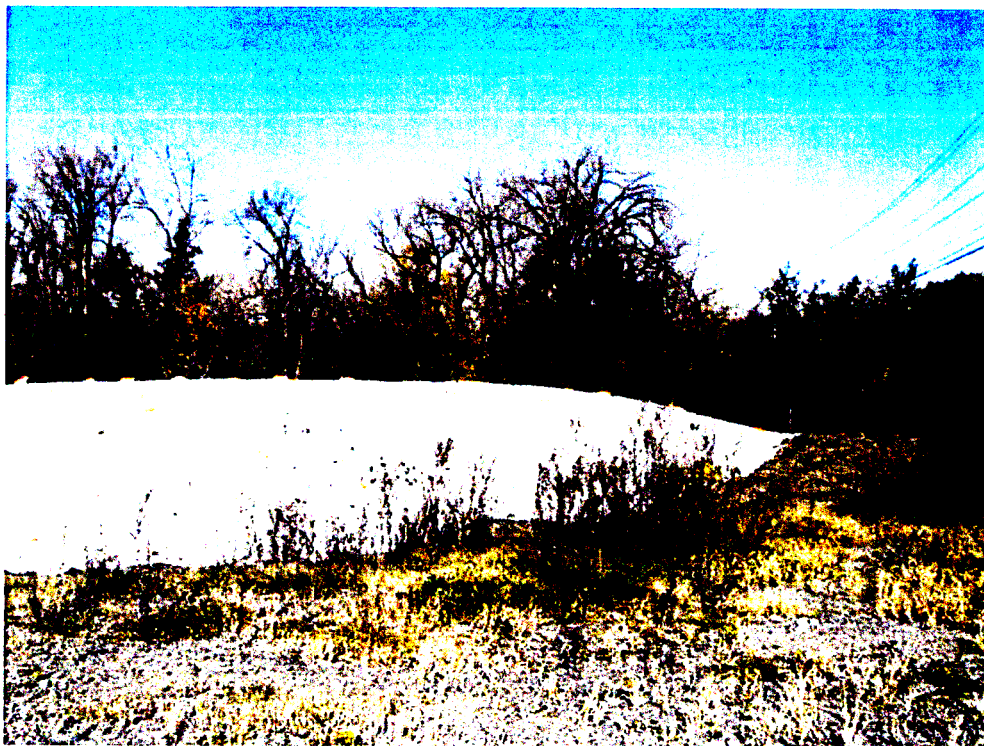
Photo #50: November 1, 2011 –Phase I: Winterization of windrows via plastic sheeting and sand bags to reduce potential run off.
