**Re: Site Photo Logs  
Former Matt/Grace Petroleum  
201 Leland Avenue  
Utica, New York (Oneida County)  
NYSDEC Spill# 88-09026**

**Photo Logs**

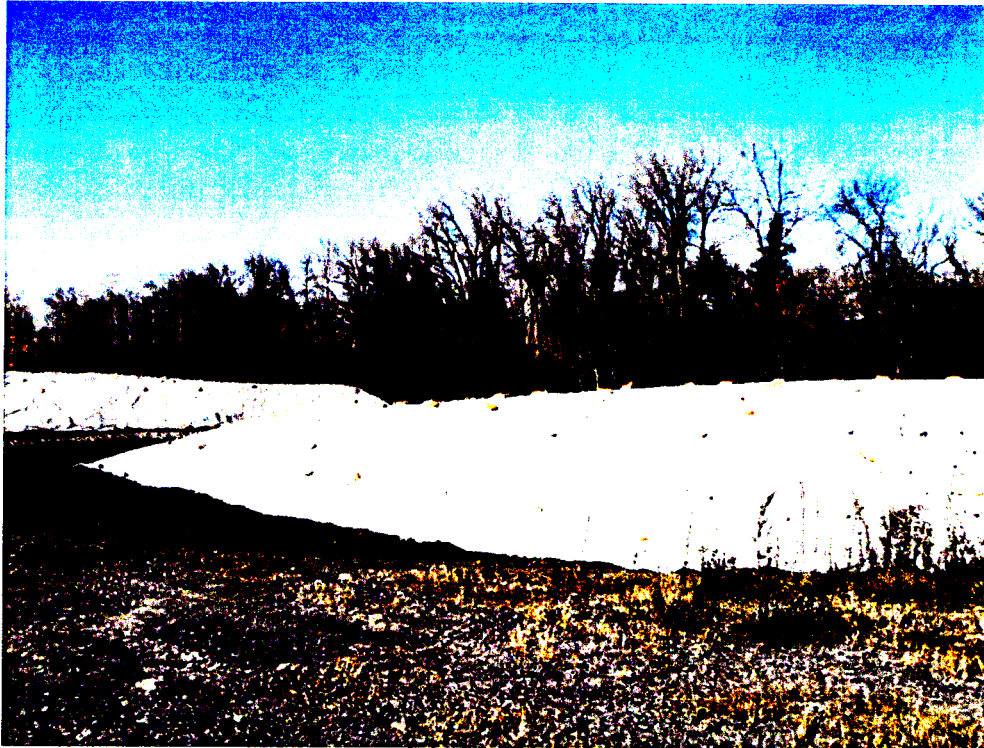
Photo #51: November 1, 2011 –Phase I: Winterization of windrows with plastic sheeting and sand bags to reduce potential run off.

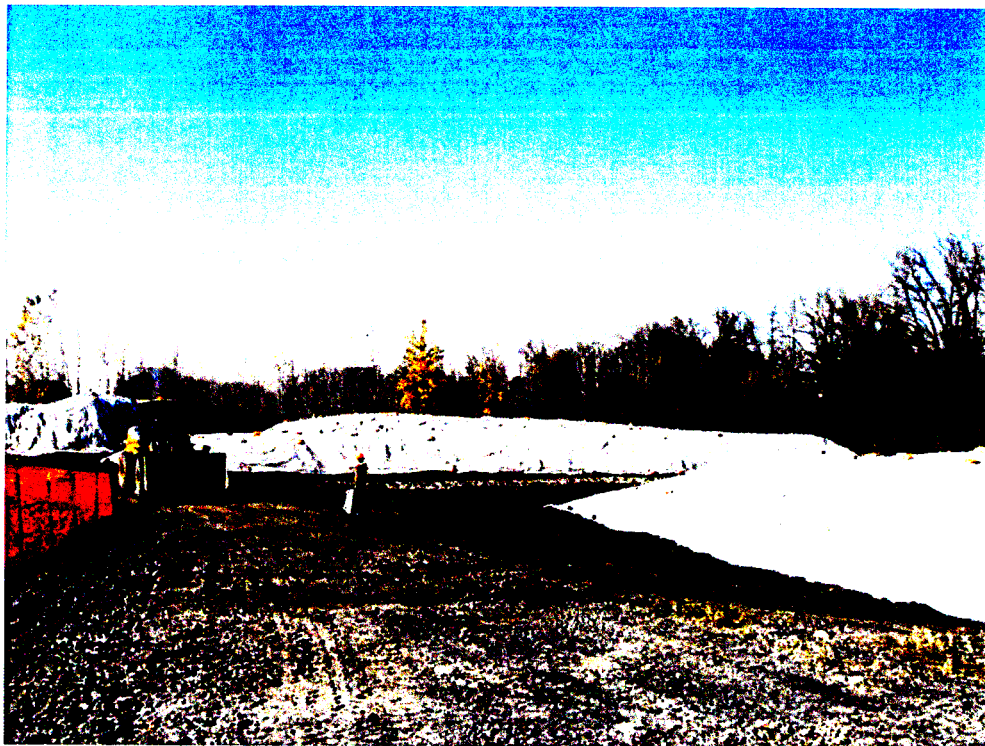
Photo #52: November 1, 2011 –Phase I: Winterization of windrows with plastic sheeting and sand bags to reduce potential run off.

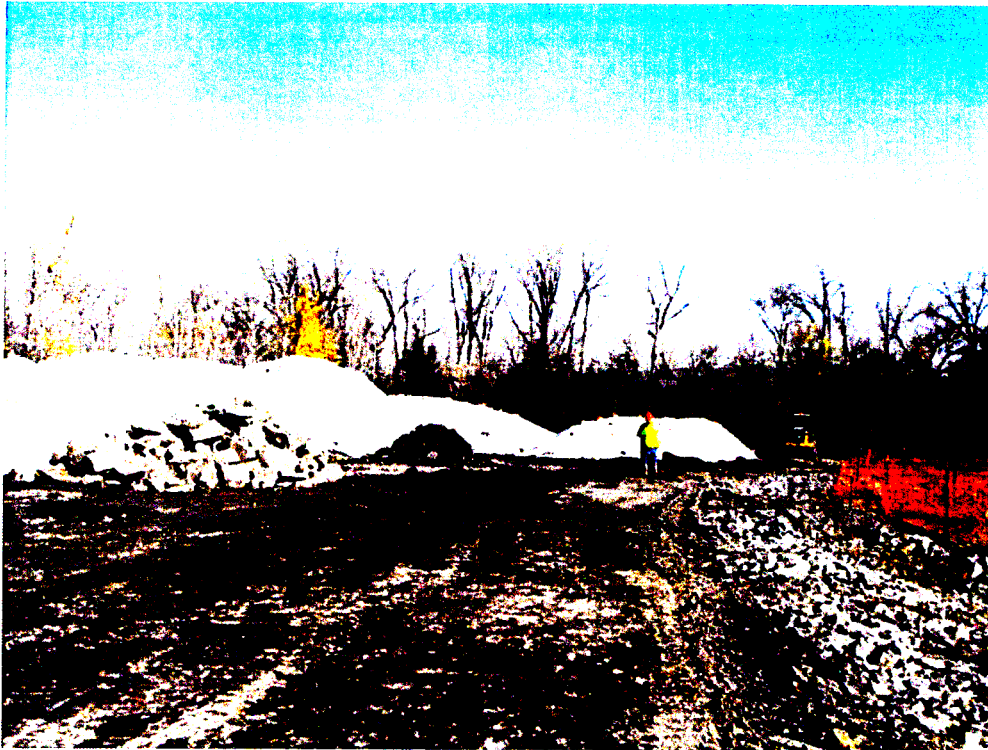
Photo #53: November 1, 2011 –Phase I: Winterization of windrows with plastic sheeting and sand bags to reduce potential run off.

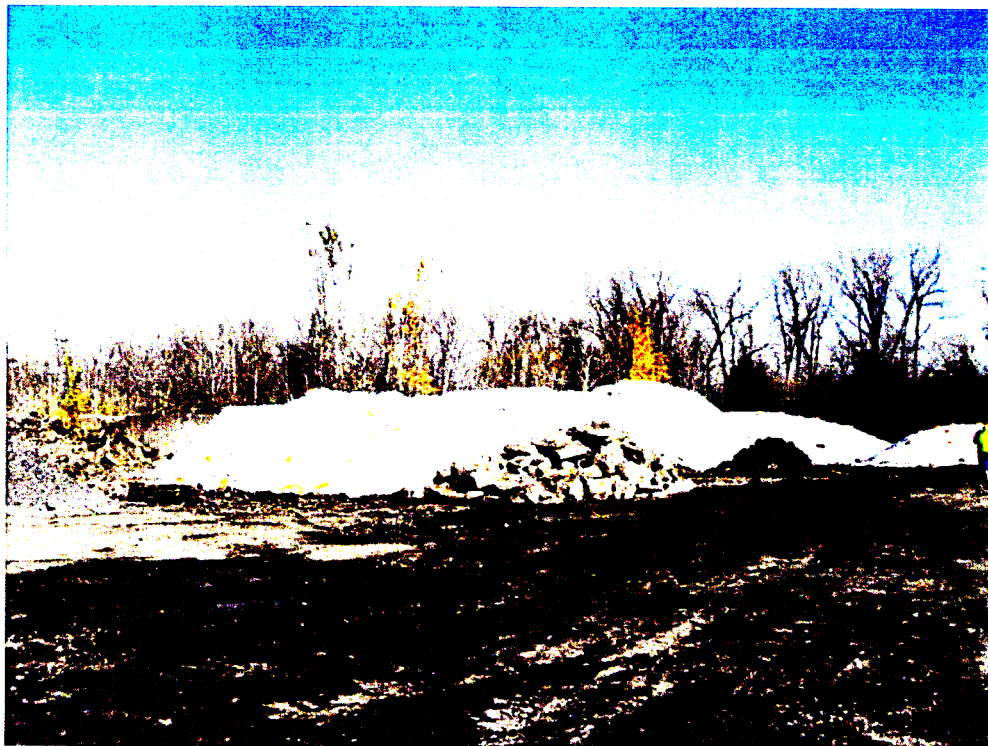
Photo #54: November 1, 2011 –Phase I: Winterization of windrows with plastic sheeting and sand bags to reduce potential run off.
