SUBJECT: Bechtel Job No. 20384,  
Alcoa, Inc., Massena East Smelter  
**OVERALL COMPLETION REPORT, REV. 2; Subject Code 1305**

# **Overall Completion Report**

## **Alcoa, Inc. Massena East Smelter Plant Site Remediation Project**

Revision 2  
July 2003

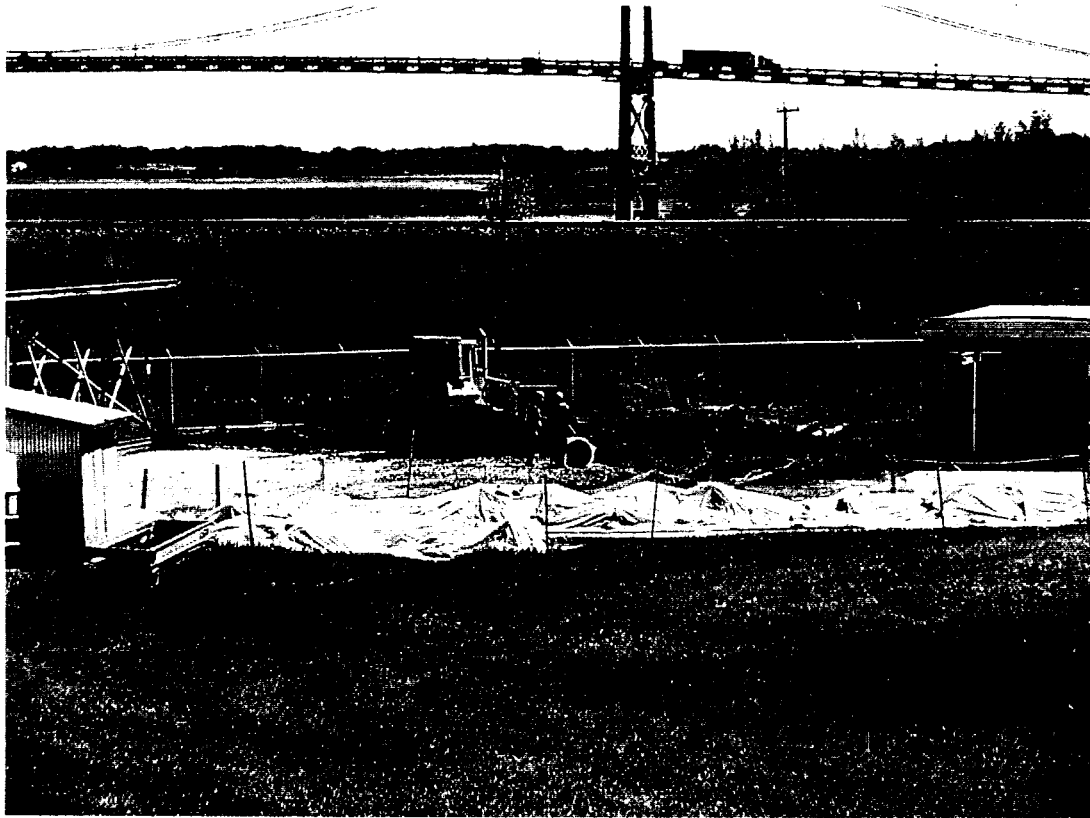
**Photo Number: 1460**      **Date: June 3, 2002**    **Work Area: 002 Diversion Area**  
**Description: Backfilling following remedial excavation near Waste Water Treatment Plan.**

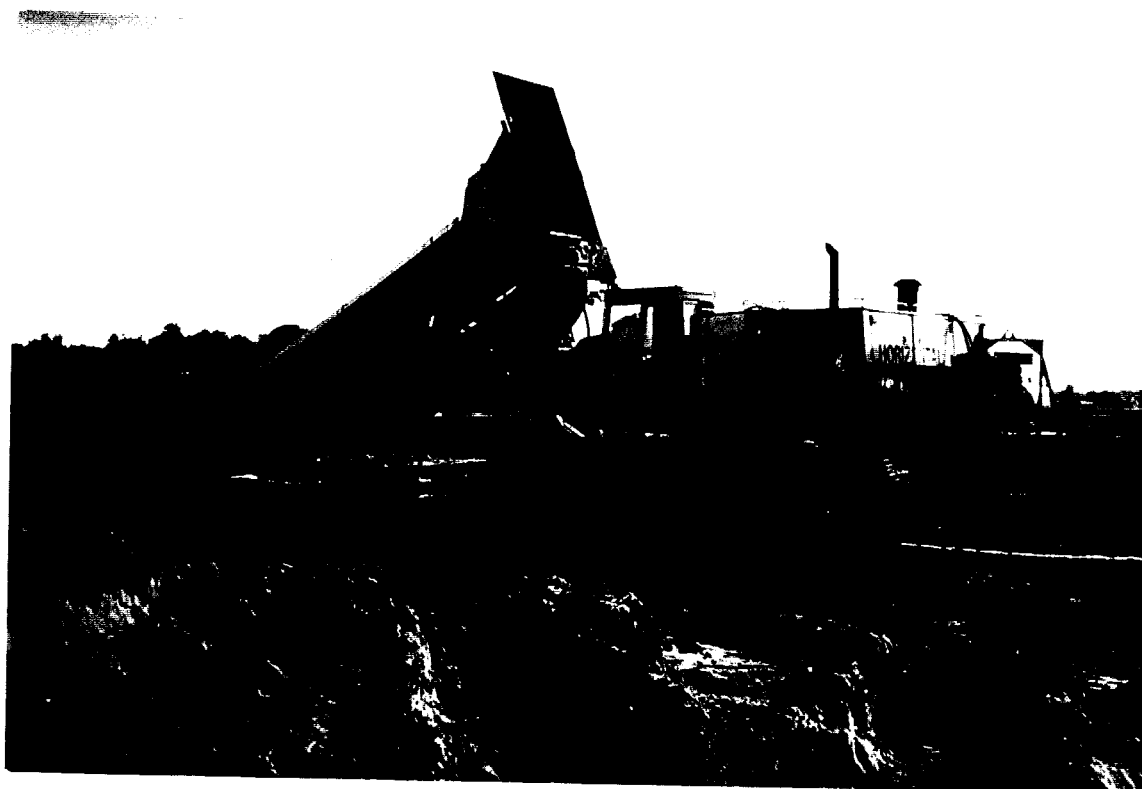
**Photo Number: 1005      Date: August 30, 1995      Work Area: Black Mud Pond**  
**Description: Trenching machine for installation of horizontal drains for dewatering the black mud. Drains consist of a perforated collection pipe wrapped in filter fabric at the bottom of a sand-filled French drain.**

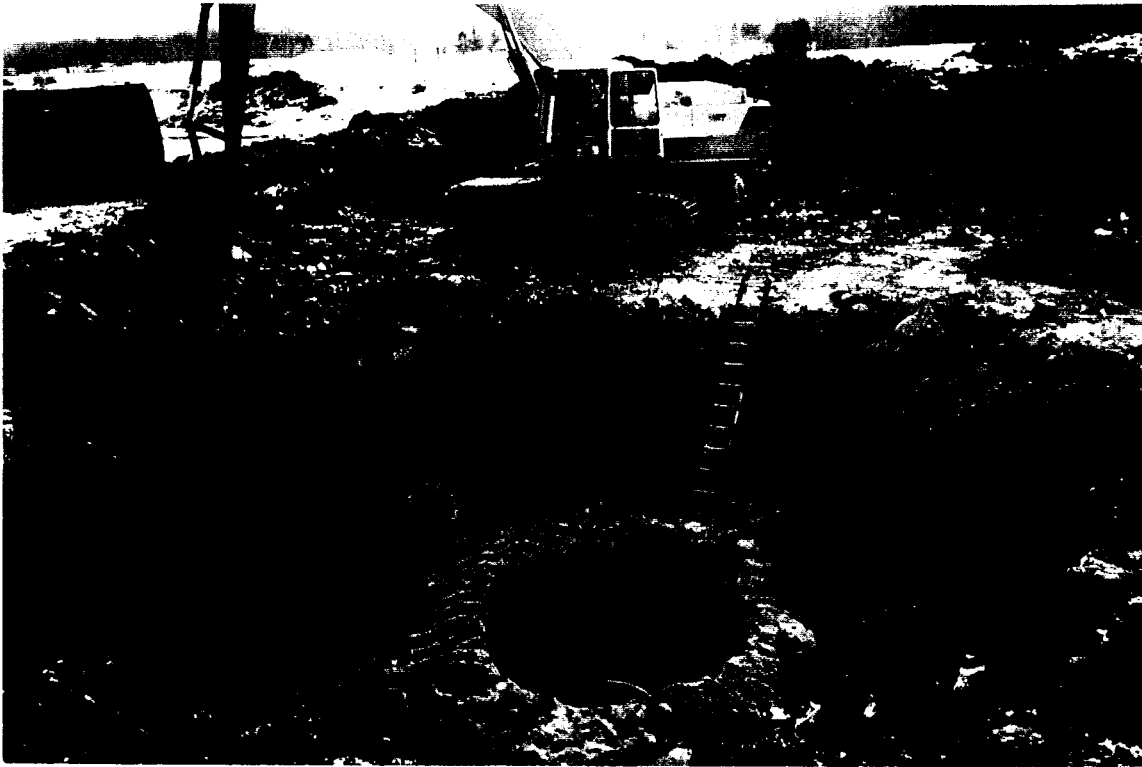
**Photo Number:** 1050      **Date:** February 16, 1996      **Work Area:** Black Mud Pond  
**Description:** Installing sump for collection and removal of black mud leachate. A network of over 2,200 linear feet of horizontal drains (photo # 1005, above) converges on this sump as part of the leachate extraction system.

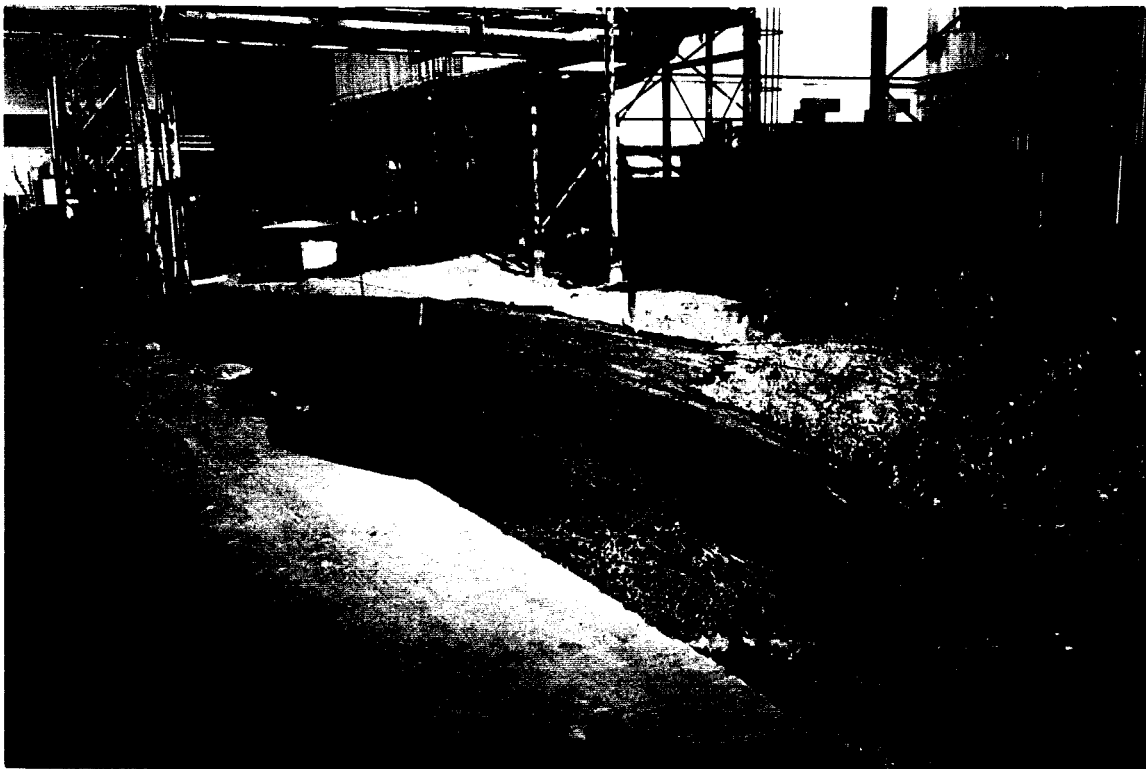
**Photo Number: 1007      Date: August 30, 1995      Work Area: North Yard**  
**Description: Placing “flowable fill” near Carbon Plant Facility 22. This innovative, high-quality backfill material allowed critical remediation areas to be quickly returned to service.**

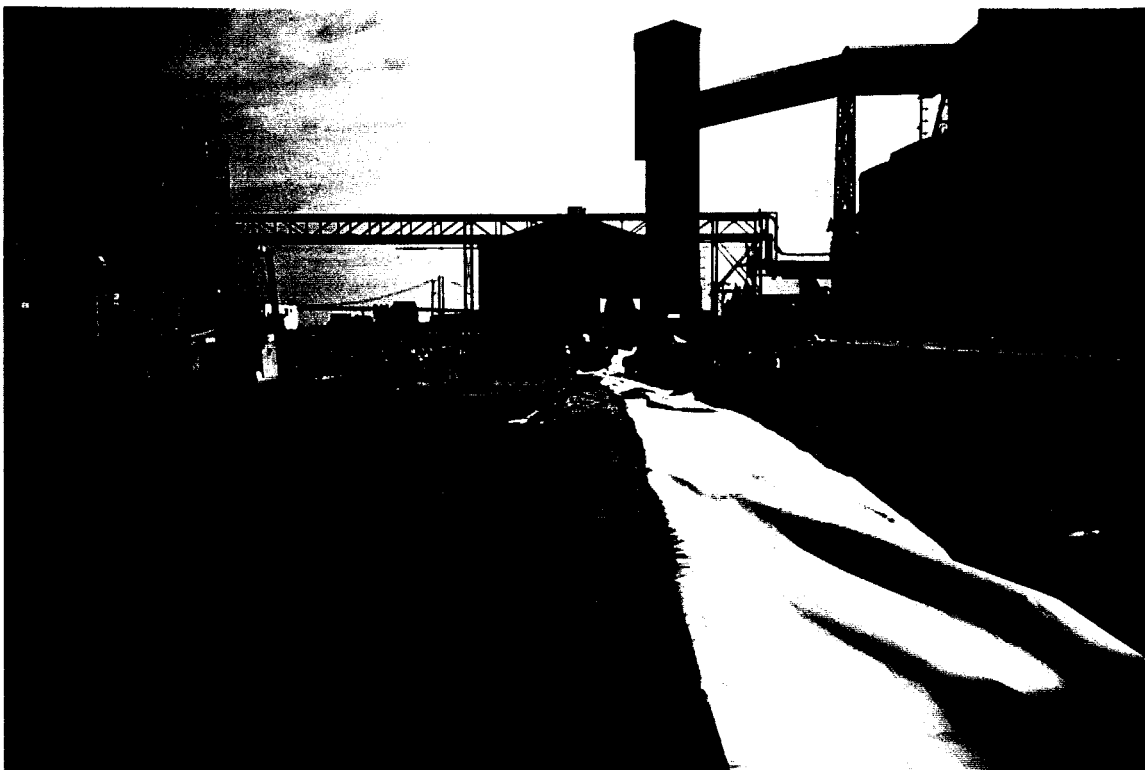
**Photo Number: 1010      Date: September 3, 1995      Work Area: North Yard**  
**Description: Restoration of the busy rail yard, including grading the cured flowable fill and installing geotextile cushion and geomembrane liner. Note that the rail tracks are temporarily removed.**

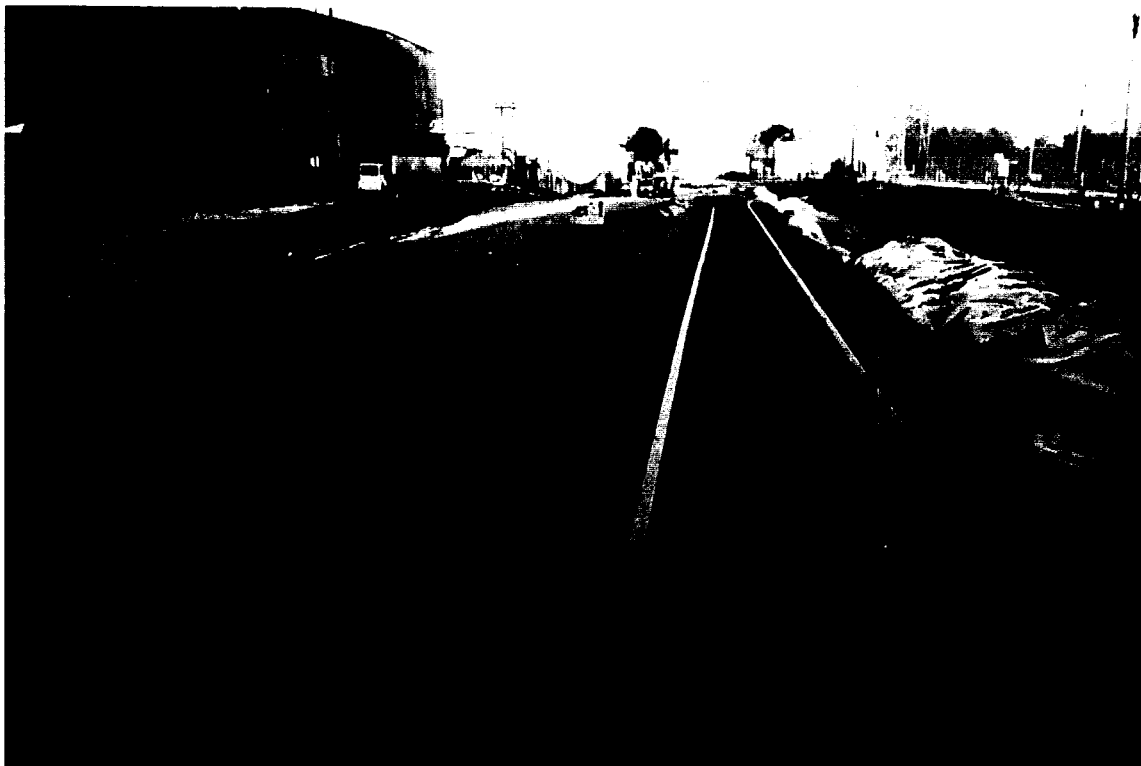
**Photo Number: 1013**      **Date: September 6, 1995**      **Work Area: North Yard**  
**Description: Re-installing tracks in the rail yard following remediation and backfilling.**

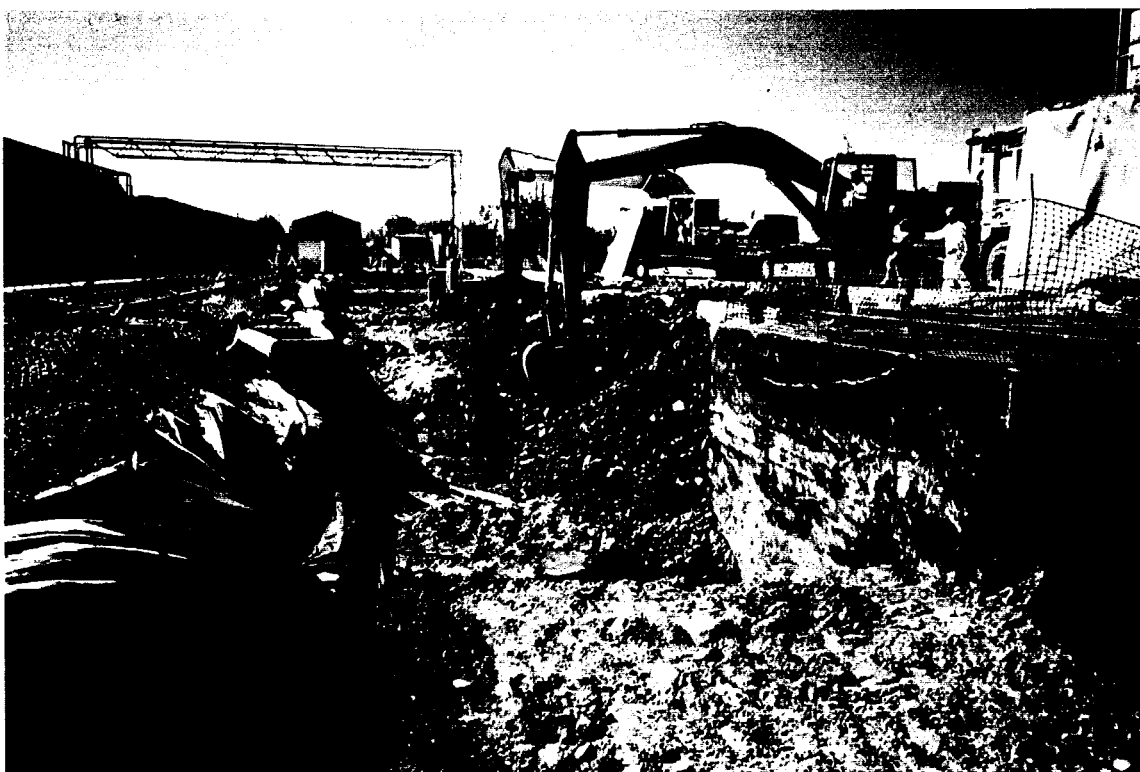
**Photo Number: 1021**      **Date: September 28, 1995**      **Work Area: North Yard**  
**Description: Deep excavations near Pitch Pumphouse (Facility 22A).**

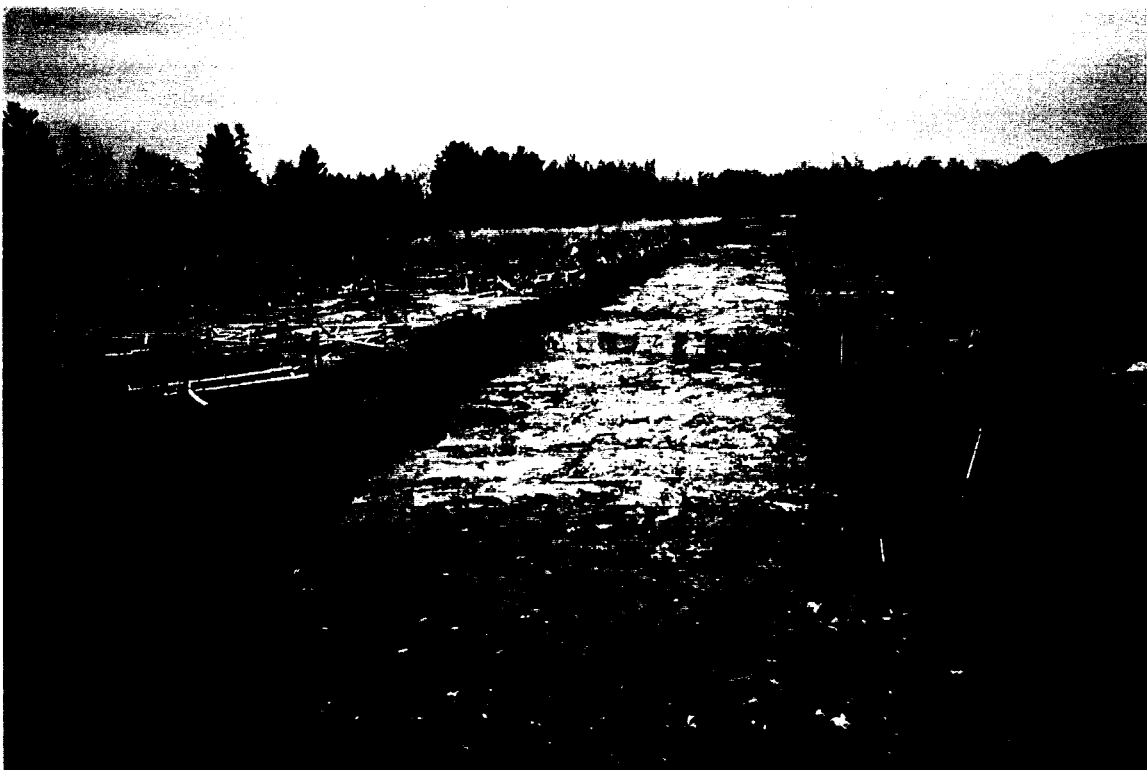
**Photo Number: 878     Date: October 19, 1994     Work Area: Landfill**  
**Description: Remediation of Landfill “toe of slope” prior to construction of dike, road, and leachate collection/removal system. Wetlands “stressed area” at left prior to remediation.**

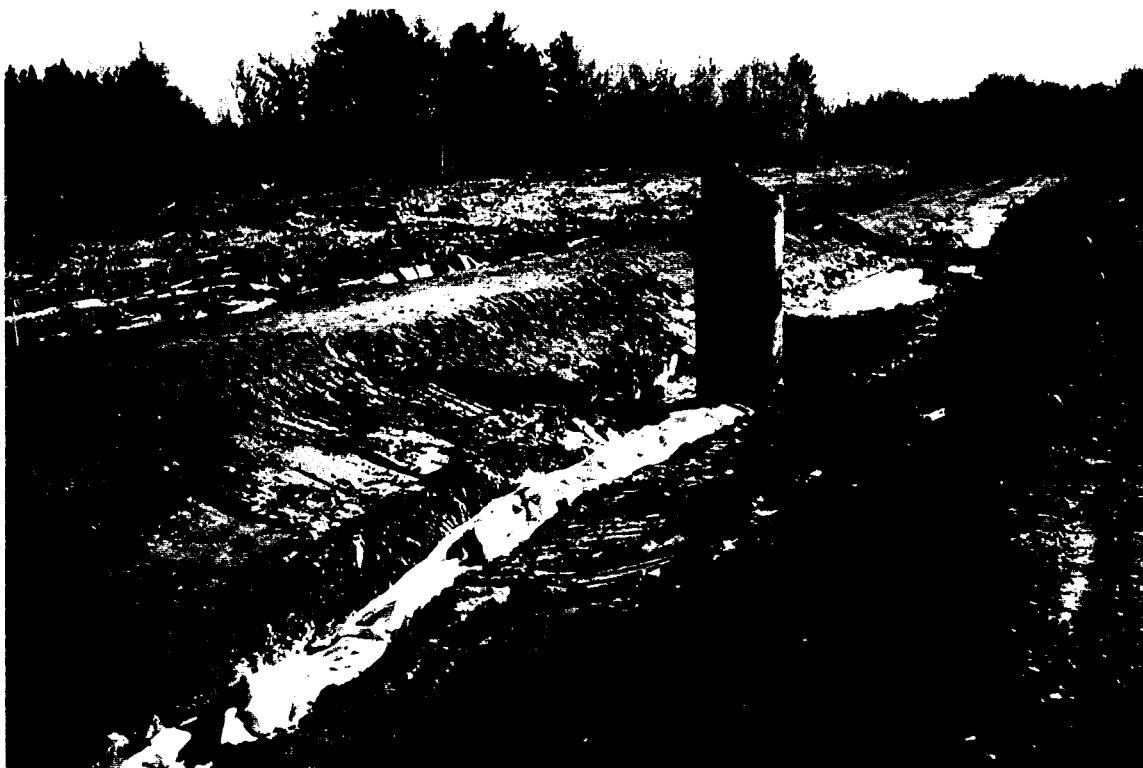
Photo Number 923      Date: May 16, 1995      Work Area: Landfill  
 Description: Leachate collection trench with perforated pipe, drainage stone, filter fabric, and monitoring manhole (MH-602) installed. Wetlands "stressed area" prior to final remediation at left. Clay dike between Landfill and Wetlands.

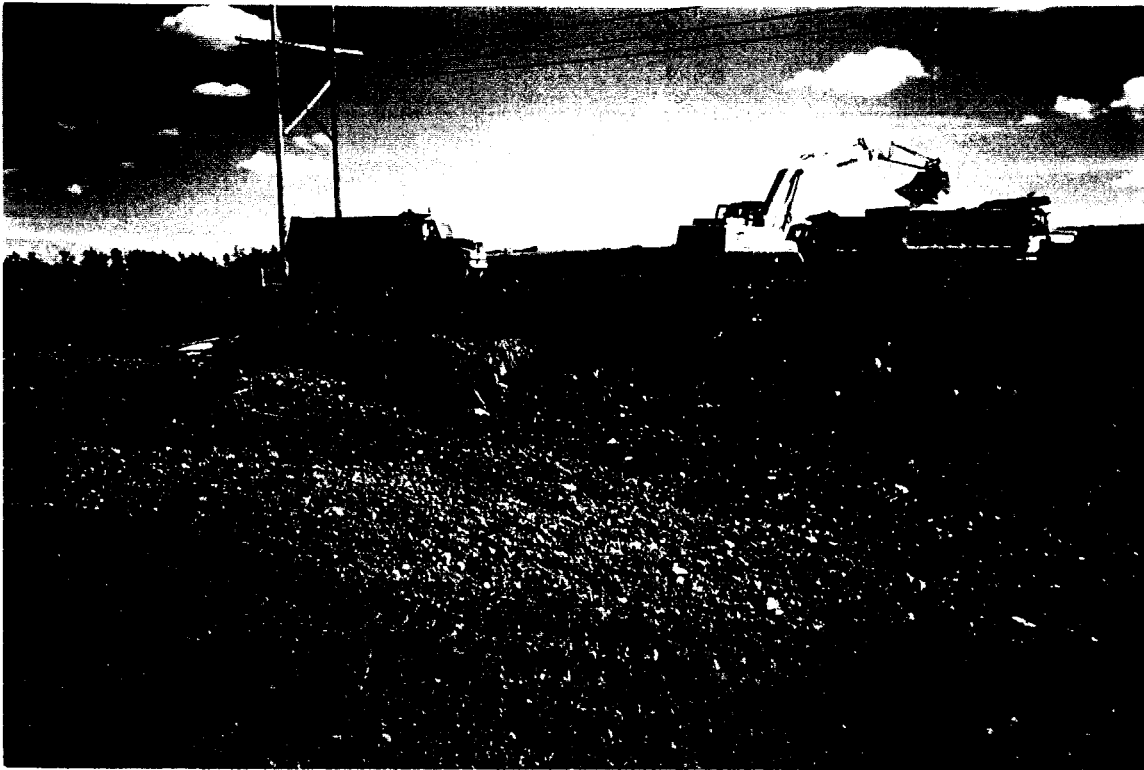
**Photo Number: 1318**      **Date: September 26, 1996**      **Work Area: Landfill**  
**Description: Consolidating northern section of Landfill toward the south to reduce the overall Landfill footprint.**

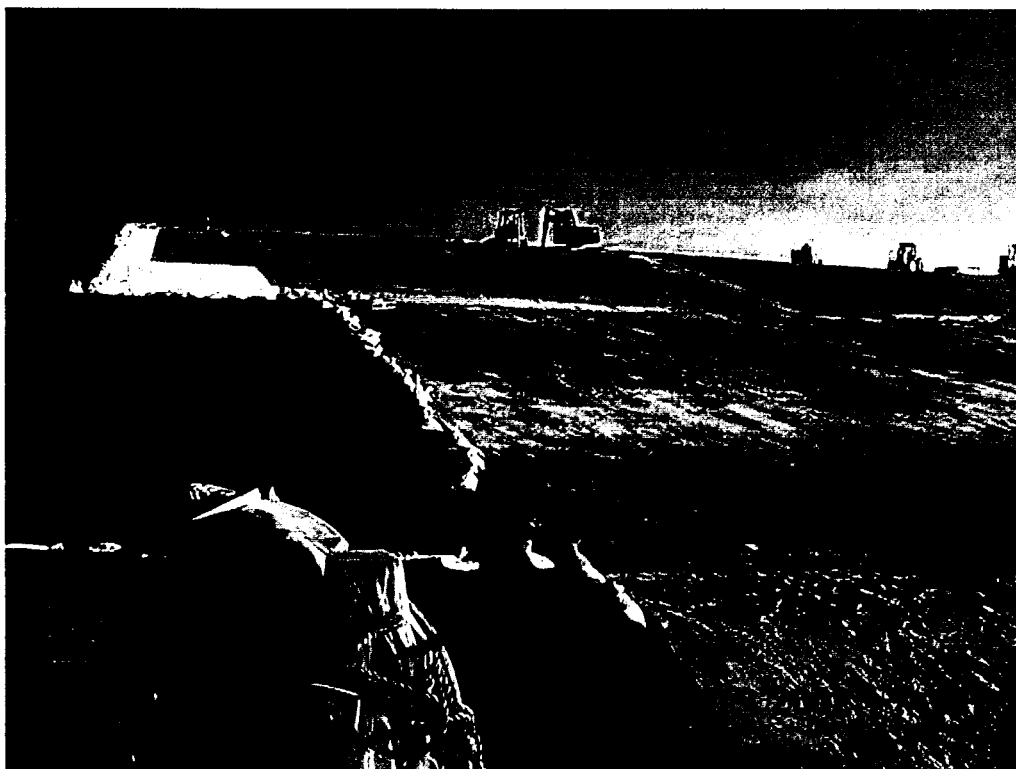
**Photo Number: 1550**      **Date: July 31, 2002**      **Work Area: Landfill**  
**Description: Installation of RCRA cap. Prepared subgrade on the right. Geomembrane liner on the left. Horizontal benches on the slopes.**

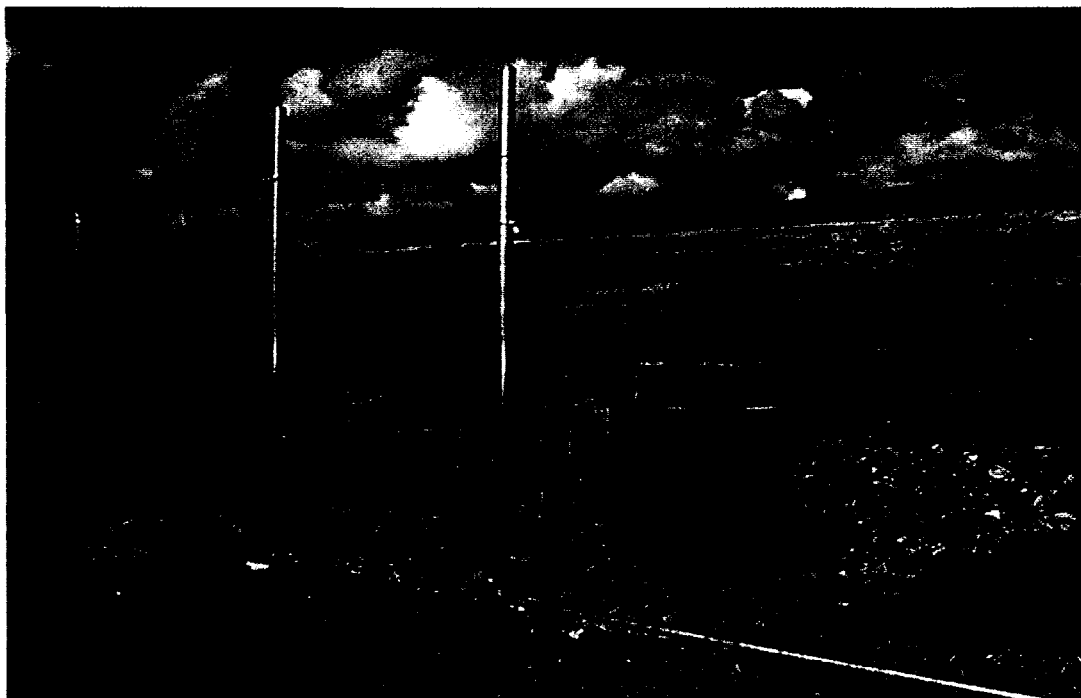
**Photo Number: 1630**      **Date: October 7, 2002**      **Work Area: Landfill**  
**Description: Manhole MH-601 of the leachate collection and removal system. Piezometer nest straddling the leachate collection trench for monitoring Landfill performance. Installation of fencing to protect Landfill.**

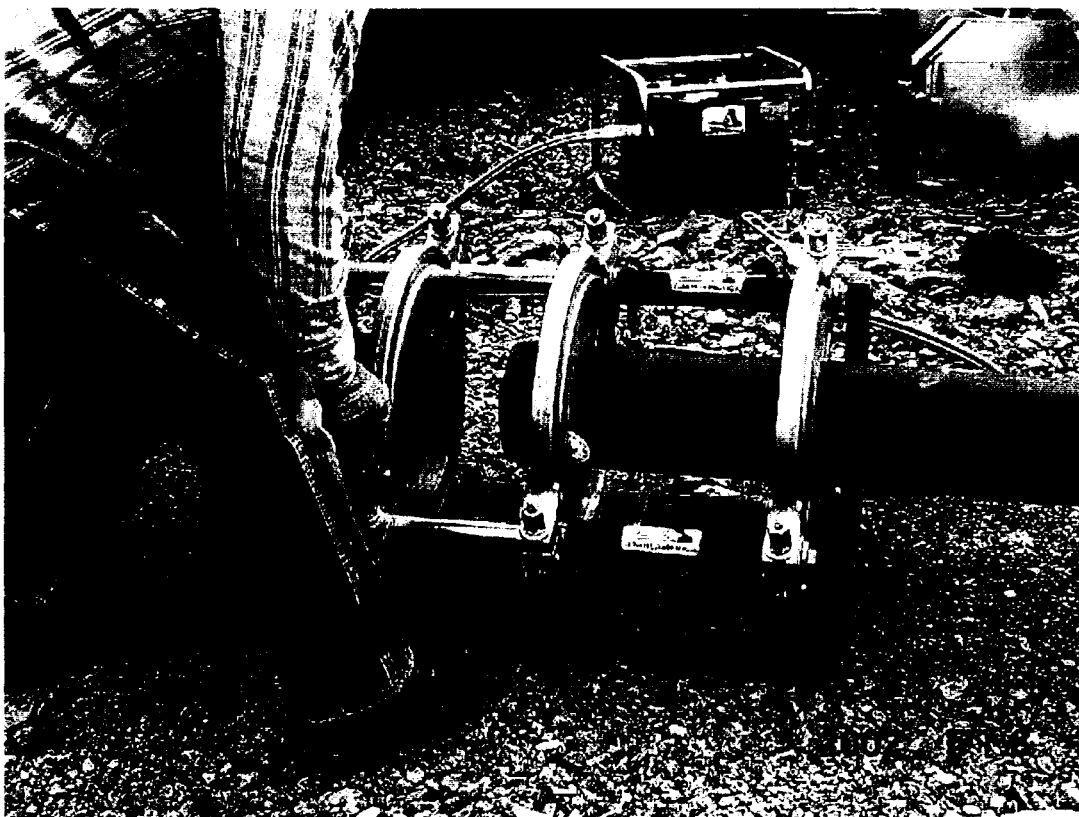
Photo Number: 1445      Date: May 6, 2002      Work Area: Landfill  
 Description: Welding the double-walled pipe for upgrading the Landfill leachate transfer line. The entire leachate transfer line is now double-walled with leak detection.

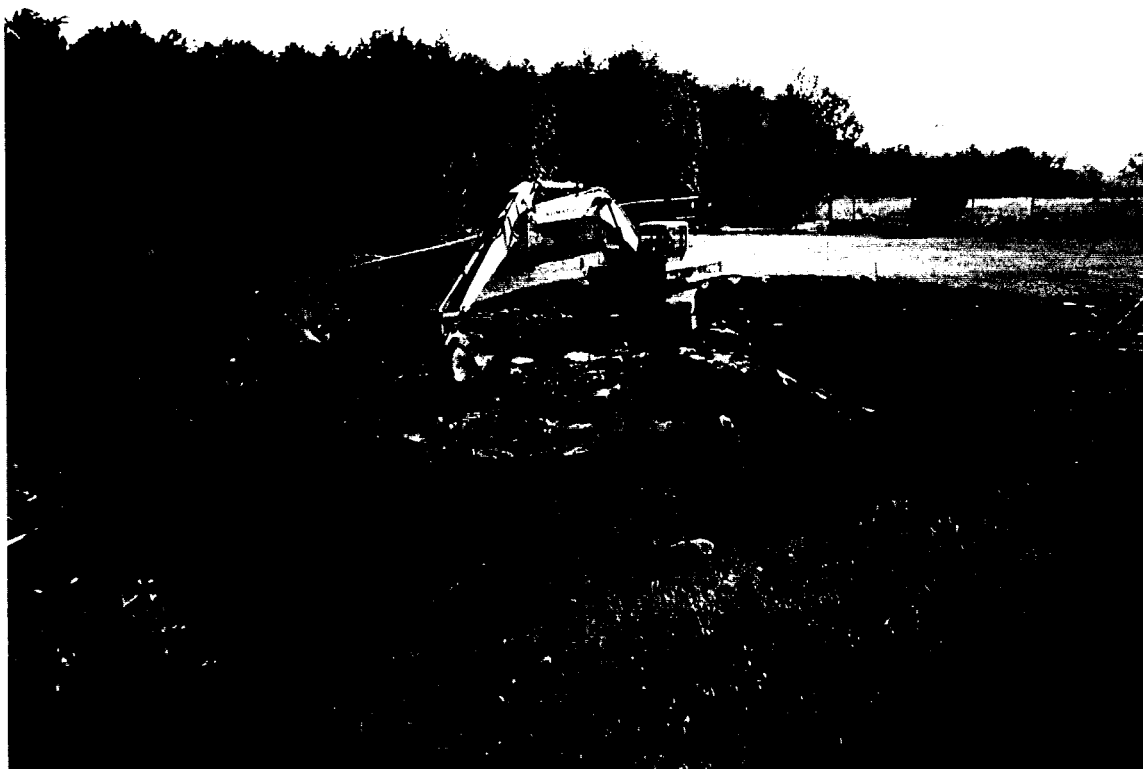
Photo Number: 949      Date: June 22, 1995      Work Area: Wetlands (Area West of Landfill)  
 Description: Deep excavation of soils containing PCBs from southwest corner of Black Mud Pond.

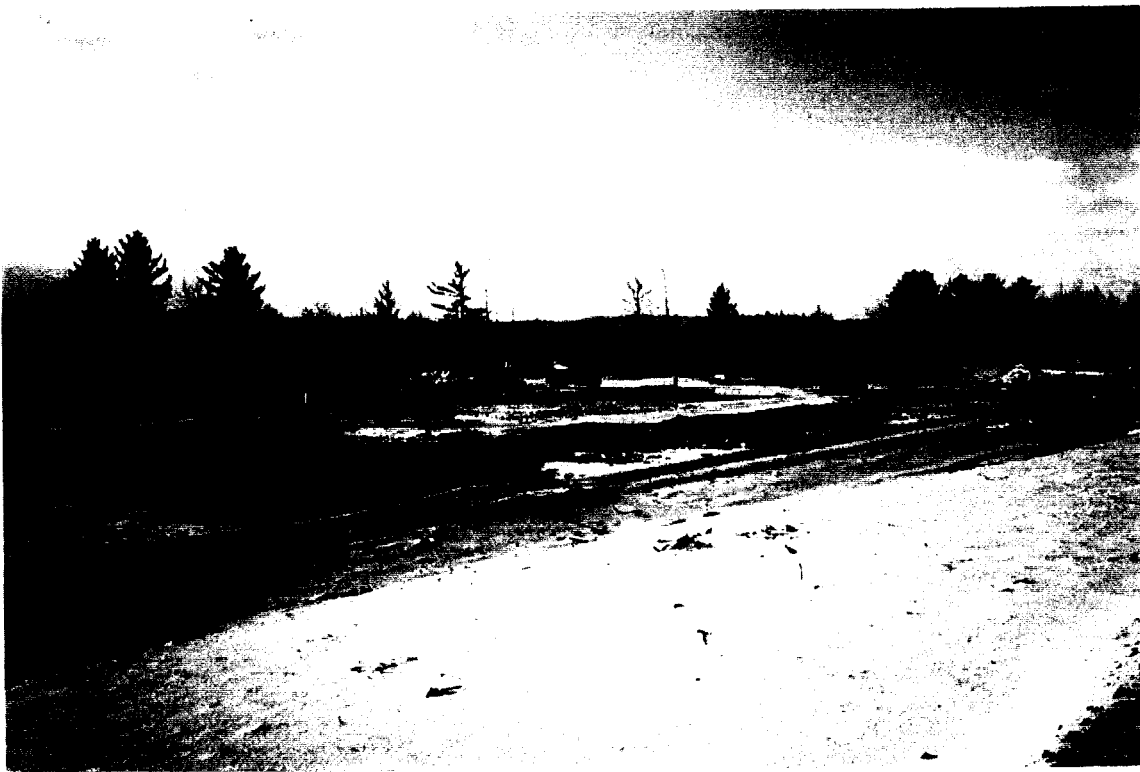
**Photo Number: 1047      Date: February 12, 1996      Work Area: Wetlands**  
**Description: Second excavation of Cell 1, including "Stressed Area." Thick ice provided access road during winter work.**

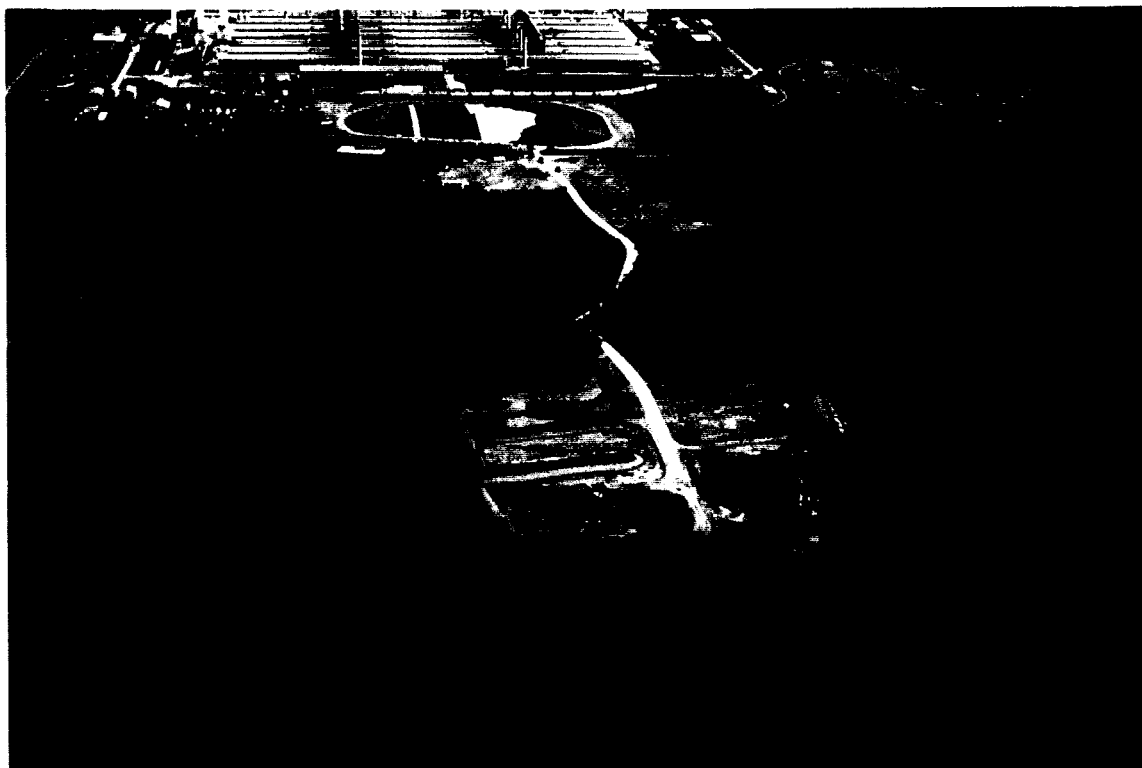
**Photo Number:** 1255      **Date:** August 9, 1996      **Work Area:** Wetlands (Mitigation Area)  
**Description:** Controlled development and ongoing excavation from Borrow Pits, which will later be converted to new wetlands. Capping of Black Mud Pond in background.
