SUBJECT: July 2014 Operating Report for the Vestal Well field 1-1 Superfund Site, Area 4,
Vestal, New York

SUBJECT: July 2014 Monthly Report on Activities at the Vestal Well field 1-1 Superfund Site, Area 4, Vestal, New York

LATA Project # 11202
Contract # W912DQ-09-D-3003,
Task Order # 008

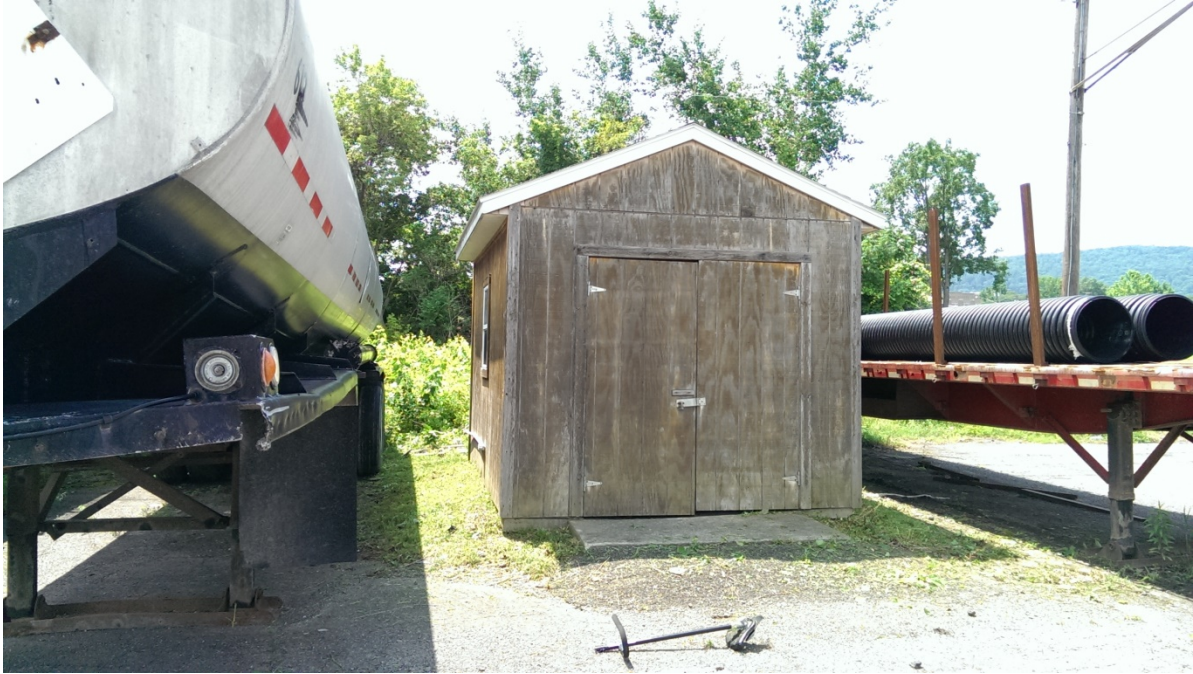
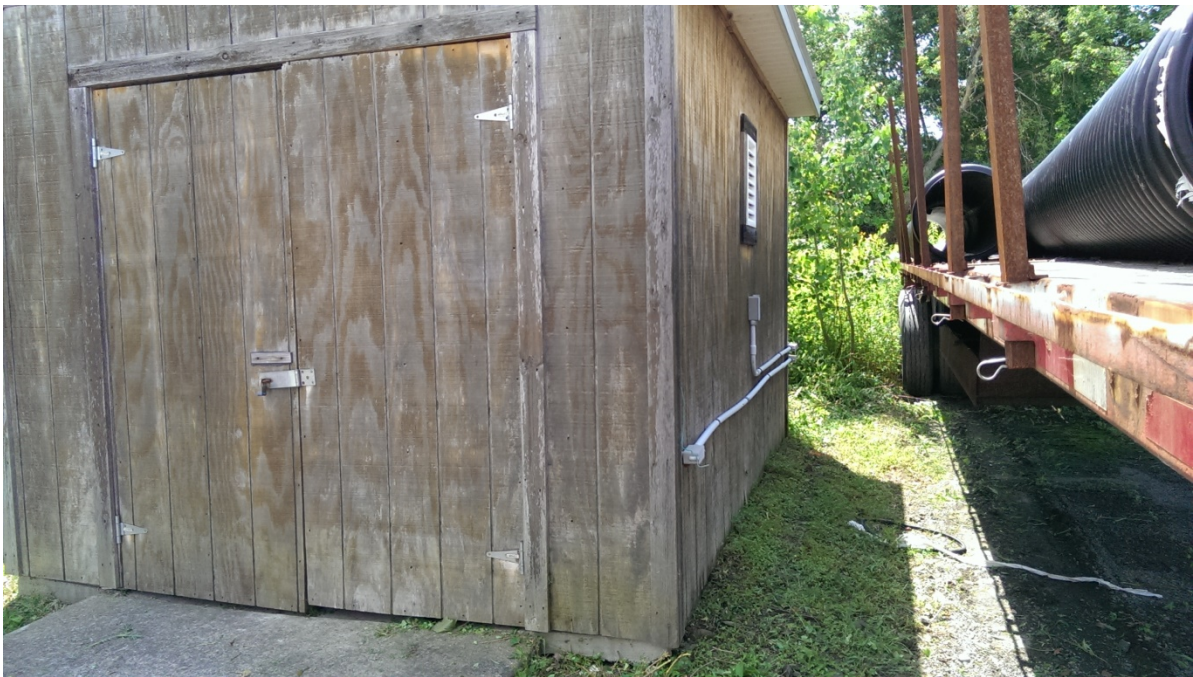
Cell Building #1

Vines around main building sprayed with Roundup.
Grass around main building, cell 1, and cell 2 trimmed with weedeater.
