LEVEE PIPE ABANDONMENT SUMMARY

Well 1-1A Treatment Plant Blow-off Pipe

Site 7-09-009A

July 2016

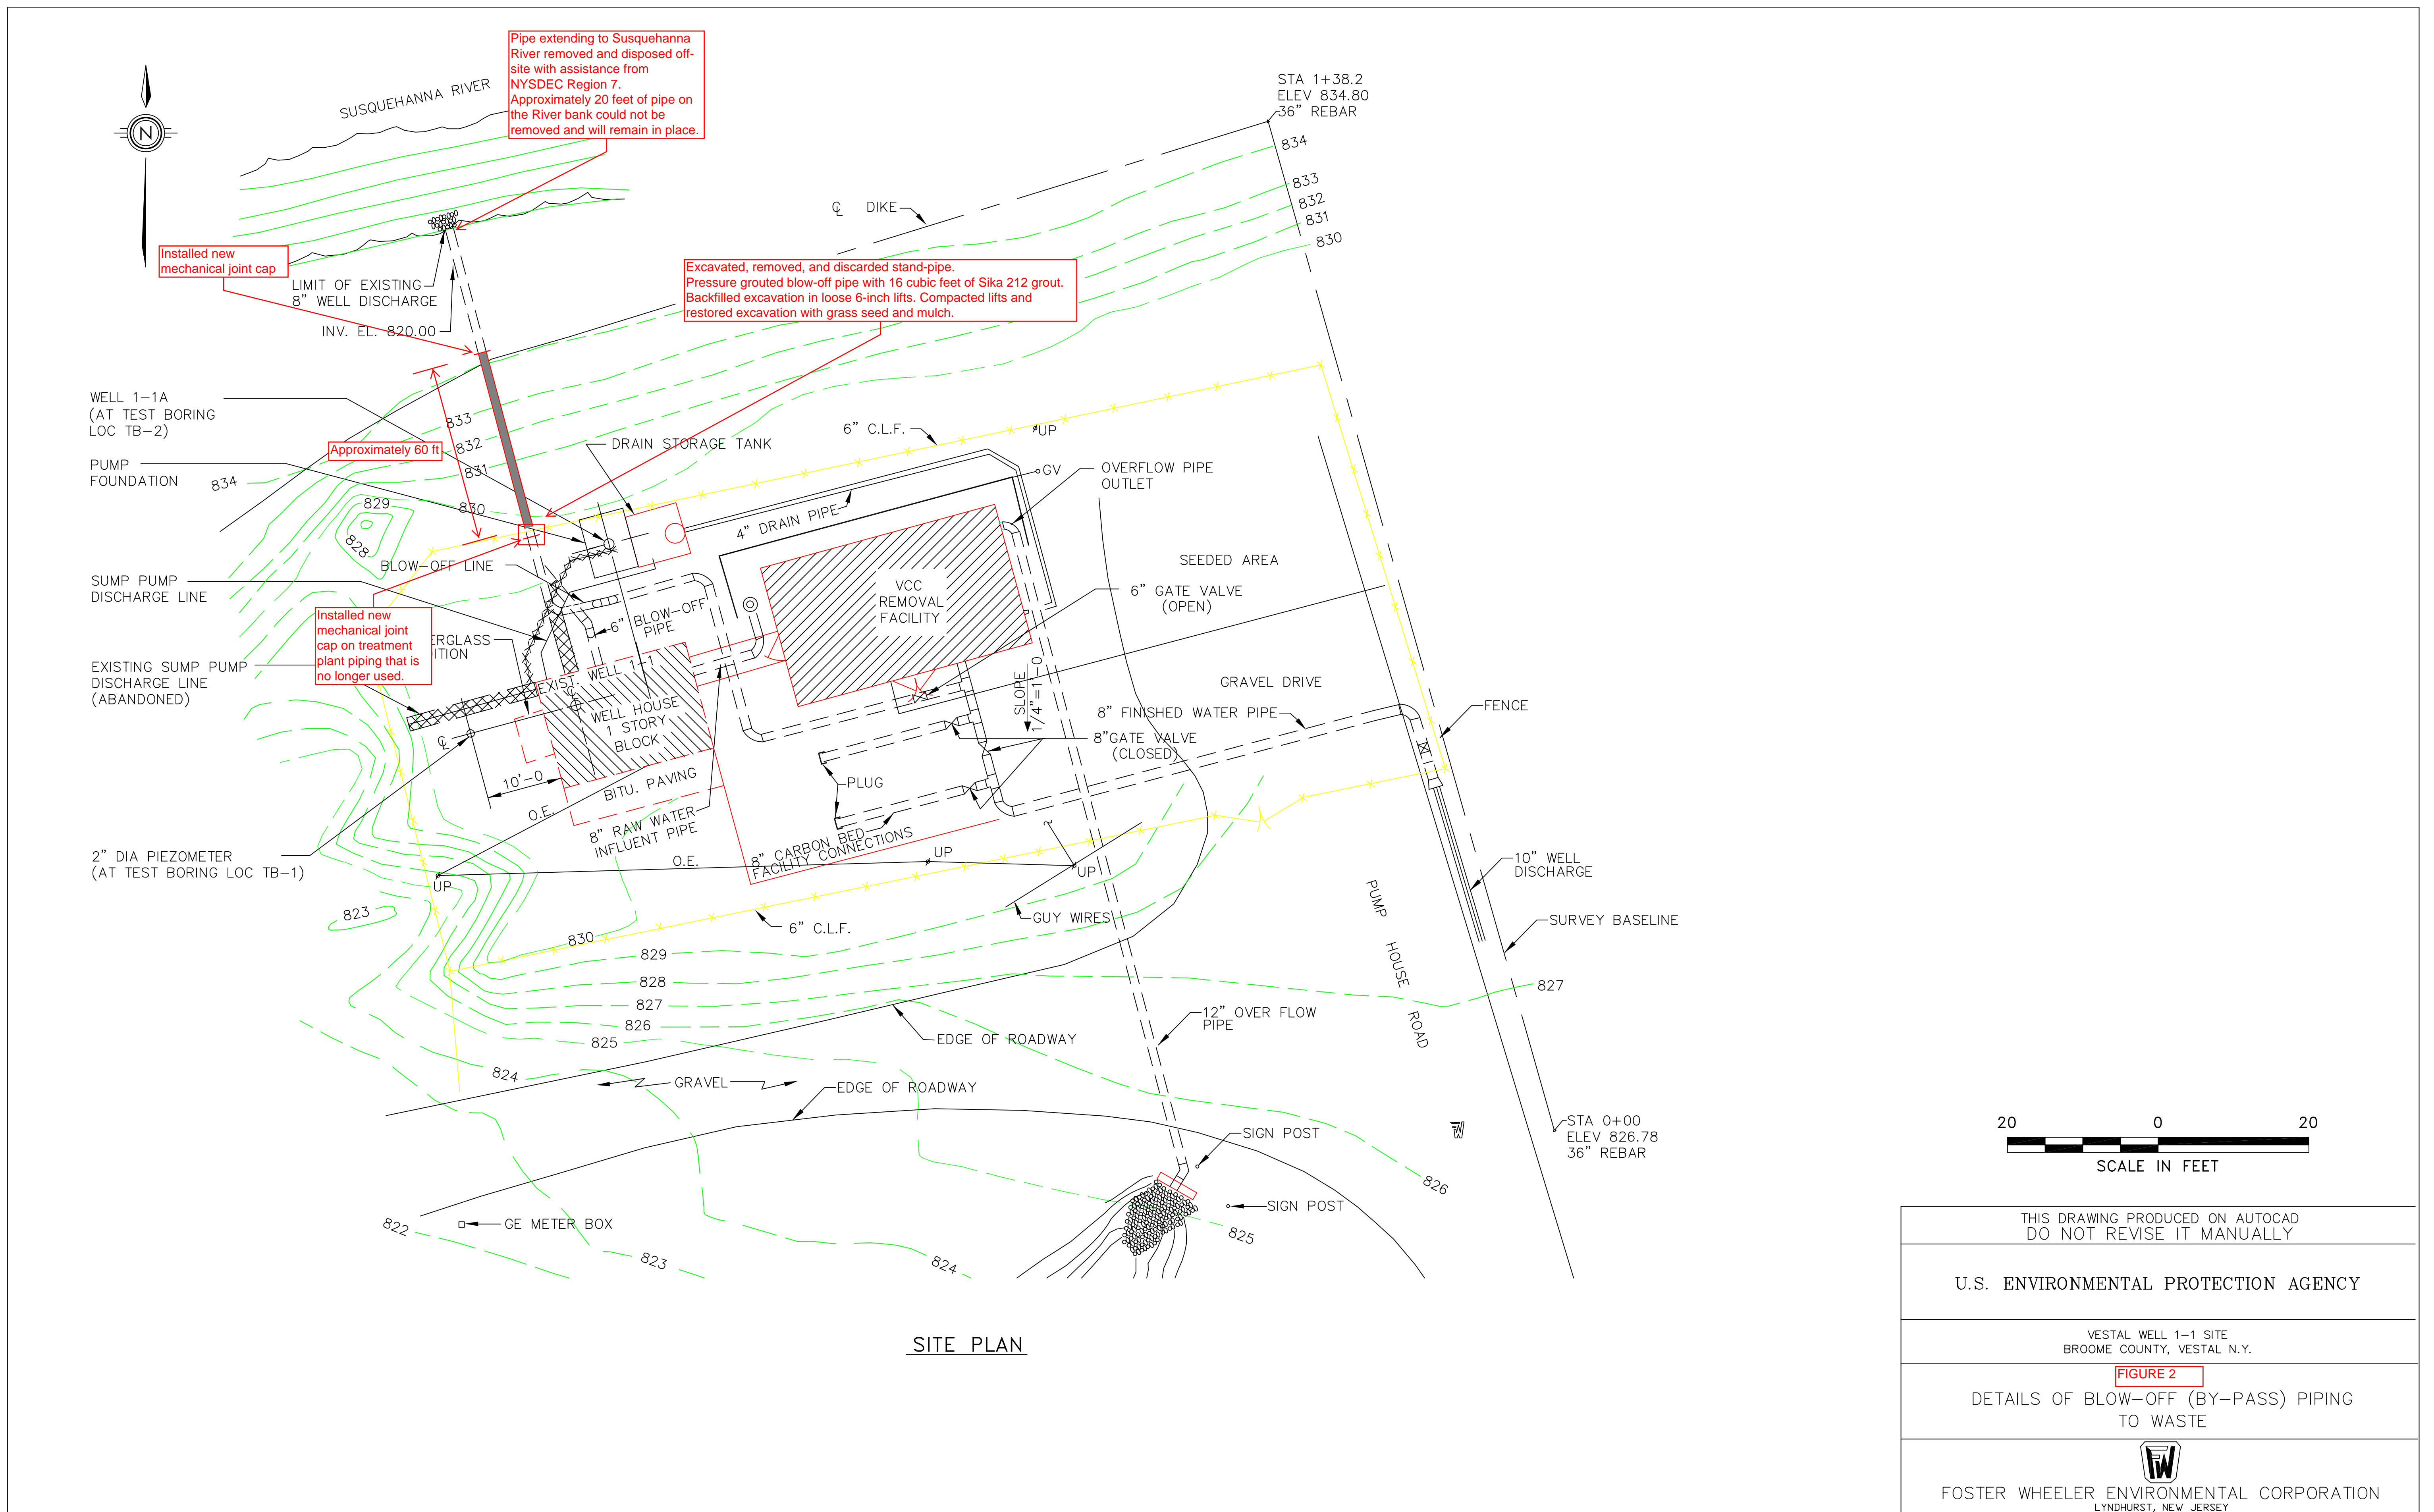
An 8-inch iron discharge pipe formerly served as a blow-off and bypass line so that water from the Well 1-1A pump house or treatment plant could bypass a State Flood Management Area and be discharged directly to the Susquehanna River. The blow-off pipes exit the pump house and treatment plant below grade, wye together and pass through a flood control levee that is regulated by the NYSDEC Region 7 Division of Water and United States Army Corps of Engineers (USACE). The pipe then extended down the levee embankment to the bed of the Susquehanna River (Figure 2).

On June 20, 2016, Arcadis excavated, exposed, and removed an existing stand-pipe that connected to the 8-inch blow-off pipe. As shown on Figure 2, the standpipe connection with the 8-inch blow-off pipe was between the pumphouse and levee embankment, immediately adjacent to the perimeter fencing for the pumphouse and treatment plant. The stand pipe was no longer required for treatment plant operations and, once removed, served as an access point to grout the blow-off pipe extending through the levee. The materials excavated to expose the standpipe consisted of poorly-sorted silt to coarse gravel with cobbles and occasional boulders. The material was firm and dry. The total depth of the excavation was approximately three feet. The materials were segregated based on the type of material (i.e. sod, gravel, etc.) and staged for re-use as backfill and restoration. The limits of the excavation were marked and barricaded at the completion of each work day while excavation remained open. No anomalies or additional sub-surface utilities were encountered during the excavation.

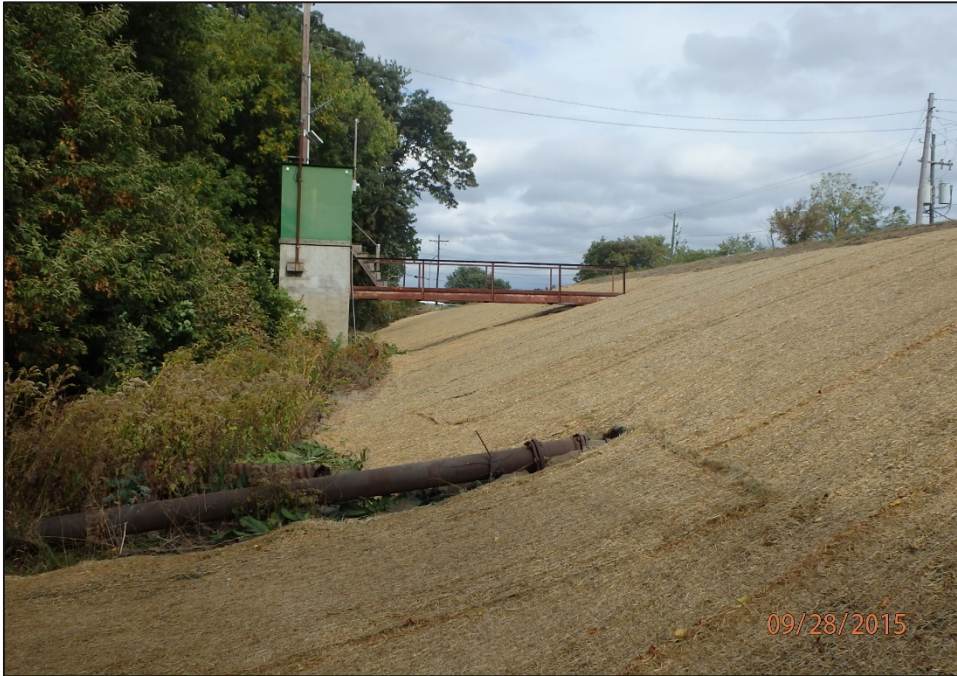
Blow-off surface pipe on levee embankment at head-wall connection (2015).

On May 23, 2016, Arcadis and NYSDEC Operations staff removed approximately 52 feet of 8-inch above-ground blow-off piping and fittings between the levee headwall and the Susquehanna River. The pipe was removed from the levee embankment using Operation's excavator, cut into lengths of approximately 10 feet and loaded into Operation's dump truck for off-site disposal. One section (approx. 20ft) of 8-inch pipe still remains along the bank of the River and extends beneath the water surface. This section of pipe remained firmly in place as the excavator pulled the other sections of pipe away. It is suspected that the discharge point of the pipe is connected to a concrete structure at the base of the Susquehanna River. Due the slope of the river bank, the exposed portions of the pipe could not be accessed to be cut and removed.

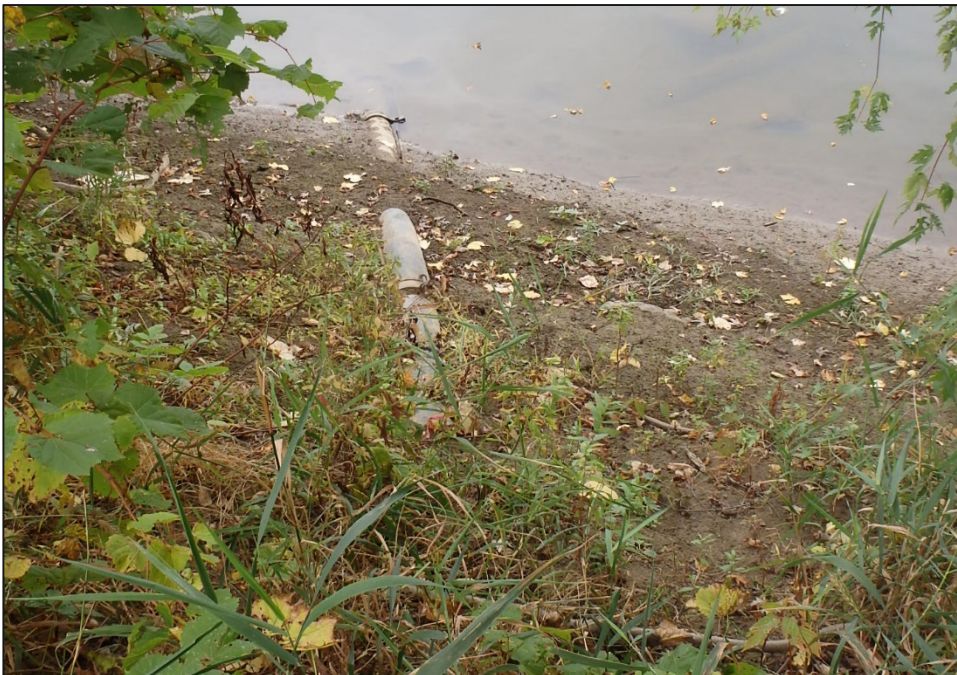
Blow-off surface pipe at river discharge (2015).

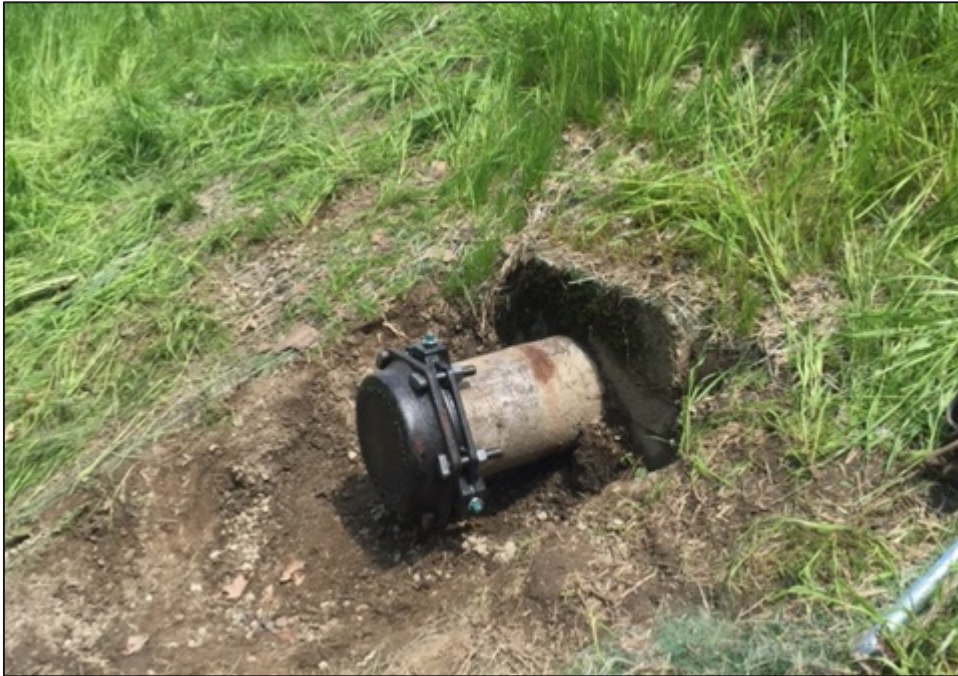
Blow-off pipe at levee head-wall connection with surface piping removed and new mechanical joint cap installed.

A new 8-inch mechanical joint (MJ) cast iron cap, retaining flange, and gasket was installed to seal the blow-off pipe at the levee headwall in preparation for grouting.

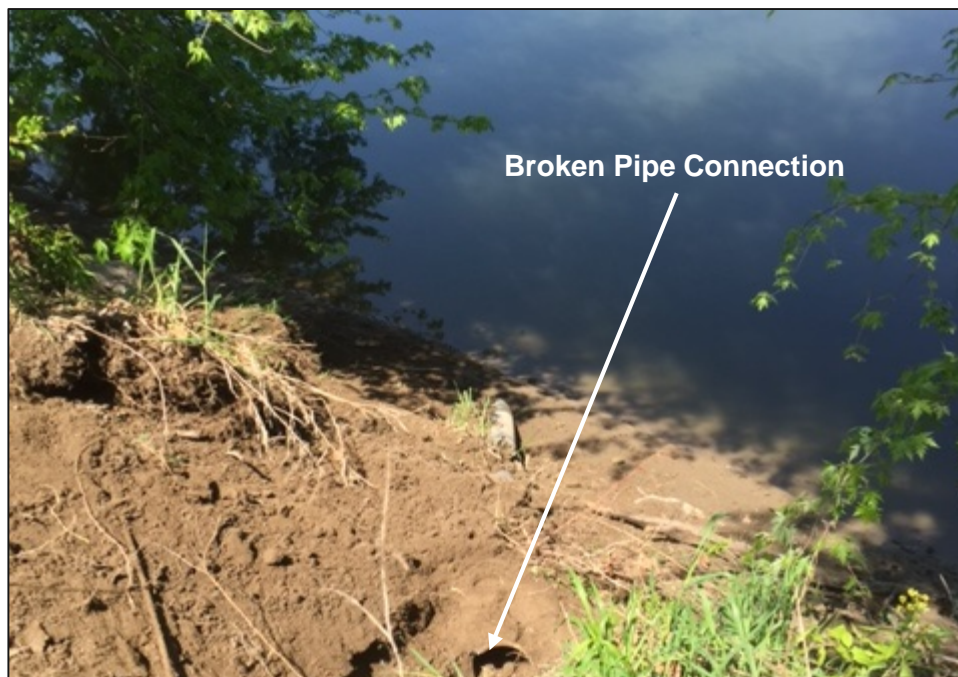
Blow-off pipe at river discharge following surface pipe removal.

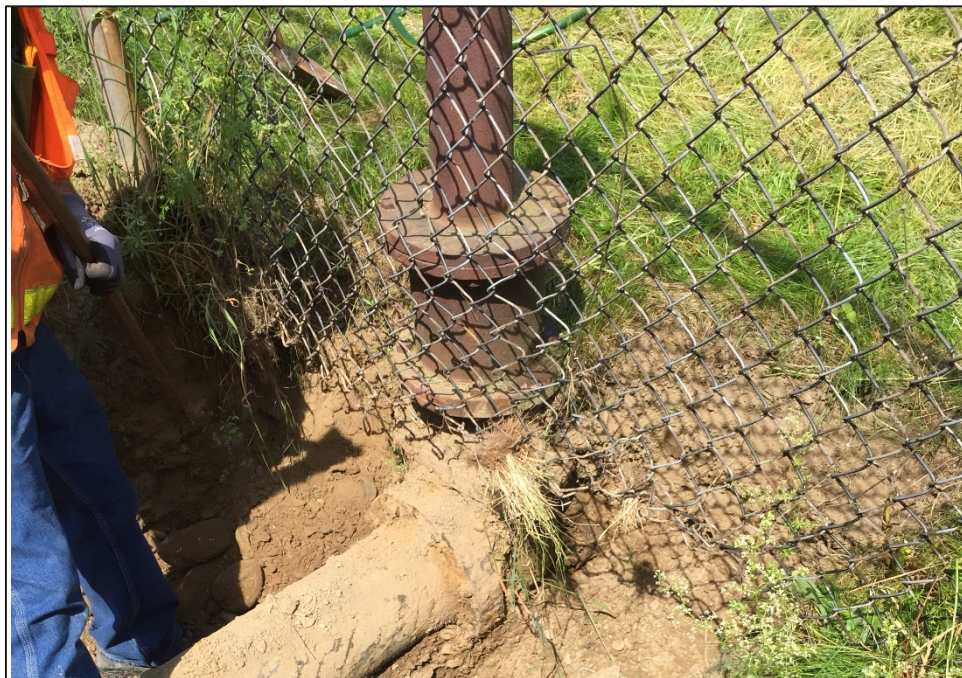
Stand-pipe and connection with Blow-off pipe.

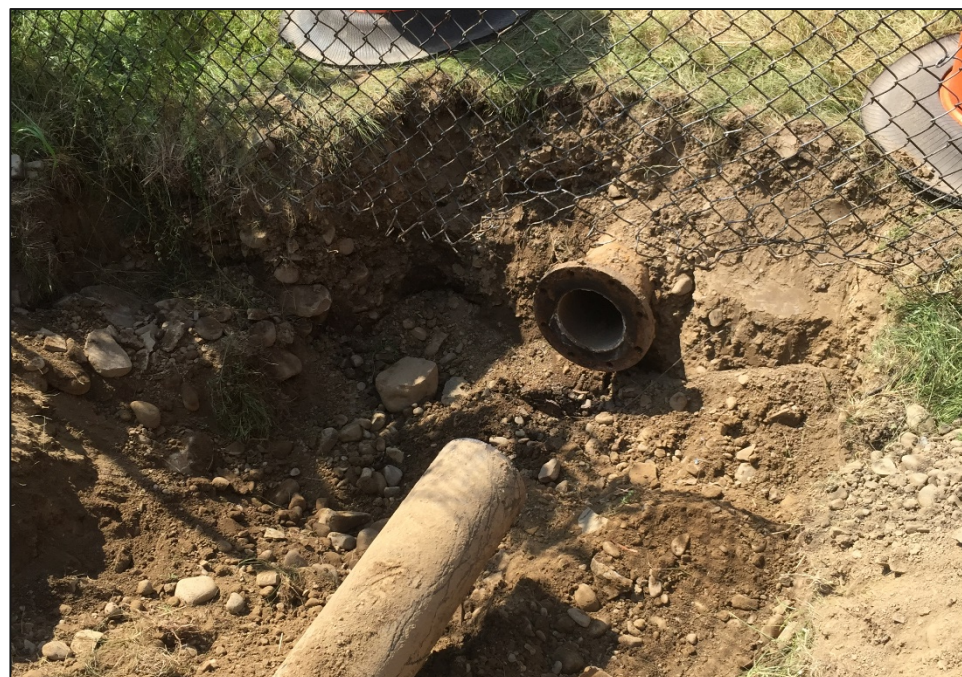
Blow-off pipe with stand-pipe removed.

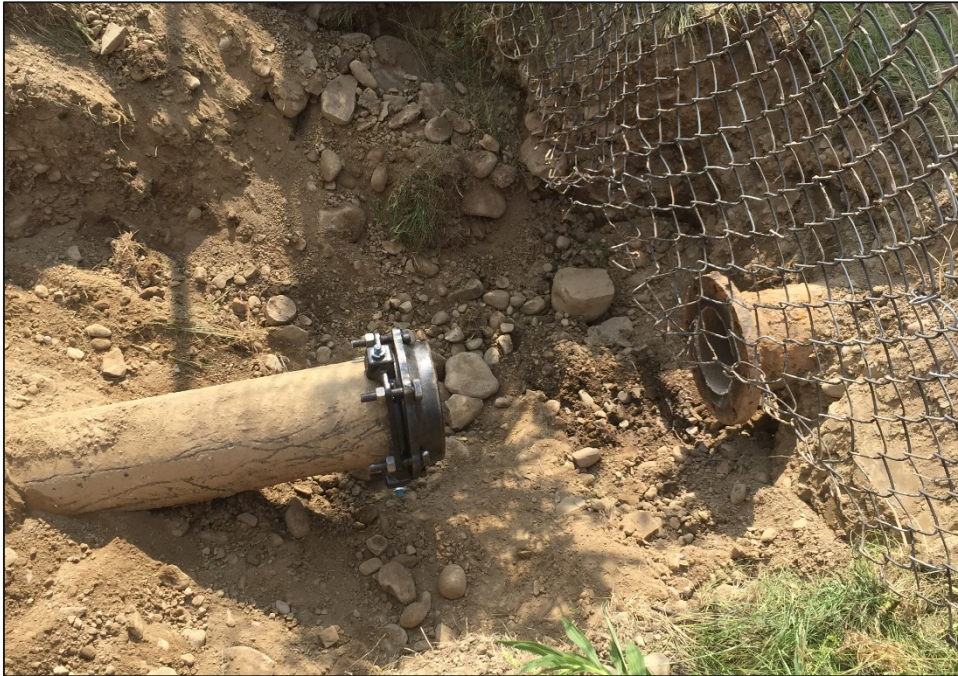
Blow-off pipe with MJ cap installed on treatment plant piping.

An 8-inch MJ cast iron cap, retaining flange, and gasket was installed to seal treatment plant blow-off piping where the stand-pipe was removed.

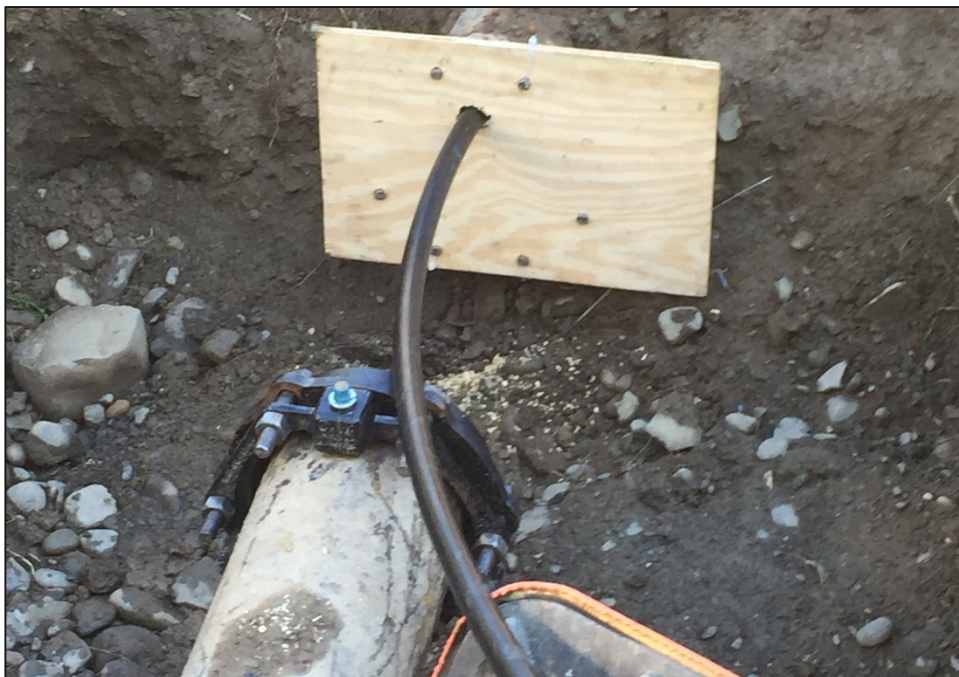
Blow-off pipe with plywood form installed. Tremie-line inserted through to of form into pipe.

Sika 212 grout was used to abandon the blow-off pipe. The grout was mixed in accordance with the manufacturer's specifications and then pumped through a tremie-line using a grout pump. The one-inch tremie-line was inserted into the blow-off pipe at the former standpipe connection. The line was then passed through the blow-off pipe so that grout was discharged into the opposite (levee bulkhead) end of pipe. As the blow-off pipe was filled with grout, the tremie-line was removed. Once the blow-off pipe was nearly filled, the tremie-line was removed and a plywood form was bolted to the flanged end of the pipe. The tremie line was then placed through the hole drilled in the form and the remainder of the pipe was filled with grout. This deviated slightly from the final Scope; a larger form and grout plug was the original plan to ensure that the pipe was completely filled with grout. However, this assumed that the blow-off pipe would have been cut to and no flange would be present to attach a form. Therefore, since the blow off pipe still retained a MJ flange, a form could easily be bolted to the pipe and allow the grout to completely fill the pipe. As estimated, a total of 24 bags (16ft³) of Sika 212 grout mixture was used to seal the blow-off pipe.

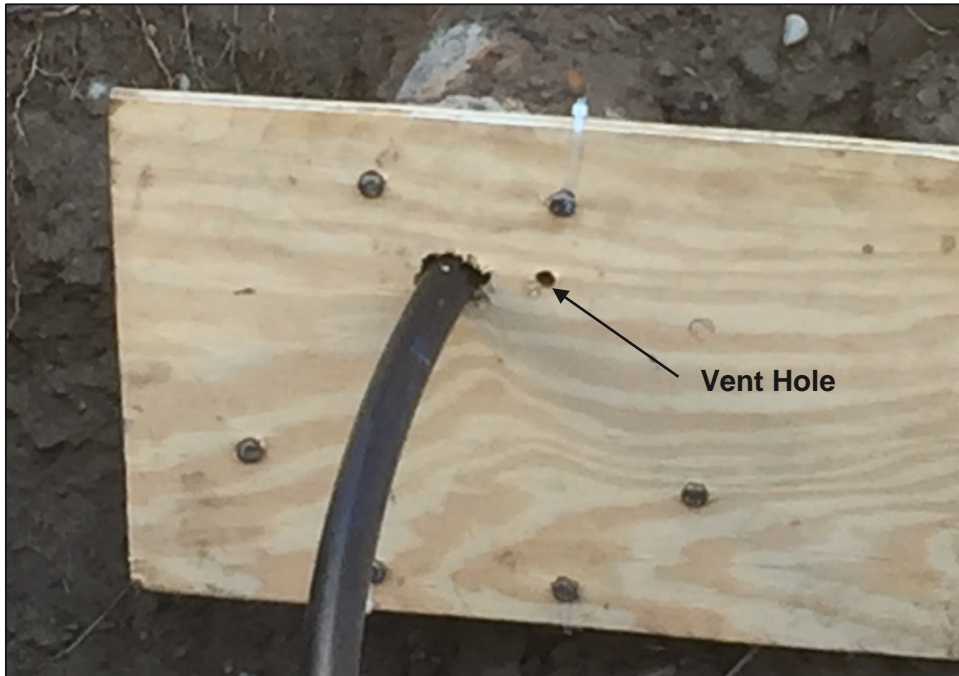
Plywood form with tremie-line inserted through hole drilled in top of form. Vent hole in form allowed air to escape while pipe was being filled with grout.

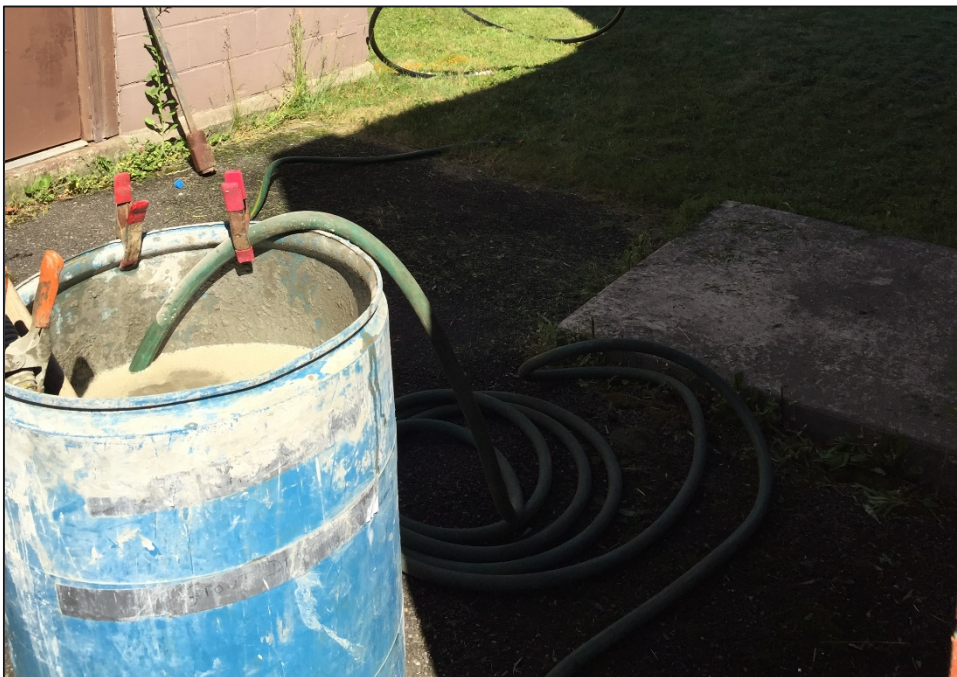
Grout batch being mix prior to pumping into blow-off pipe.

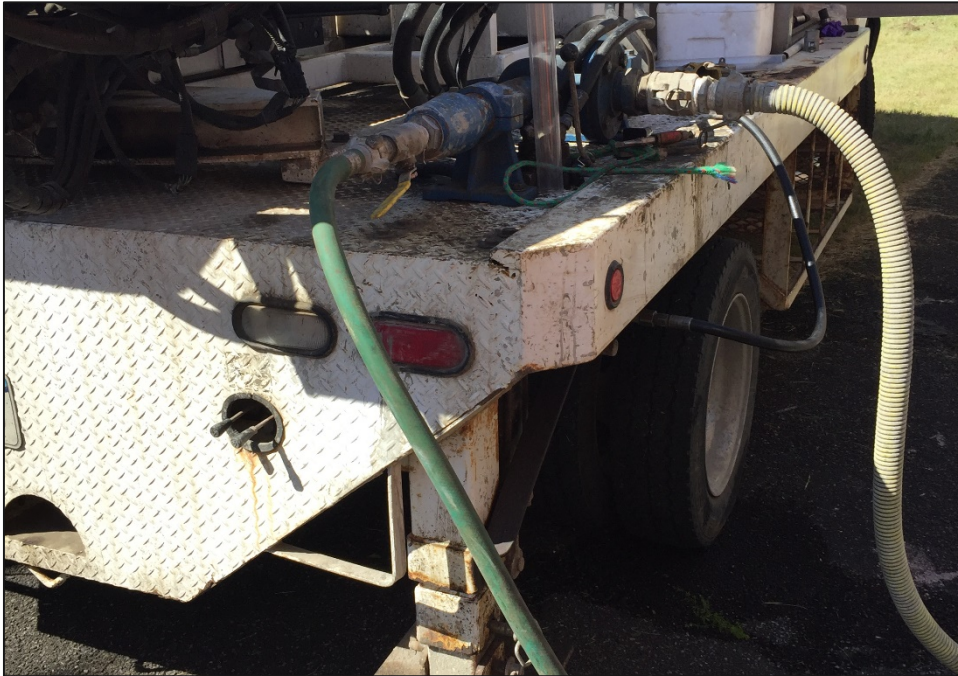
Grout pump used to mix and deliver grout through tremie-line to blow-off pipe.

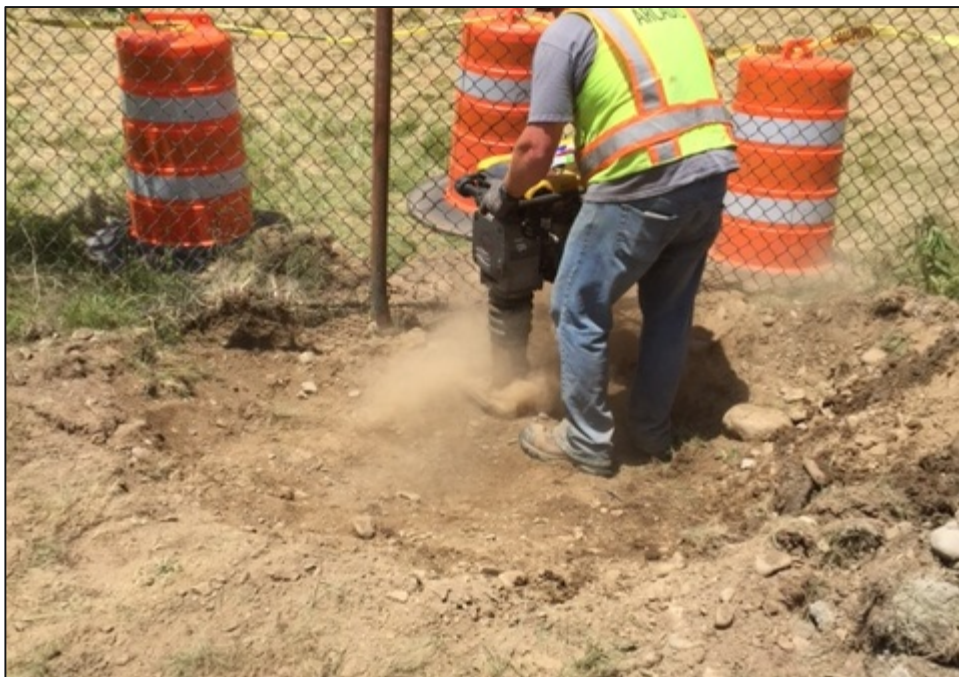
Compaction of backfill material.

The excavated area was backfilled with the materials removed to expose the standpipe. The material was placed with an excavator bucket in loose, 6-inch lifts. Each lift was then compacted with a plate compactor until the excavation area conformed to the pre-existing grade. The excavation and disturbed areas were then graded, seeded with grass, and mulched.

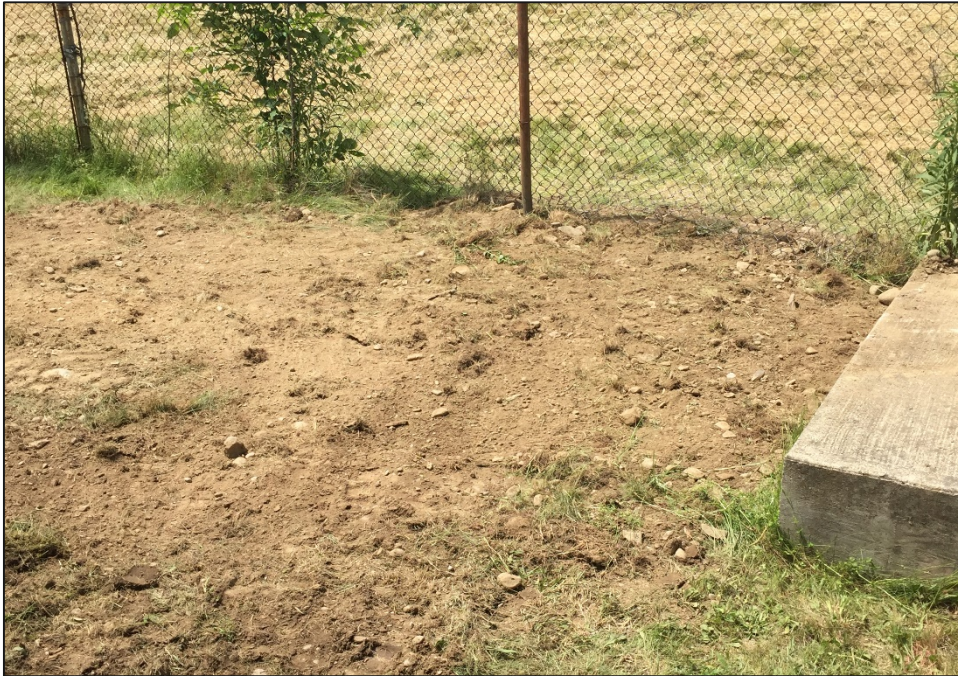
Final grading of excavation area.

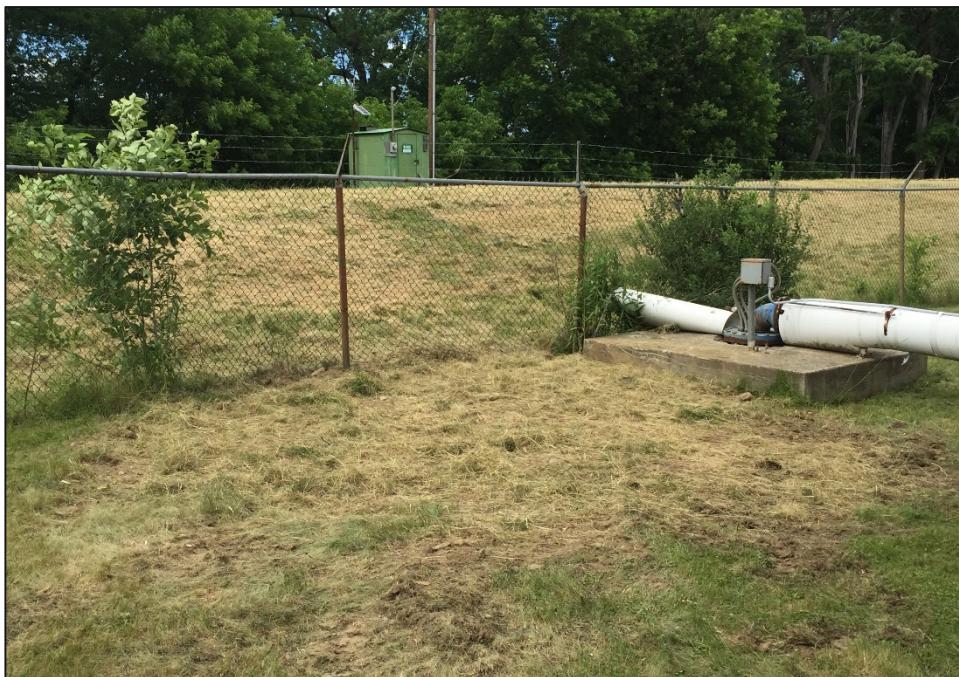
Completed site restoration.
