SUBJECT: August 2017 Operating Report for the Vestal Well Field 1-1 Superfund Site, Area 4,  
Vestal, New York

SUBJECT: August 2017 Monthly Report on Activities at the Vestal Well field 1-1 Superfund Site, Area 4, Vestal, New York

**LATA Project # 11202**  
**Contract # W912DQ-09-D-3003,**  
**Task Order # 008**

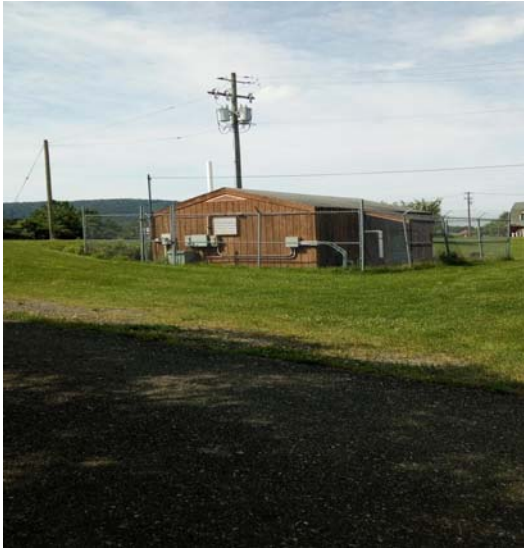
Picture 1 - Main Treatment Building Exterior

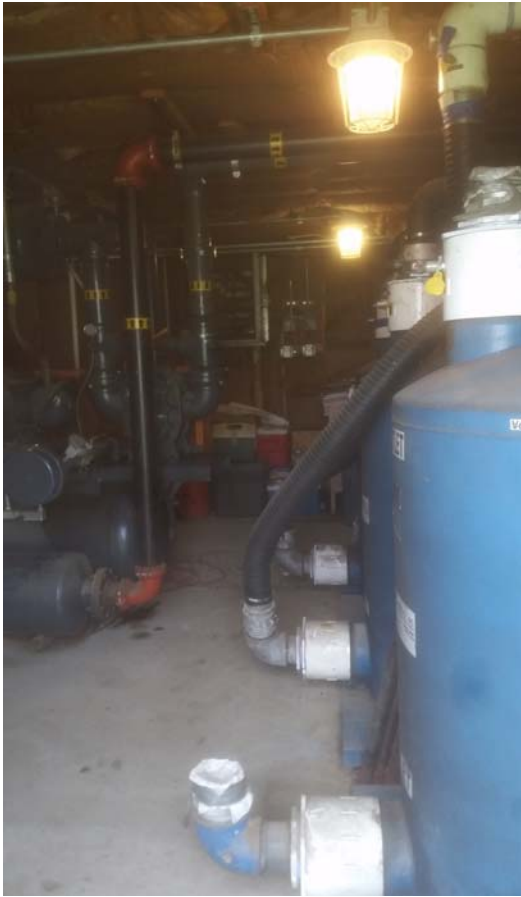
The insulation inside the treatment building was inspected. The insulation is in acceptable condition, though some deterioration over time has occurred. One small section of wood on the south wall of the treatment building had previously deteriorated and had been patched with wood in February 2014. It was observed that the pieces of wood which had been used to patch this hole had been knocked loose. This will be repaired during the September site inspection.

Picture 2 - Main Treatment Building Interior

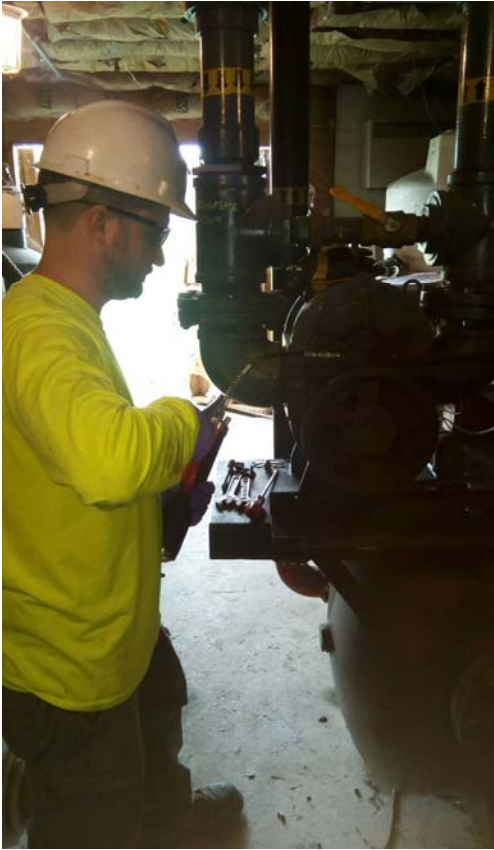
Prior to re-starting the system, the system was de-energized at the main breaker panel and tagged out, and the electrical closet was closed. After de-energizing the system, both of the Roots® injection and vacuum blowers were greased and the oil changed. Shell Gadus® S2 U1000 #2 grease was added to the drive end bearings using a hand operated grease gun until traces of clean grease came out of the relief fitting in accordance with the manufacturer's operation manual. Oil levels in the blowers were checked and found to be within the manufacturer's specified range. The blowers were then drained of oil, the overflow drain was opened and the top vent plug removed. The blowers were then refilled with Roots® Synthetic VG-220 oil until oil flowed from the overflow drain port in accordance with the manufacturer's operation manual. The overflow valve drain was then closed and the top vent plug reinstalled. The belt guard for the blowers was then removed for inspection of the belts and sheaves. The belts were found to be properly aligned and in good condition, without excessive wear. The General Electric® motor that drives the blowers was inspected in accordance with the manufacturer's operation manual. The motor was clean and the ventilating openings were clear. In accordance with the manufacturer's operation manual for this 40 HP motor, which is mounted in a horizontal configuration and operated infrequently, the lubrication interval is 7 years. Overgreasing can damage the motor, so no lubrication was performed on the motor. Following this inspection the belt guard was reinstalled.

Picture 3 - Greasing the Injection and Vacuum Blowers

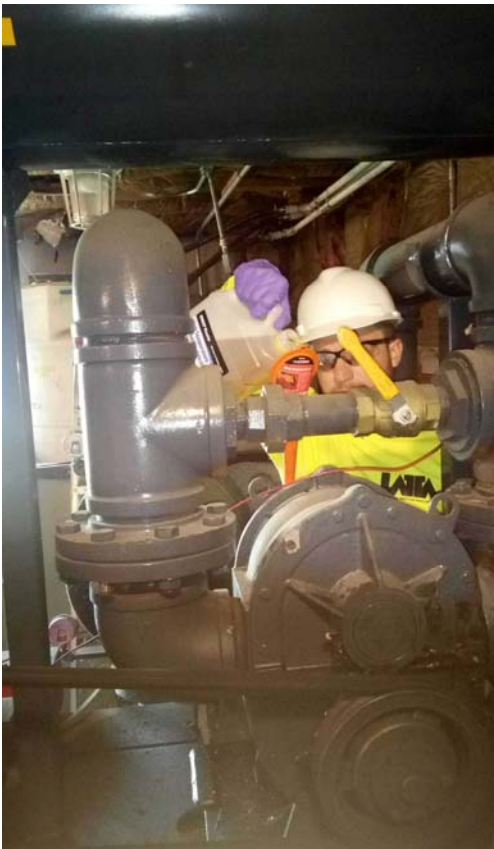
Picture 4 - Refilling the Injection and Vacuum Blowers With Oil

**Comments** - Checked oil levels in blowers. Drained both blowers of oil and refilled with Roots Synthetic VF-220 oil. Greased drive end bearings with Shell Gadus S2 U1000 #2 grease. Inspected belts for wear and alignment

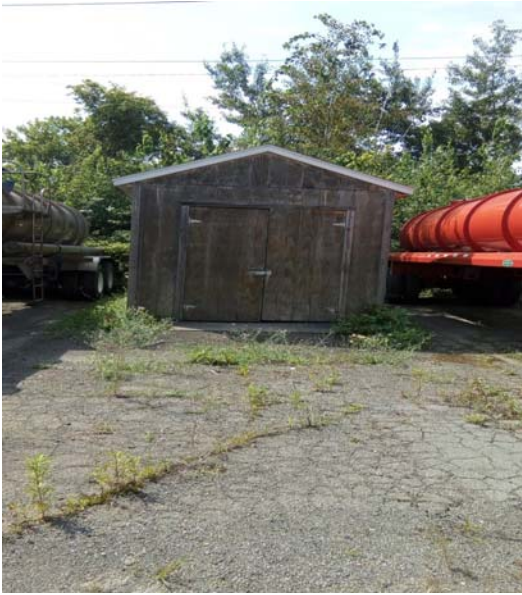
Picture 5 - Distribution Cell 1 Exterior

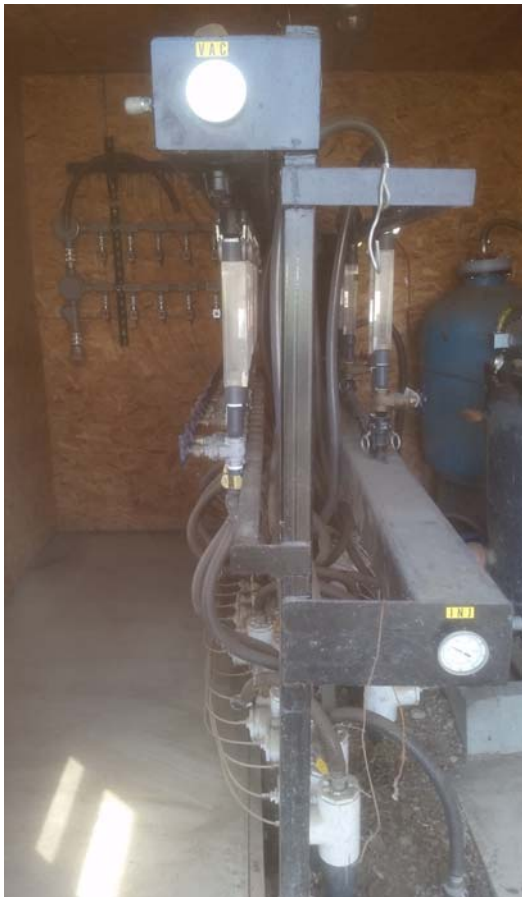
Picture 6 - Distribution Cell 1 Interior

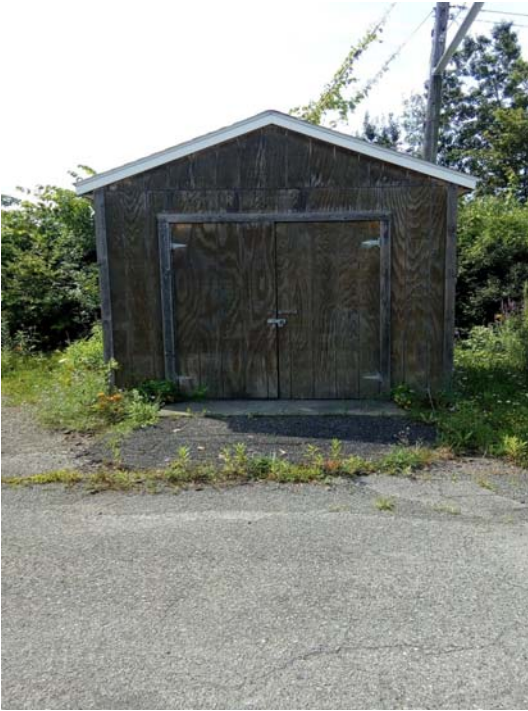
Picture 7 - Distribution Cell 2 Exterior

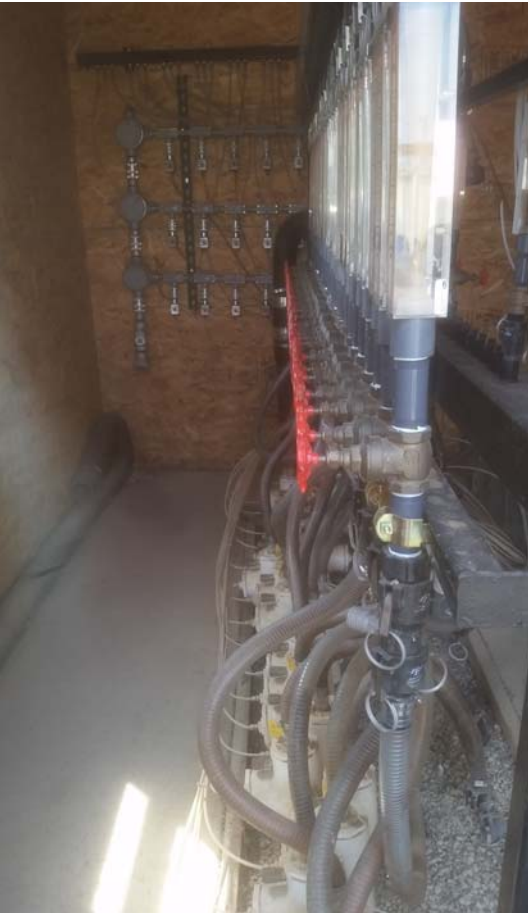
Picture 8 - Distribution Cell 2 Interior
