Colesville Landfill 5-Year Review

DER Site Management, November 10, 2009

Photos with Notes

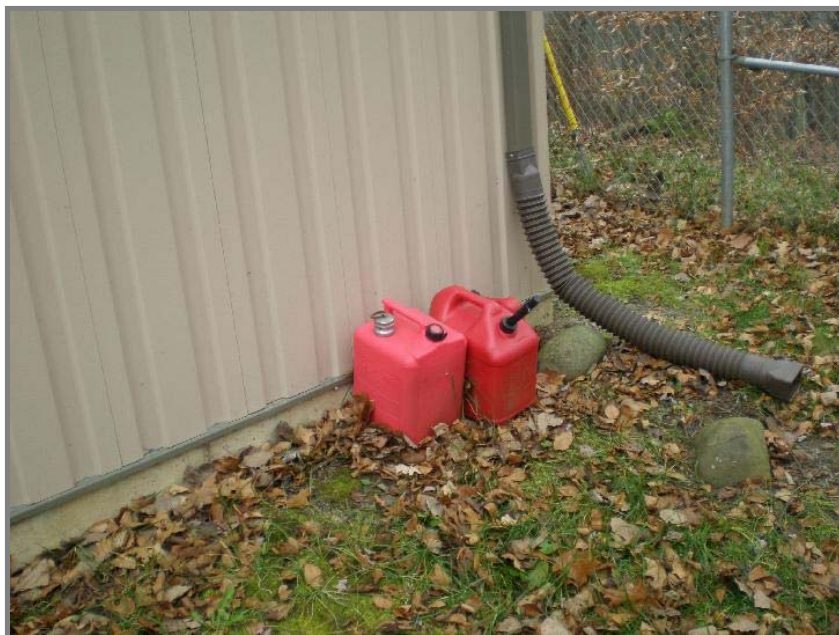
Outside storage of gas cans.

These cans need to be stored in a flammable locker.

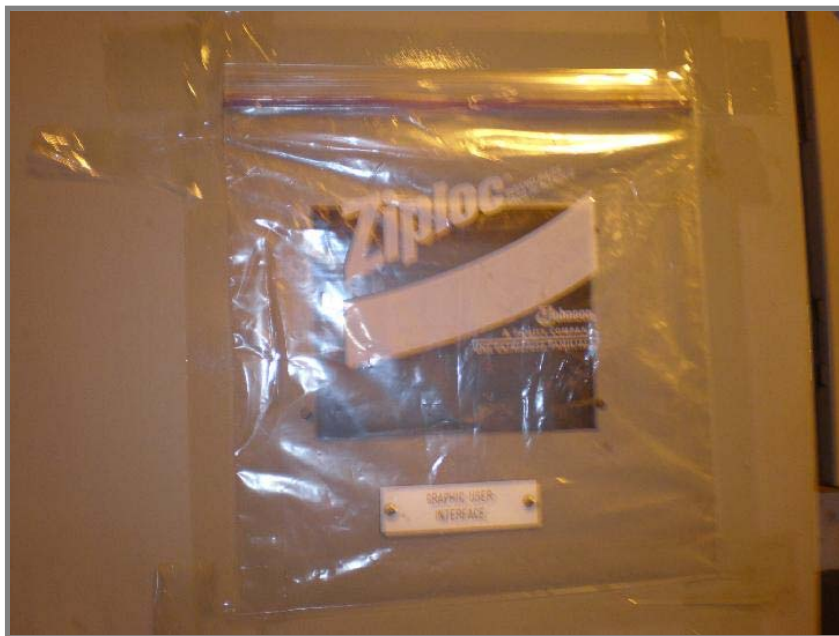
Missing panel cover. A blank needs to be installed.

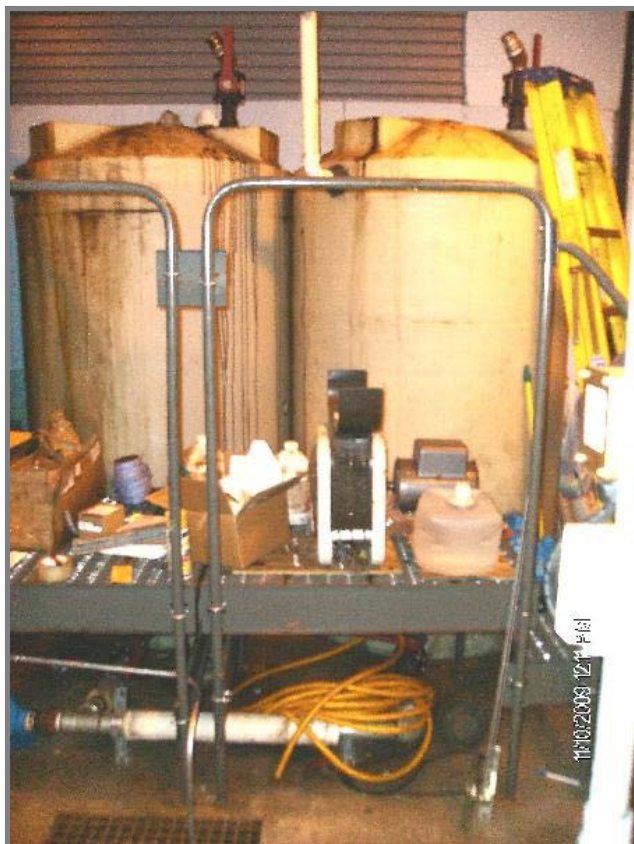
Feed-grade molassas being handled as food-grade molassas. I'm not sure I understand what this means, it seems that the process uses the cheaper, livestock feed-quality ingredient in food-grade equipment.

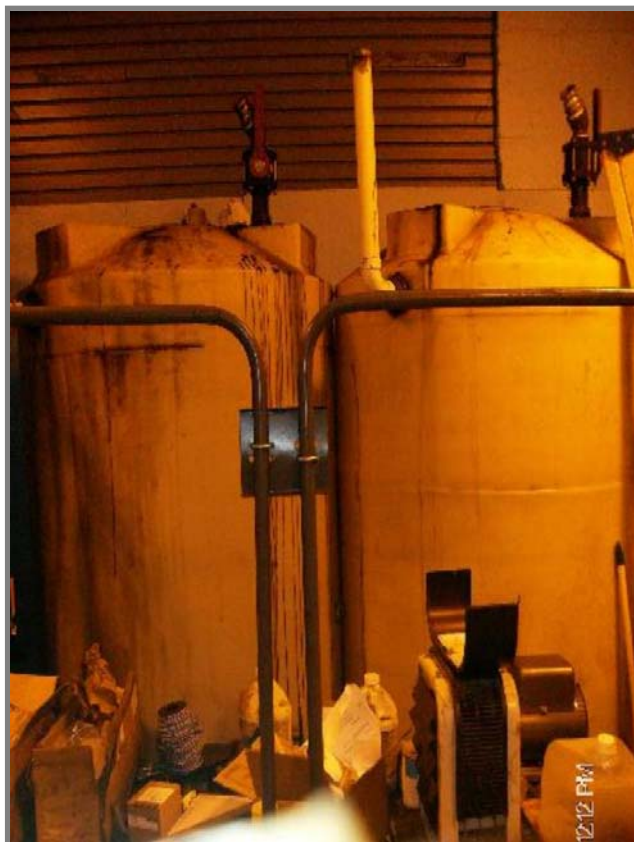
Feed-grade molassas being handled as food-grade molassas. I'm not sure I understand what this means, it seems that the process uses the cheaper, livestock feed-quality ingredient in food-grade equipment.

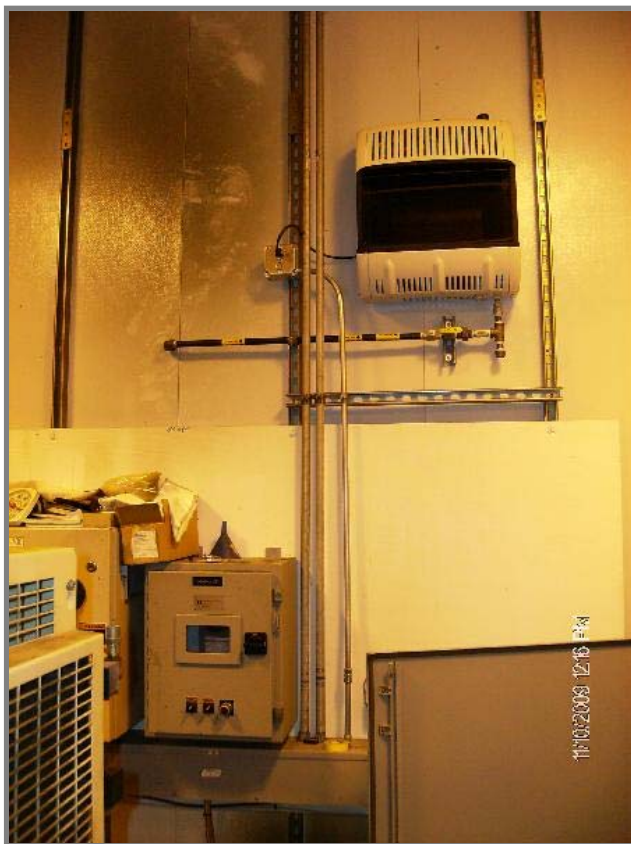
Heater. Note the smoke residue or scorch mark. The plant venting needs to be reviewed.

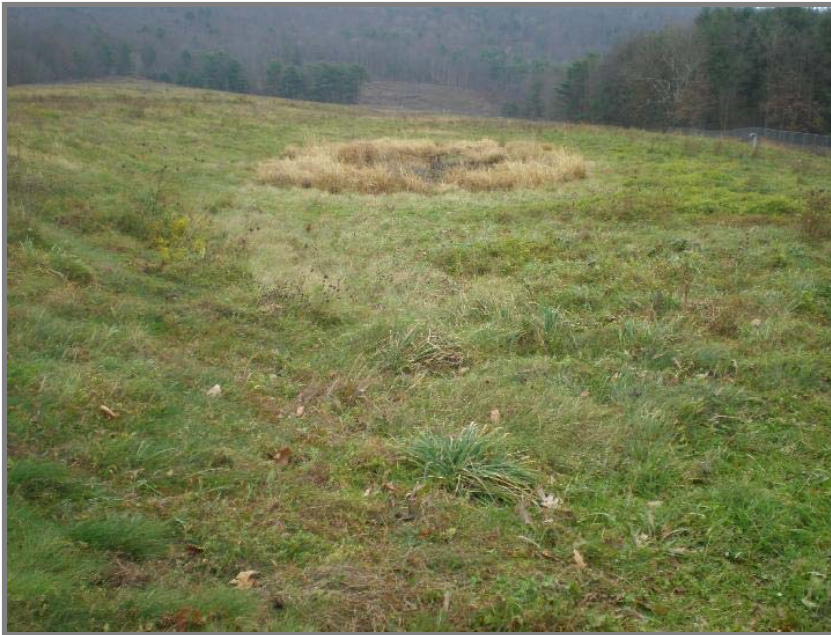
Looking east along the settlement

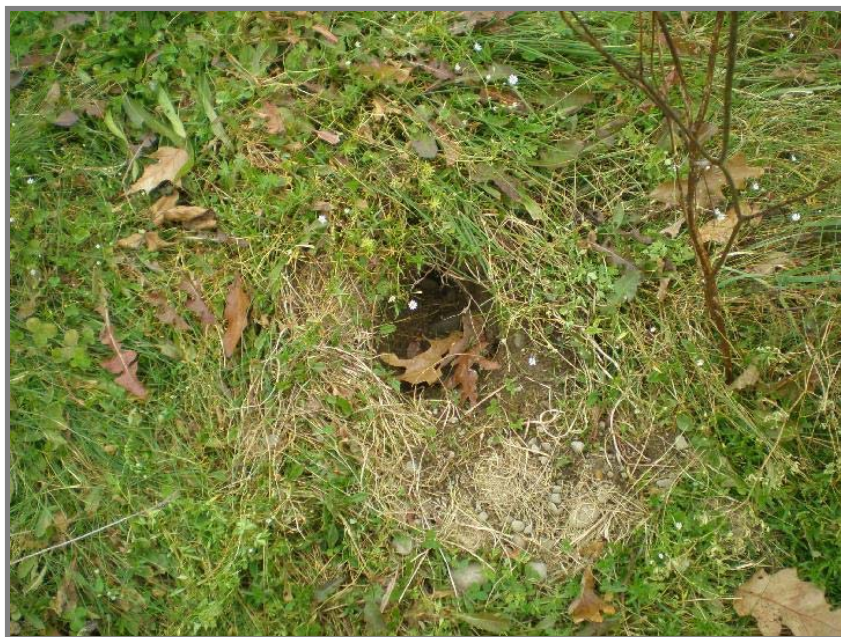
Gopher hole located just west of the first wetland.

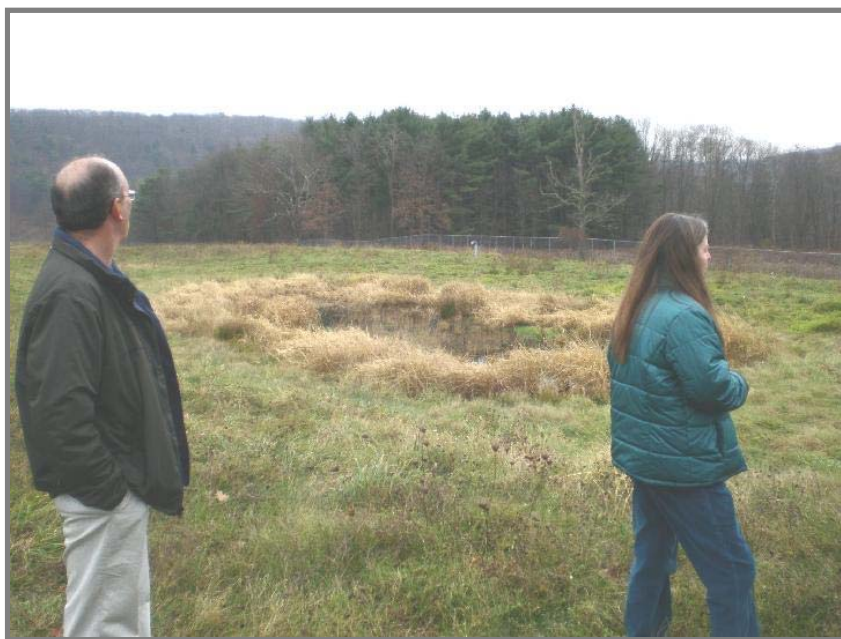
Observing the wetland that was also present at the time of the previous 5-year review.

"It's still there."

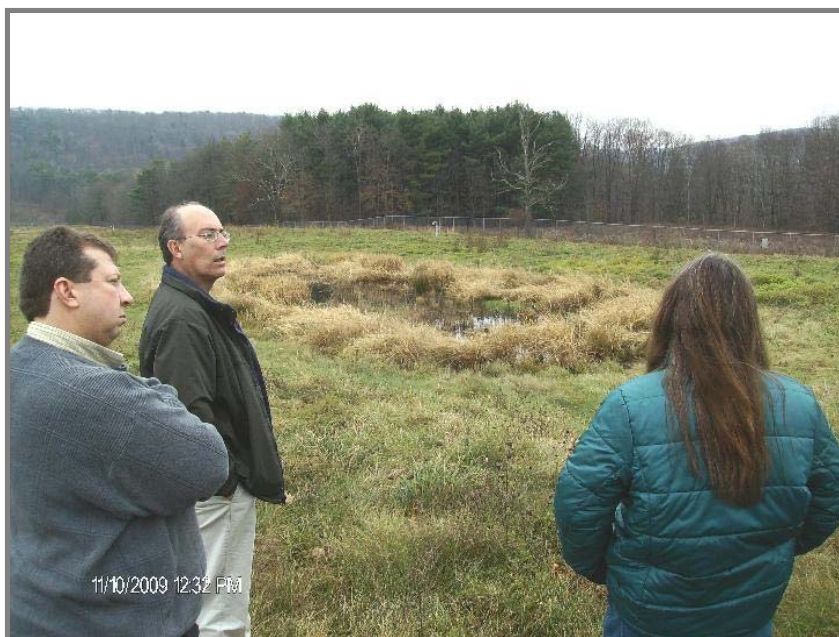
The most notable point of our landfill traverse were the settlement areas holding standing water.

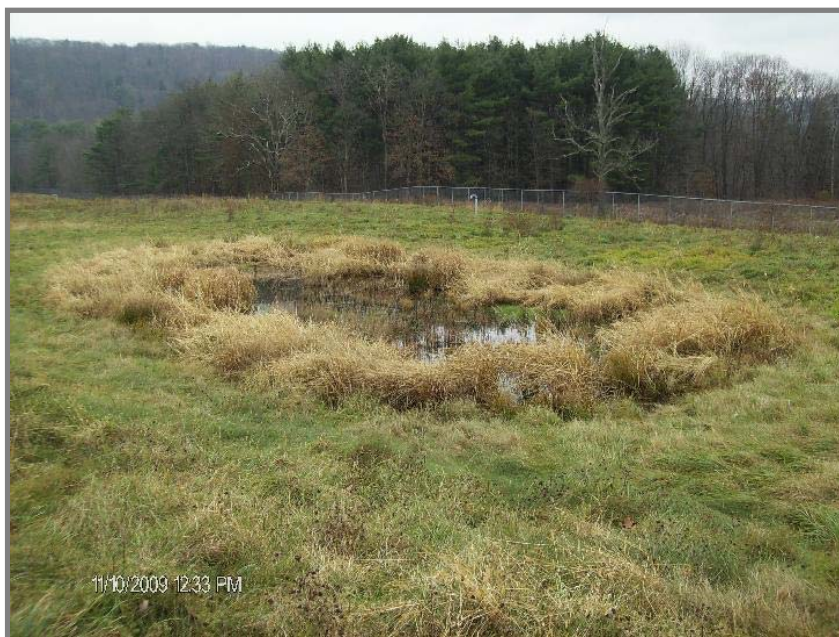
Coleville Landfill settlement area now filled with water. NYSDEC and USEPA said that these depressions should be filled and the cap regraded so water can drain off.

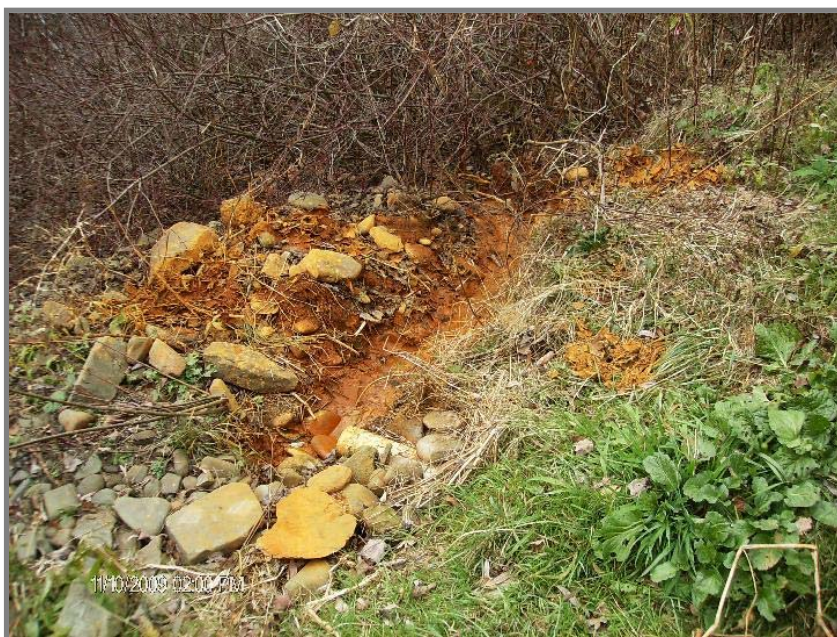
Iron at the outfall from the treatment plant. This water is "clean" said Steve Feldman. The iron is due to the change in eH/pH as the ground water daylights. This is future "bog iron."

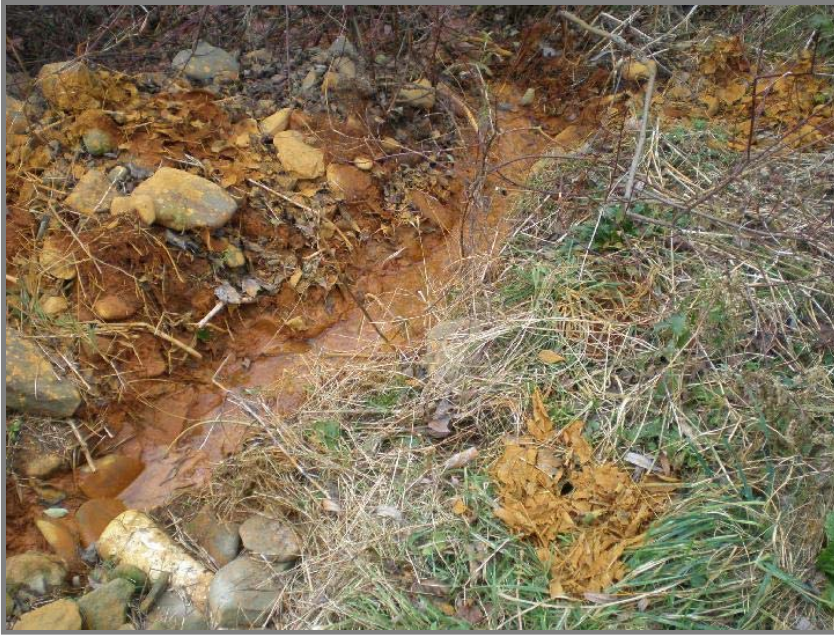
Closeup. Iron staining at the outfall

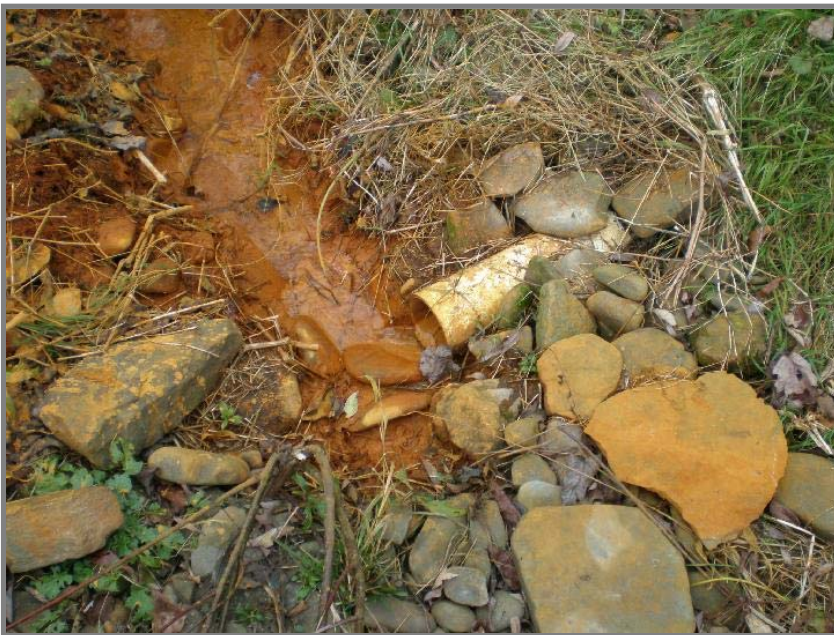
Iron staining

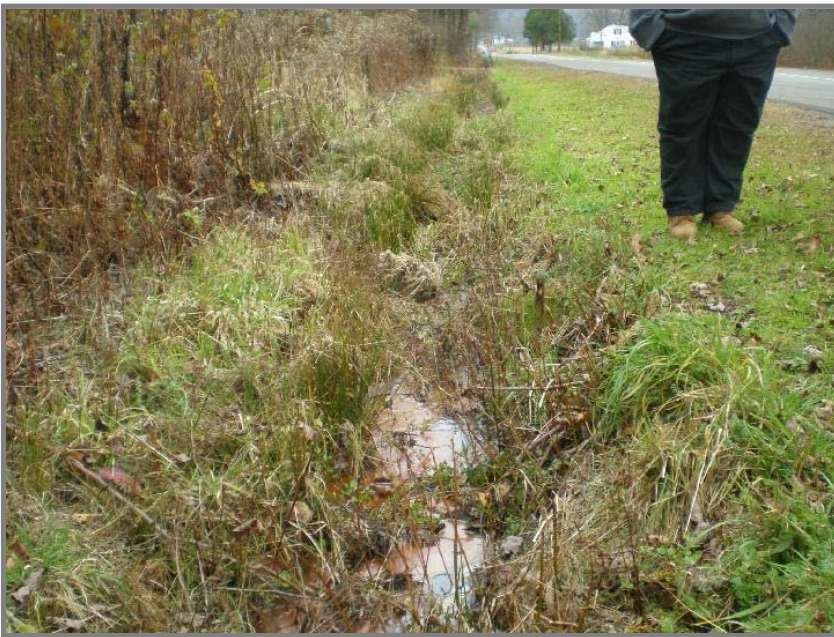
Bacterial sheen along the road

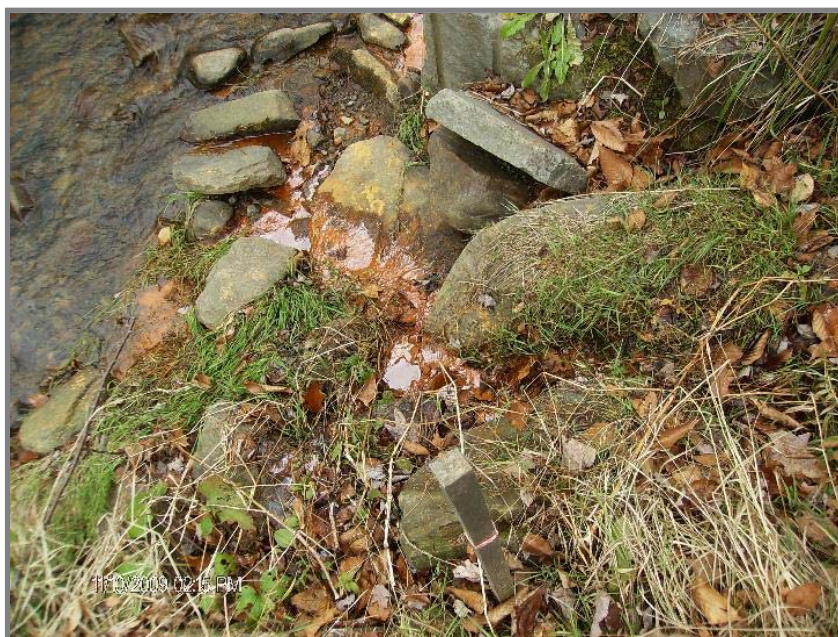
Iron-stained seep
