**CONKLIN LANDFILL  
FOLLOW-UP REPORT  
TO  
5-YEAR USEPA REVIEW**

For the:  
Former Conklin Landfill  
EPA ID NYD981486947  
Broome Parkway  
Town of Conklin  
Broome County, New York

SCE Project No. R08126.00

August 2008

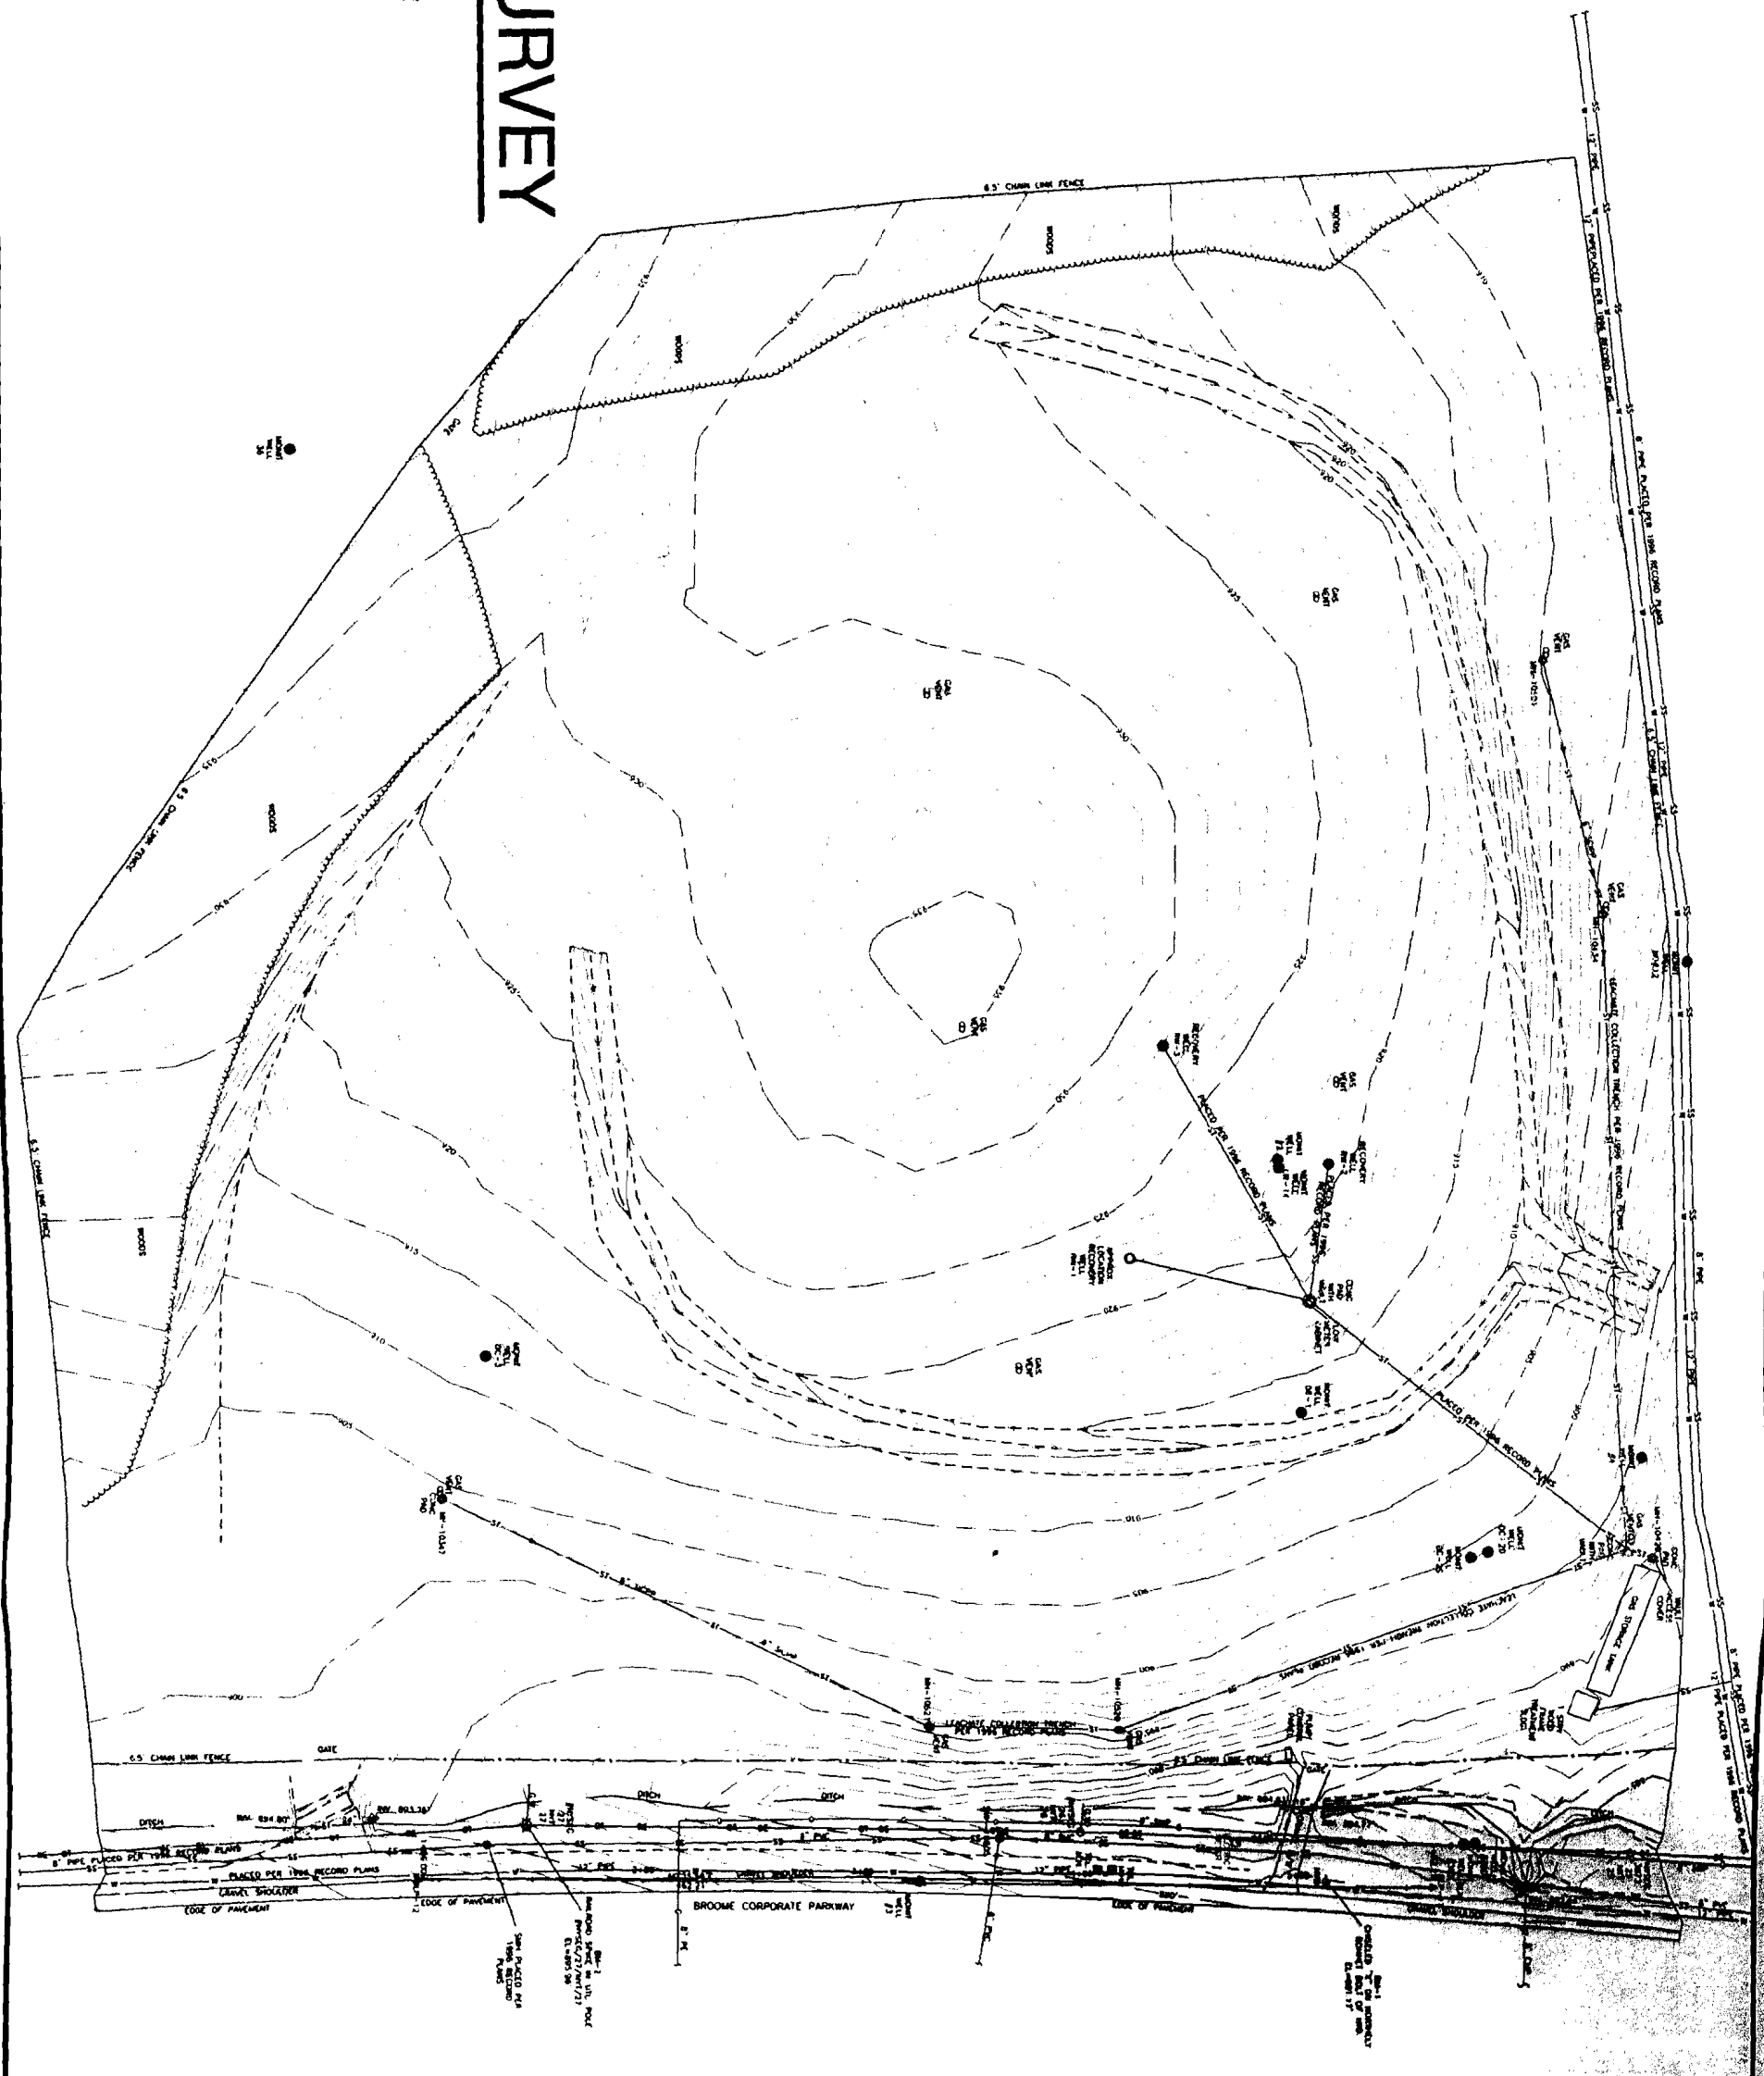
**FIGURE 2**

Prior to SCE’s involvement with this site, personnel from Jones Water investigated and made repairs to monitoring wells MW-2 and LW-4 which both exhibited protrusion of the interior PVC pipe. According to Mr. Thomas Delamarter of the Town of Conklin, Jones Water welded approximately 4 inches of additional length of protective casing around each of the well pipes so that the wells were able to be properly secured. During the field assessment, it was determined that MW-2 also exhibited interior damage, whereas the water level detector could not pass an apparent blockage in the well pipe at a depth of approximately 19 feet below the top of the well. The cause for the blockage in MW-2 could not be determined during SCE’s field investigation. A map depicting the landfill, and all monitoring wells, gas vents, and leachate collection system components is included as **Figure 2**.

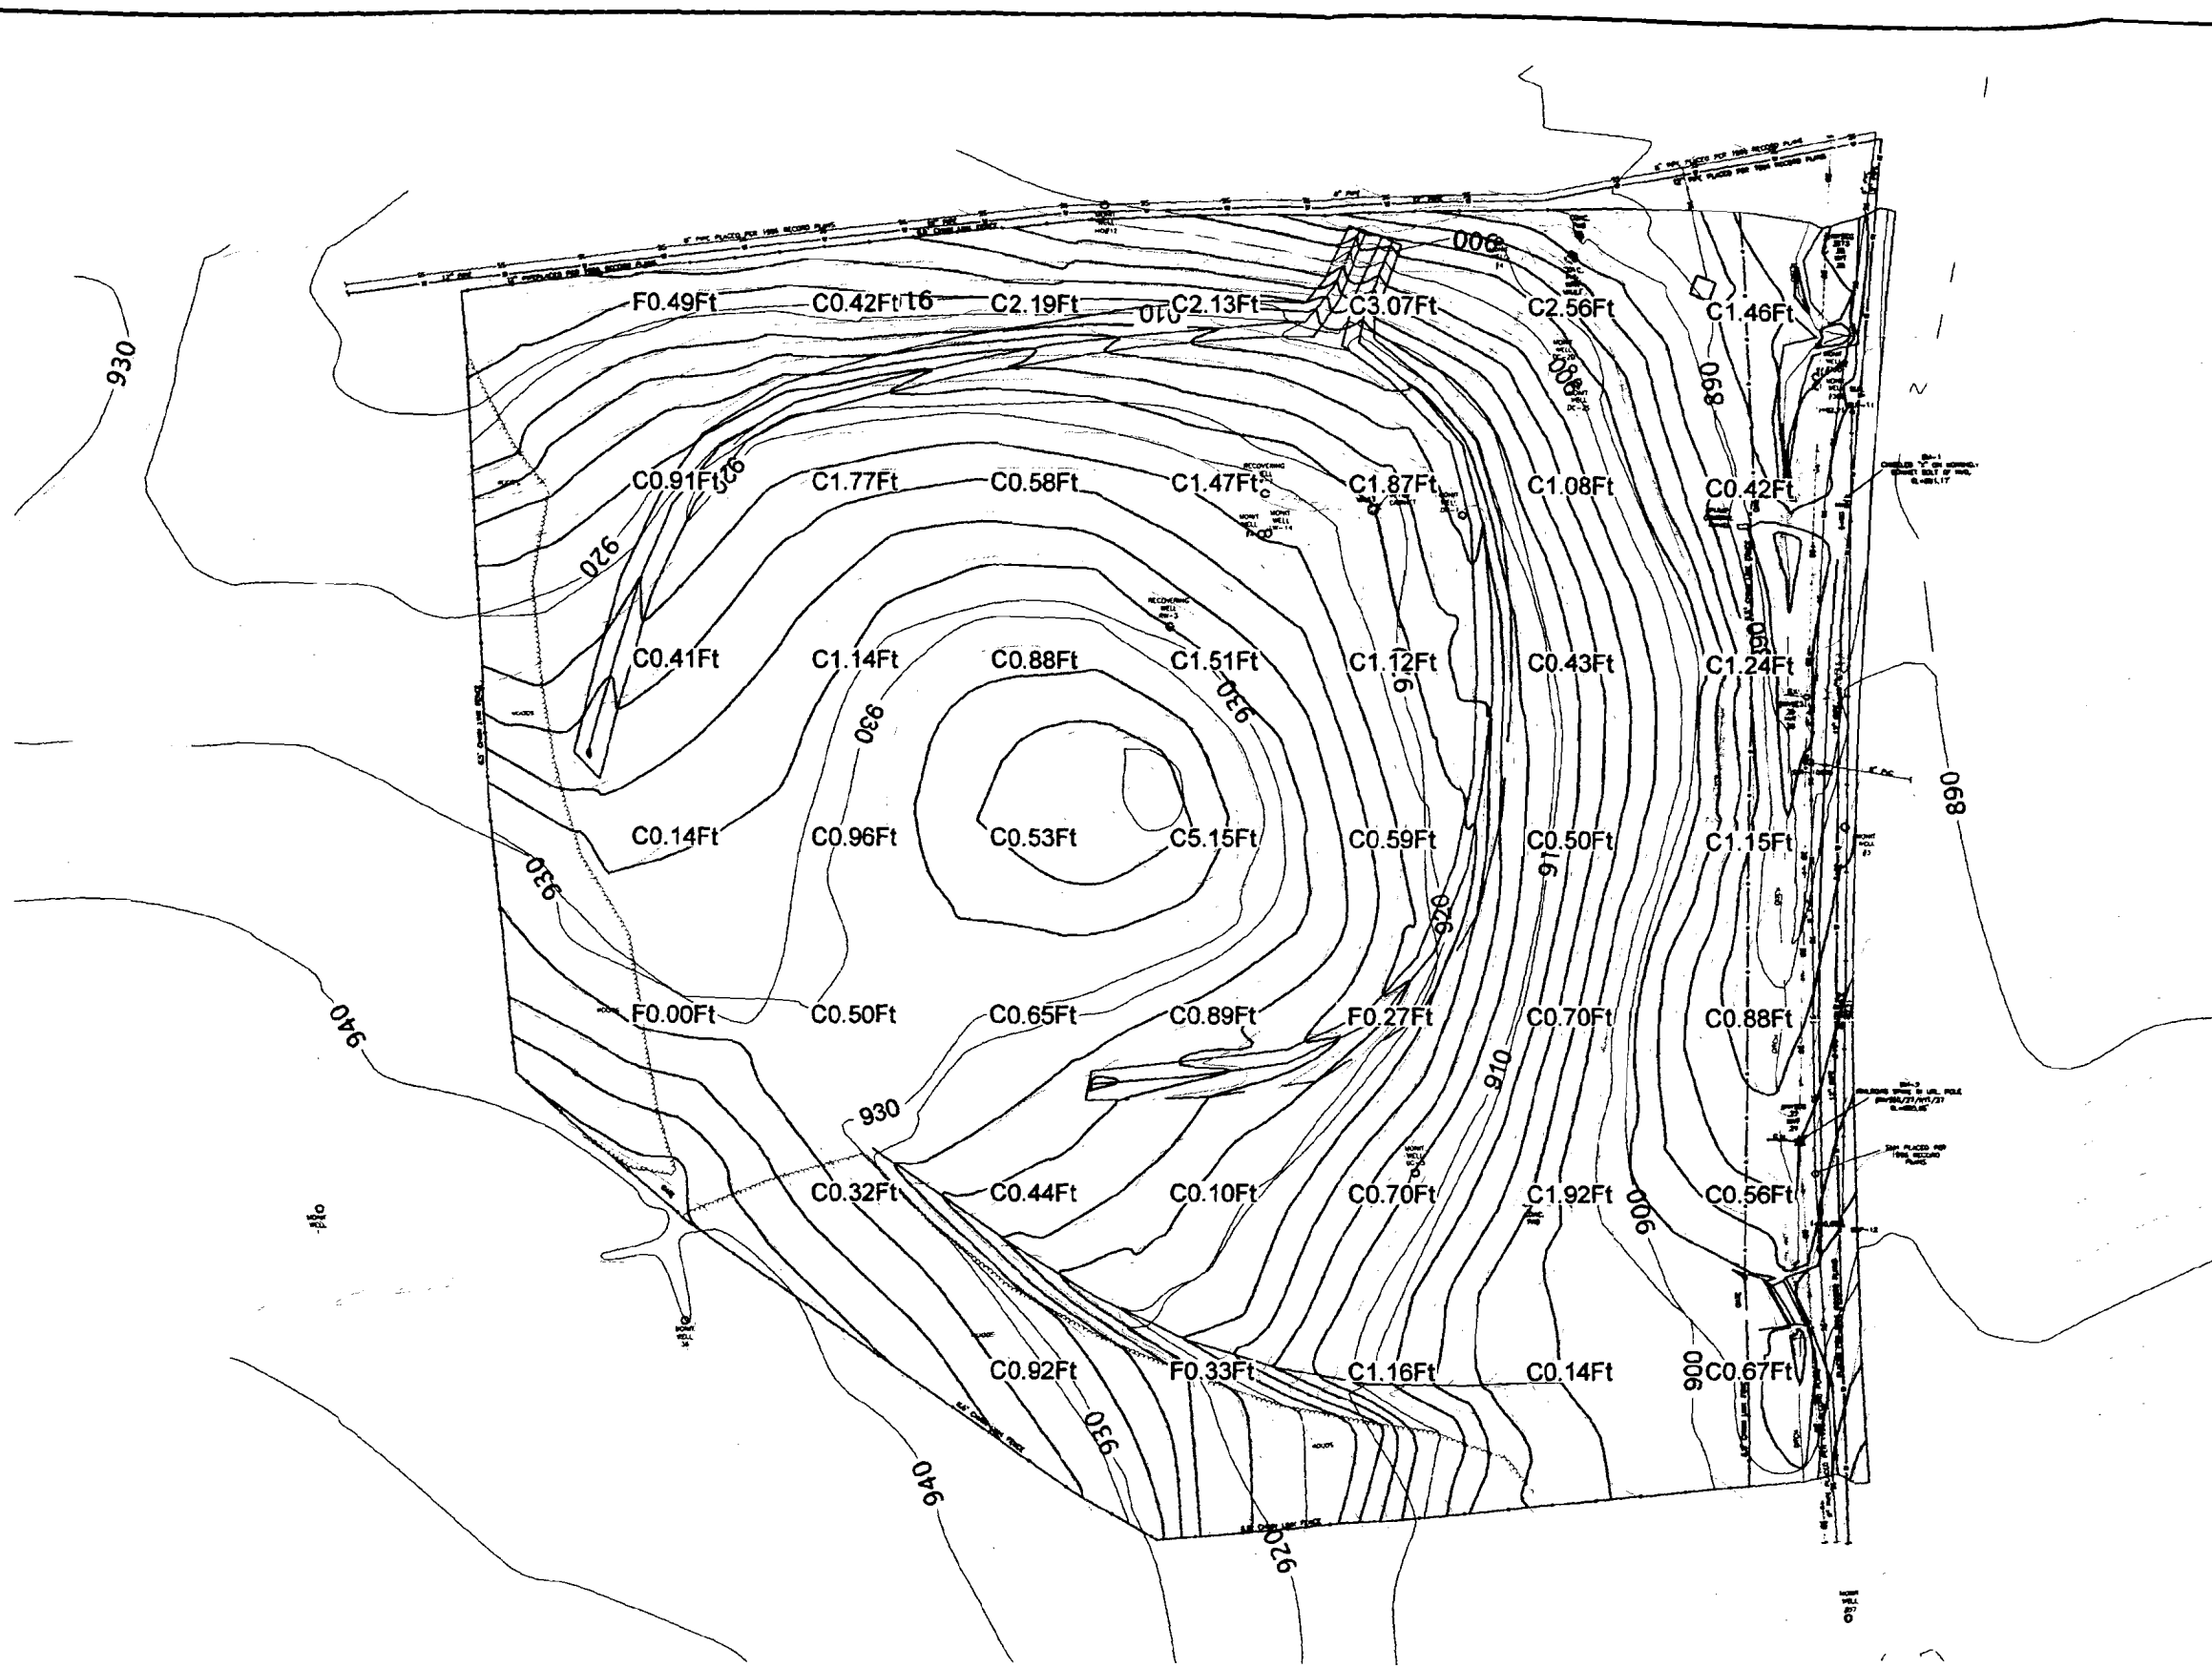
**Figure 3** depicts the results of the 2008 survey relative to the survey of the landfill conducted in 1996, just after the landfill cap was completed. Based on the calculated subsidence depicted on Figure 3, it can be summarized that the landfill cap and area has generally settled. Calculated settlement ranges from 0.0 feet in the southwest corner to over 5.1 feet near the landfill center at the high point of the cap.

Although the settlement of the landfill has occurred overall, the settlement has been generally less than 1 foot in total change, and there are no areas that may suggest that the cap is allowing surface water to collect or pond. In the northeast corner of the landfill site, generally from the site entrance gate westerly to the leachate collection wells on top of the cap area, settlement has taken place between 1.0 to 1.5 feet in total depth.

Along the northern fenceline, from the leachate collection tank westerly along the alignment of the leachate collection trench, subsidence has generally occurred between 2.0 to 3.0 feet.

The highest degree of settlement calculated in the entire landfill cap is situated in a localized area near the landfill peak and also at the point where underlying refuse is the deepest. Although not

unexpected, increased localized settlement in this area could suggest improper compaction while the landfill was being constructed and should be monitored to ensure that surface water continues to drain from the surface.

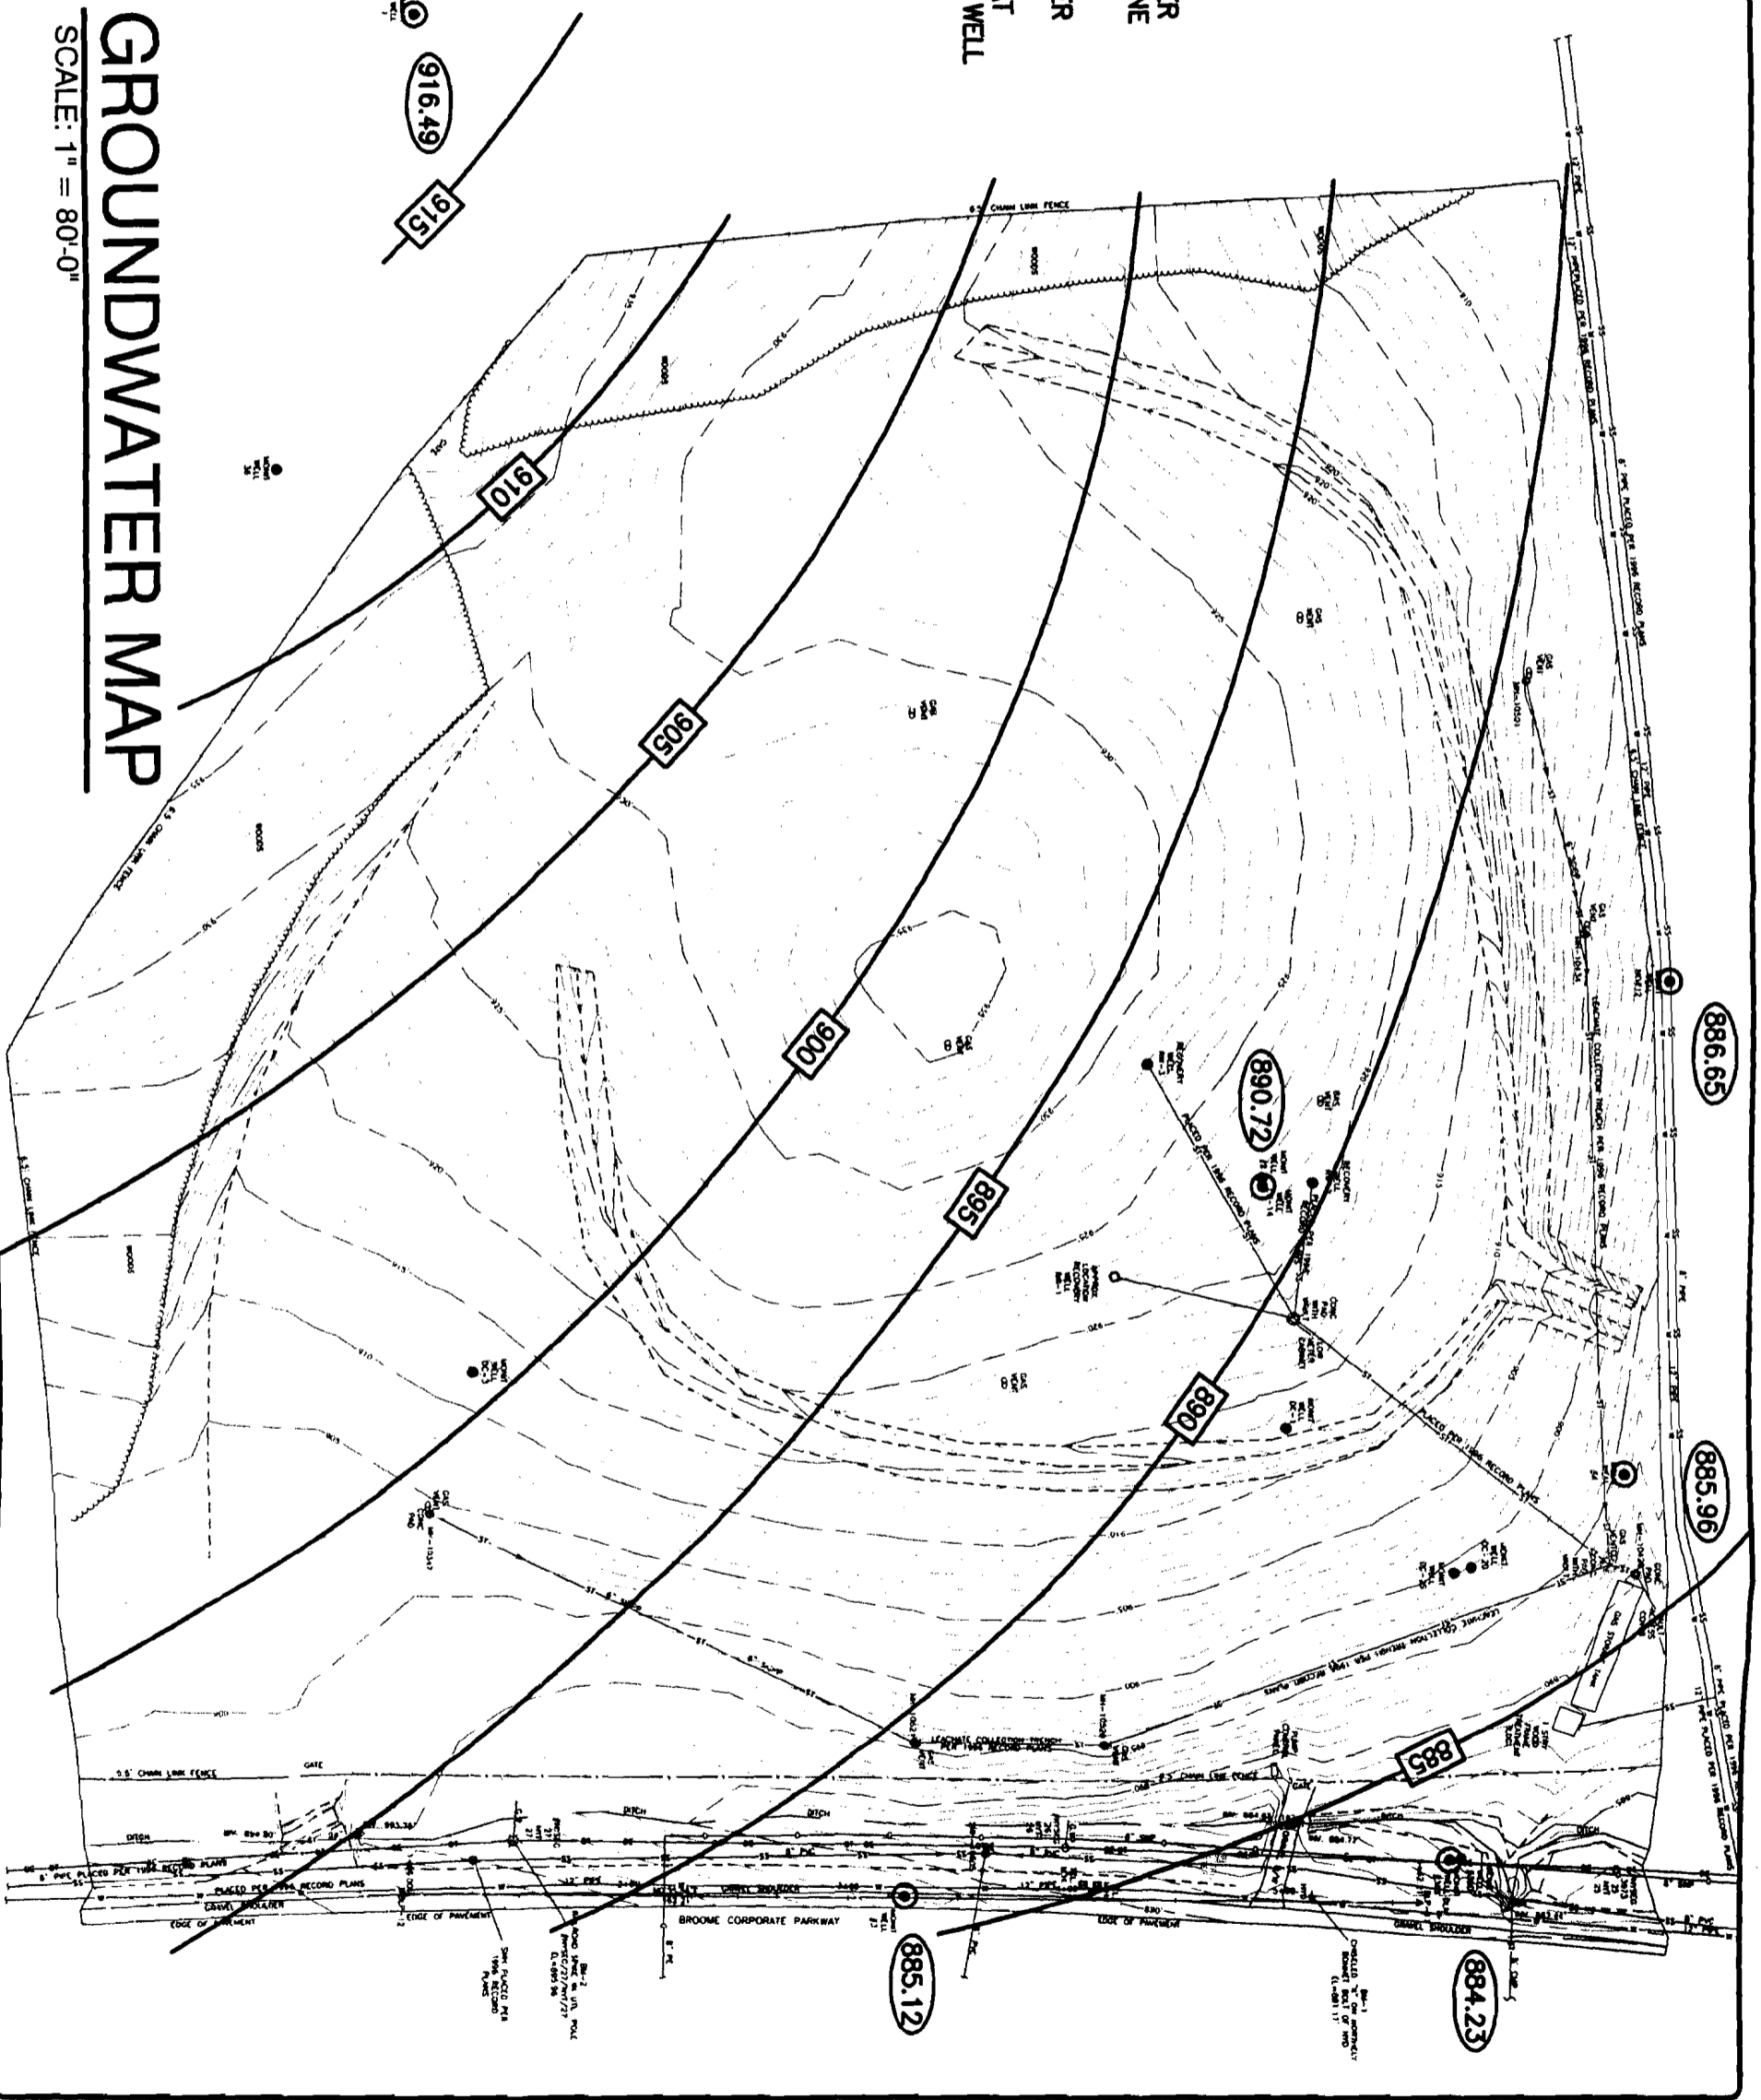
DRAWING TITLE **JULY 2008 GROUNDWATER POTENTIOMETRIC MAP**

operational during this study, and the groundwater contours depicted on Figure 4 are likely natural contours. With follow-on monitoring events, it is recommended that a groundwater flow map be determined so that the actual potentiometric maps will reflect drawdown caused by the leachate collection system.
