**Re: Review of Landfill Operations – Calendar Year 2019  
Town of Conklin Landfill  
Conklin, New York  
SCE No. R09357.11**

CONKLIN LANDFILL  
FOLLOW-UP REPORT

DEC 2019  
GROUNDWATER  
POTENTIOMETRIC  
MAP

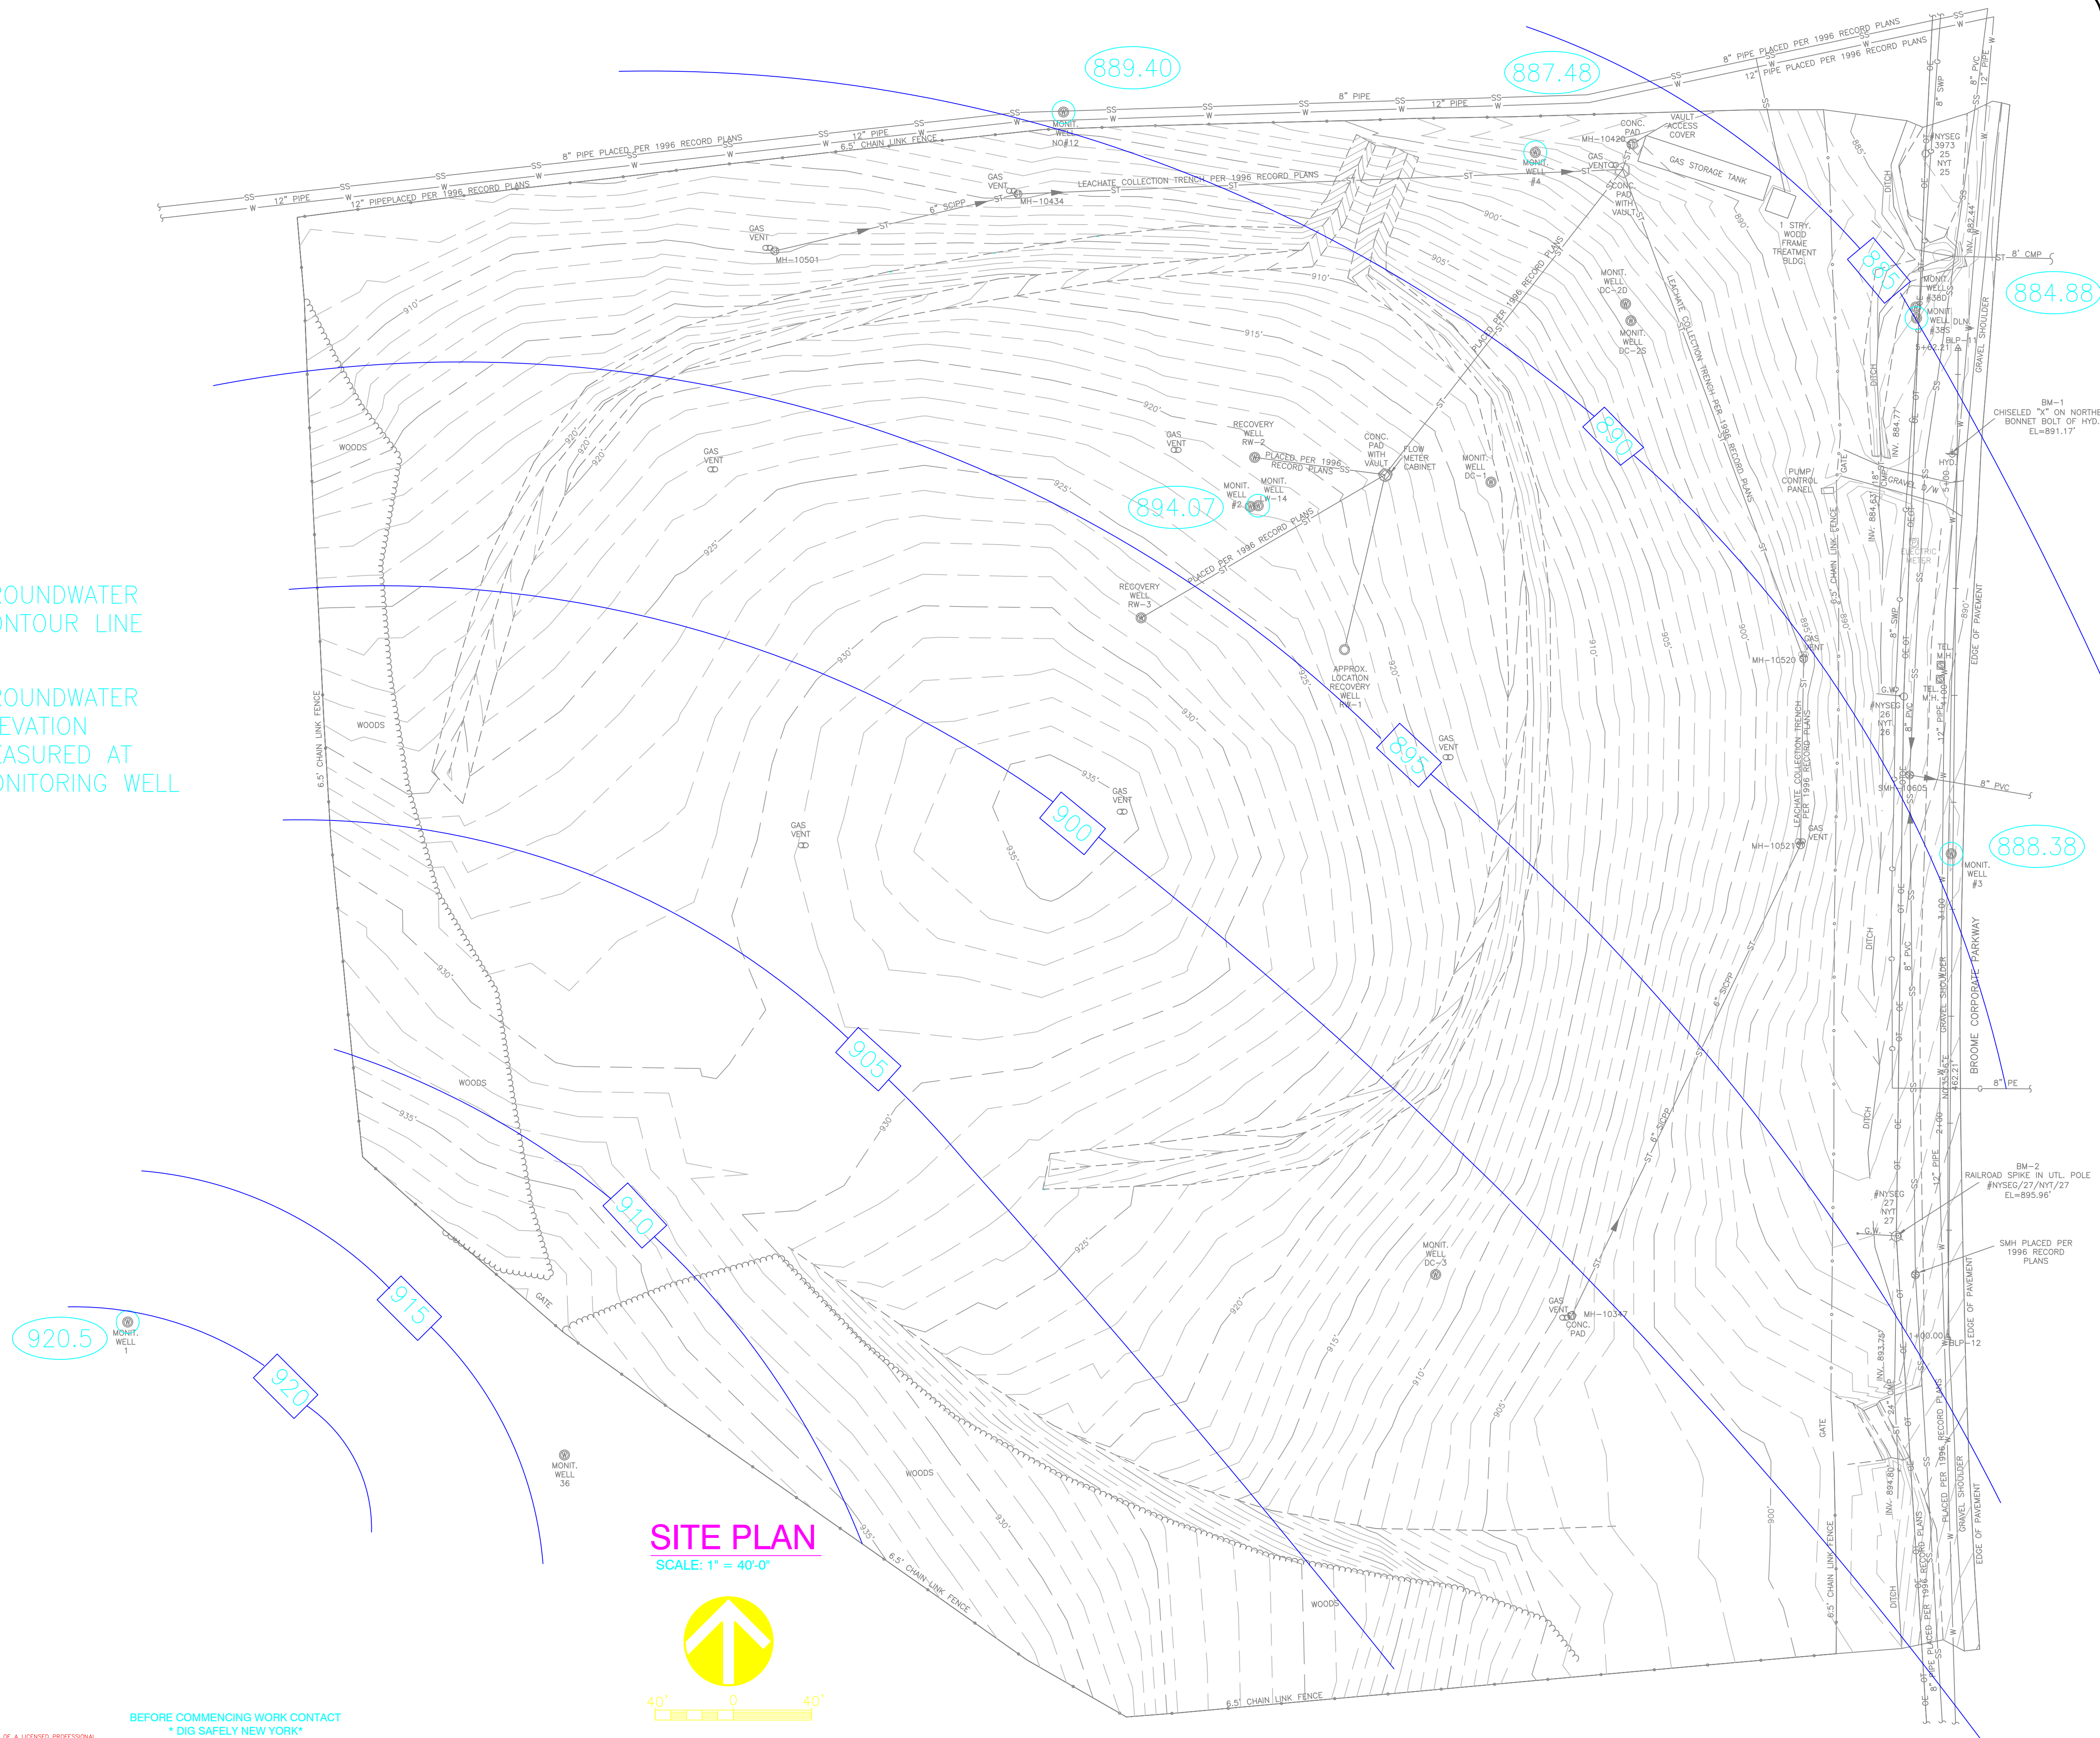
FIGURE #1

Top of Casing Elev. (ft)	- Depth to Water (ft)	=	Water Level Elev. (ft)
MW-1	946.69	- 26.19	=	920.5
MW-2	925.73	-	=	Obstructed at ~19feet
MW-3	892.40	- 4.02	=	888.38
MW-4	897.18	- 9.70	=	887.48
MW-12	901.08	- 11.68	=	889.40
MW-37	908.71	-	=	Inaccessible- hit by car
MW-38S	890.13	- 5.25	=	884.88
MW-38D	888.34	- 6.10	=	882.24
LW-14	926.24	- 32.17	=	894.07
