SCE No. 09357.14

**Re: Review of Landfill Operations – Calendar Year 2022
Town of Conklin Landfill
Conklin, New York**

Appendix A
2022 Field Inspection Form

APPENDIX C – PHOTOGRAPHS

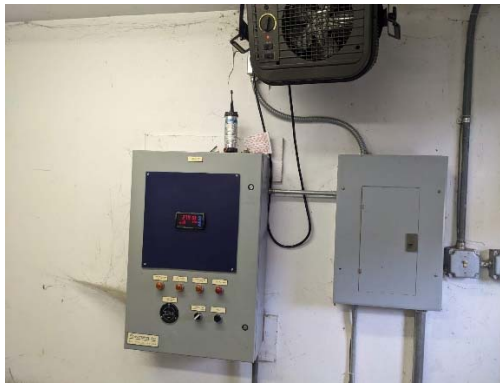
Photo Number: 1
Photo Date: 03/30/2022
Photo Location: Inside Treatment Building
Direction Facing: East
Photo Description: Tank Volume in Gallons

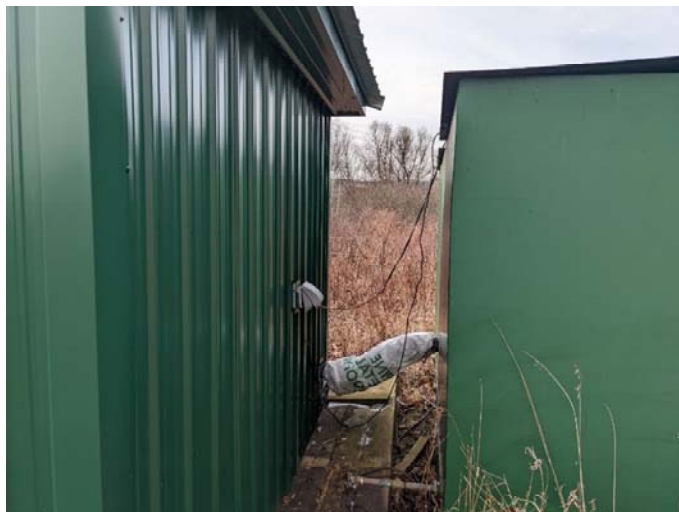
Photo Number: 2
Photo Date: 03/30/2022
Photo Location: Between treatment building and leachate tank
Direction Facing: North
Photo Description: New pipe between treatment tank and leachate tank

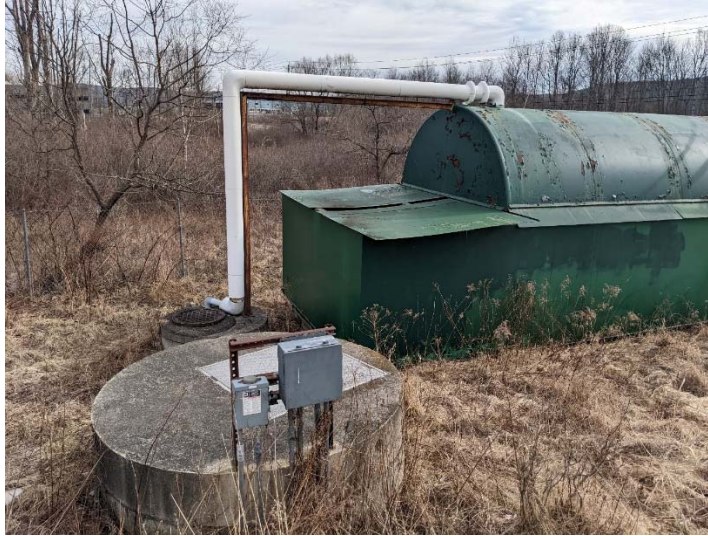
Photo Number: 3

Photo Description: west side of Leachate tank

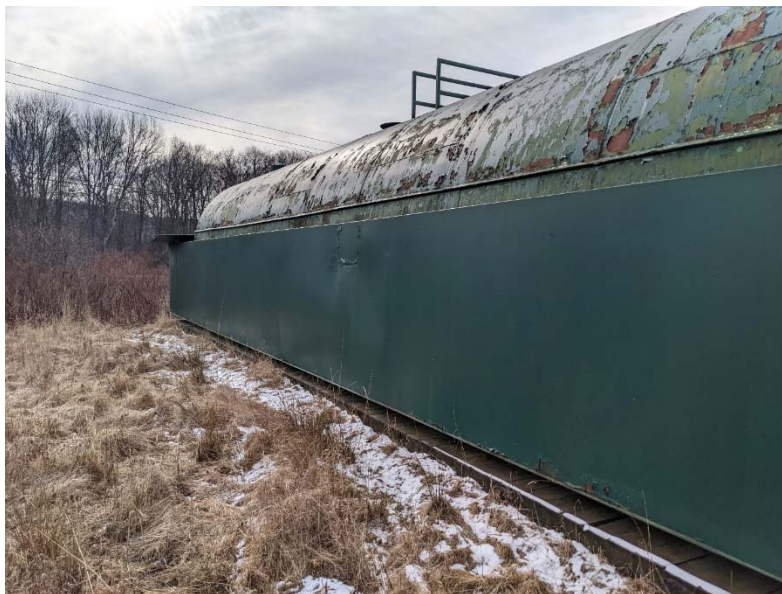
Photo Number: 4

Photo Description: North side of leachate tank, minor rust.

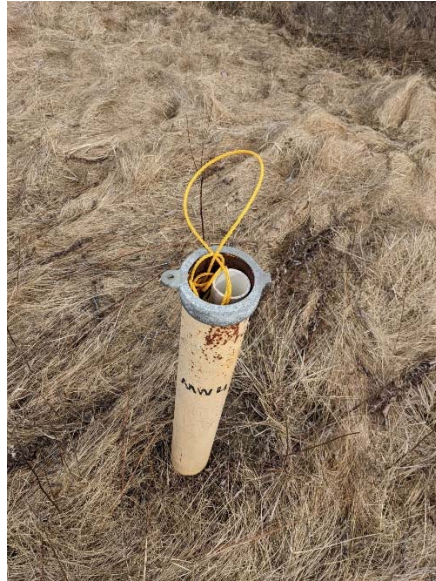
Photo Number: 5

The monitoring wells appeared to be in generally good condition except for MW-37 which is not viable due to damage and needs repair. In addition, there is a bailer stuck in MW-4

preventing use for depth to water determination and sample collection. All well casings showed evidence of some surface corrosion, but repainting is not necessary at this time.

MW4 - bailer stuck in PVC well

Photo Description: Bailer frozen stuck in MW - 4

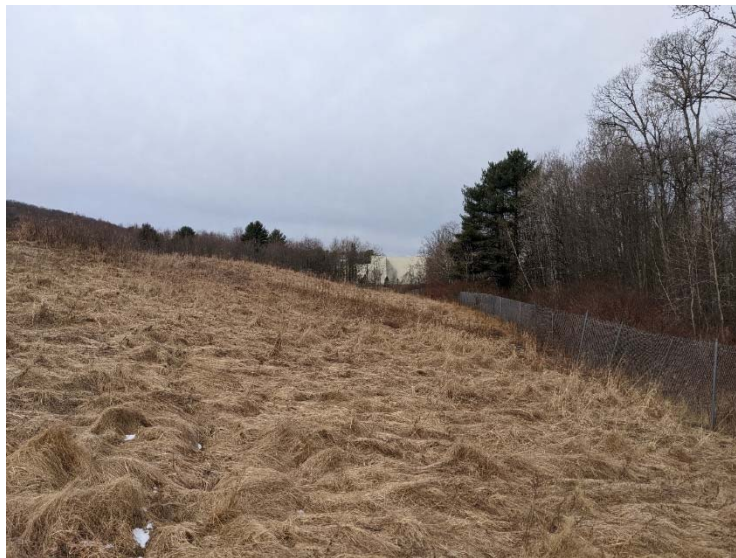
Photo Number: 6

Photo Description: Brush needs to be cut back

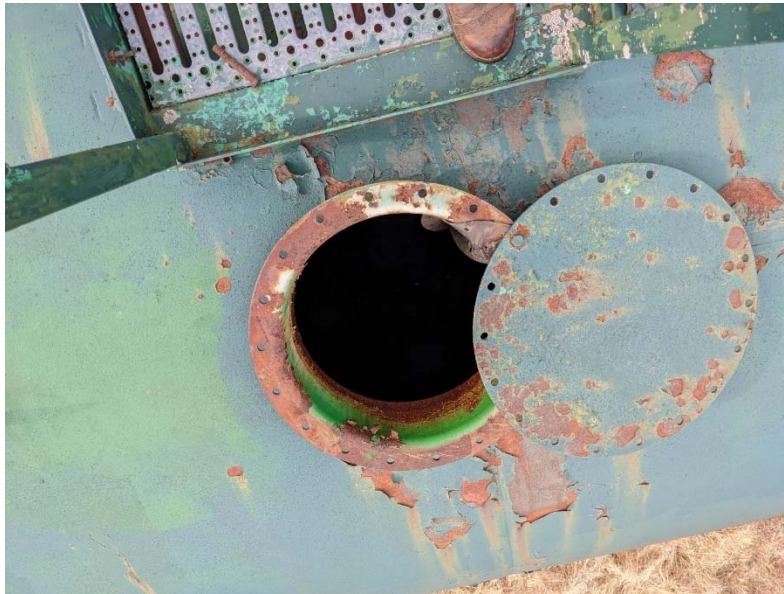
Photo Number: 7

Photo Description: Looking down inside leachate tank, slight odor, tank low and slightly frozen

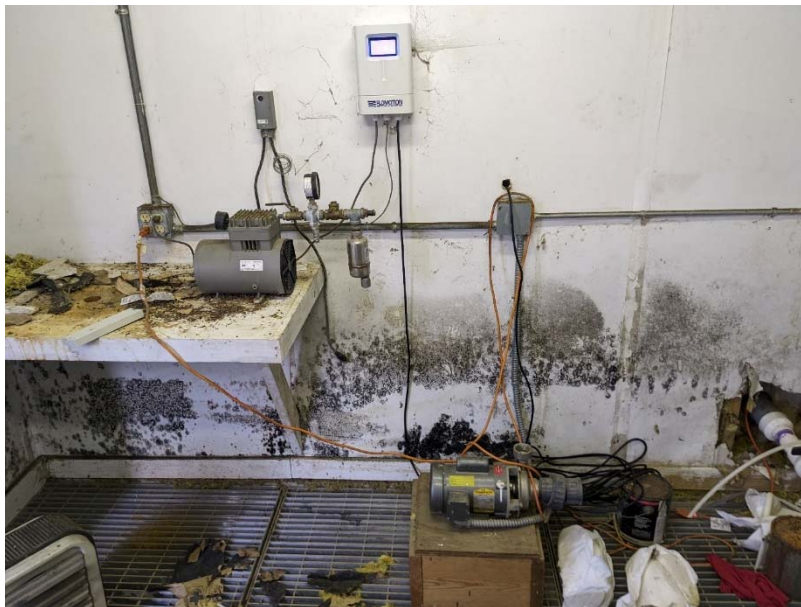
Photo Number: 8

Photo Description: Mold on walls and rat/mouse droppings in treatment building

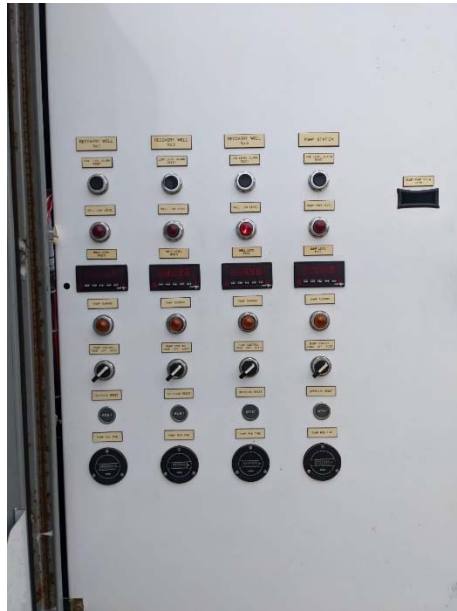
Photo Number: 9

The operation of the leachate collection system was observed and tested during this field visit. Recovery Well No. 1 and the pump station appeared to be in working order, however, Recovery Well No. 2 did not change from the initial reading, when checking the leachate collection pumps. Recovery Well No. 2 should be inspected and repaired to make sure it is properly functioning. In addition, Recovery Well No. 3 well level was low and had the light on and should also be inspected and repaired to make sure it is properly functioning.

Photo Description: Pump levels pictured, and Recovery Well No. 3 has light on

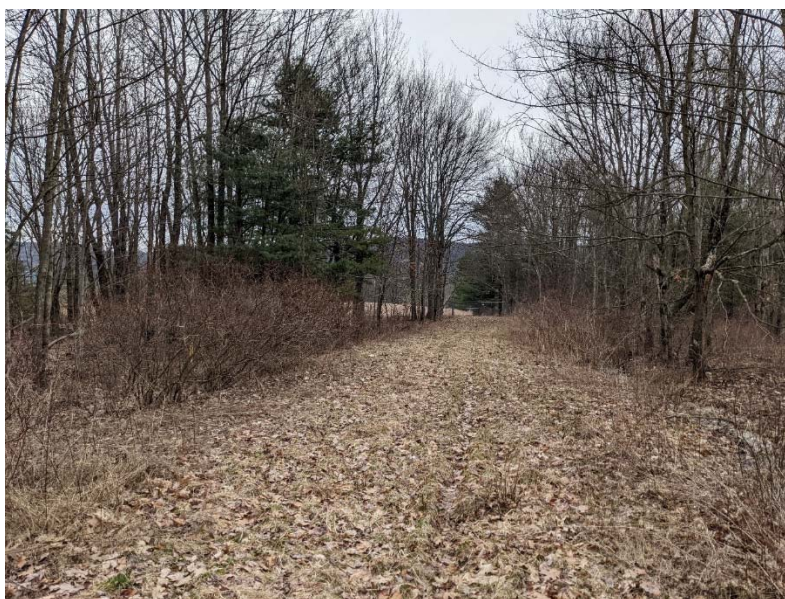
Photo Number: 10

Photo Description: Entrance looks ok.

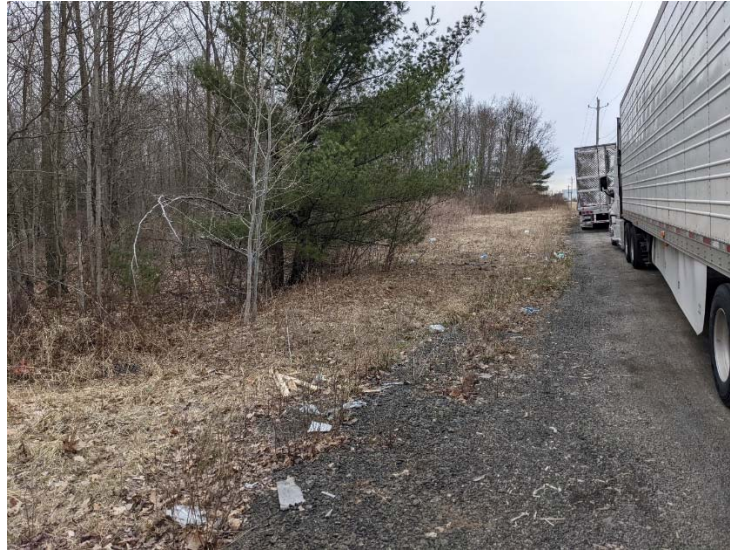
Photo Number: 11

Trash near MW 1 and 37

Photo Description: Trash and trucks along roadway near MW-1

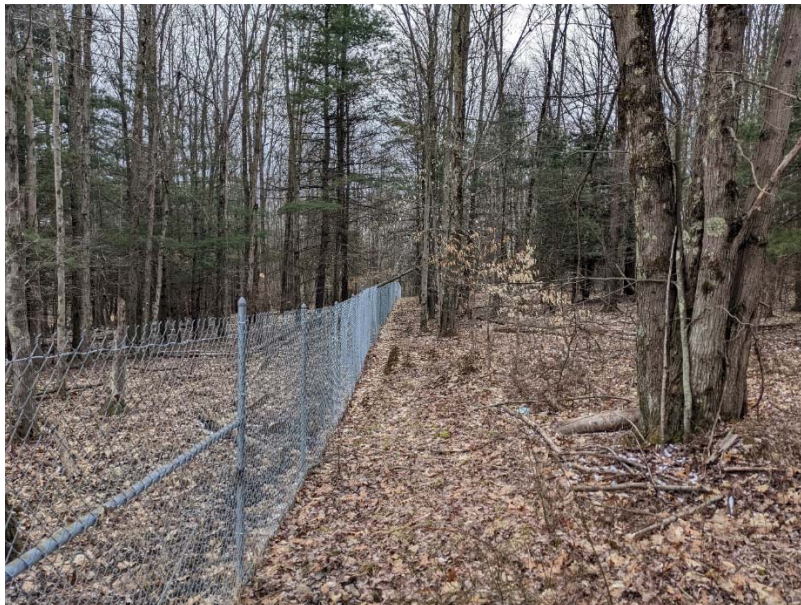
Photo Number: 12

Photo Description: Leaf litter along fence, looks ok.

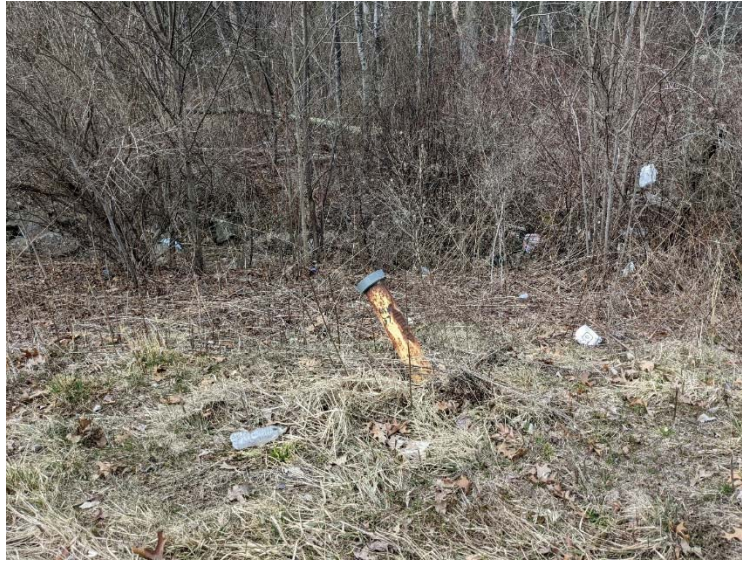
Photo Number: 13

MW37 inaccessible - bent over

Photo Description: MW-37 hit by plow/car

- A. The level sensor in Recovery Well No. 2 should undergo a maintenance check to confirm proper operation.
- B. Monitoring Well 37 is inaccessible since the riser has been damaged and needs repair before it can be viable. SCE recommends a protective cage be installed around the well or the well be converted into a flush mount protective cover.
- C. Monitoring Well 4 is inaccessible due to a bailer stuck in the PVC of the well.
- D. As an ongoing recommendation, the Town should perform a limited amount of tree and brush removal outside of the perimeter fence, to ensure the long-term performance of the security fence.
- E. Woody vegetation should be removed from the surface drainage swale to maintain the integrity of the landfill cap.
- F. Two leaning or tipped over vents along the northern cap perimeter should be righted.
