Visual Inspection Report
14 June 13

Facility: Air Force Plant (AFP) 59

Inspection Dates: 3 – 6 June 2013

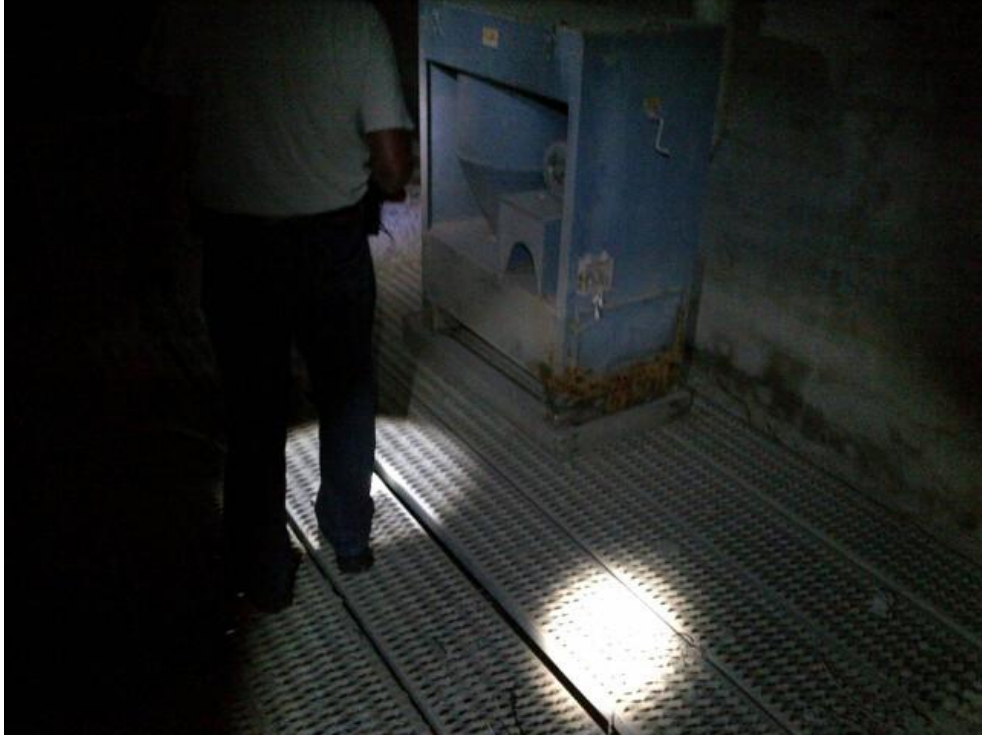
Pit Covered with Grate in Basement (SW) Area

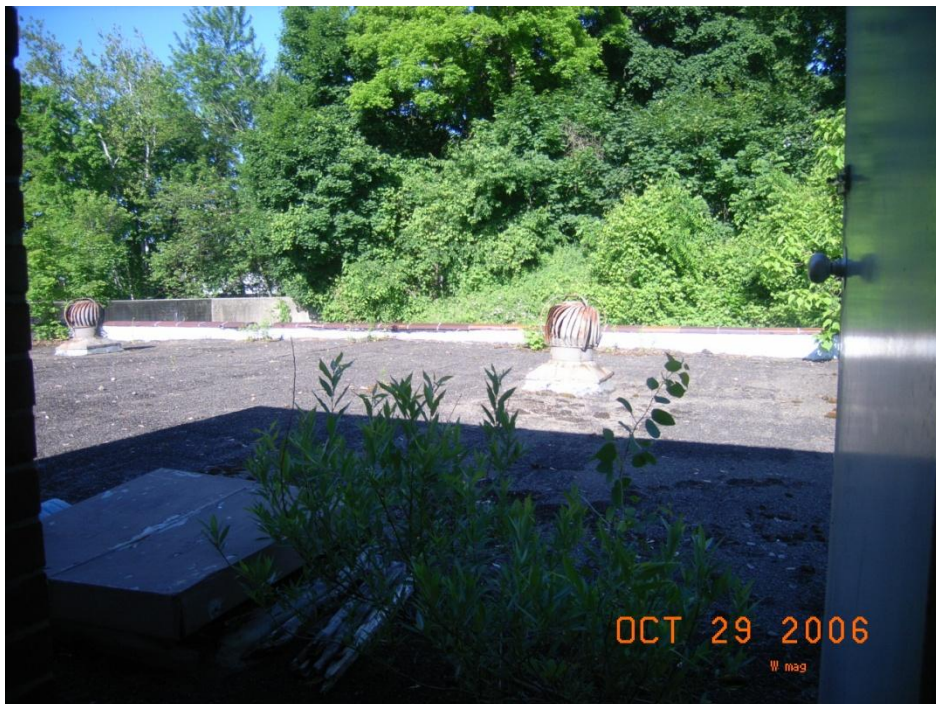
The pump station has concrete floors, walls and ceiling. It is located in the southwest corner of the property. The roof on the adjacent reservoir was unstable; the inspection team was not able to walk on it. At the time of the survey all equipment and electricity was still energized in this building.

Roof of Reservoir

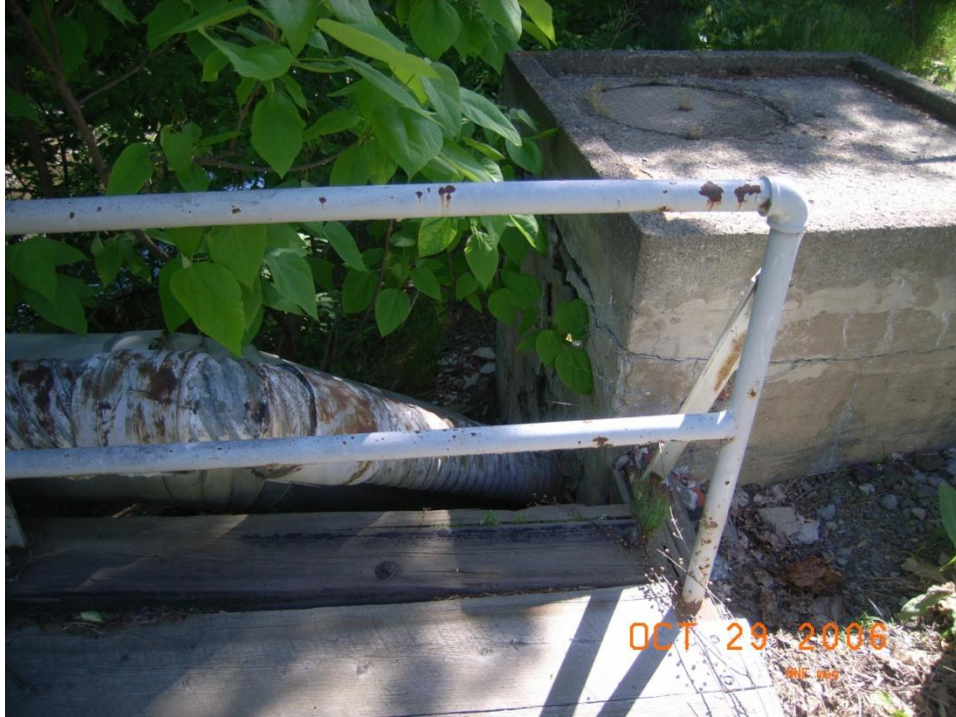
Steam Pipes go underground at the south end of the bridge

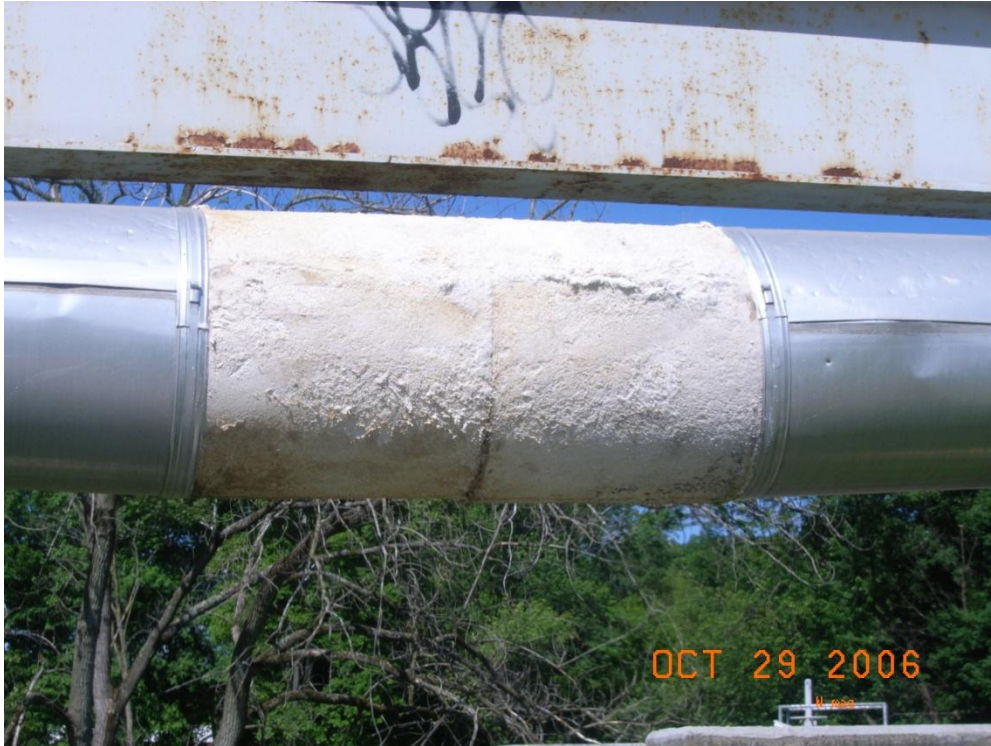
Steam Pipe (Metal Jacket Fallen Off)

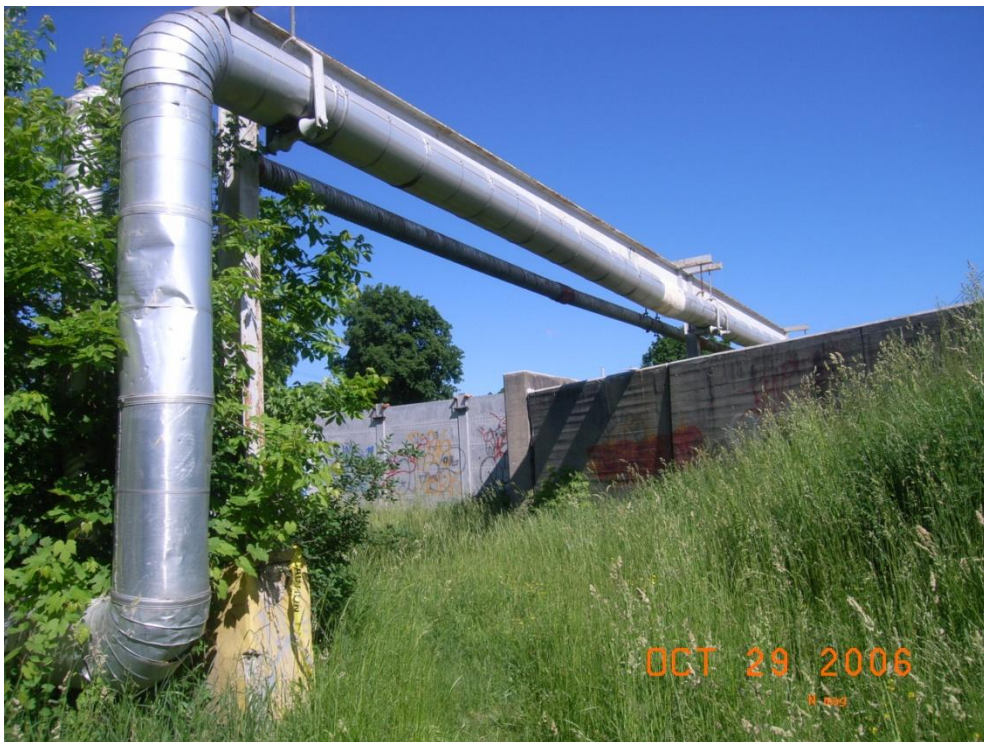
Steam Pipe over the Concrete Wall and Berm

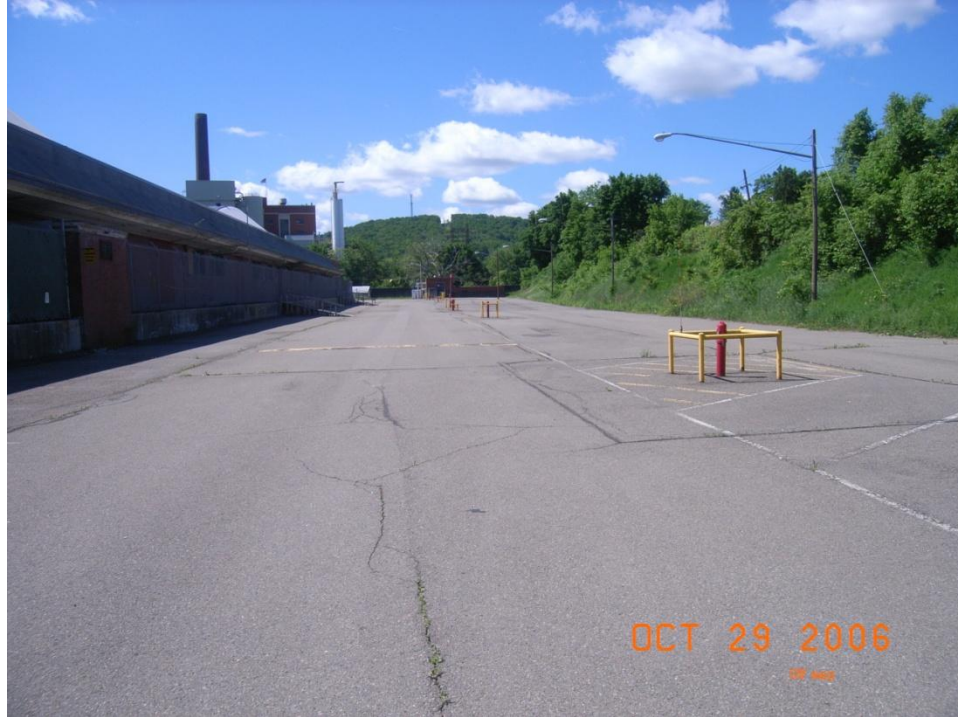
Fire Suppression Loop (West Side of Building)

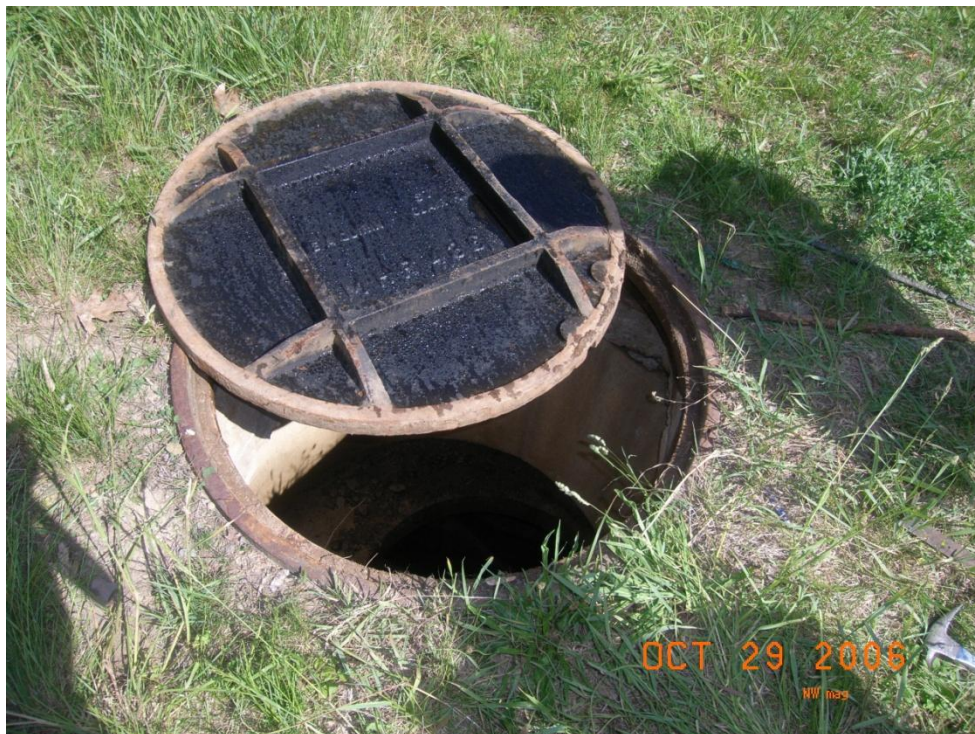
Oil Water Separator near Pump House

*The contractor will need to sample the sludge inside the oil water separators and solvent-Oil separator. There was some discussion as to whether these would need to be removed or just have the contractor leave them in place because the storm lines go through them.

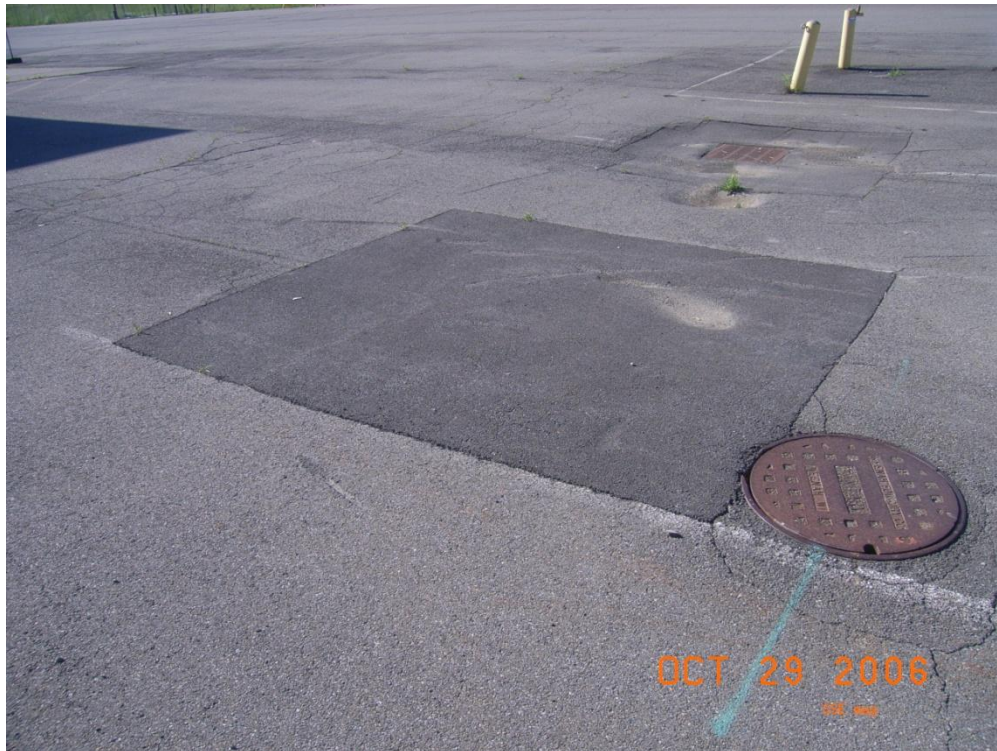
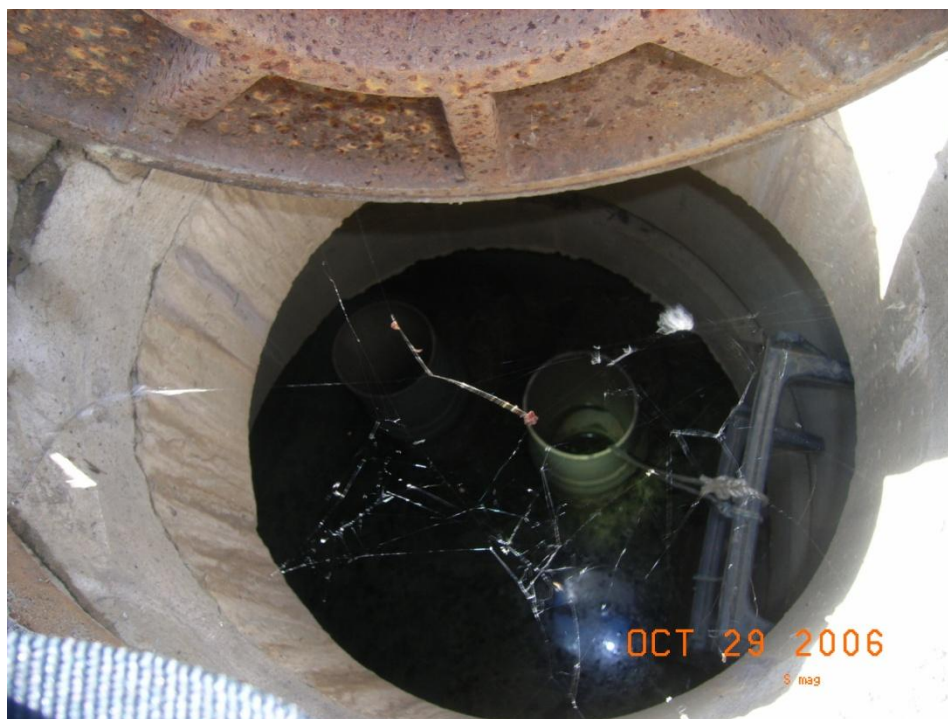
Oil Water Separator near Exit 16

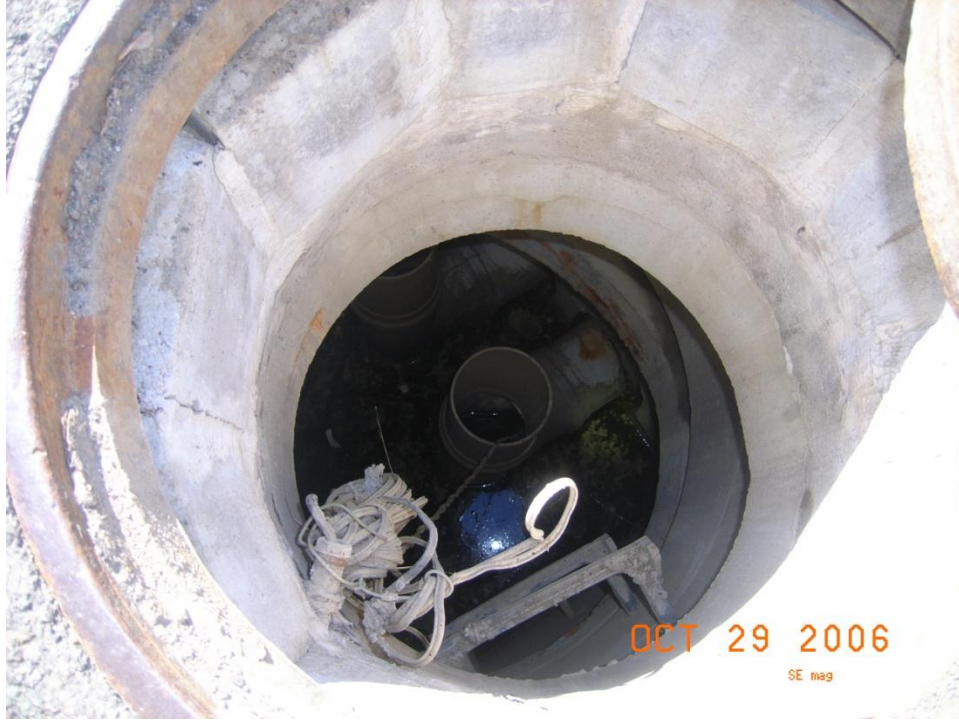
Oil Water Separator near Exit 10

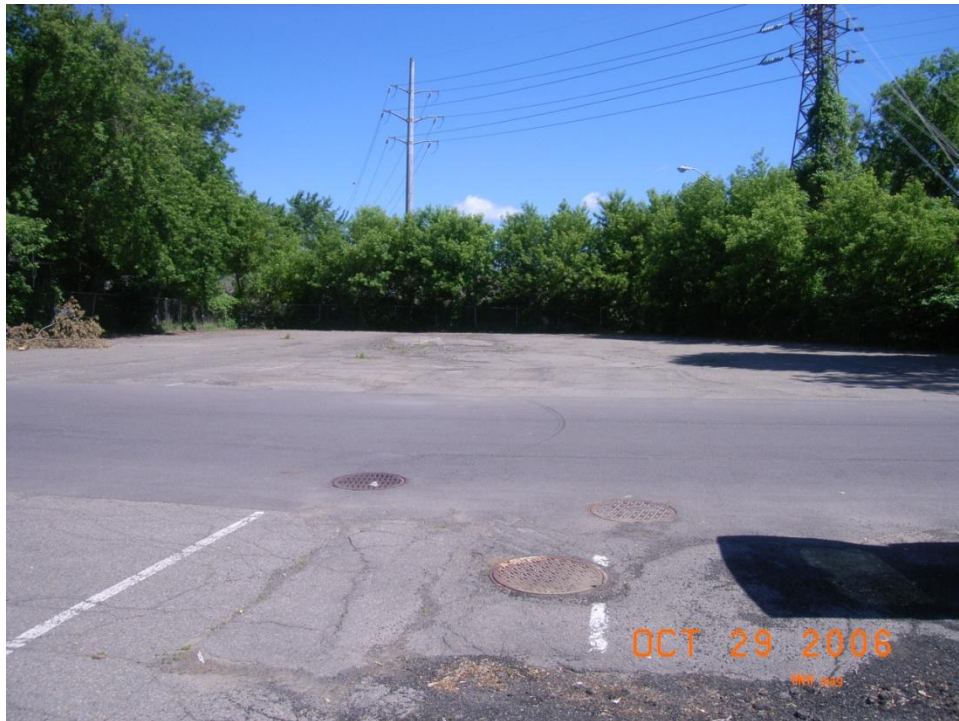
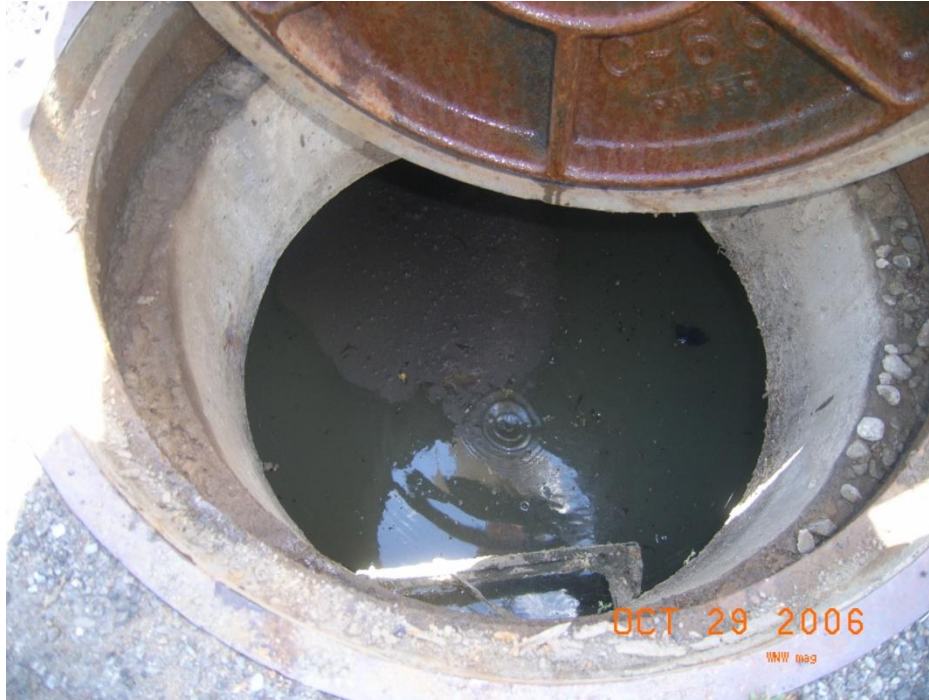
Oil Water Separator North Parking Lot

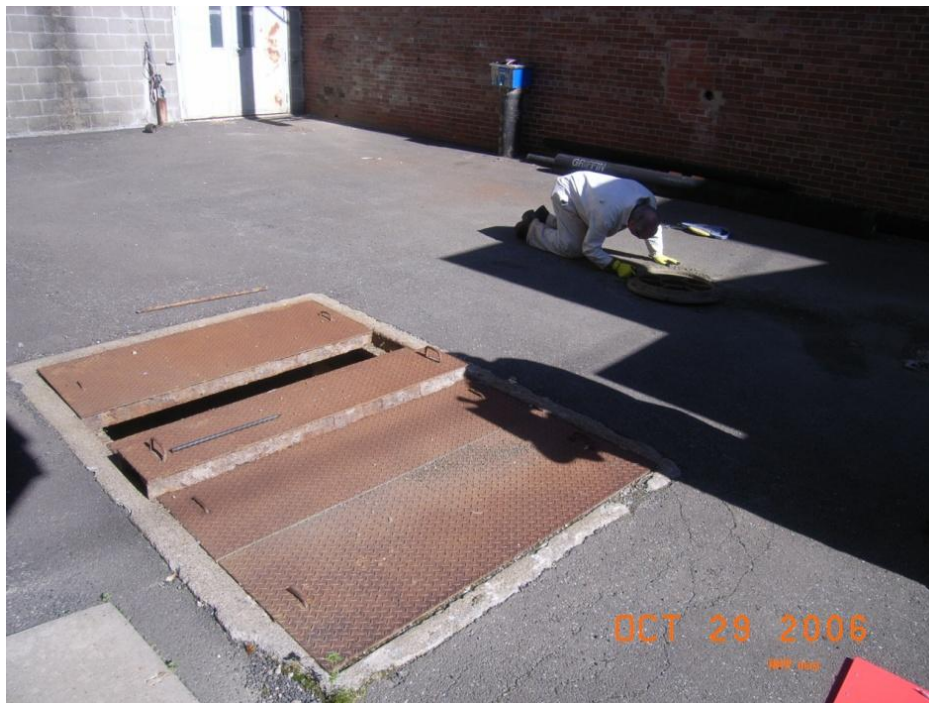
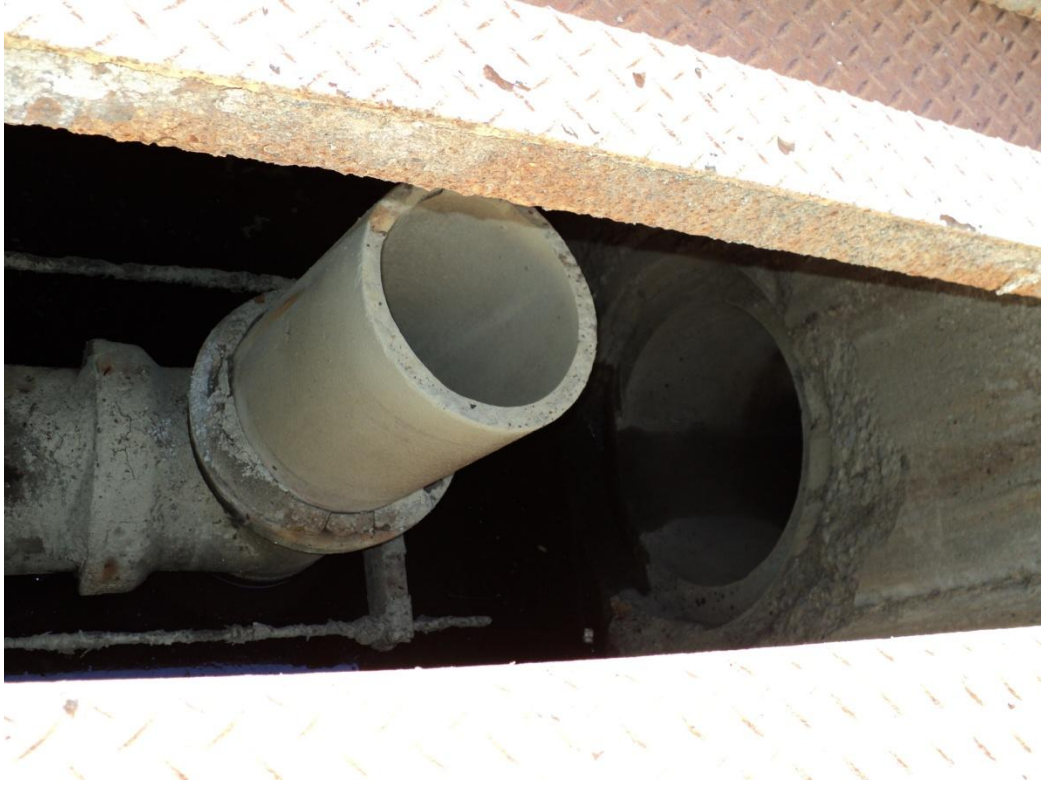
Oil Solvent Separator

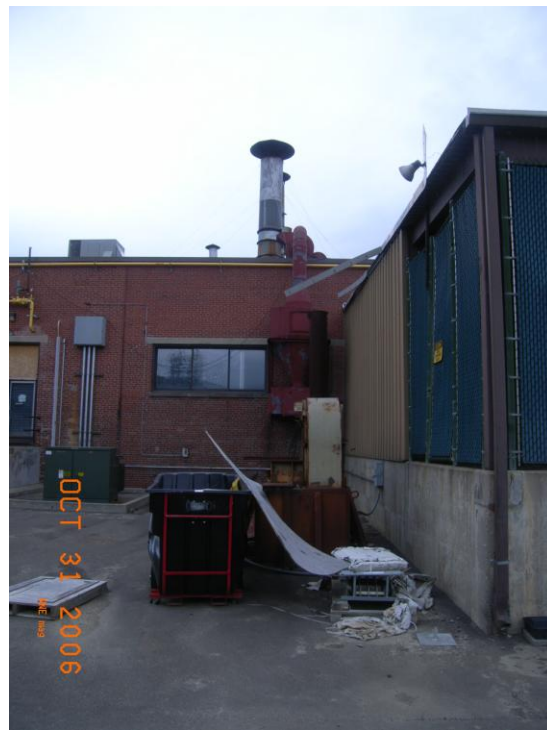
****Dust collection system was currently being used in the carpentry shop by BAE. There is no information as to when this was installed or what it may have been used for in the past.

Collection System for Local Exhaust

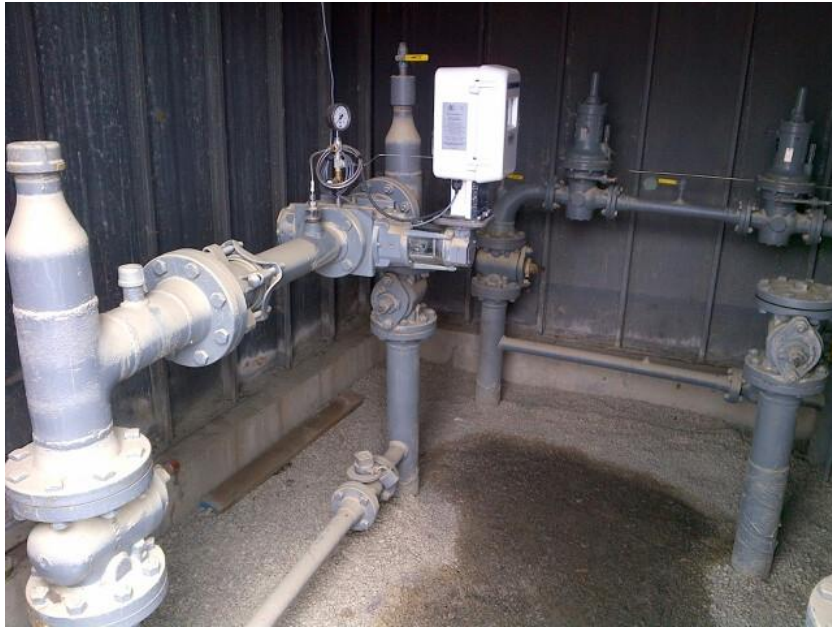
Oil Staining in Natural Gas Pipeline Shed, East Parking Lot

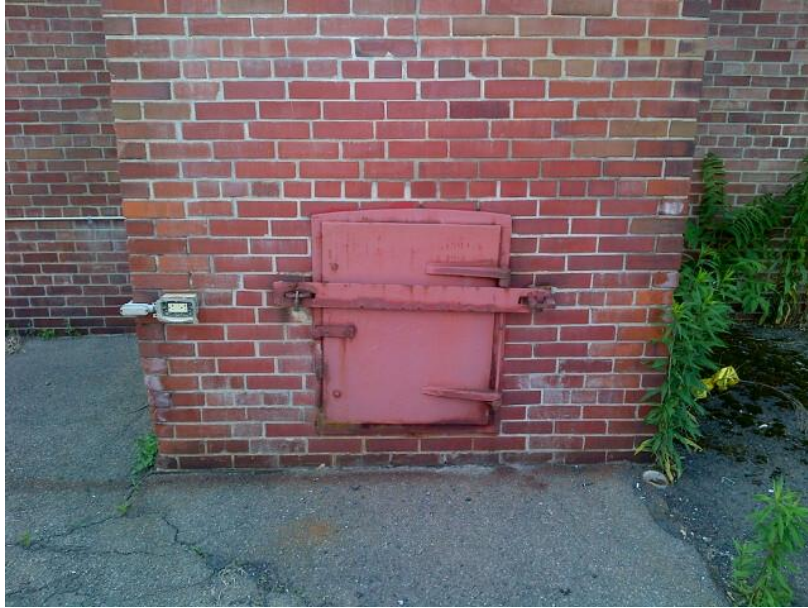
***The plant had an incinerator in its early years of operation. It was not used while BAE operated the plant. The BAE representative thought it was used to burn FOUO type documents; however, BAE stated that samples of the stack indicated a high level of chromium. This can be seen on the 1942 drawing of the facility. The inspection team was not able to locate the incinerator inside the building.

Access Door to Incinerator Stack (East Side of Building)

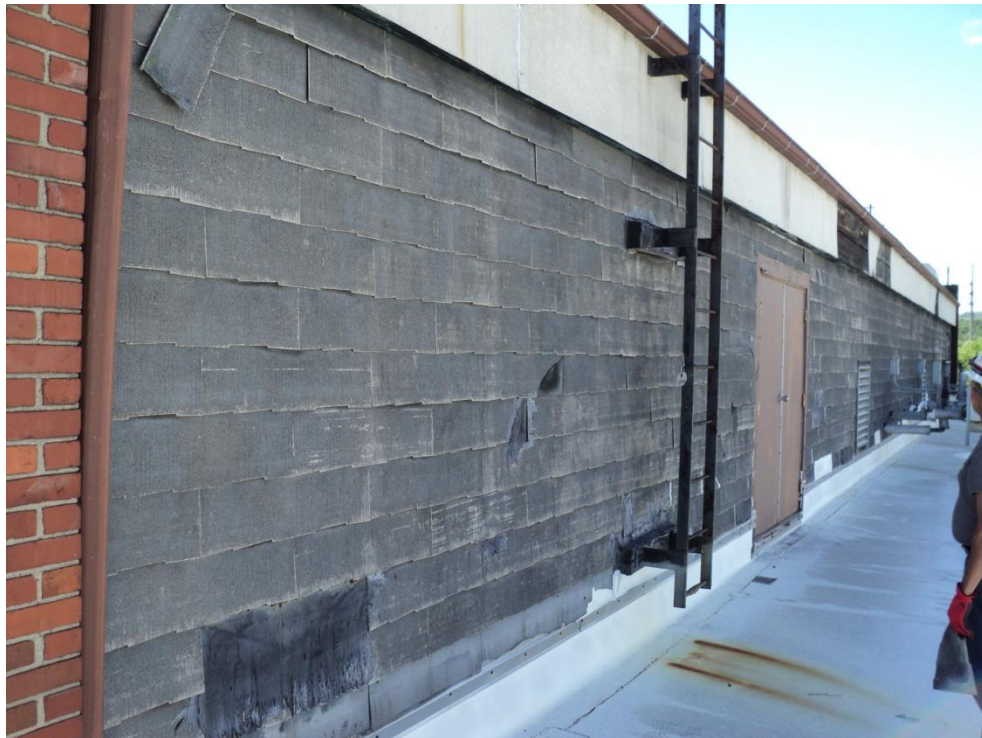
Transite Shingles on Roof

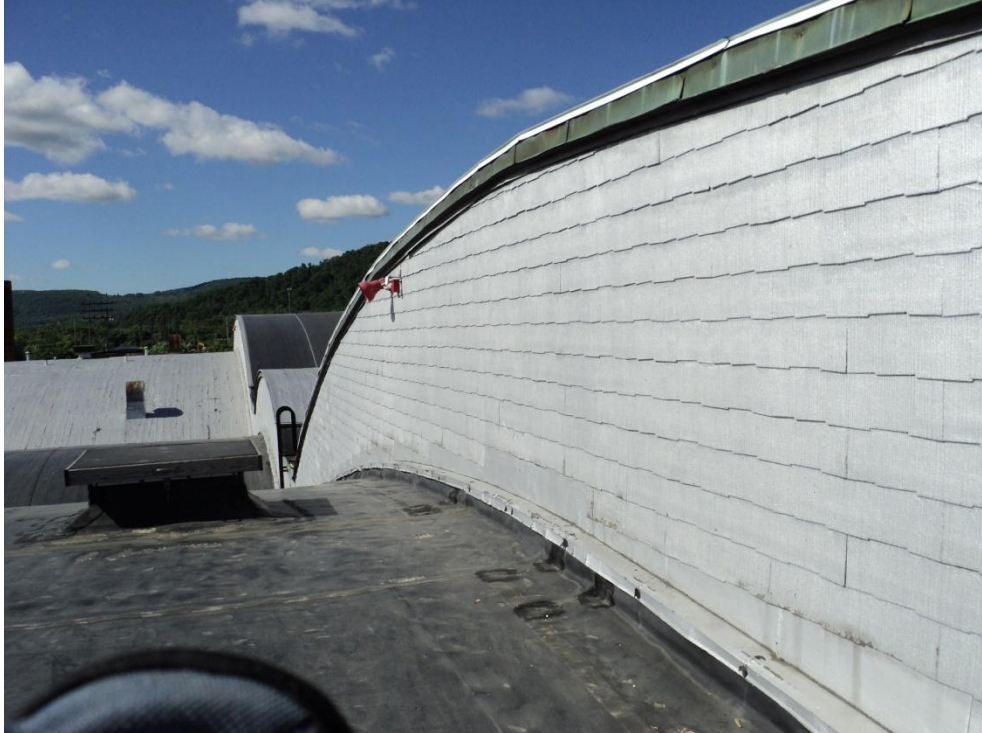
Asbestos Shingles on Roof

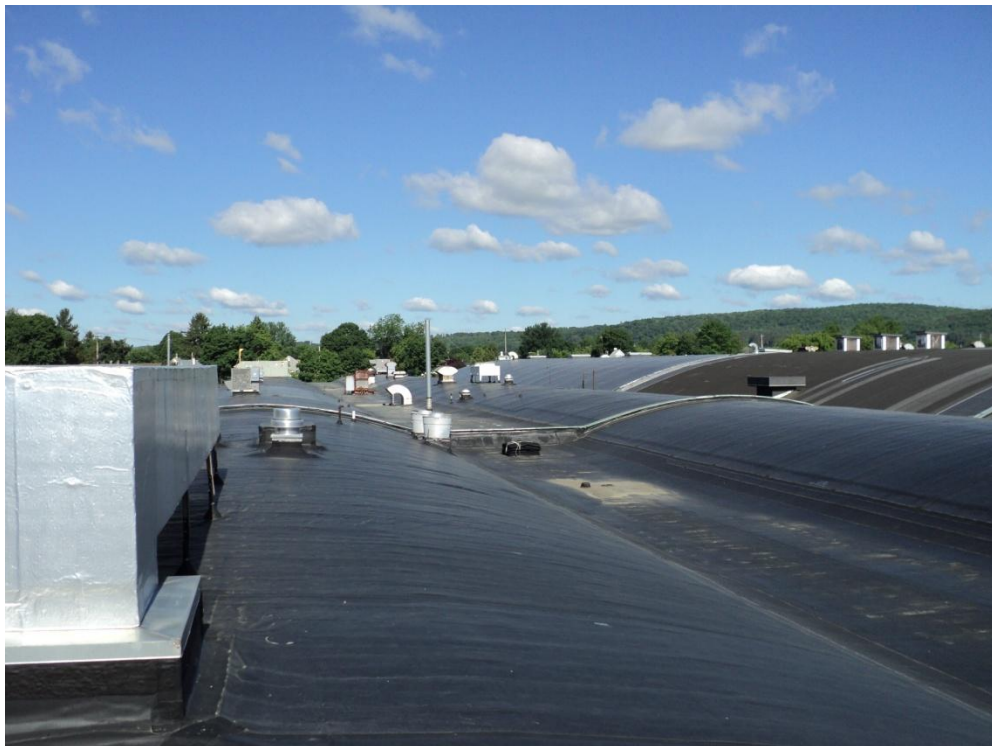
According to the BAE representatives the original roof, which probably contains asbestos has not been removed. It was covered over by the new roof. The contractor will need to sample both roofs for correct amount of asbestos-containing roof materials.

Roof

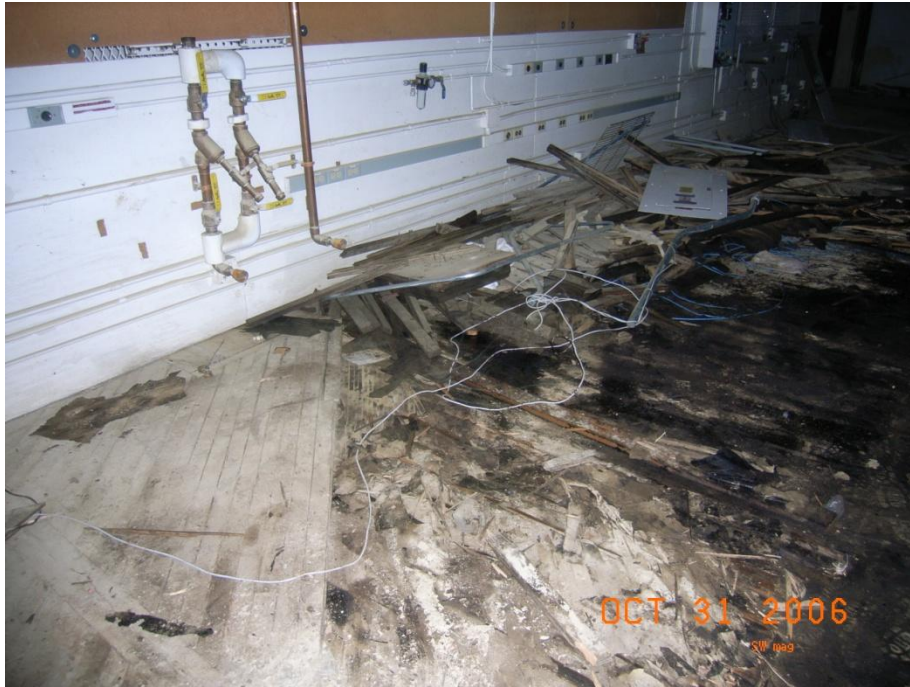
Oily Substance on Floor (Wood Planks removed) Room 703

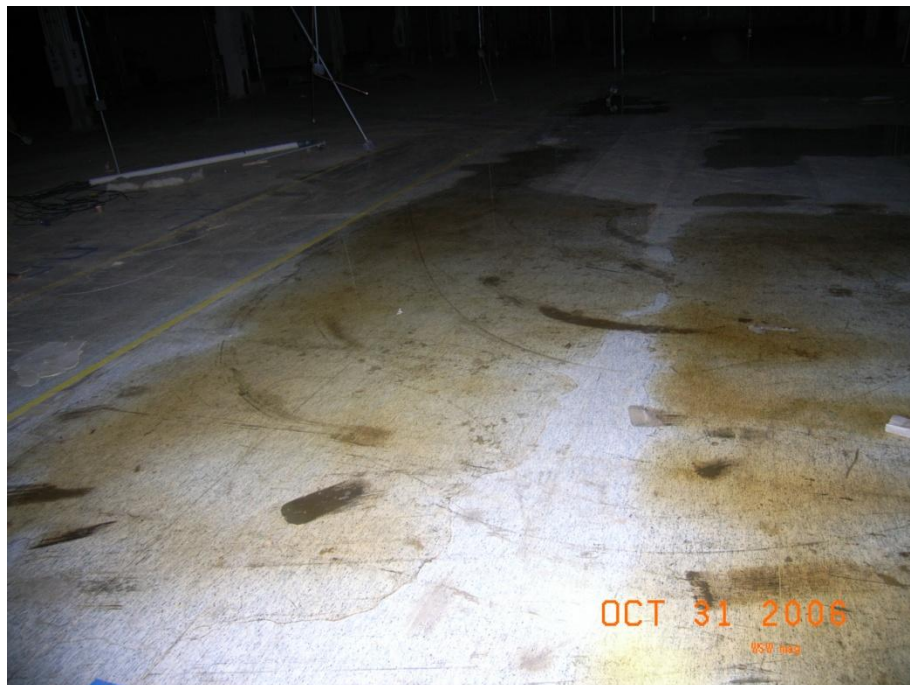
Staining of Floors in the Production Building

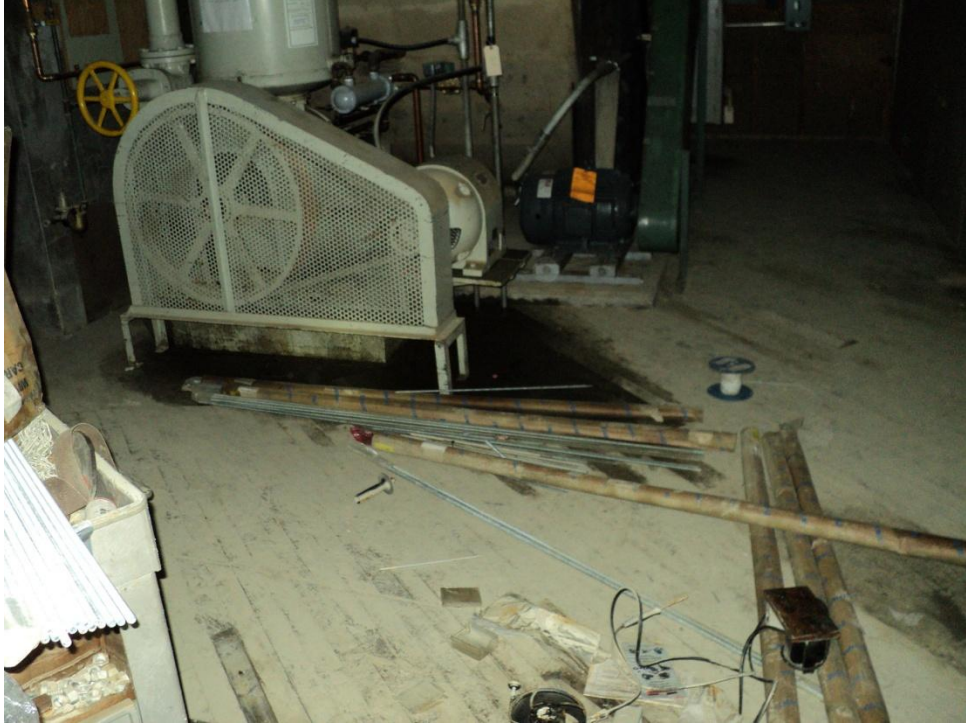
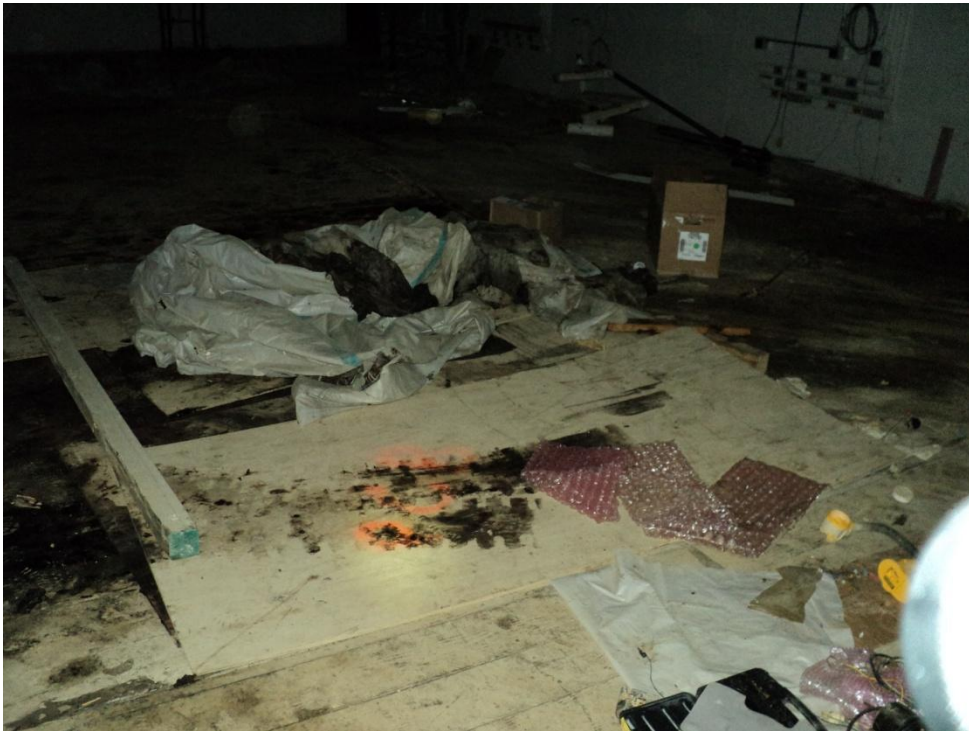
Oil Contamination on Floor of Production Building

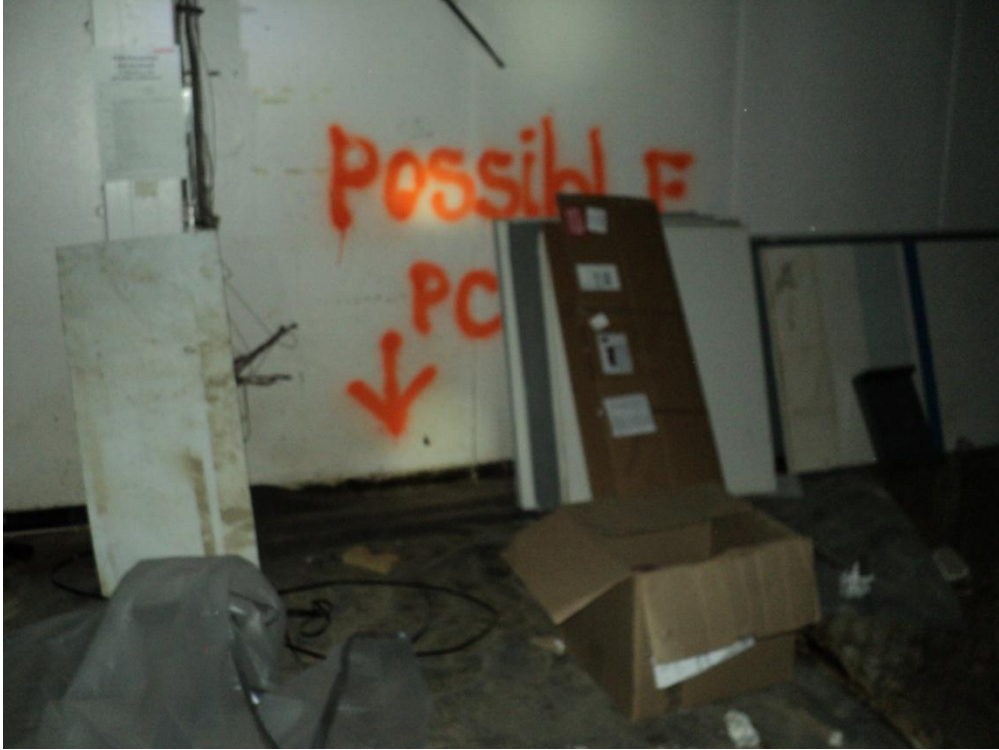
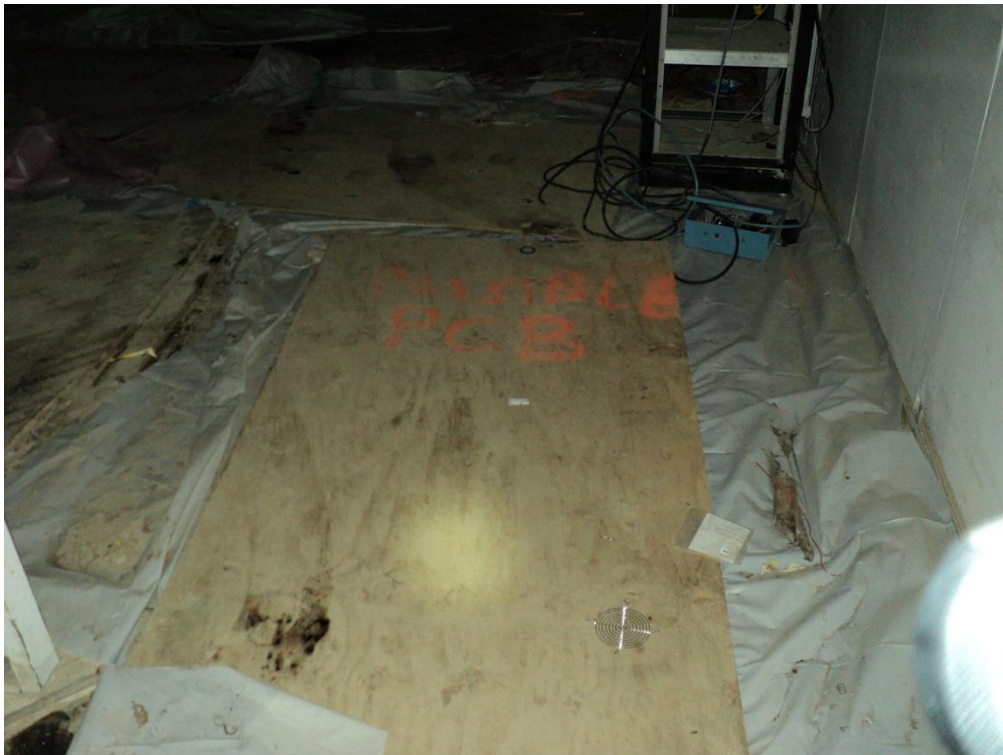
PCB Contamination in Production Building

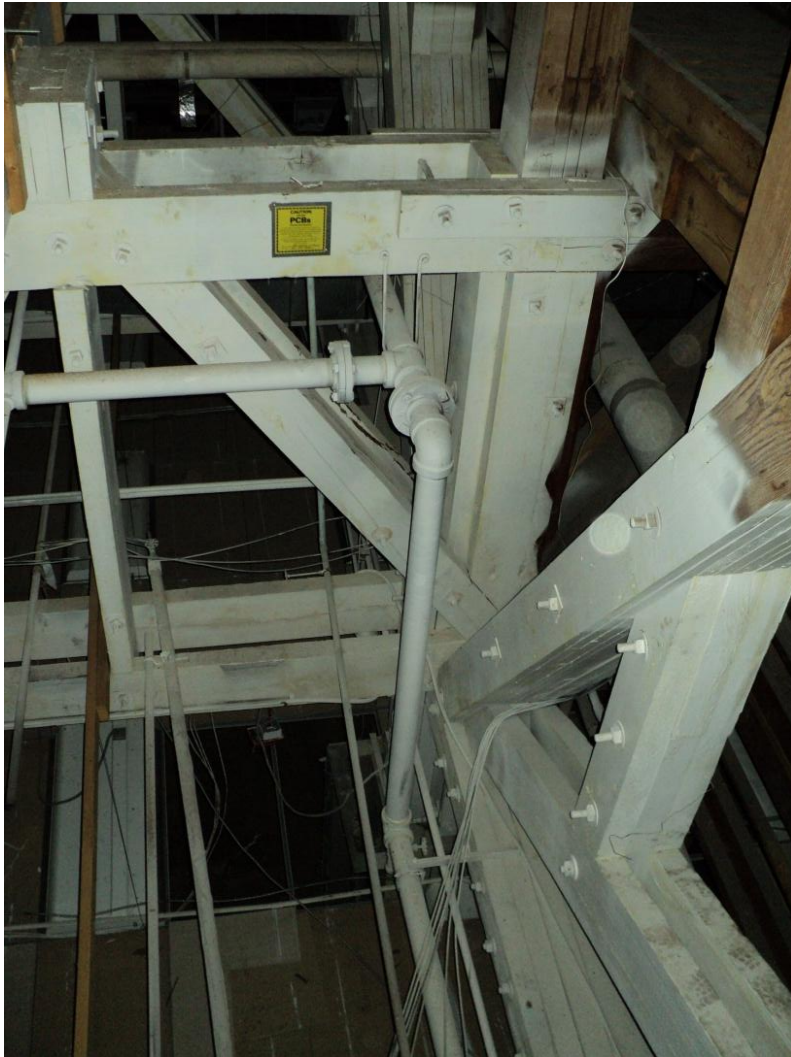
PCB Contaminated Beams and Columns in Catwalk (Painted)

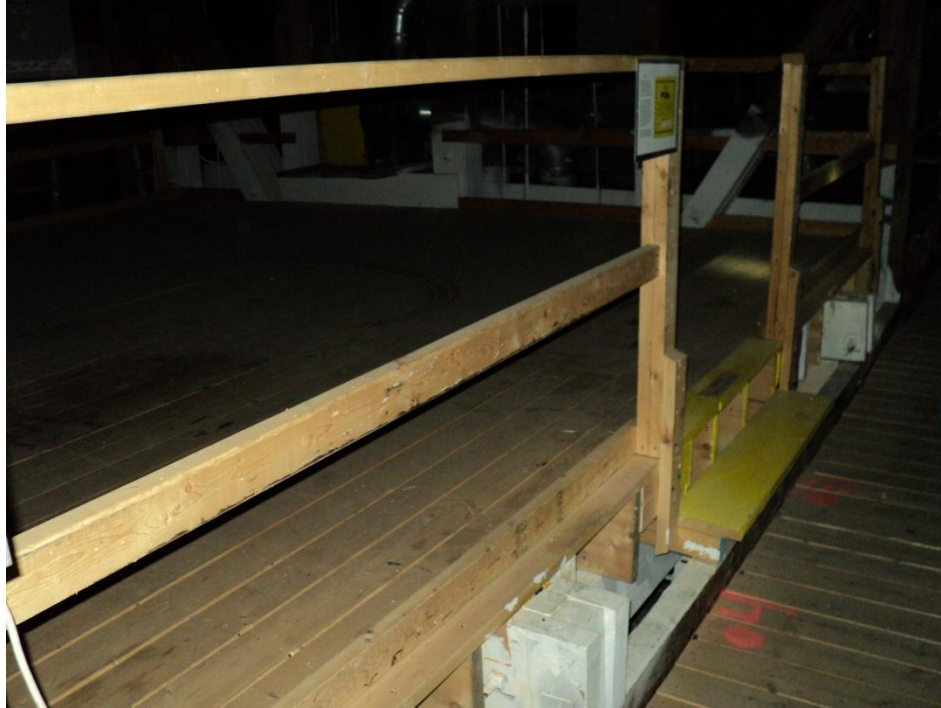
PCB Contaminated area in Catwalk (Posted)

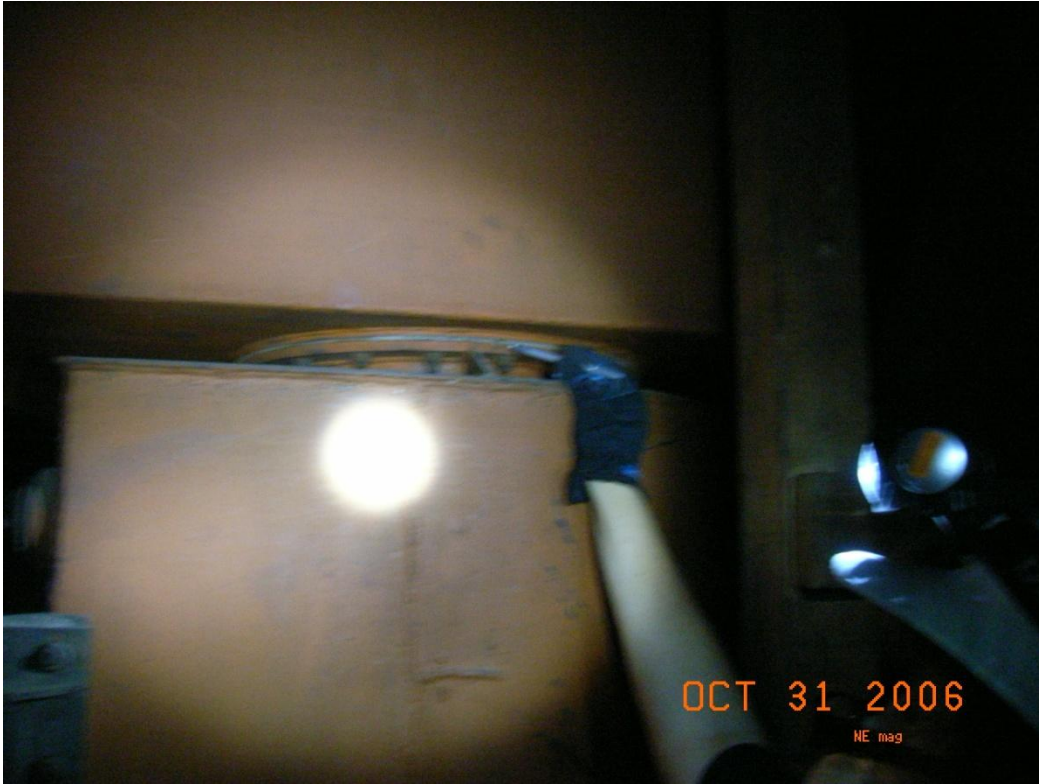
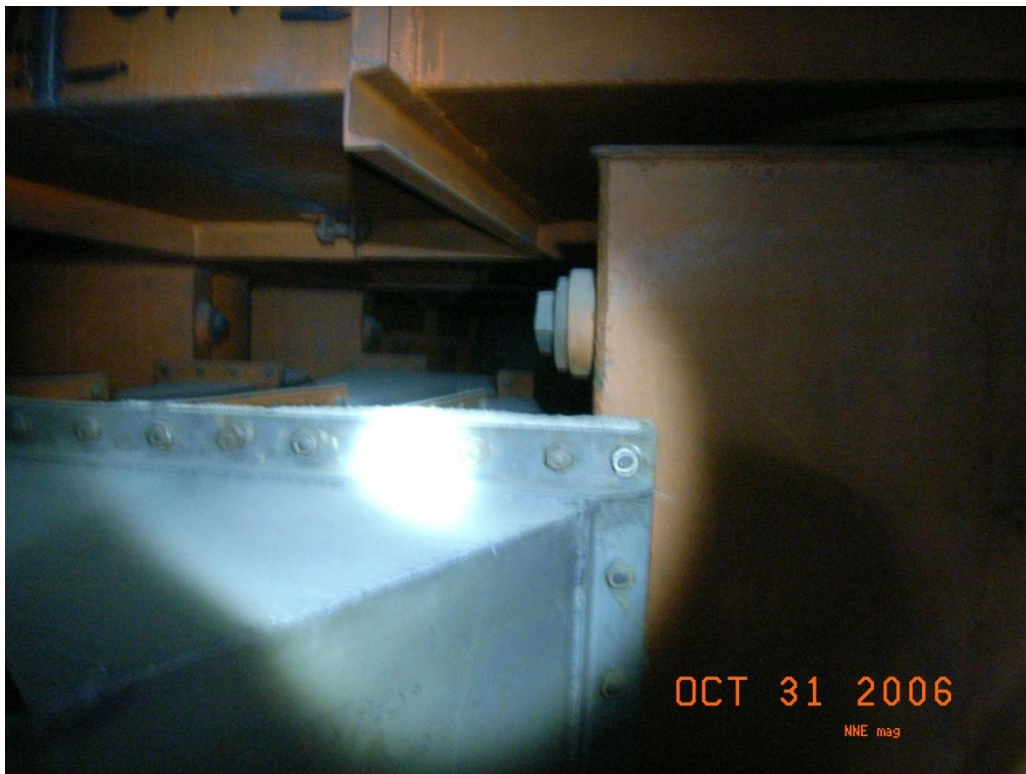
*According to BAE representatives 42 Units for the reclamation of metal chips and cutting oils were installed in the production facility. Most of these units are 20'X20' and are located in the catwalks of the production facility. When they were used the metal chips were transported via ducts to a waiting rail car on the east side of the building while the cutting oils were dispersed onto the roof. The roof part of these units has been removed. The ducting for these units goes throughout the production building in the walls and underneath the floors. The metal chips were swept into the holes in the floors and carried by this system to the waiting railcars. There was no way to estimate the LF of duct associated with this system. The systems will need to be tested for PCB and heavy metal contamination. Refer to drawing 846-1-SK35 dated Dec 1942.

Metal Reclamation Unit on Catwalk (Suspect CWM gasket)

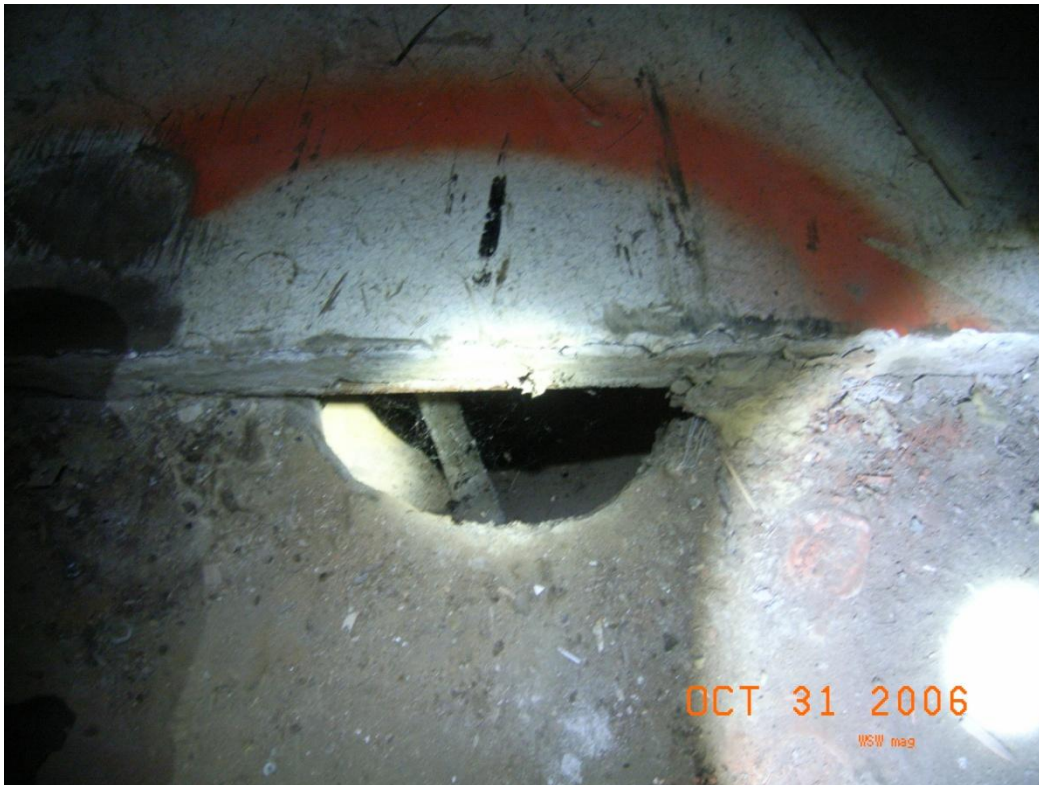
Hole in Floor (Part of Metal Reclamation Unit) Production Building

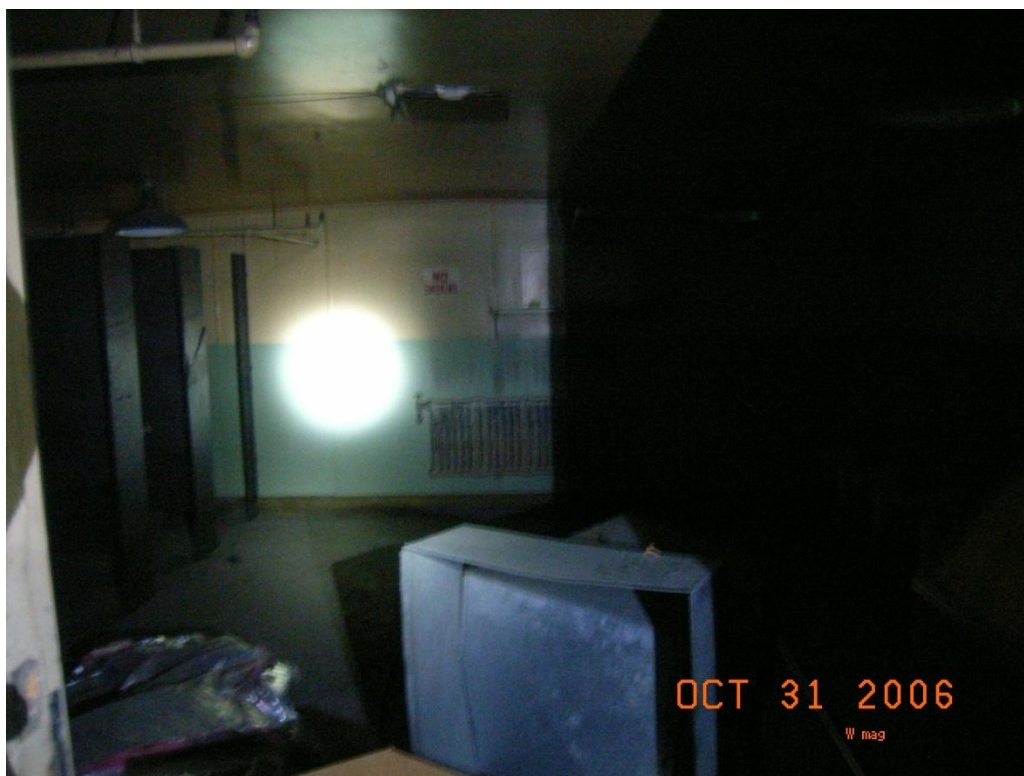
Very Large AHU, North Catwalk (Posted PCB Contaminated)
