Visual Inspection Report
14 June 13

Facility: Air Force Plant (AFP) 59

Inspection Dates: 3 – 6 June 2013

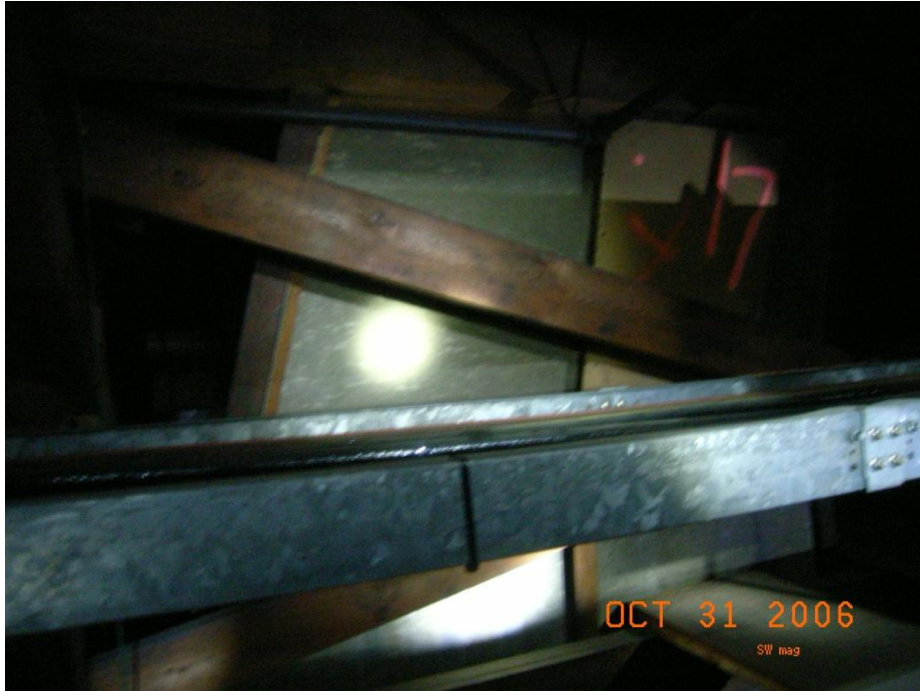
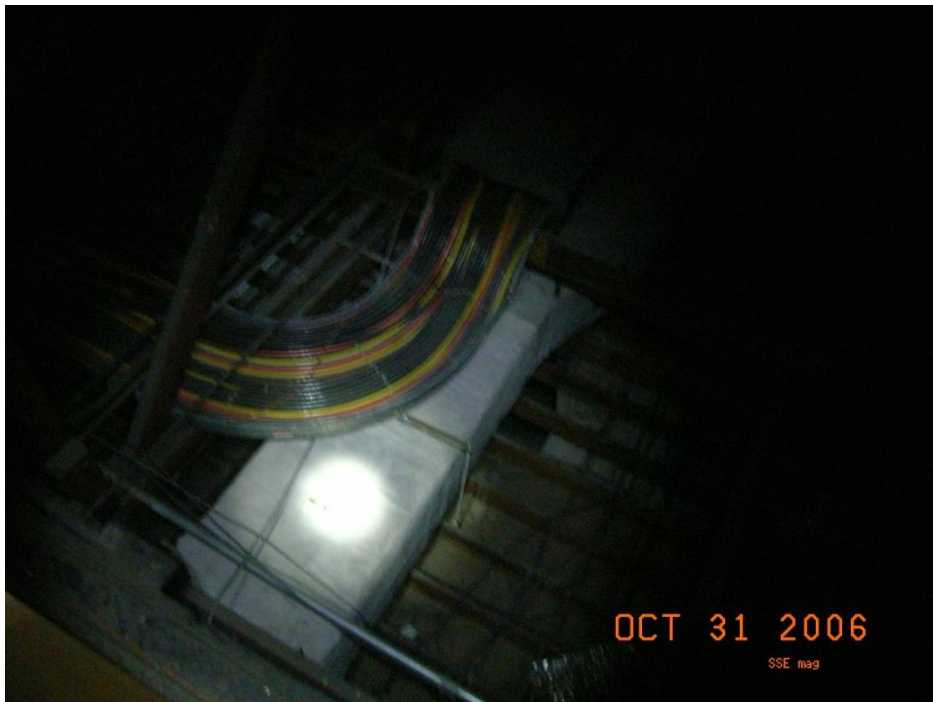
Transite Duct above Catwalk

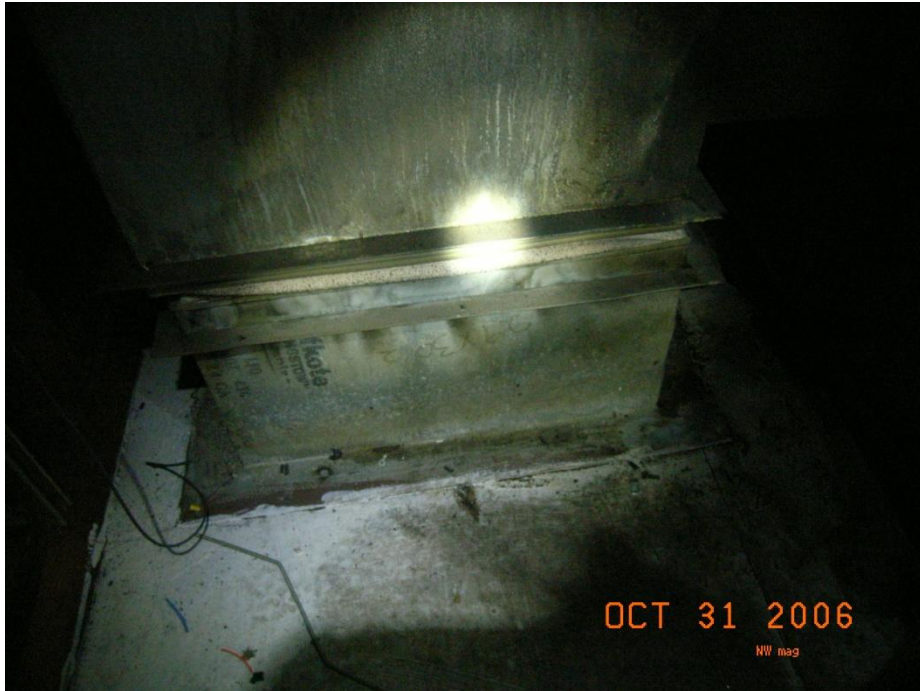
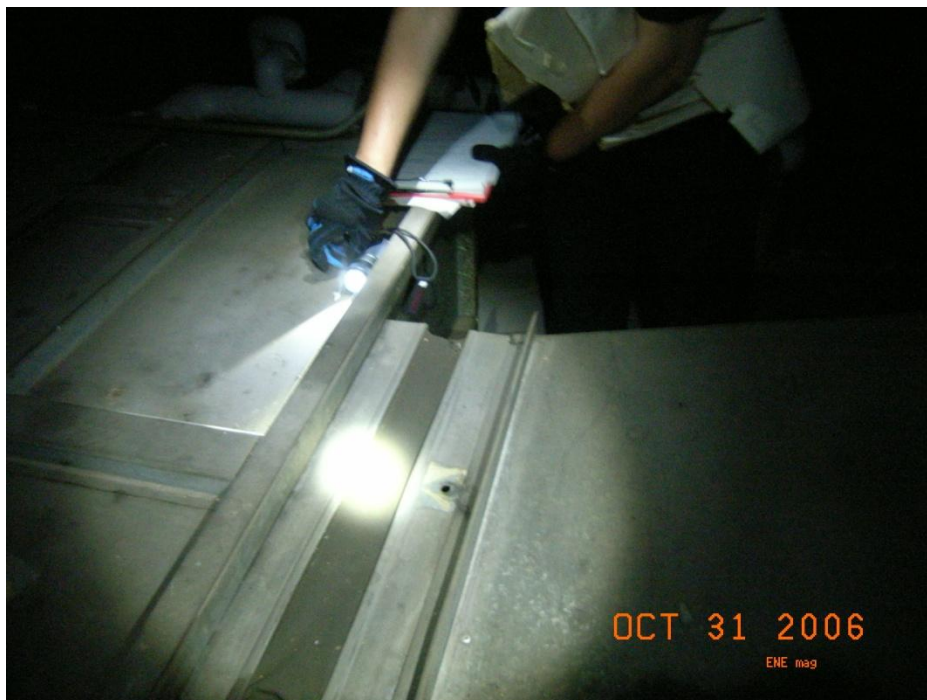
Vibration Dampening Material on Duct in Catwalk

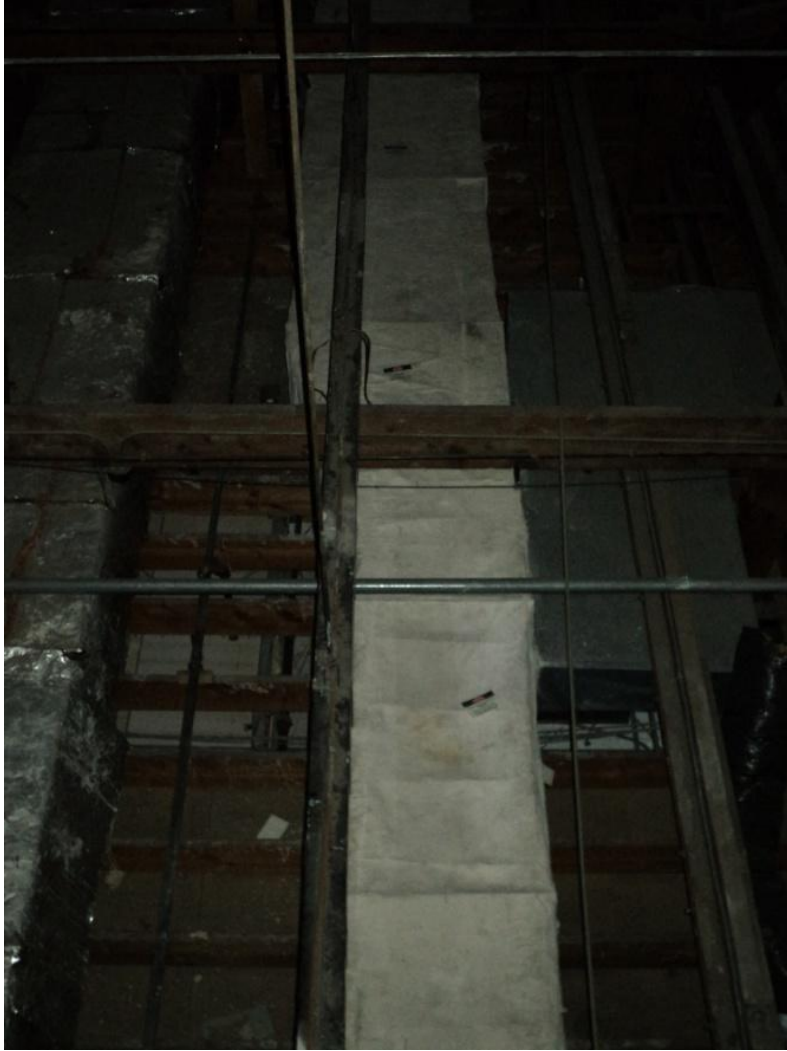
Duct Insulation – Catwalk (Labeled ACM-containing)

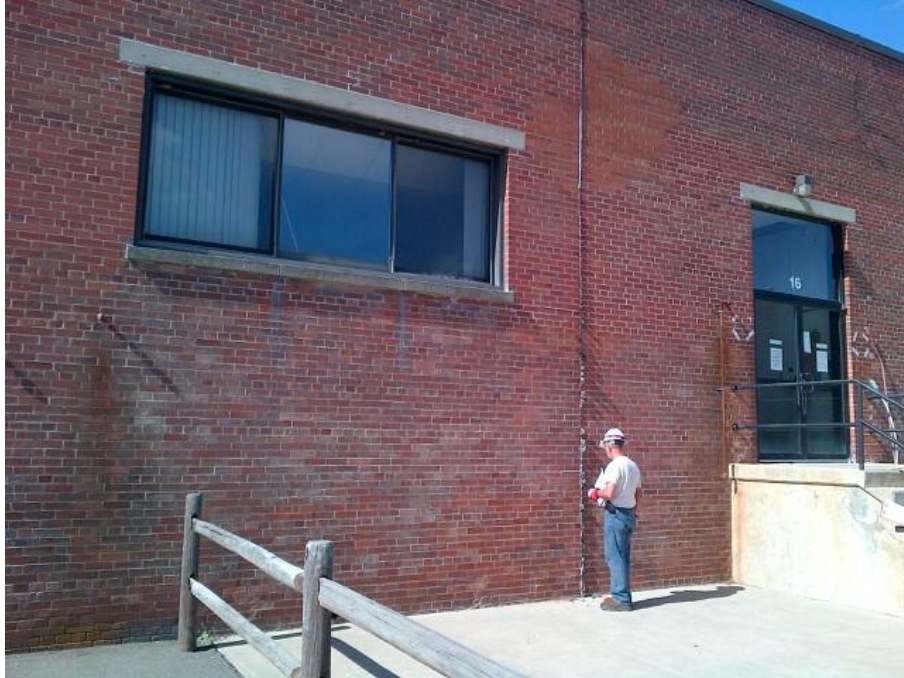
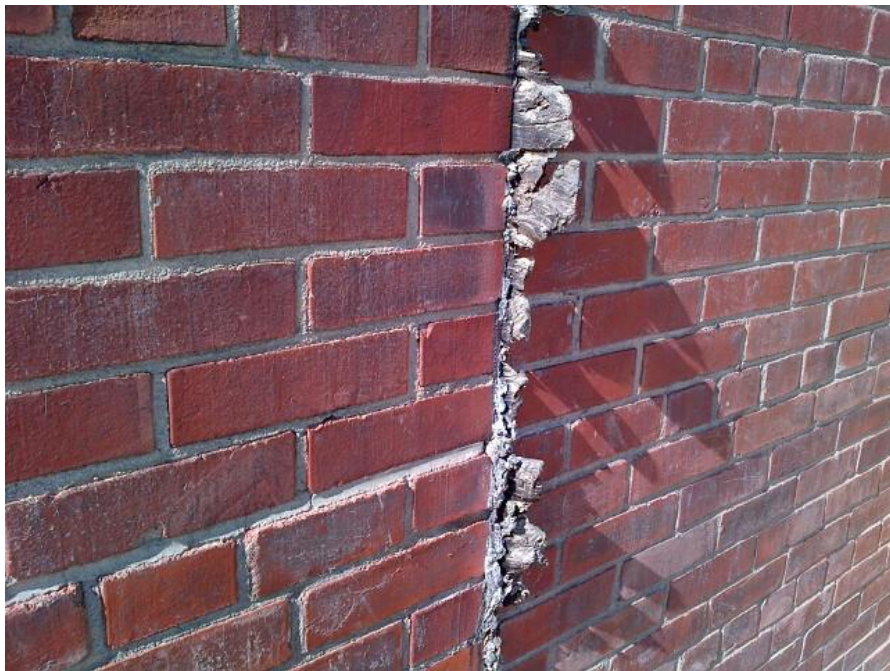
Wall Sealant (Suspect ACM) near Exit 16

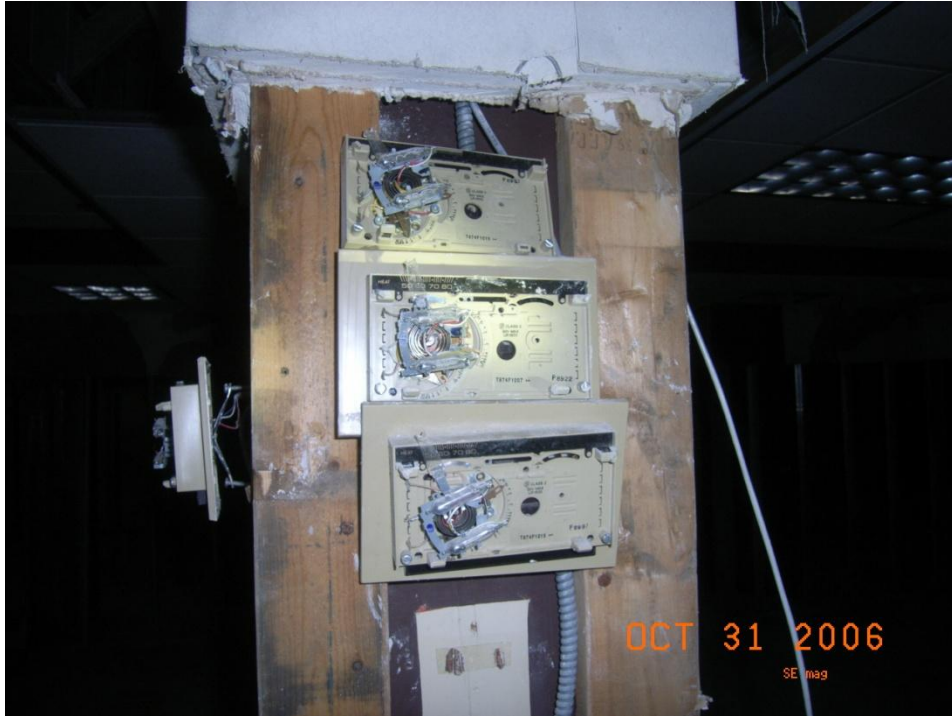
*Total amount estimate by BAE for all buildings. Small percentage of these contains mercury. BAE had been replacing old thermostats.

Mercury Thermostats in Office Building

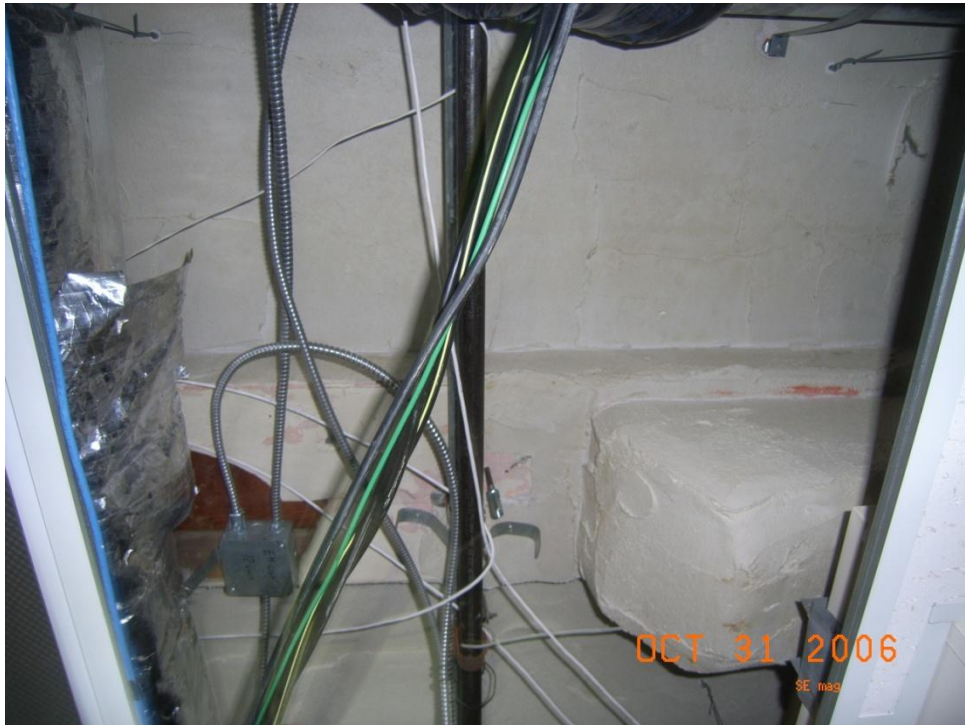
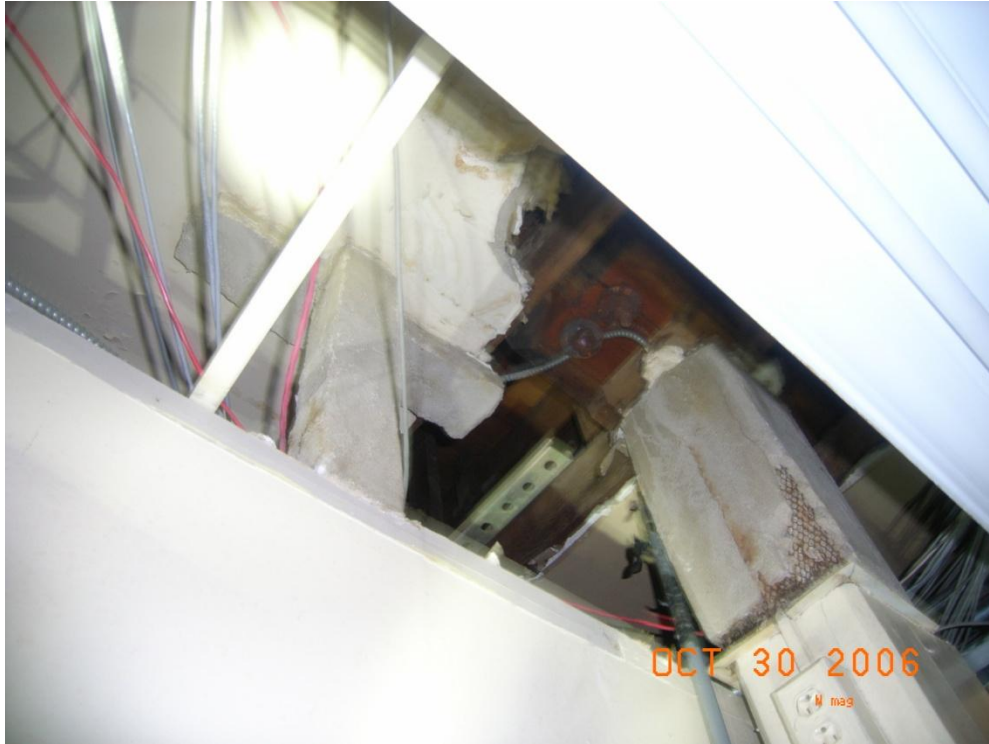
Suspect ACM on Beams & Some Columns Office Bldg & Production Bldg
