Re: Spill Closure Report  
Former Dover Electronics Site, Kirkwood, Broome County, New York  
NYSDEC Site No. 7-04-026  
Spill 1309286 – Pin # H1522 – Sodium Permanganate

On behalf of Dover Corporation (Dover), Verina Engineering, P.C. (VERINA) has prepared this Spill Closure Report to summarize the site inspections, investigations and actions taken to respond to permanganate solution release into the storm water collection system near the Pilot Truck Stop area. The Pilot Truck Stop area is located south of the former Dover Electronics site in Kirkwood, Broome County, New York.

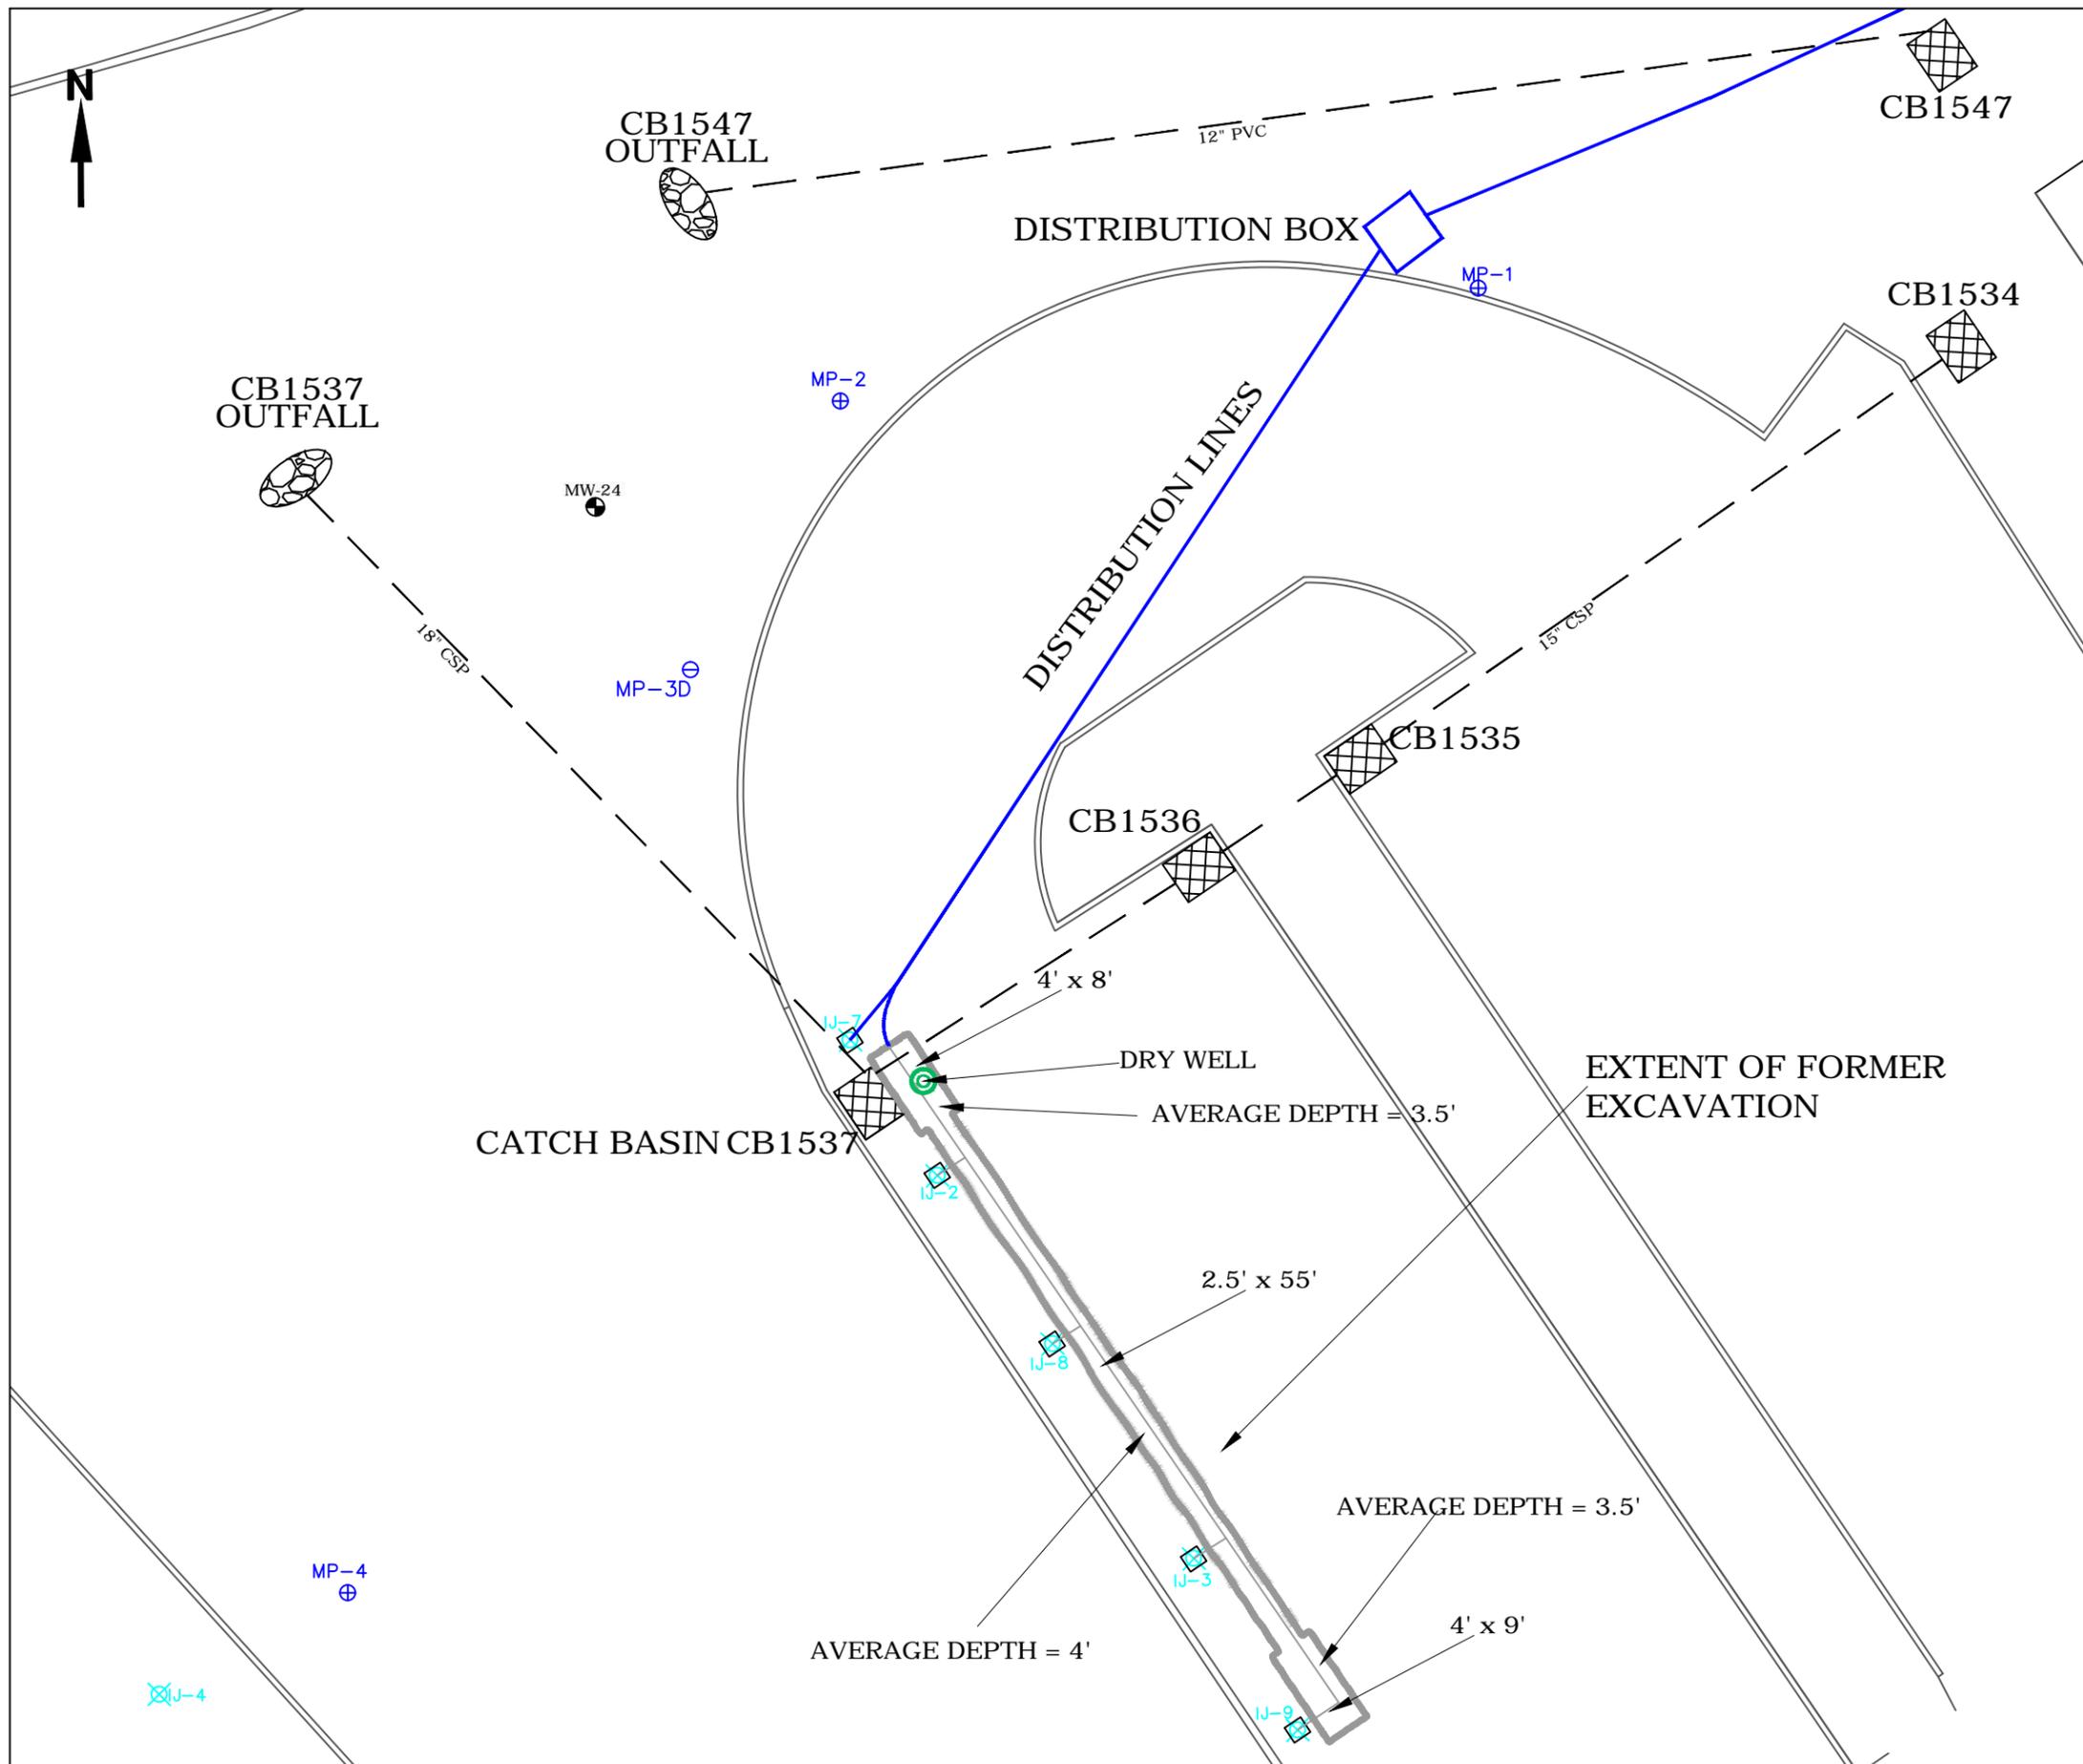
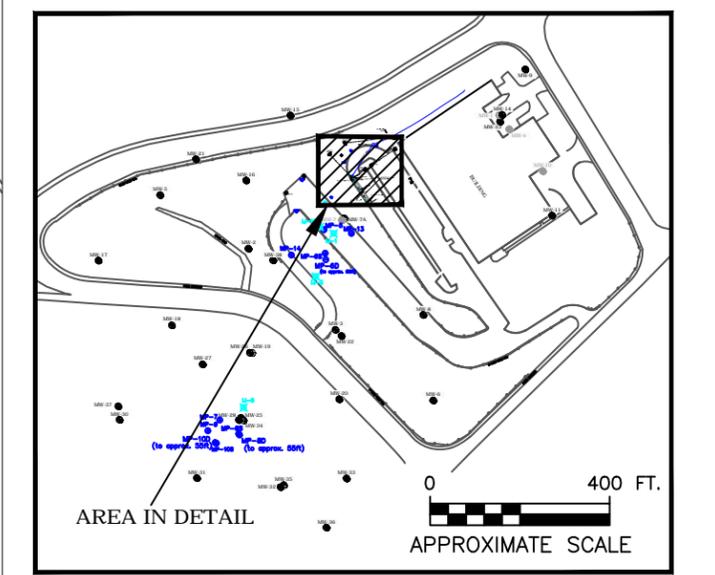
APPROXIMATE LOCATION AND EXTENT OF EXCAVATION

From December 28 to 30, 2013, with the concurrence of NYSDEC, the piping trench area was excavated to contain residual permanganate solution before seeping into the catch basin CB-1537. The excavated piping trench is located between catch basin CB-1537 and injection well IJ-9 (Figure 4).

The majority of the permanganate impacted soils were bedding materials used in the original backfilling of the injection piping trench. During the excavation, permanganate solution was observed to be seeping into the trench from the sidewalls of the excavation. The discoloration was evident in the sand bedding of the ISCO distribution piping and the asphalt sub-base of the parking lot.

The excavation work was completed on Monday, December 30, 2013. The final dimensions of the excavated area were 2.5 feet wide in the middle and 4 feet wide at the two ends by 72 feet long, with an approximate depth of 3 to 4 feet below grade (ft, bg). Approximately 30 cubic yards of soils were excavated. The excavated soils were stored on site in three 20-cubic yard

On December 31, 2013, SEC excavated additional soils for the installation of a dry well north to the catch basin CB-1537 in order to recover any remaining permanganate solution in the subsurface and to prevent it from entering into the storm water catch basin CB-1537. The excavation was completed to 8 ft, bg. Approximately 10 cubic yards of soils were excavated and stored in the on-site roll off boxes. A perforated corrugated 12" pipe was installed vertically to allow a submersible pump or other extraction devices to be lowered to depth and remove any accumulated permanganate solution. The 12" well was backfilled with clean #2 stone up to 4.5 ft below grade.

Upon completion of the dry well installation, SEC vacuumed any pooling permanganate solution from the trench bottom as well as from the four injection well vaults (IJ-2, IJ-8, IJ-3 and IJ-9), catch basin CB1537 and excavated sump area adjacent to CB1537 and stored the recovered solution in an onsite 6,000-gallon frac tank supplied by Adler Tank Rentals. Until the accumulated permanganate solutions to be vacuumed, the trench was treated with neutralizing solution on December 31, 2013 and subsequently backfilled. Prior to backfilling, all 1inch HDPE permanganate supply lines were cut and removed from the trench. The cut ends were plugged/capped with 1inch PVC fittings. After a steel collar with steel lid was placed over top of the 12" dry well, the trench and area around the dry well were backfilled completely to grade.

The trench was refilled with the previously excavated top soil, which did not exhibit any signs of a presence of permanganate impact and  $\frac{3}{4}$ " clean crushed stone provided by Gorick Construction of Binghamton, New York. Approximately 70% of the backfilling was completed on December 31, 2013. Material was backfilled and compacted using a jumping jack compactor starting from the farthest well (IJ-9) and working towards the catch basin CB-1537. All backfilling was completed on January 2, 2014.
