# Dvirka and Bartilucci

Re: Pre-Design Investigation  
Work Assignment No. D003600-39  
American Cleaners Site, Site No. 7-04-030  
D&B No. 2216

AMERICAN CLEANERS SITE REMEDIAL DESIGN  
BINGHAMTON, NEW YORK

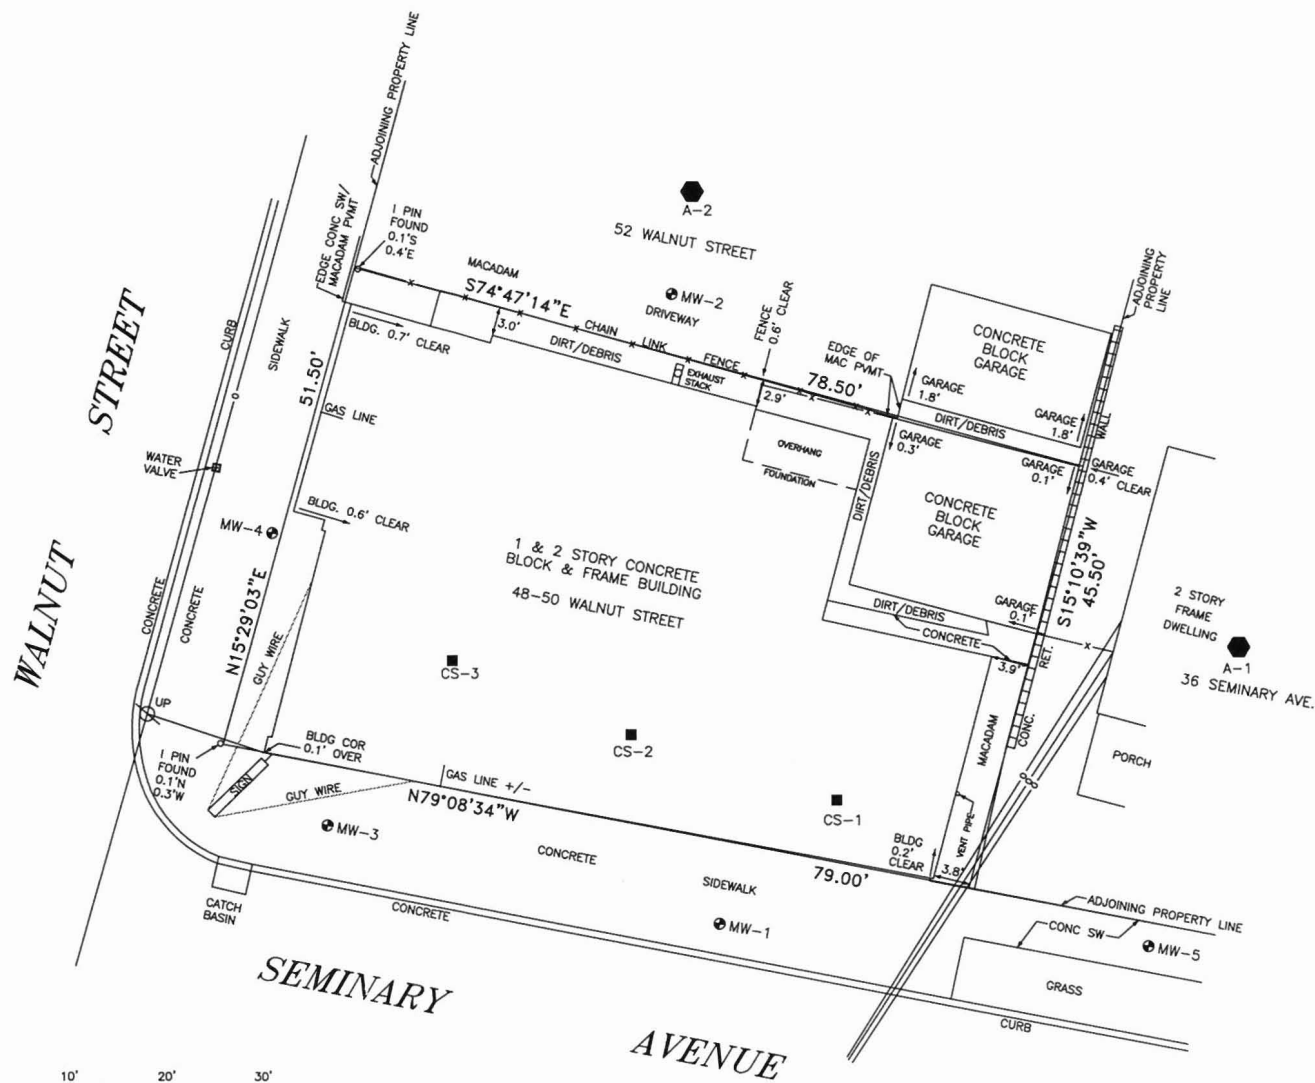
FIGURE 2

American Cleaners Site in order to evaluate the need for mitigation systems. The locations of the houses sampled are shown on Figure 2 (Attachment A). The sub-slab soil vapor samples were collected by drilling a  $\frac{9}{16}$ -inch diameter hole through the concrete basement floor to a depth of approximately 1.5 feet below grade. A 1-inch diameter hole was then drilled approximately 1-inch into the upper surface of the concrete basement floor. A Teflon™ tube was placed in the hole, sealed with bentonite, connected to an air sampling pump and purged until photoionization detector (PID) readings were constant. The air sampling pump was then disconnected and the Teflon™ tube was connected to the sample canister and allowed to fill. Samples were collected with 6-liter Summa® canisters and analyzed for chlorinated VOCs, benzene, toluene, ethylbenzene and xylene (BTEX) and methyl-tert-butyl ether (MTBE) by Method TO-15 using selective ion monitoring. Sample canisters were set up to collect air samples for one hour.

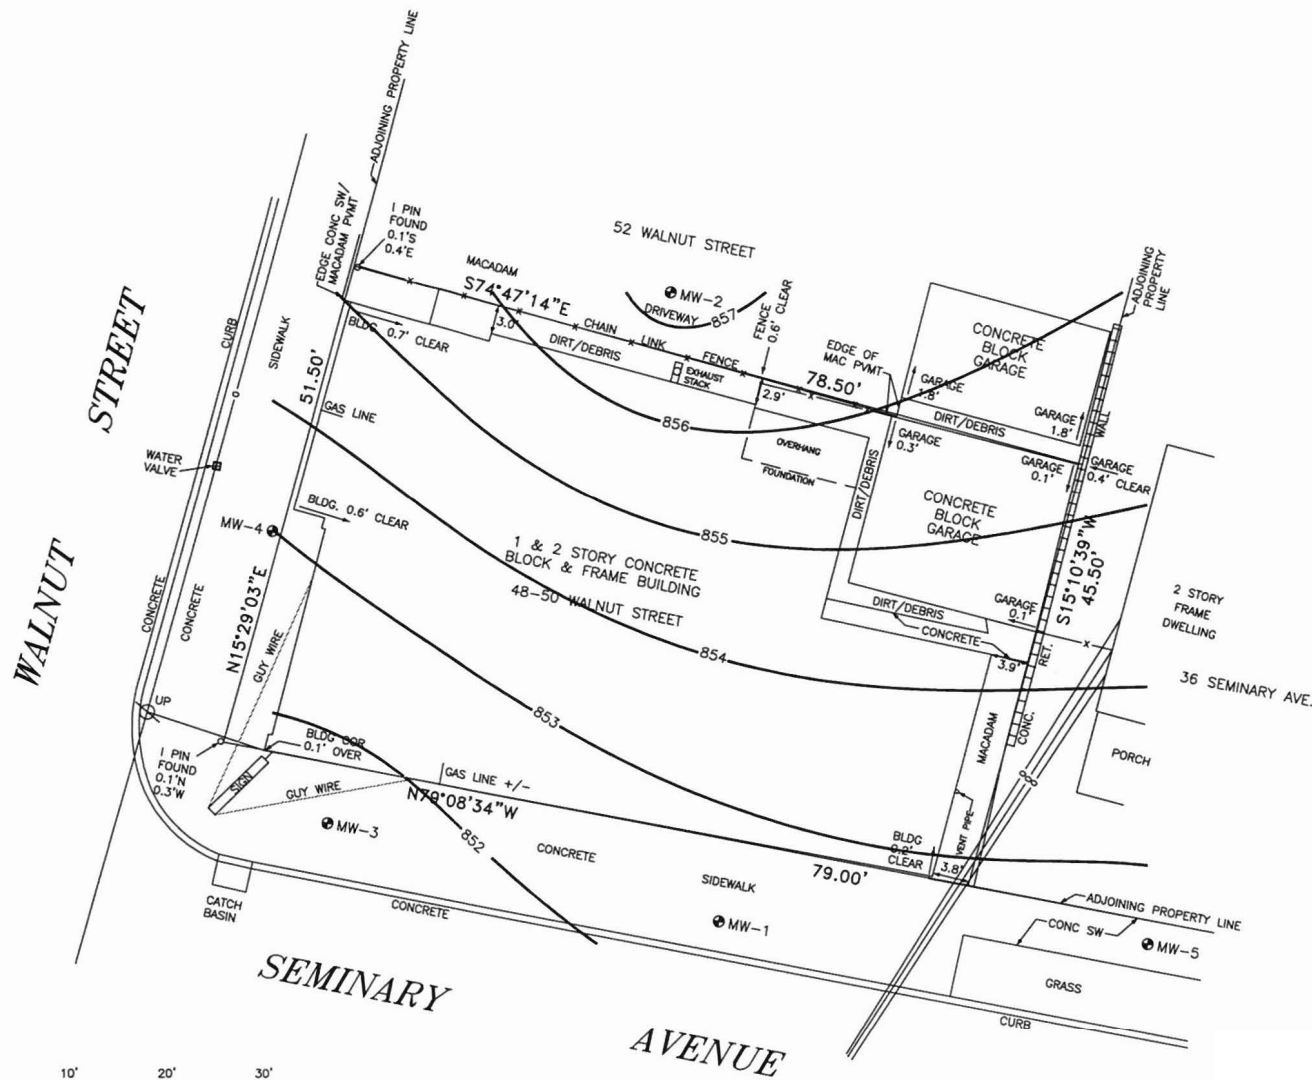
FIGURE 3

Water levels were measured on July 19, 2004, August 27, 2004 and September 14, 2004, using an electronic water level indicator. Depth to groundwater measurements were used to calculate groundwater elevations at the site (Table 3, Attachment B). Water table elevation contour maps (Figures 3, 4 and 5, Attachment A) were constructed using the water level measurements for each of the three days. Based on the results of each of the three water table measurement events, the direction of groundwater flow at the site is to the north-northeast.

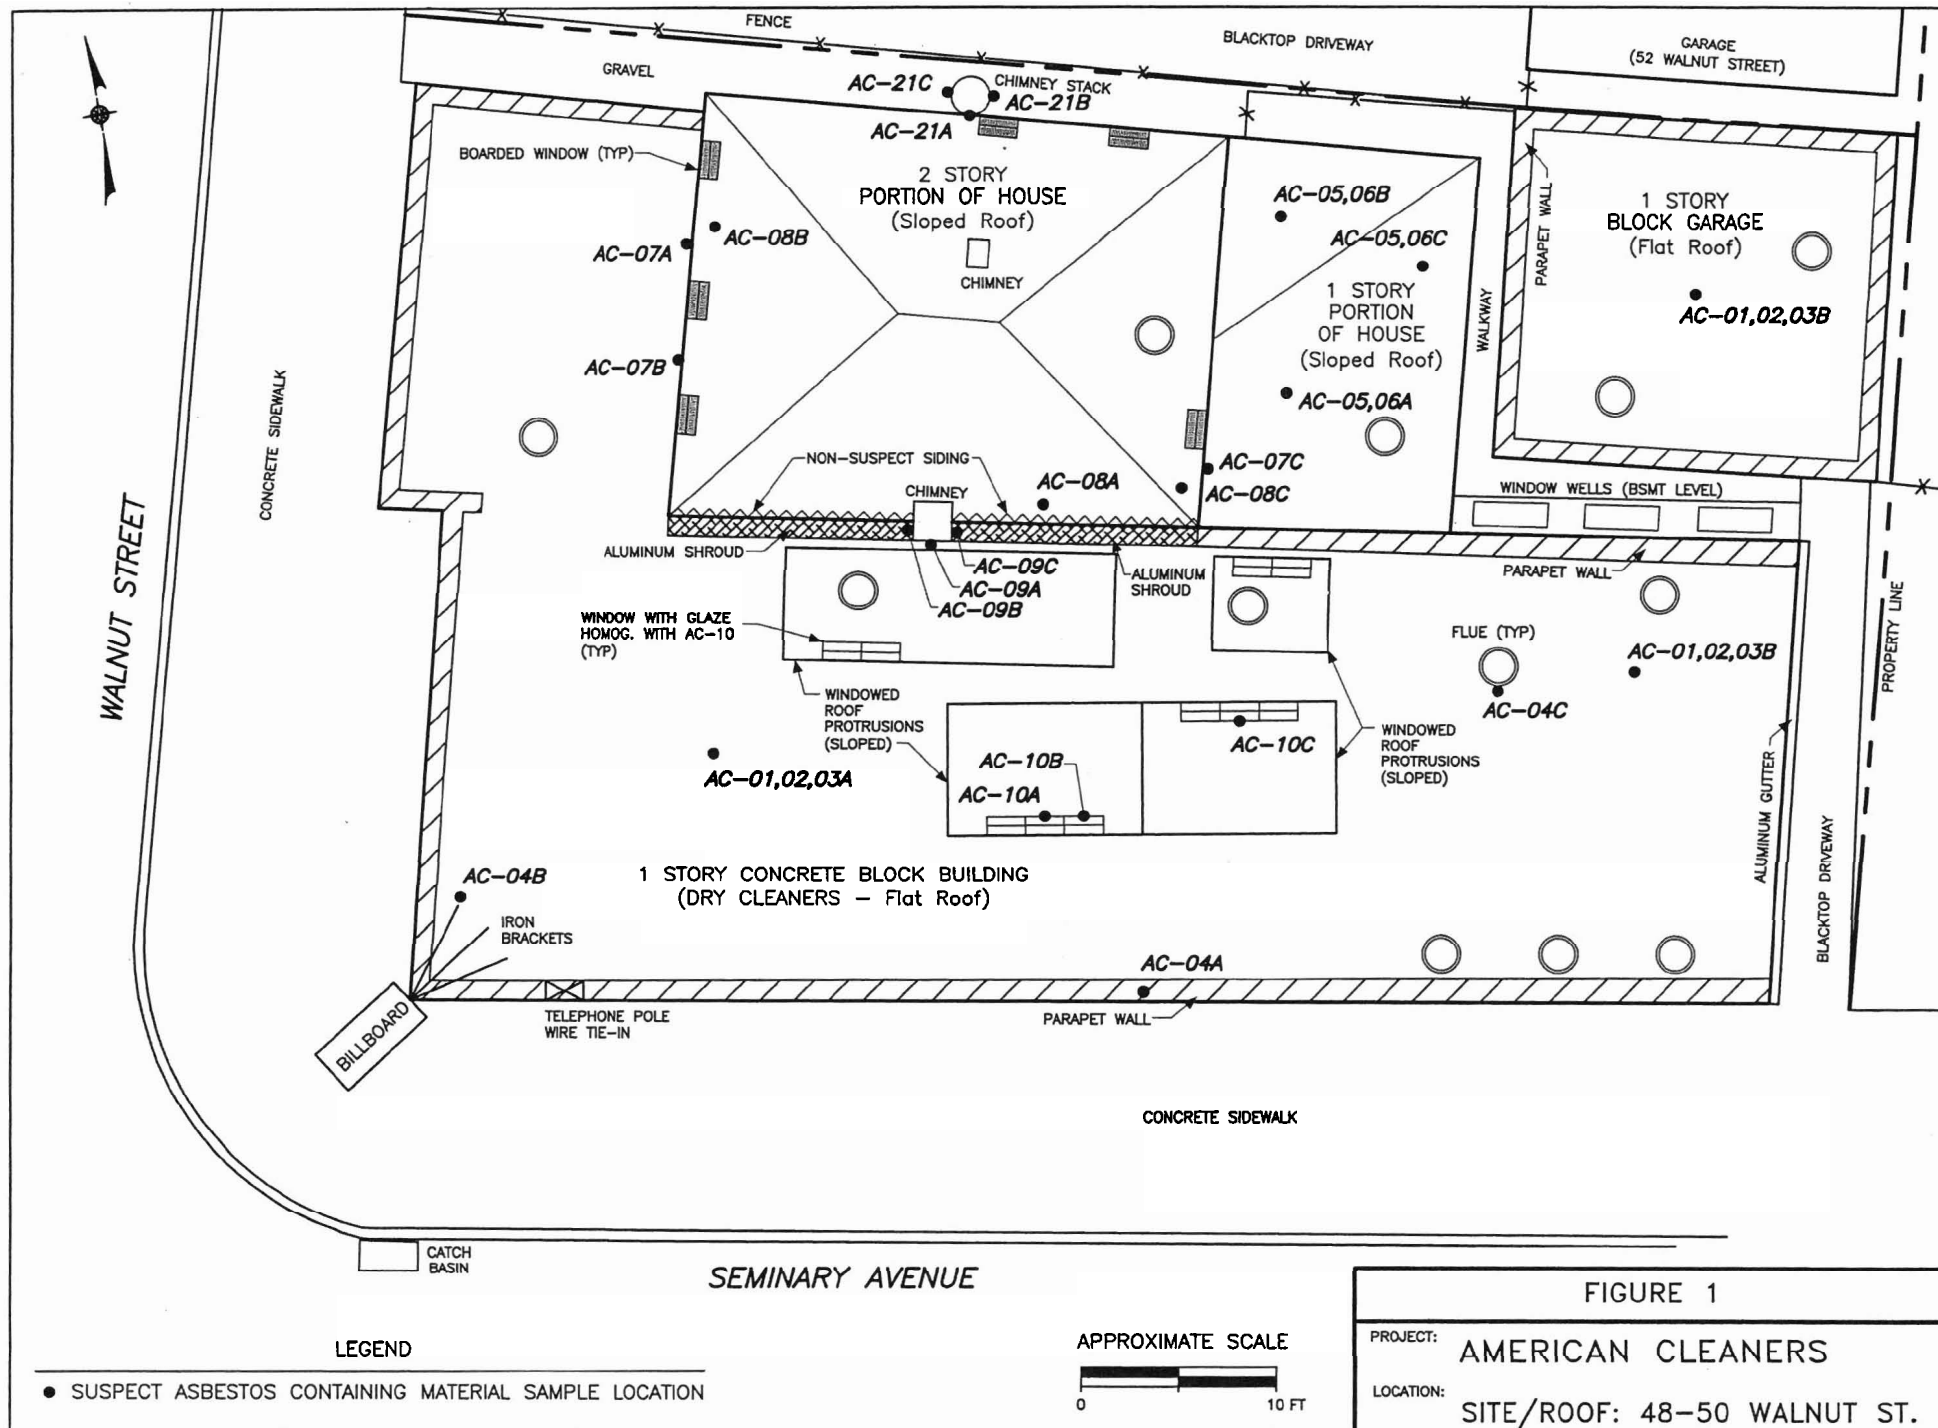
Sample Number	Material Description	Location	Quantity	Condition	Comments	PLM	TEM
AC-01A	Black roof tar	SW area of flat roof	1200 ft <sup>2</sup>	Fair	See Figure 1	NAD	NAD
AC-01B		Eastern area of flat roof				NAD	Trace Chr.
AC-01C		Center of garage roof				NAD	NAD
AC-02A	Brown hair-like insulation	SW area of flat roof	964 ft <sup>2</sup>	Fair	See Figure 1	NAD	NA
AC-02B		Eastern area of flat roof				NAD	NA
AC-02C		Center of garage roof				NAD	NA
AC-03A	Black tar paper	SW area of flat roof	1200 ft <sup>2</sup>	Fair	See Figure 1	NAD	NAD
AC-03B		Eastern area of flat roof				NAD	NAD
AC-03C		Center of garage roof				NAD	NAD
AC-04A	Gray tar patching material	Center of South parapet wall	215 ft <sup>2</sup>	Good	See Figure 1	6.2% Chr.	NA
AC-04B		Base of billboard bracket				NA/PS	NA
AC-04C		Base of flue at Eastern edge of flat roof				NA/PS	NA

- The flat roof, which covered the newer addition to the dry cleaners and the garage on the property, contained four layers. They were from top to bottom, respectively, black roof tar, brown hair-like insulation, black tar paper, and wood. The first three layers were suspect asbestos-containing materials (SACM) and sampled respectively as AC-01, 02, and 03. No asbestos was detected in these samples, except for a chrysotile trace found in sample AC-01B, which was taken at the eastern area of the flat roof. A trace amount of asbestos detected by TEM analysis means that it is <1% asbestos.

Based on the asbestos inspection, 2,297 square feet and 82 linear feet of asbestos were found at various locations on or in the concrete and wood frame buildings located on the American Cleaners Site. No asbestos materials were found on or in the concrete garage. Removal of asbestos will be required in accordance with applicable New York State regulations prior to the demolition of the building.

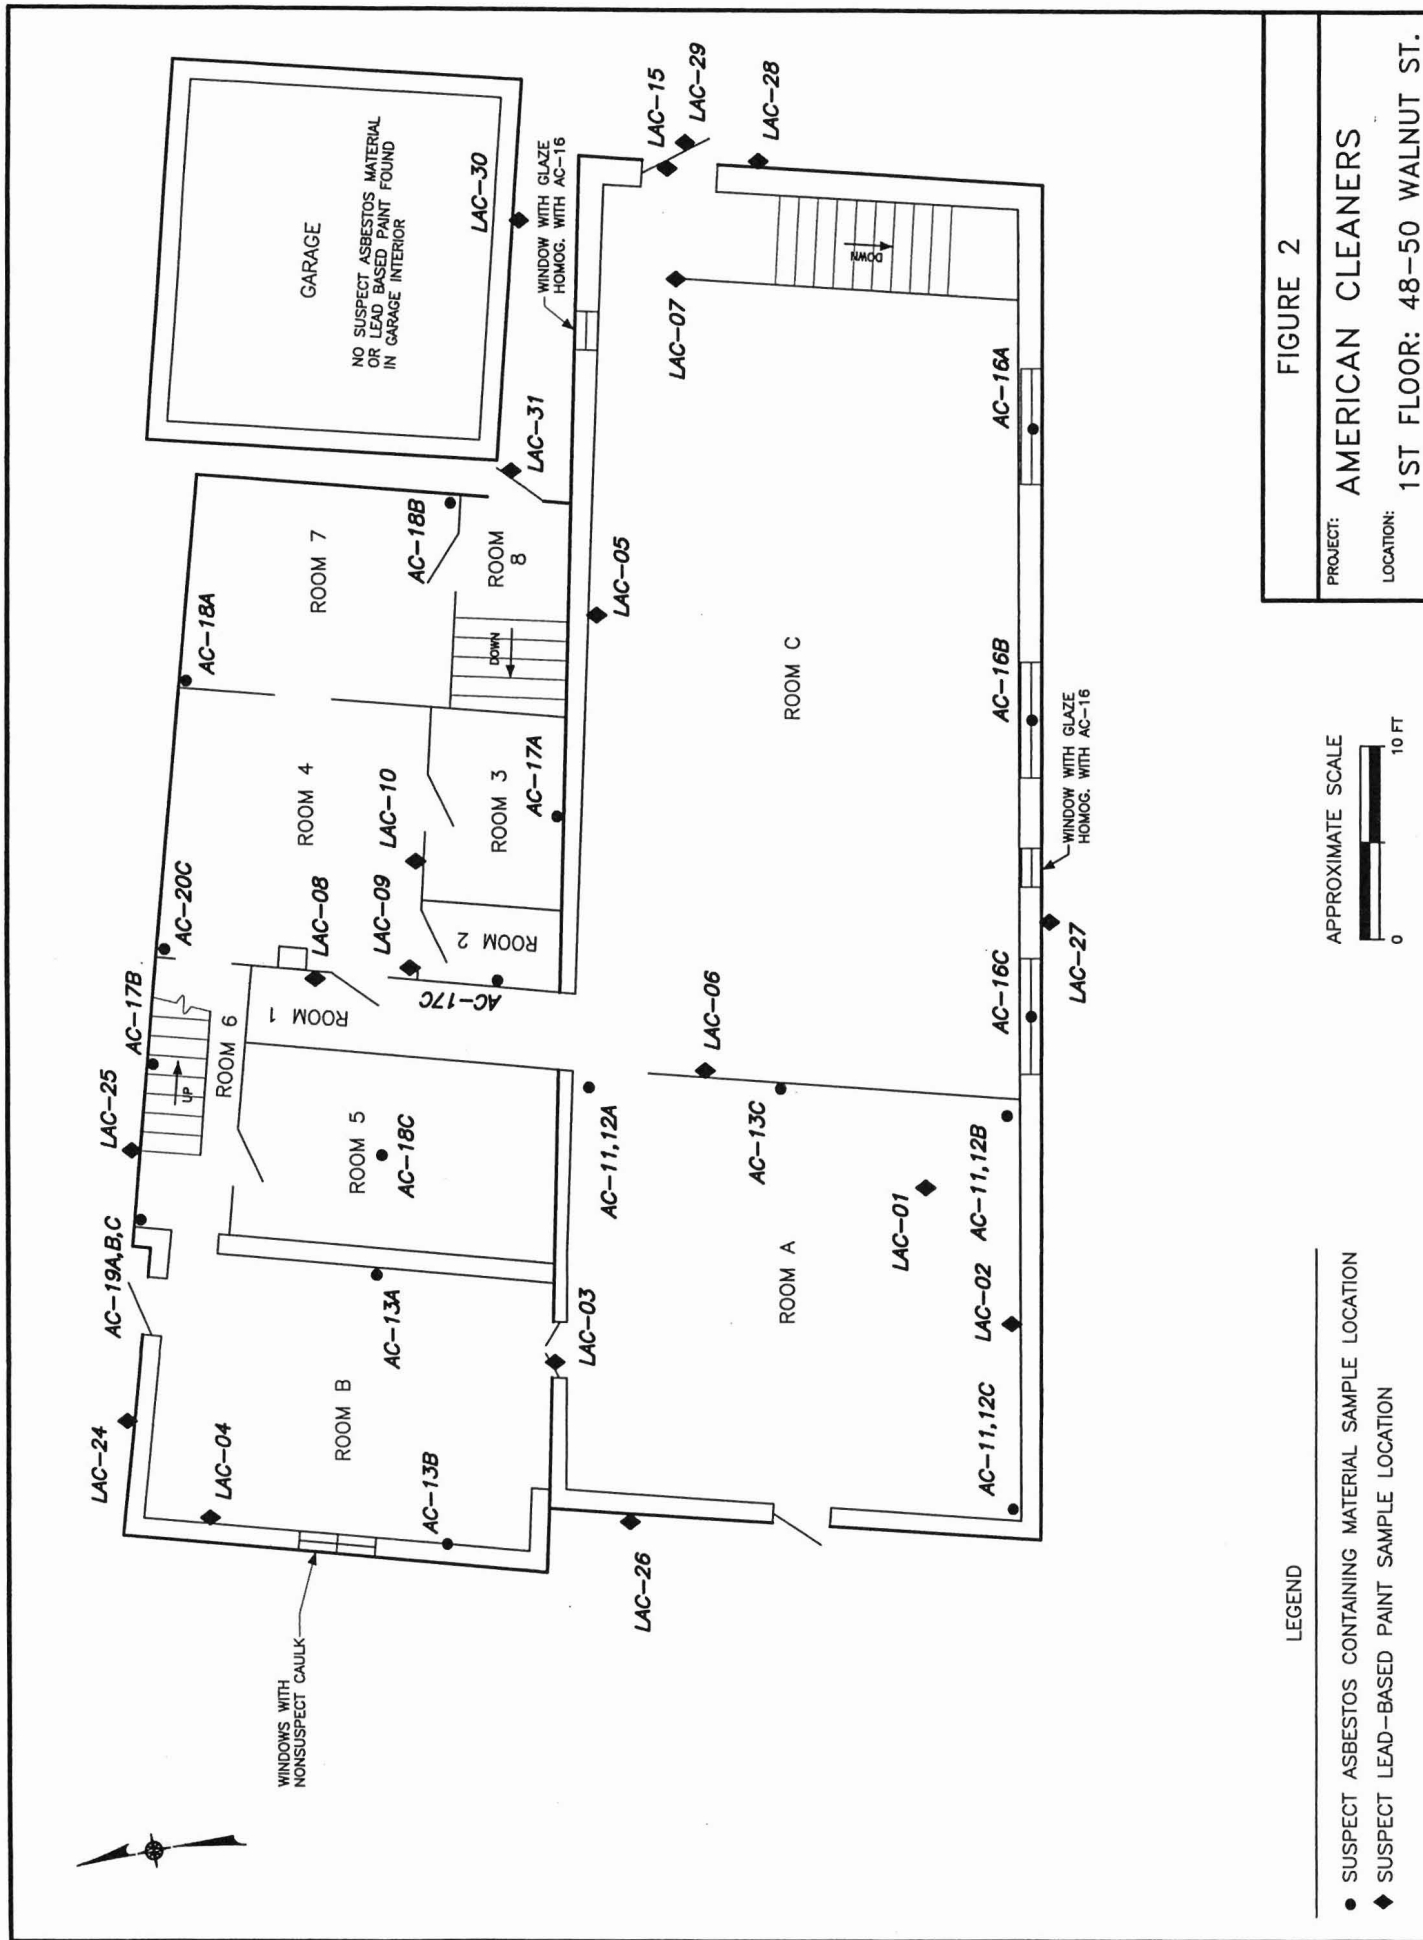
Sample Number	Material Description	Location	Quantity	Condition	Comments	PLM	TEM
AC-09A	Beige chimney brick mortar	South side of southernmost chimney at roof level	50 LF	Fair	See Figure 1	NAD	NA
AC-09B		West side of southernmost chimney at roof level				NAD	NA
AC-09C		East side of southernmost chimney at roof level				NAD	NA
AC-10A	White window glaze	Window of south facing protrusion/skylight	50 LF	Poor	See Figure 1	Trace Chr.	Trace Anth. 1.4% Chr.
AC-10B		Window of south facing protrusion/skylight				Trace Chr.	NA/PS
AC-10C		Window of north facing protrusion/skylight				NAD	NA/PS
AC-11A	9" x 9" floor tile	NE corner of floor in Room A	500 ft <sup>2</sup>	Poor	See Figure 2	Trace Chr.	<1% Anth. 8.5% Chr.
AC-11B		SE corner of floor in Room A				Trace Chr.	NA/PS
AC-11C		SW corner of floor in Room A				Trace Chr.	NA/PS
AC-12A	9" x 9" floor tile mastic	NE corner of floor in Room A	500 ft <sup>2</sup>	Poor	See Figure 2	NAD	<1% Chr.

1. Sample AC-11 A,B,C and AC-12 A,B,C – 9”X9” floor tile and mastic - ACM
  - Total quantity: 500 sq. ft. for each material.
  - Floor is in very poor condition with more than half of the tiles destroyed.
2. Sample AC-13 C – Gypsum Board – not ACM
  - Sample AC-13C was taken from the east wall of Room A.
  - Materials homogeneous with AC-13C were the north, west and south walls.
3. Some wiring associated with metal switch boxes, outlets, and heat control panels was homogeneous with AC-20A – not ACM
4. Non-suspect materials found in Room A are: tin drop ceiling; wood ceiling; metal switch boxes, outlets, and heat control panels; rubber wiring; wood floor beneath ACM floor tiles and mastic; metal and rubber silicon window frames (no suspect caulk or glaze was found); wood window frames; metal and wood doors and doorframes; metal and wood cabinets.
