Report: HW.704031.2008.01.23. Sewer-Line-IRM  
monitoring report.

New York State Electric & Gas Corporation  
66-Inch Storm Drain Liner Interim Remedial Measure Project  
Court Street Site, Binghamton, New York

Date:  
January 23, 2008

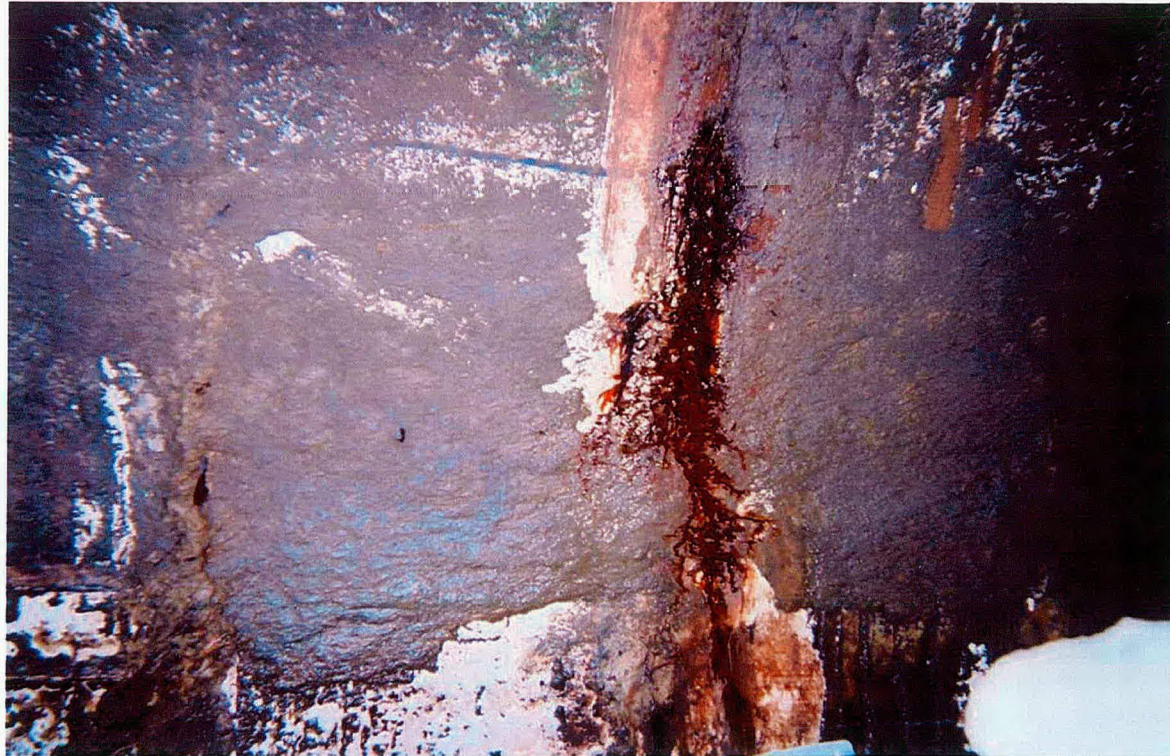
**Exhibit 1**

During the September 2007 monitoring event, staining was observed on the interior of the liner joiner strip at one location (Attachment A, Exhibit 1). The location was wiped down with an absorbent cloth and field staff noted a small amount of water

**EXHIBIT 1. LOCATION OF OBSERVED STAINING**

| <b>Distance<br/>Downstream of<br/>Manhole MH-2<br/>(ingress/egress)</b> | <b>The location of the<br/>NAPL stain or location<br/>of NAPL infiltration with<br/>respect to the<br/>circumference of the<br/>pipe wall (e.g., using<br/>clock position<sup>4</sup>)</b> | <b>Approximate surface<br/>area of the NAPL<br/>stain</b> | <b>Description (including<br/>approximate dimensions)<br/>of the opening or breach<br/>in the liner in which NAPL<br/>infiltration is observed</b> |
|---|---|---|---|
| At 247 ft<br>downstream<br>(south) of MH-2 | At 4 o'clock position (west<br>side of pipe) | Approximately 0.21 ft <sup>2</sup><br>(3" wide x 10" long) | Staining was observed at<br>the seam. Wiped down the<br>area and re-seating the<br>joiner strip with a mallet.<br>No infiltration was observed<br>following re-seating the<br>joiner strip. |

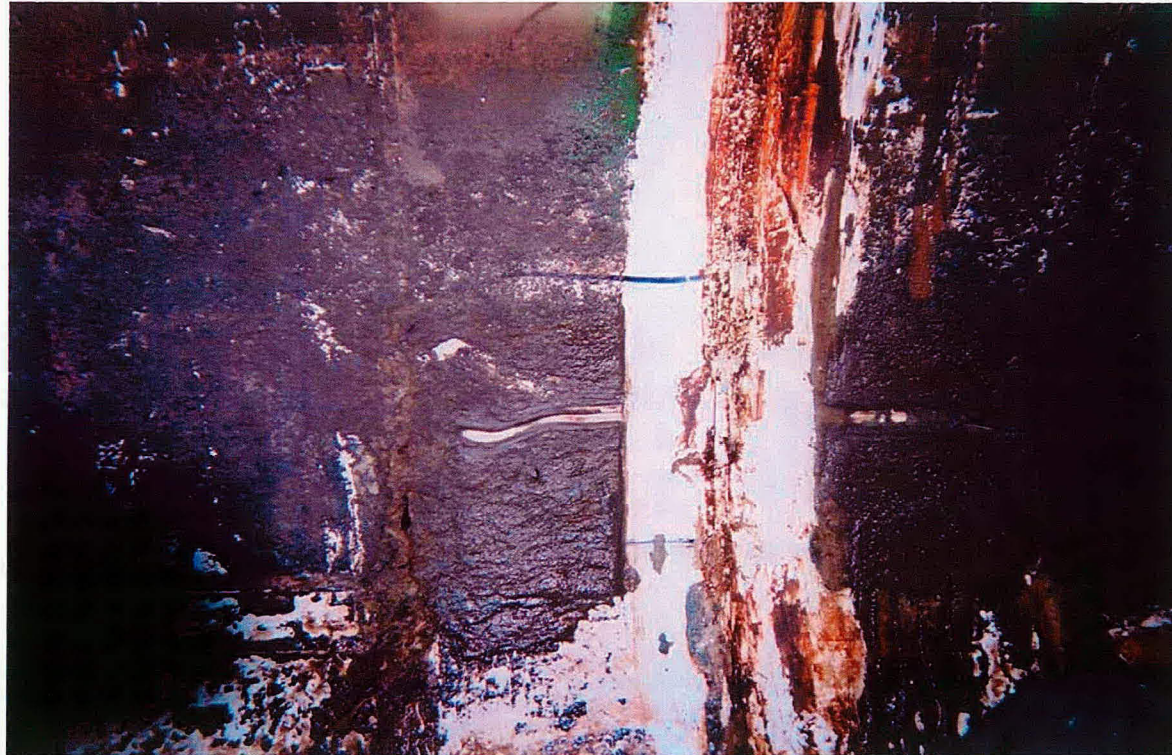
**Exhibit 2**

trickling along the joiner strip. As a precautionary measure, the joiner strip was re-seated with a mallet and no further trickling was observed (Attachment A, Exhibit 2). The water observed may have been a result of condensation within the pipe and along the joiner strip, or residual water in the joiner strip from a backwater condition (flow back up in the sewer). No sheens or NAPL were observed in the water or sediment present in the pipe at or downstream of this location. Note also that this location was not one of the fifteen locations that were repaired during the November 2006 work.

**EXHIBIT 2. LOCATION OF OBSERVED STAINING FOLLOWING RESEATING OF JOINER STRIP**
