Report.HW:704031.2009.02.03 - NAPL Barrier Wall
Annual Report.

New York State Electric & Gas Corporation
Report for 66-Inch Storm Sewer Liner Annual Monitoring
Court Street Site, Binghamton, New York

**IRM MONITORING LOG
STORM SEWER INTERIM REMEDIAL MEASURE MONITORING PROGRAM**

**NEW YORK STATE ELECTRIC & GAS CORPORATION
COURT STREET SITE
BINGHAMTON, NEW YORK**

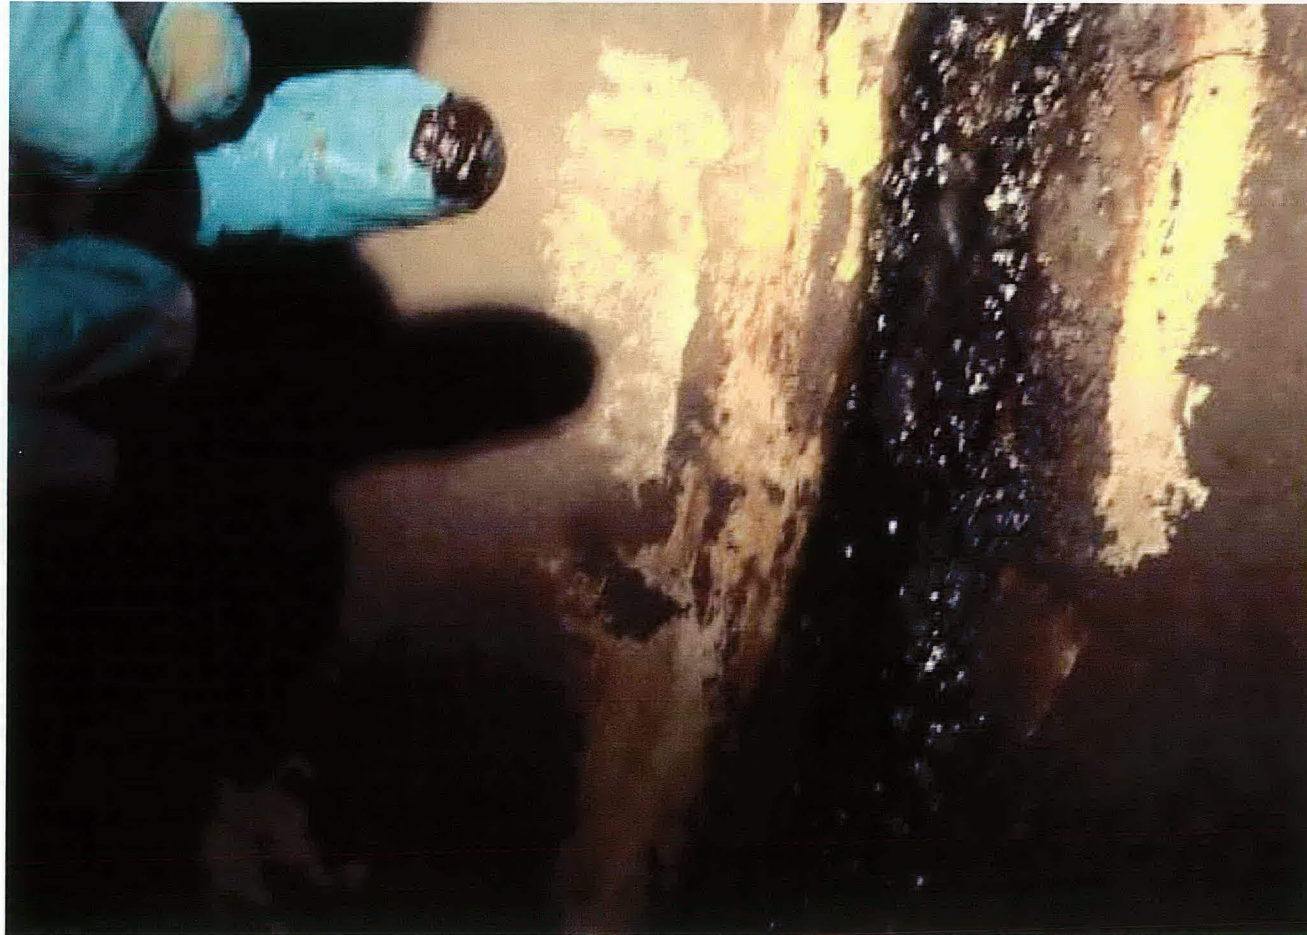
EXHIBIT 1. LOCATION OF NAPL IMPACTS

During the October 2008 monitoring event, black NAPL-like material was observed on the interior of the liner joiner strips at several locations between 155 feet and 170 feet south of manhole MH-2 (Attachment A, Exhibit 1). NAPL-like material appeared to be present along the west wall joiner strip from the 9- to 7-o'clock position (facing south/downstream from MH-2). When wiped from the liner wall, the NAPL-like material appeared to exhibit a coal tar-like odor. No sheens or NAPL were observed in the water or sediment present in the pipe at or downstream of this location. Other stained areas (lighter in color and not of the same physical consistency as the NAPL-like material) along the inside of the PVC liner pipe were also observed during the inspection, but none exhibited a coal tar-like odor. The impacted seams (containing NAPL-like material) described above appeared to be consistent with those observed during the August 2006 monitoring event. As discussed in the January 23, 2008 monitoring report, these seams were removed and evaluated for potential failure, and subsequently repaired in November of 2006 by reseating the joiner strips. No

Distance Downstream of Manhole MH-2 (ingress/egress)	The location of the NAPL stain or location of NAPL infiltration with respect to the circumference of the pipe wall (e.g., using clock position⁴)	Approximate surface area of the NAPL stain	Description (including approximate dimensions) of the opening or breach in the liner in which NAPL infiltration is observed
From 155 ft to 170 ft downstream (south) of MH-2	At 9 o'clock position (east side of pipe)	Approximately 0.67 ft ² (4" wide x 24" long)	NAPL appeared to be present along 3 seams from 9 o'clock to 7 o'clock. NAPL contained a coal-tar like odor.

At this time NYSEG is exploring different options (intrusive and nonintrusive) to further investigate the impacted joiner strips. NYSEG will also contact both the manufacturer and installer of the PVC liner to discuss recommendations for proper repair of the seams in question. Additionally, a more frequent sewer inspection schedule will be initiated due to the findings of this annual monitoring event. Beginning in early 2009, once the river level is low enough to safely conduct the work, inspections of the sewer will take place 3 times per year. We anticipate the first event will shortly follow the spring melt/runoff. We will notify NYSDEC two weeks prior to conducting the inspection event, and will inform NYSDEC of the results of that inspection shortly after the work is completed. A plan and associated schedule to address the NAPL-impacted areas of the lined sewer will be developed and provided to NYSDEC during the month of April.
