Report.HW.704031.2010.05.04-sewer_line-repair-~~AA~~
Alternative_Analysis

MEMO

Subject:
Court Street Former MGP Site
Binghamton, NY
66-Inch Storm Sewer Rehabilitation Alternatives Evaluation

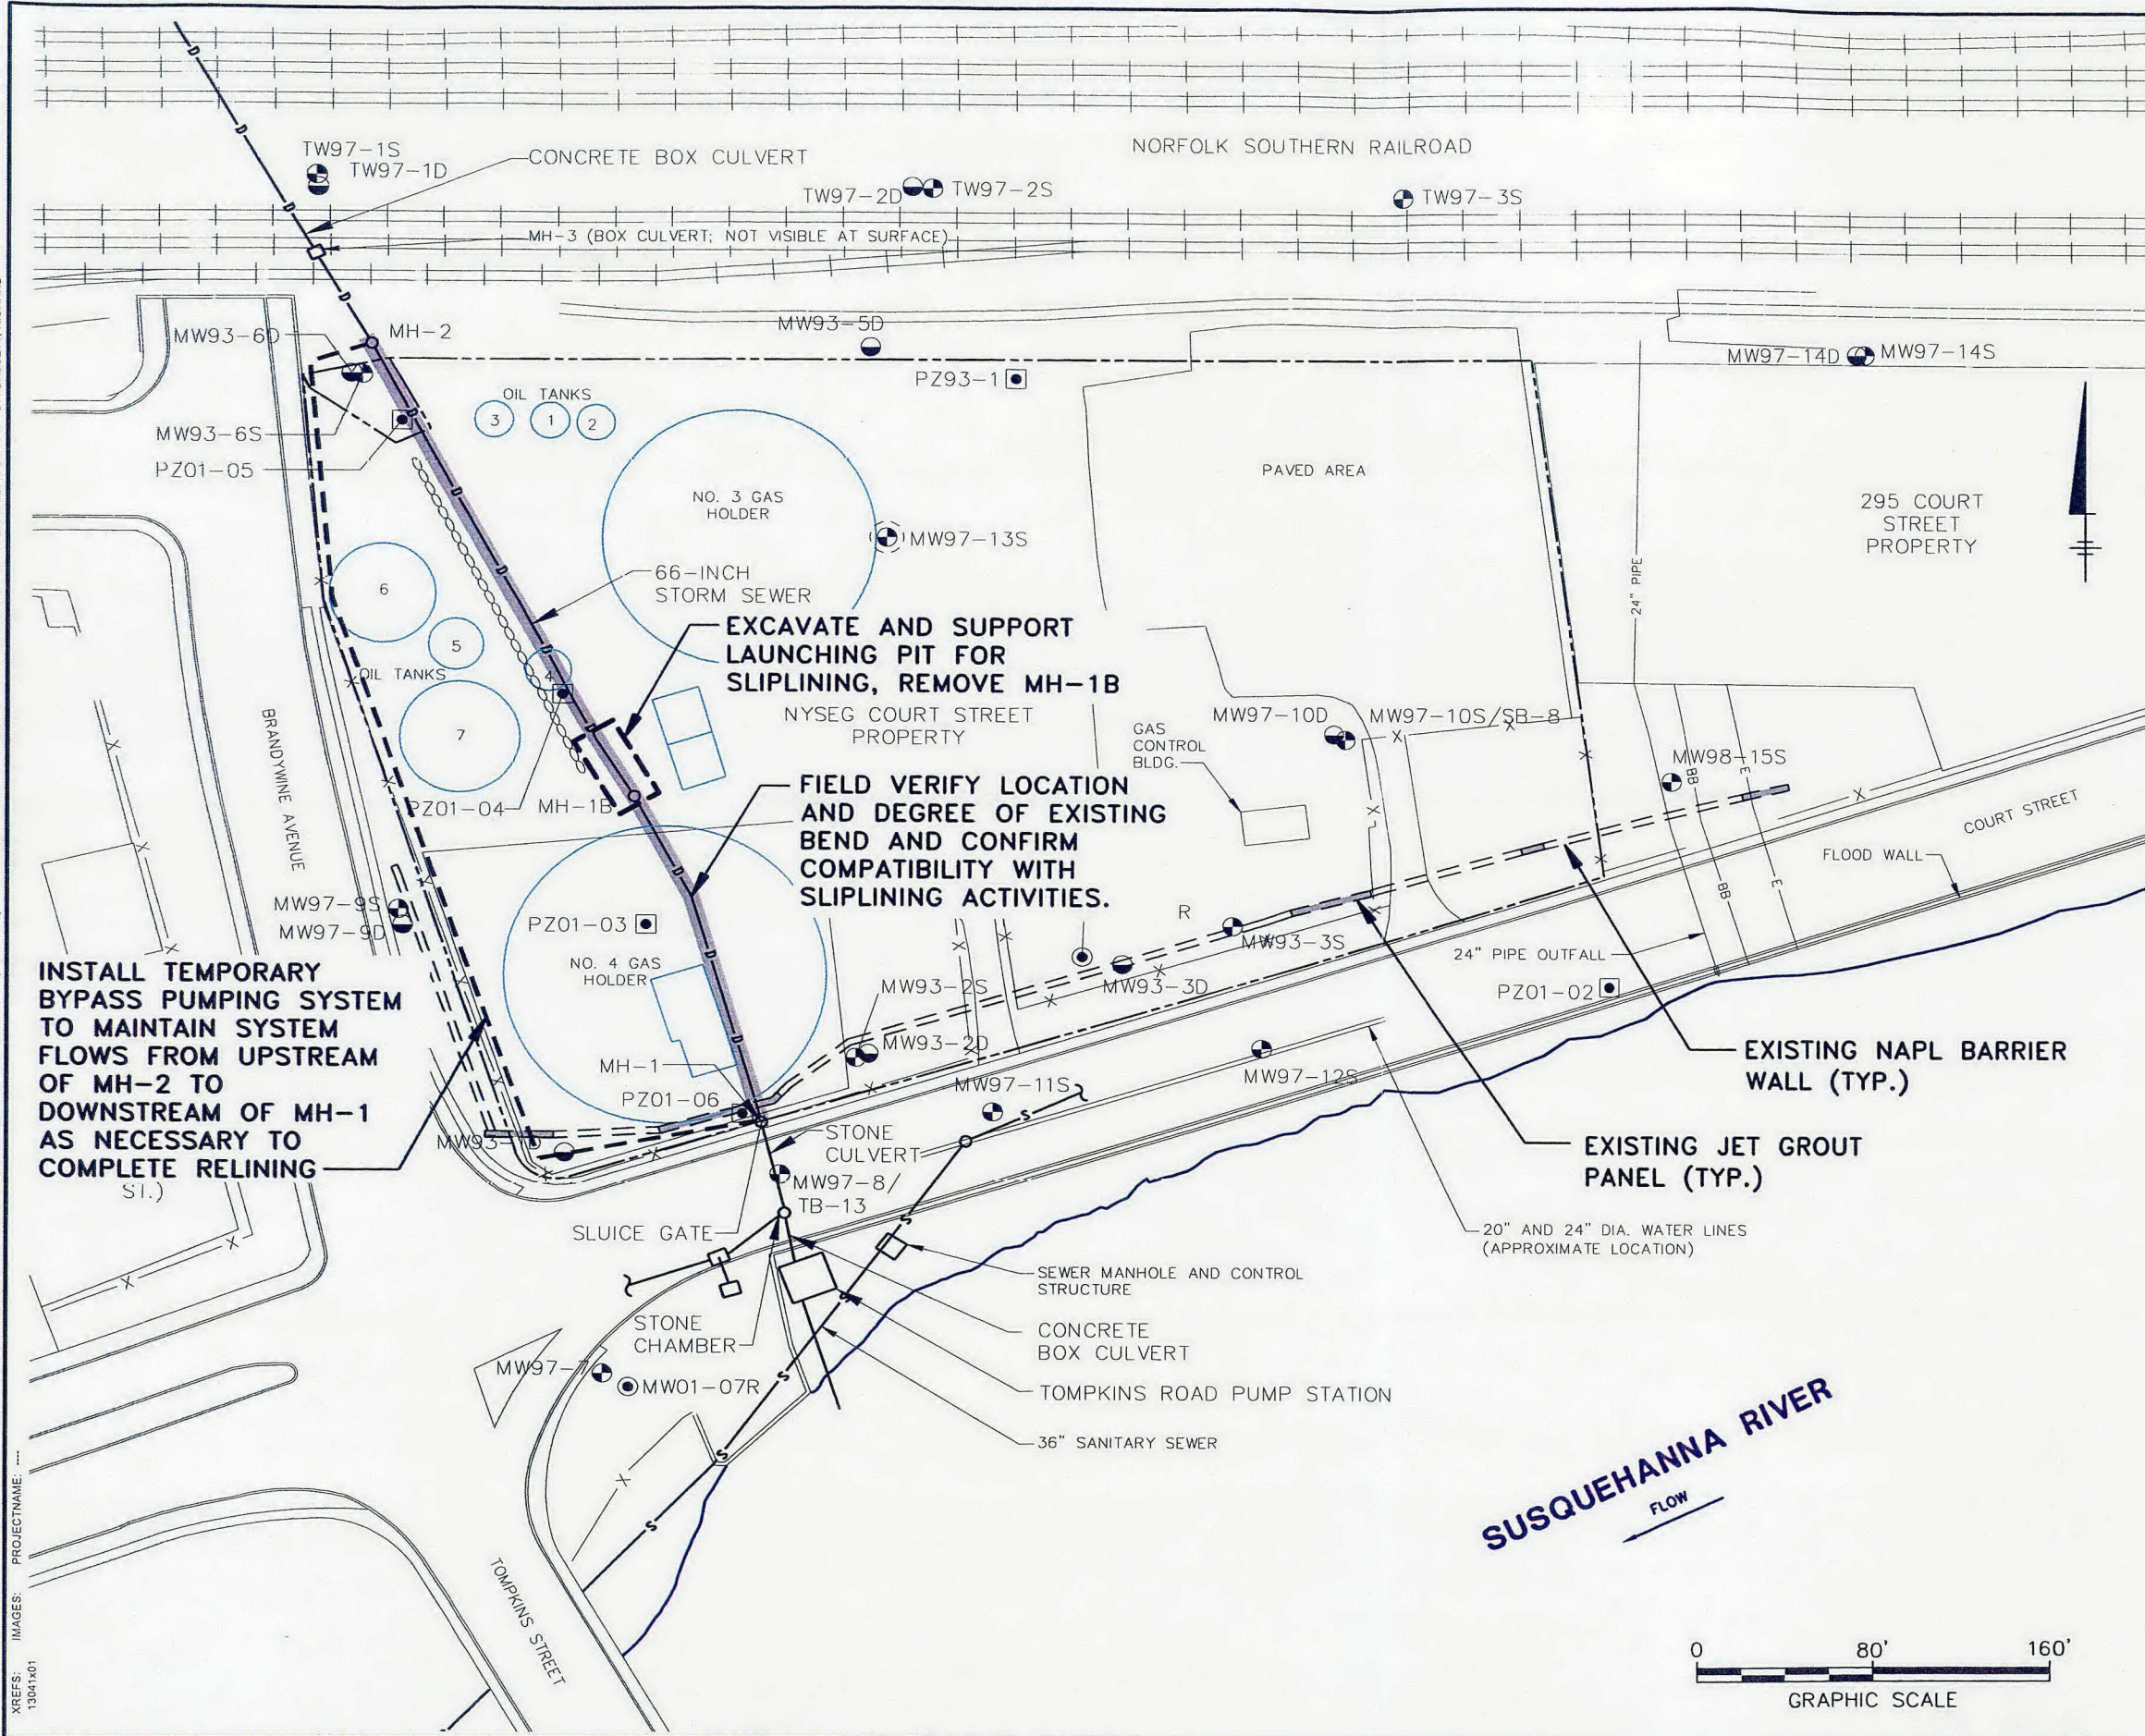
FIGURE
2

**SLIPLINING OF EXISTING
STORM SEWER PIPE**

- **Option 4 - Slip-lining the Existing Storm Sewer – Retained:** This technology consists of installing a new pipe of smaller diameter is either pushed or pulled through the existing pipe. Slip-lining the existing storm sewer is an “in-pipe” rehabilitation solution which refers to a process where the new pipe is installed from a launching pit that is excavated around the existing pipe at either a bend or the midpoint of the pipe (Figure 2 presents a conceptual plan for implementation of the slip lining alternative).

Once the launching pit is excavated, the existing pipe is cut and removed to allow for new pipe sections to be lowered into place and installed in the existing pipe. A variety of materials can be utilized for this technology as described below and shown on Table 1. The main advantage of this alternative is the utilization of the existing pipe as a carrier pipe, which requires little excavation and subsequent handling of impacted soil and groundwater. However, under most applications, the carrier pipe must be cleaned prior to installation of the new pipe, and be free of flowing water during installation, both generally require bypass pumping to maintain storm water flows during the cleaning and installation process (with the exceptions described below).

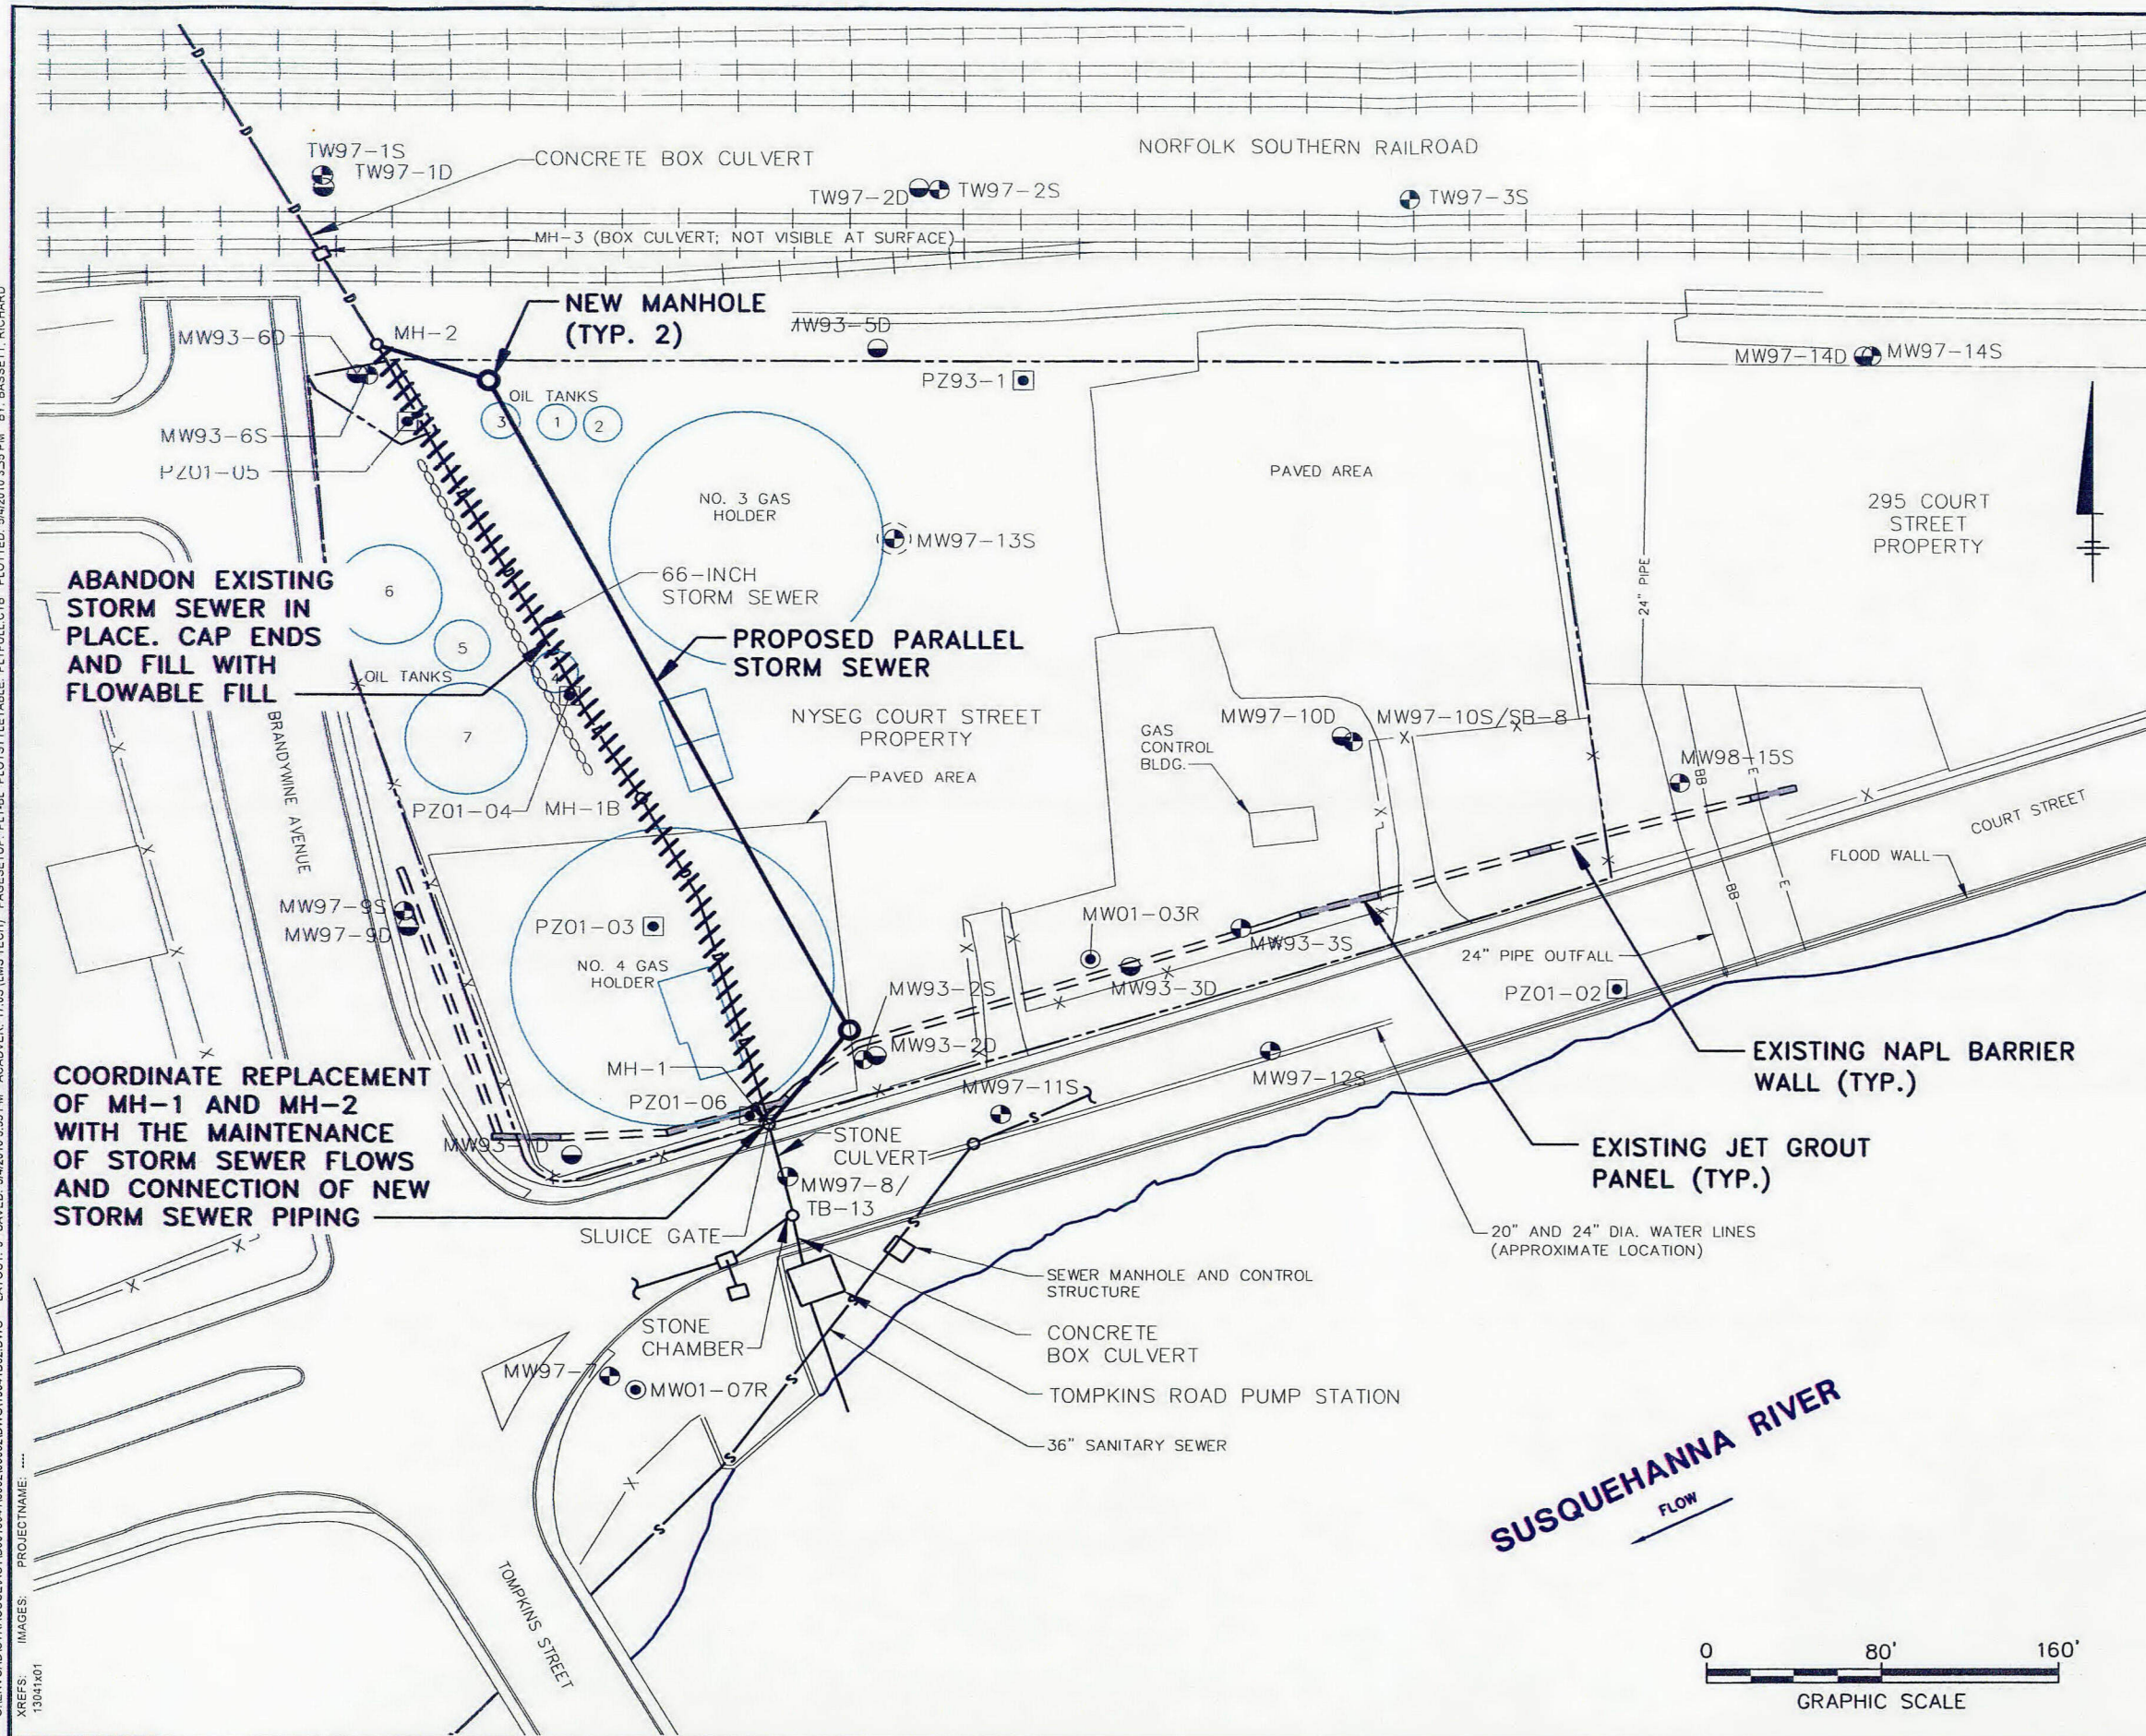
FIGURE
3

**PARALLEL STORM SEWER PIPE
INSTALLATION**

- **Option 5 - Replacement of the Existing Storm Sewer – Retained:** This technology consists of installing a new storm sewer parallel to the existing storm sewer as shown on Figure 3. The new storm sewer could be constructed while the existing storm sewer remains in service. After completion of the new storm sewer, the existing manholes at the site (MH-1 and MH-2) would be replaced with new structures and the storm sewer flows would be diverted into the new storm sewer. The existing storm sewer would be capped and abandoned in place.

An advantage of this alternative is that bypass pumping during a majority of construction is not required. The new upstream and downstream (replace MH-1 and MH-2) cast-in-place connecting structures could be built around existing manholes while the existing storm sewer remains in

service until the new storm sewer installation is completed. Two additional manholes would be required to allow for the transition of the new parallel pipe section into the existing locations of MH-1 and MH-2.
