Subject: 2020 Transloading Area Restoration Monitoring Report
NYSEG Court Street Former Manufactured Gas Plant Site
NYSDEC Site No. 7-04-031
Our Ref: 30045314.00021
Date: December 21, 2020

NYSEG
 COURT STREET FORMER MGP SITE
 BINGHAMTON, NEW YORK
**2020 TRANSLOADING AREA RESTORATION
 MONITORING REPORT**

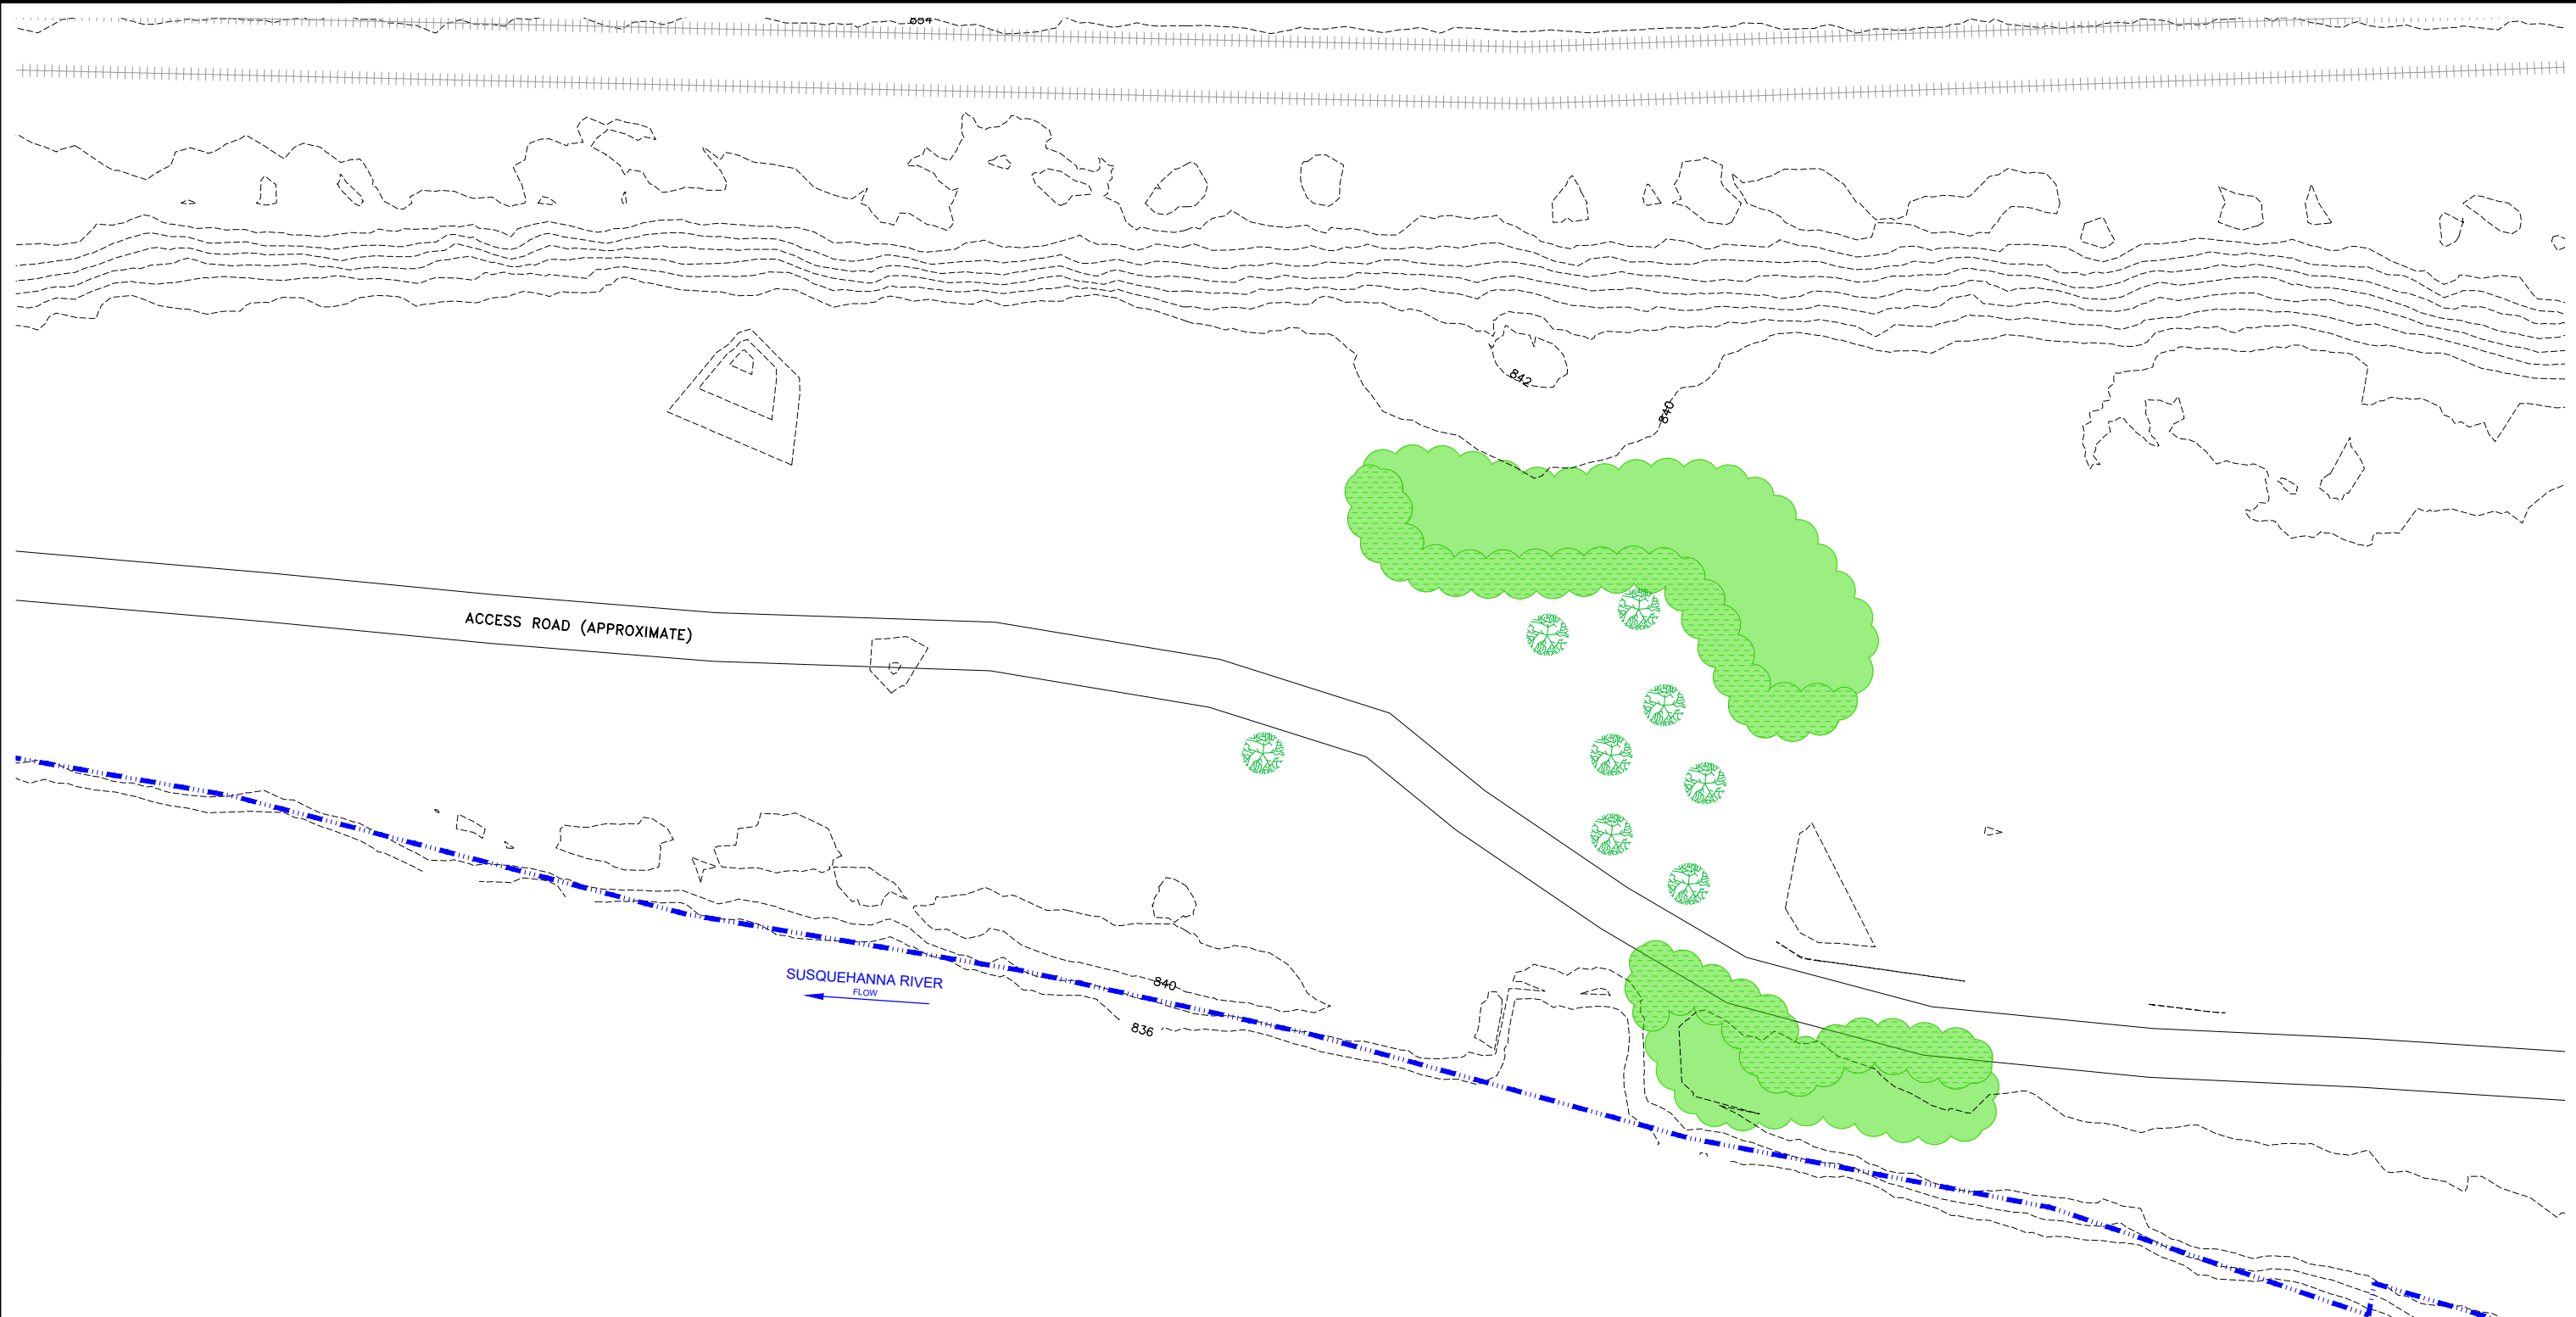
FIGURE
2

As part of the July 20, 2020 monitoring event, Arcadis (under Commercial Pesticide Applicator license # C0838939) applied herbicide (specifically Garlon3a) using backpack sprayers via foliar application to Japanese knotweed and other nuisance species found within the Transloading Area (and original Transloading Area). Individual Japanese knotweed and nuisance species were treated throughout the Transloading Area. Larger stands of previously existing Japanese knotweed surrounding the Transloading Area were sprayed to an approximate perimeter buffer of 5 feet (see Figure 1). This pre-emptive treatment was performed to control the spread of invasive species within the restored area and to meet the long-term monitoring goals for invasive species. In addition, to protect the trees planted in the original Transloading Area, herbicide was applied via backpack sprayers to treat the encroaching Japanese knotweed in this area (See Figure 2).

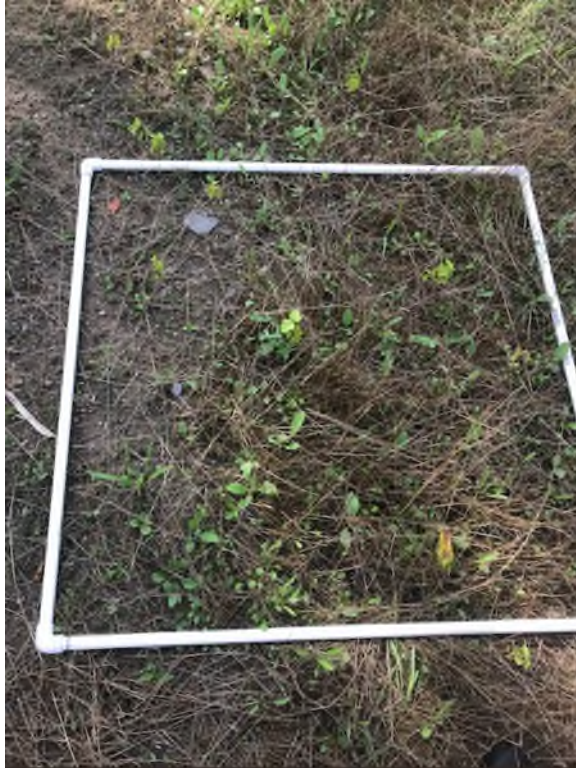
Photograph: 1

Description:
Vegetation Quadrat 1

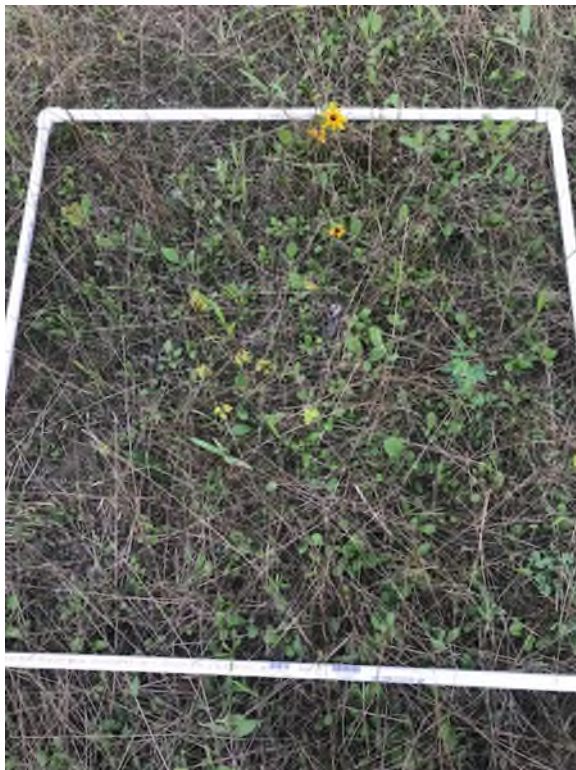
Photograph: 2

Description:
Vegetation Quadrat 1

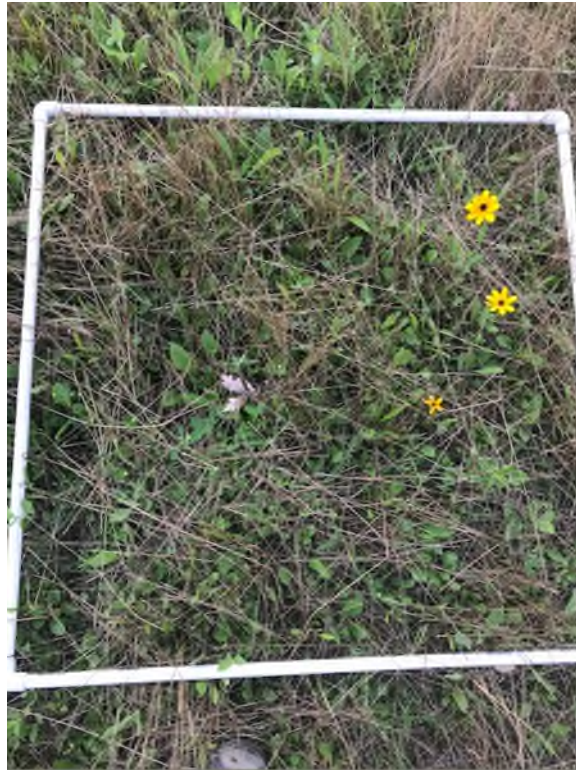
Photograph: 3

Description:
Vegetation Quadrat 3

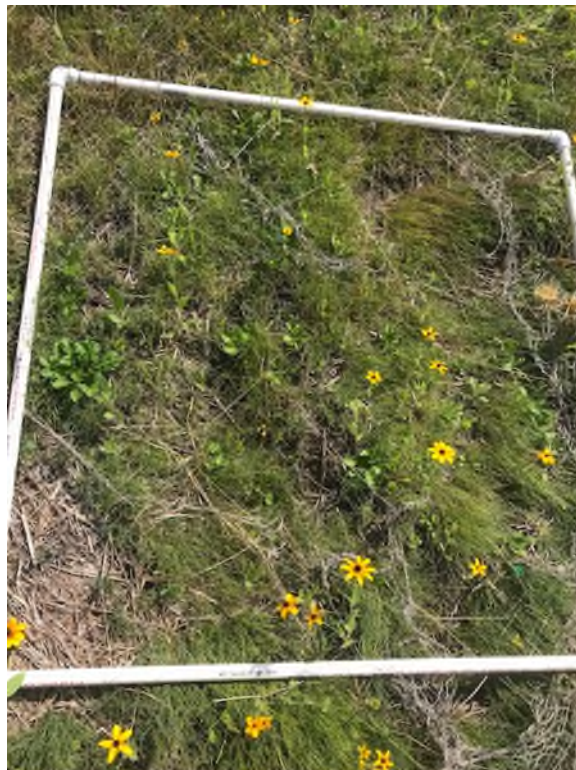
Photograph: 4

Description:
Vegetation Quadrat 4

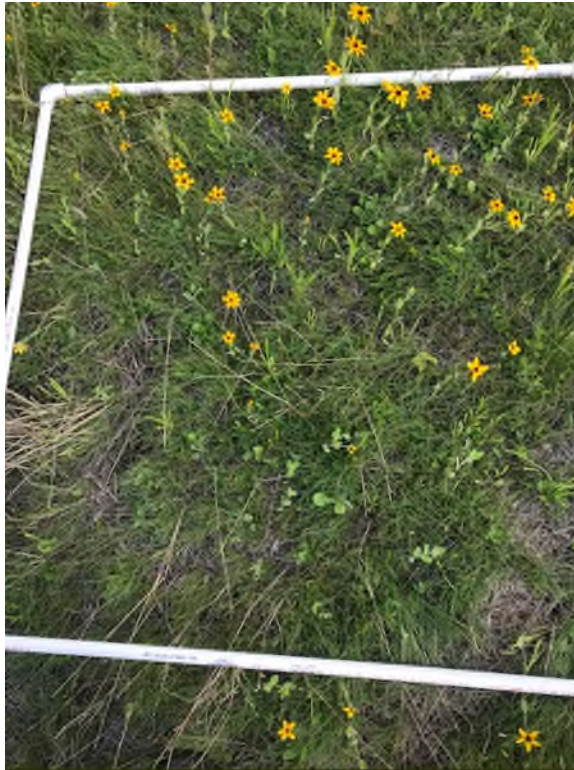
Photograph: 5

Description:
Vegetation Quadrat 5

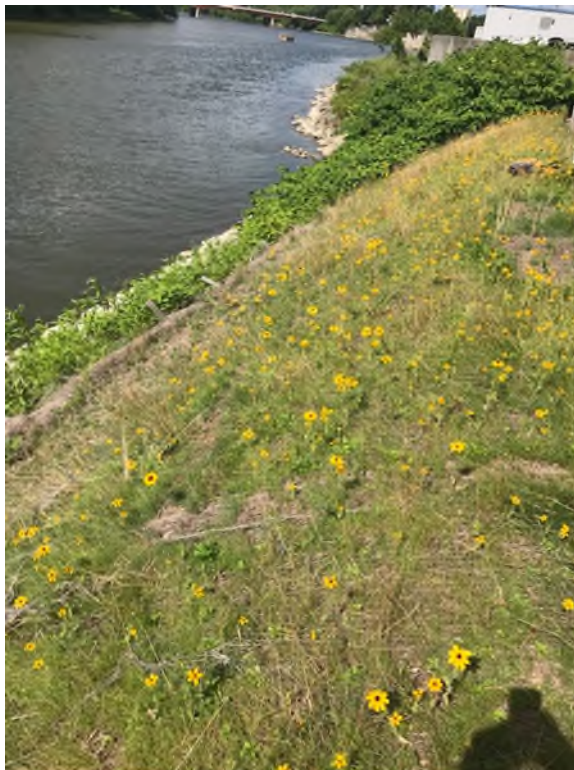
Photograph: 6

Description: Riverbank
restoration, facing
downstream

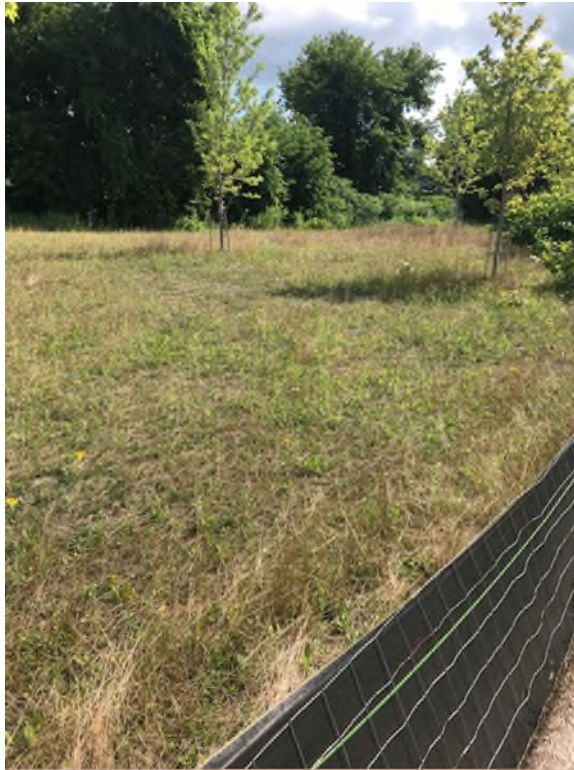
Photograph: 7

Description: Seeded portion of the Transloading Area (Upland, facing upstream/east)

Based on the herbaceous cover observed during the first assessment, on July 20, 2020, the vegetative cover in the main upland area was slightly below the 85% performance criteria. Overseeding was completed in September using a grass seed mix. Arcadis inspected the overseeding of the Transloading Area during the October 21, 2020 monthly bank inspection and new herbaceous groundcover was observed growing.

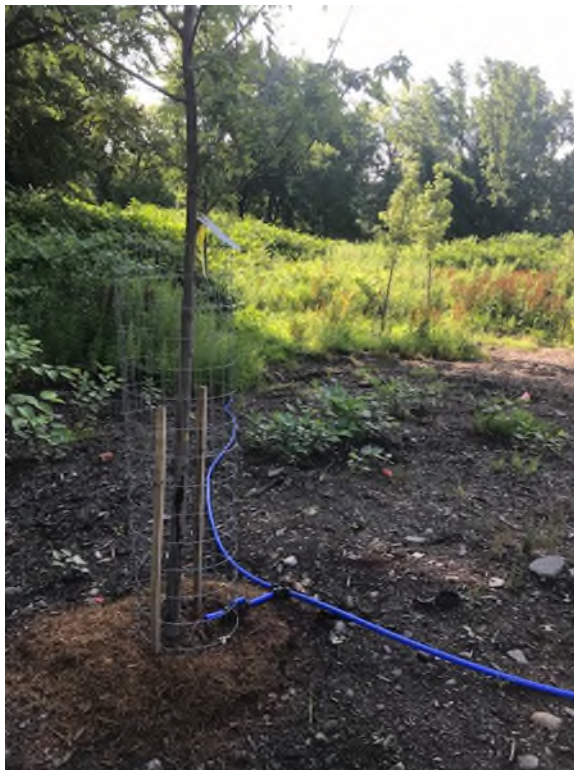
Photograph: 8

During the March 17, 2020 monthly inspection seven of the eight silver maples planted in the original Transloading Area were found to be severely damaged as a result of herbivory by beaver. These seven trees were replaced on June 8, 2020. During the June 17, 2020 monthly bank inspection, the eighth original silver maple at the original Transloading Area was found to have been damaged by herbivory. This silver maple was replanted in September. All trees at the original Transloading Area inspected during the July 20, 2020 assessment and subsequent monthly bank inspections were found to be in good health, fully leaved, with only minor signs of insect damage in the crown of one specimen.

Description: Replaced silver maple within the Original Transloading Area

As discussed above, trees that had been damaged by beavers were replaced. During replanting, wire tree cages were installed around all planted trees in the Transloading Area (and original Transloading Area) to deter herbivore activity. Additionally, trees were watered throughout the summer season.

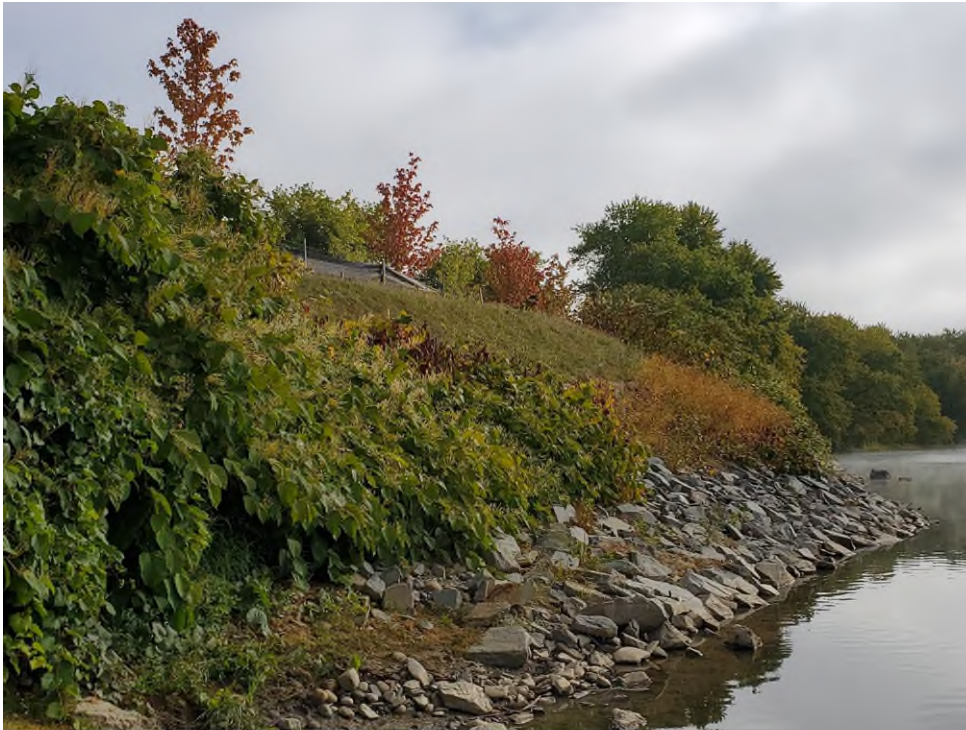
Photograph: 9

Description: Riverbank restoration facing east, upstream

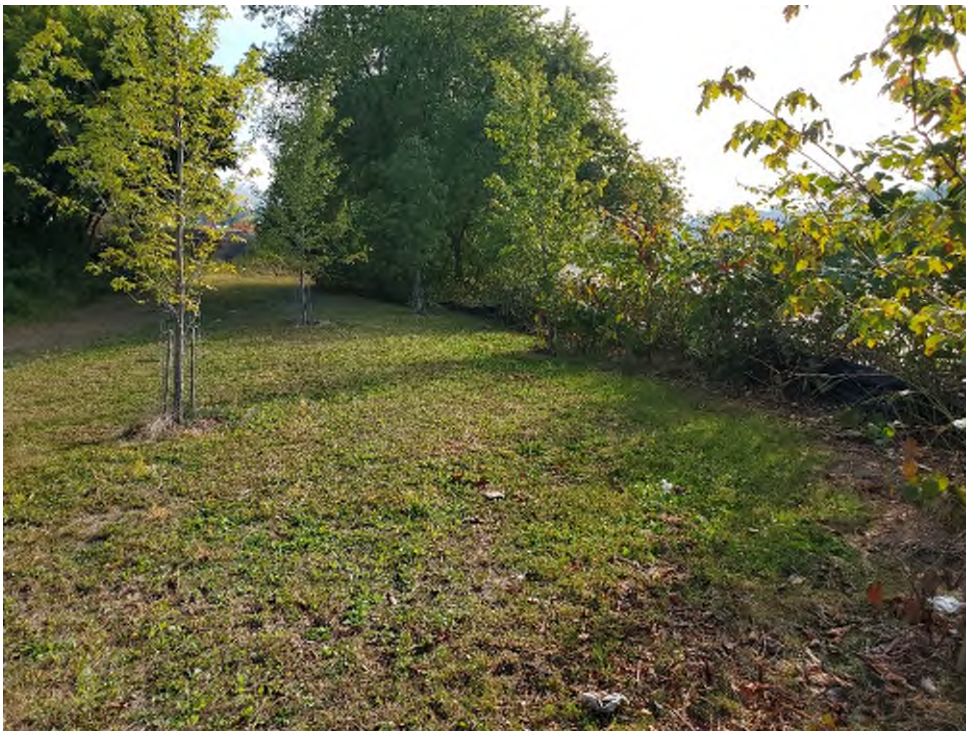
Photograph: 10

- During the September 22, 2020 monthly bank inspection, third-party maintenance mowing within the upland portion of the Transloading Area was observed. The mowing has disturbed the restored herbaceous vegetation and damaged tree bark and protective beaver cages. These conditions were discussed between NYSDEC and NYSEG in a September 29, 2020 email and follow-up telephone conversations, and it is NYSEG's understanding that mowing is completed by NYSDEC's Flood Control group
- During the November 23, 2020 monthly bank inspection, approximately 30 piles of dredge spoils were observed within the restored Transloading Area on a portion of the herbaceous vegetation area and up to the base of several restored trees. NYSEG's understands that the piles were placed by NYSDEC's Flood Control group, from the Park Creek project.

Description: Mowed upland area within the Transloading Area

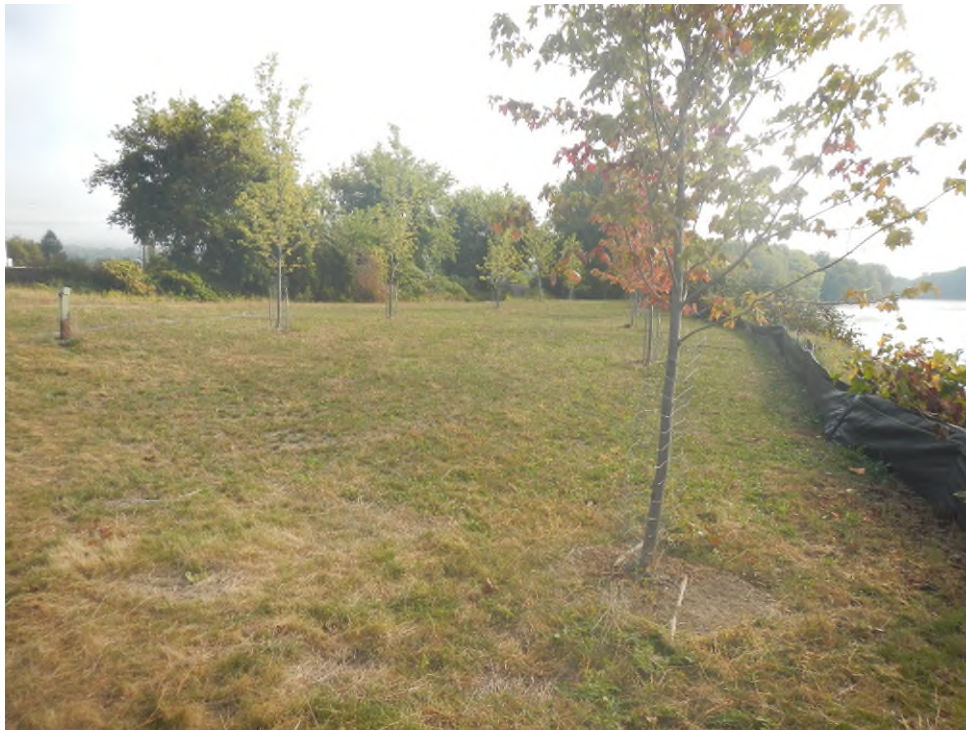
Photograph: 11

Description: Mowed upland area within the Transloading Area

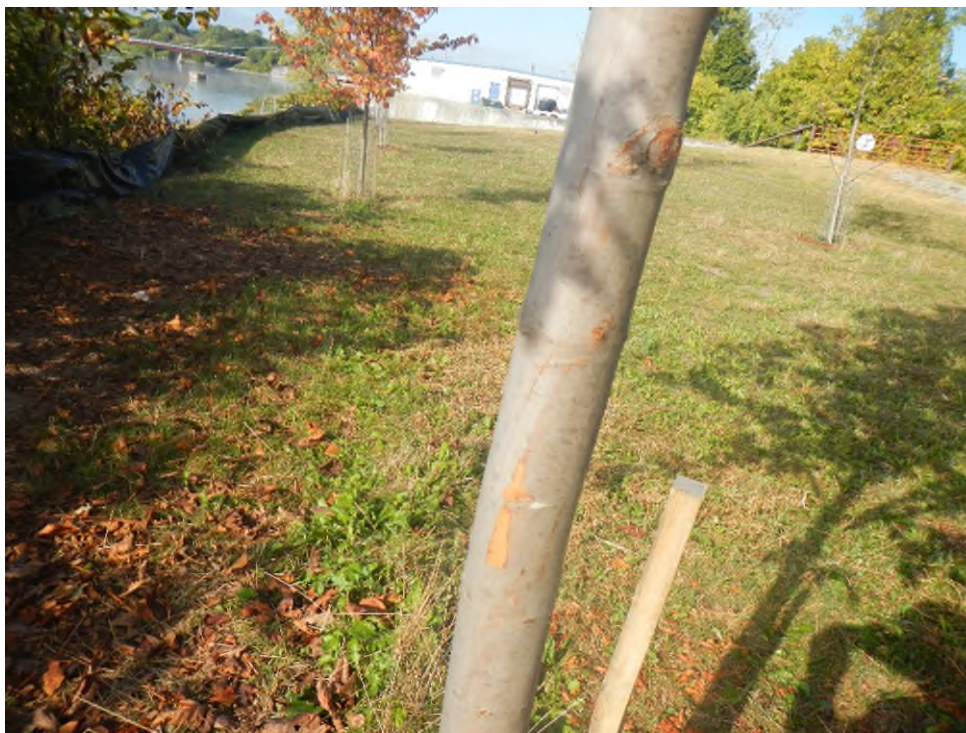
Photograph: 12

Description: Bark damage on red maple from mowing activities within the Transloading Area

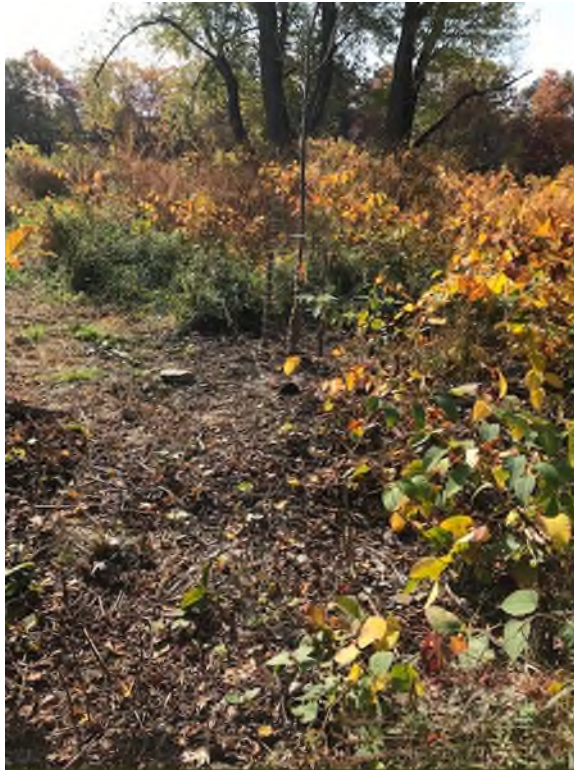
Photograph: 13

Description: Replaced silver maple tree in original transloading area

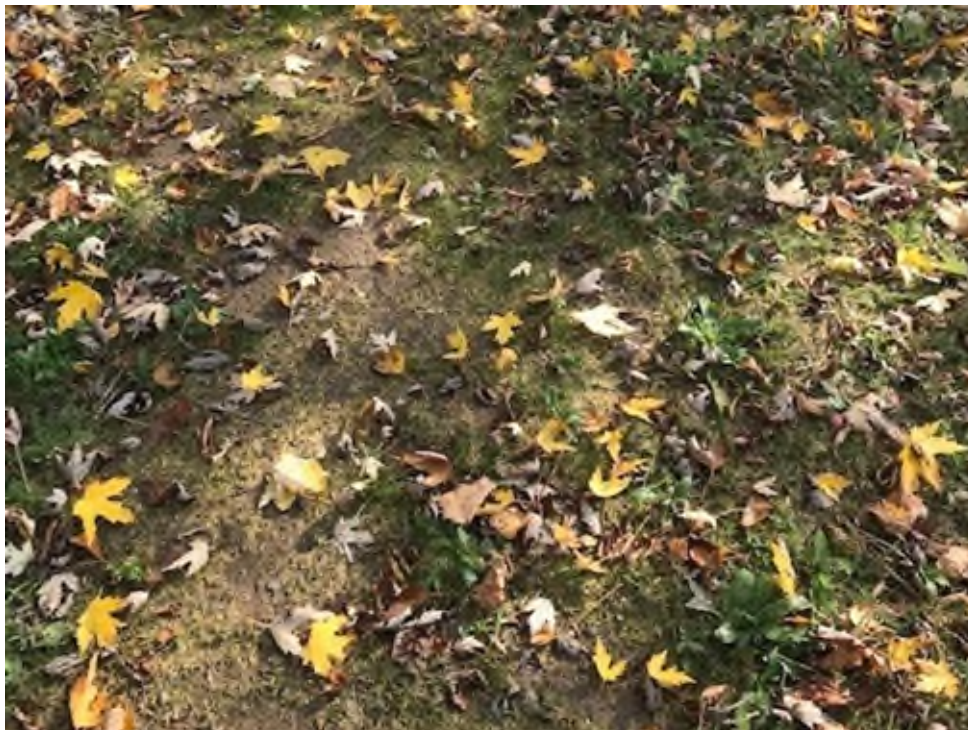
Photograph: 14

Description: Reseeded upland area within Transloading Area

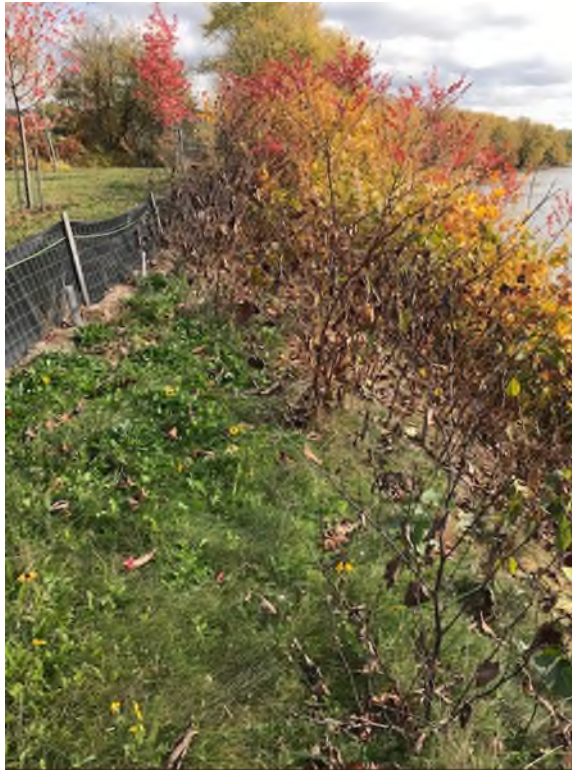
Photograph: 15

During the October 21, 2020 monthly bank inspection, increased die back and visual stress on Japanese knotweed was observed in these treated areas. Photos of the Japanese knotweed are included as part of the photograph log provided as Attachment 1.

Description: Herbicide treated bank Japanese knotweed

However, given continued encroachment of Japanese knotweed within both the bank and upland areas, Arcadis completed an additional foliar application of herbicide. On October 1, 2020, Arcadis (under Commercial Pesticide Applicator license # C0838939) applied herbicide (specifically AquaNeat) using backpack sprayers via foliar application to Japanese knotweed and other nuisance species found within the Transloading Area (and original Transloading Area). This application was conducted consistent with the first application, with additional focus on establishing a buffer between native and restored areas.

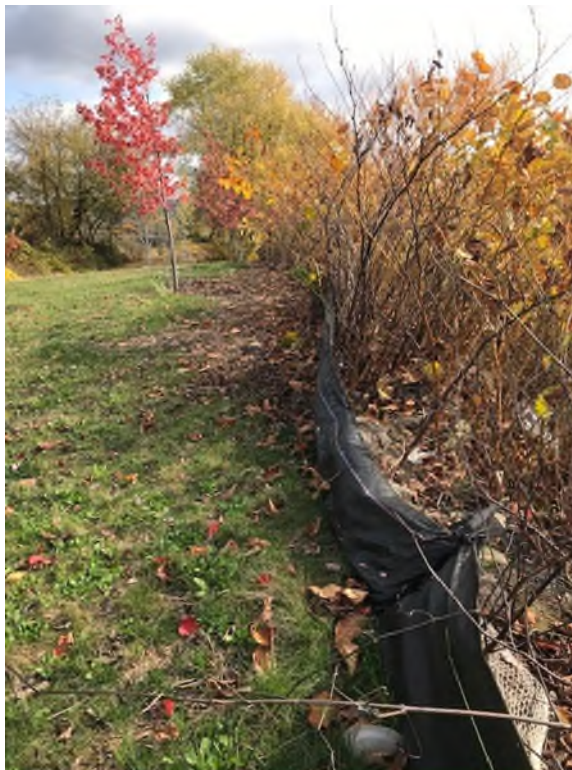
Photograph: 16

Description: Herbicide treated upland Japanese knotweed

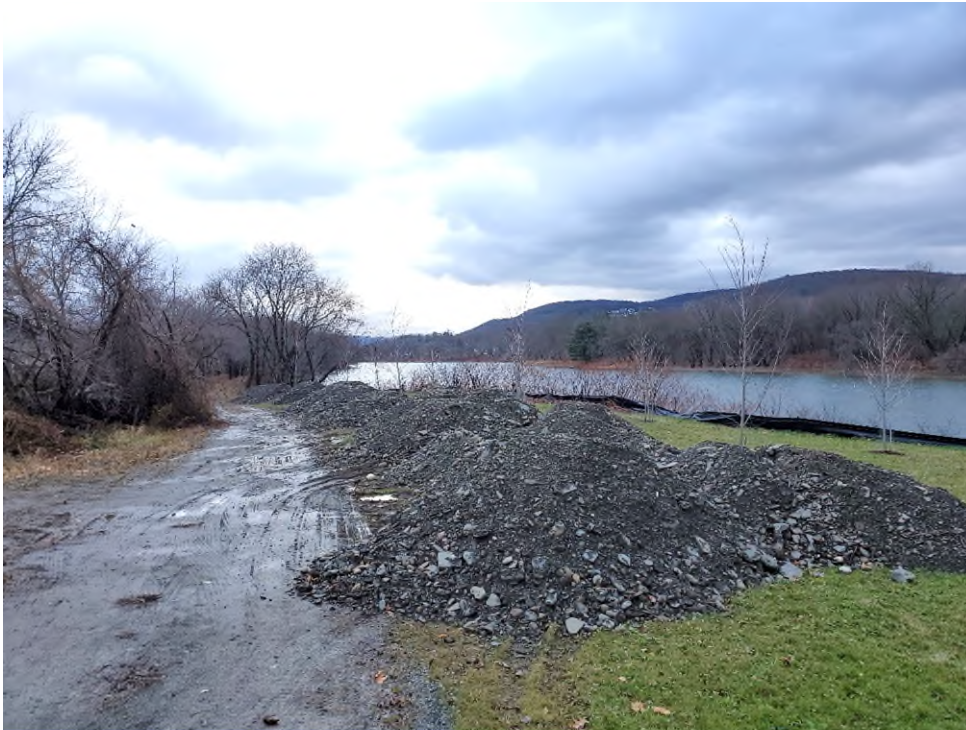
Photograph: 17

Placement (and assumed eventual removal) of dredge spoil material in the upland portion of the restored Transloading Area has likely damaged the established herbaceous vegetation. The location of the dredge spoil material immediately adjacent to newly planted trees also has the potential to affect the survivability of the trees. Please note that NYSEG will not be responsible for repairing/replacing vegetative cover or trees damaged by others (beyond NYSEG's control) and therefore, performance criteria may not be achieved in the affected areas.

Description: Dredge spoil piles in Transloading Area, facing east

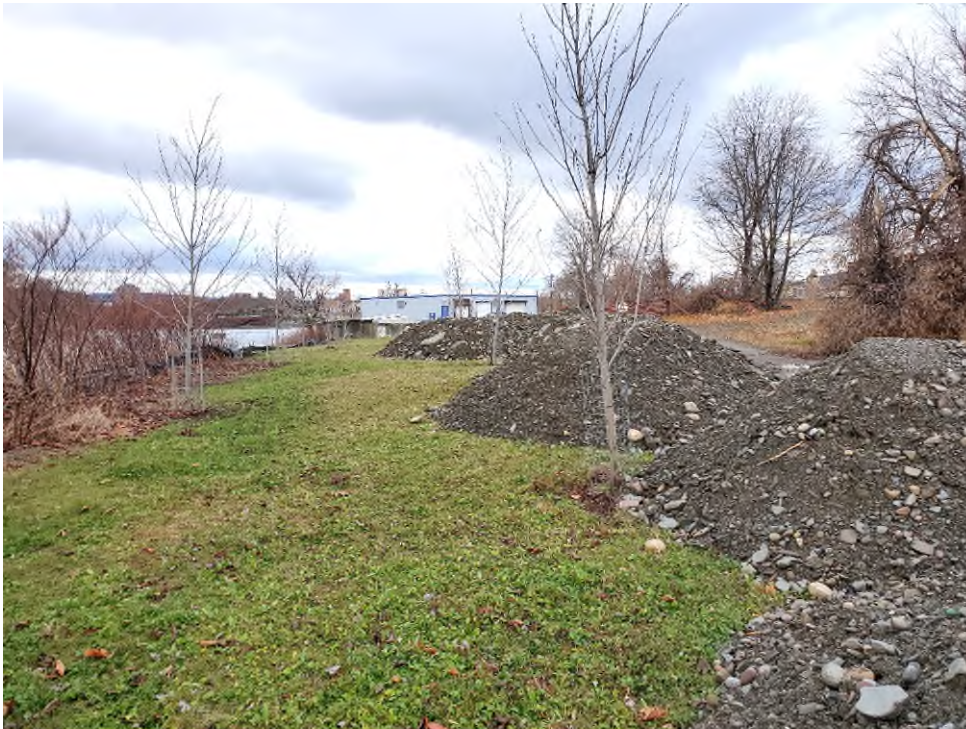
Photograph: 18

Description: Dredge spoil piles in Transloading Area, facing west
