2023 Transloading Area – Qualitative Site Inspection
NYSEG Binghamton Court Street Former Manufactured Gas Plant Site
NYSDEC Site No. 7-04-031

June 27, 2023

2023 Qualitative Site Inspection

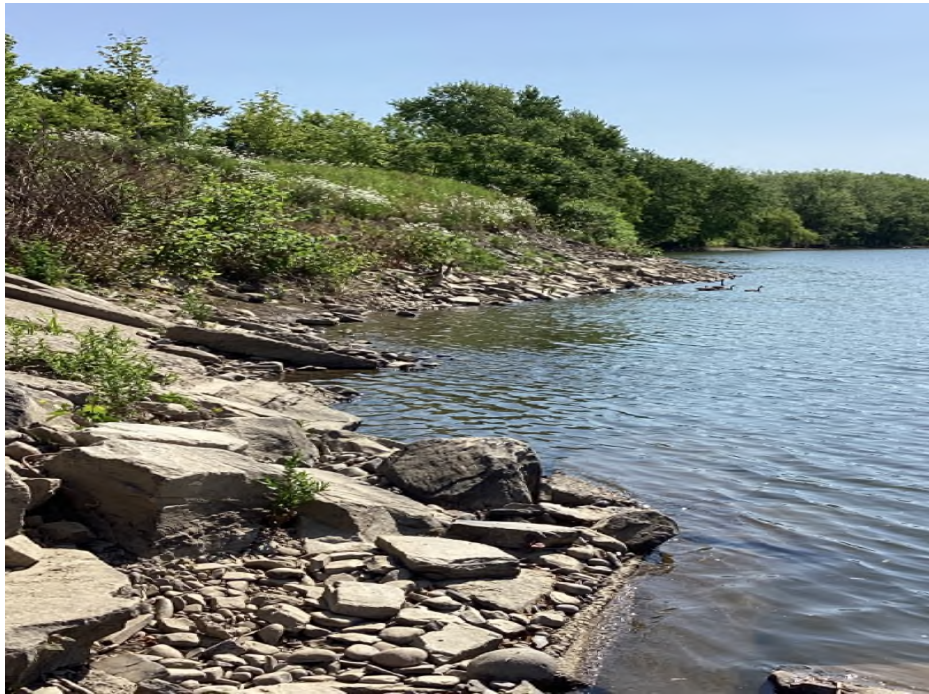
Photo: 1
Location:
Transloading Bank Area
Description:
Restored bank area.

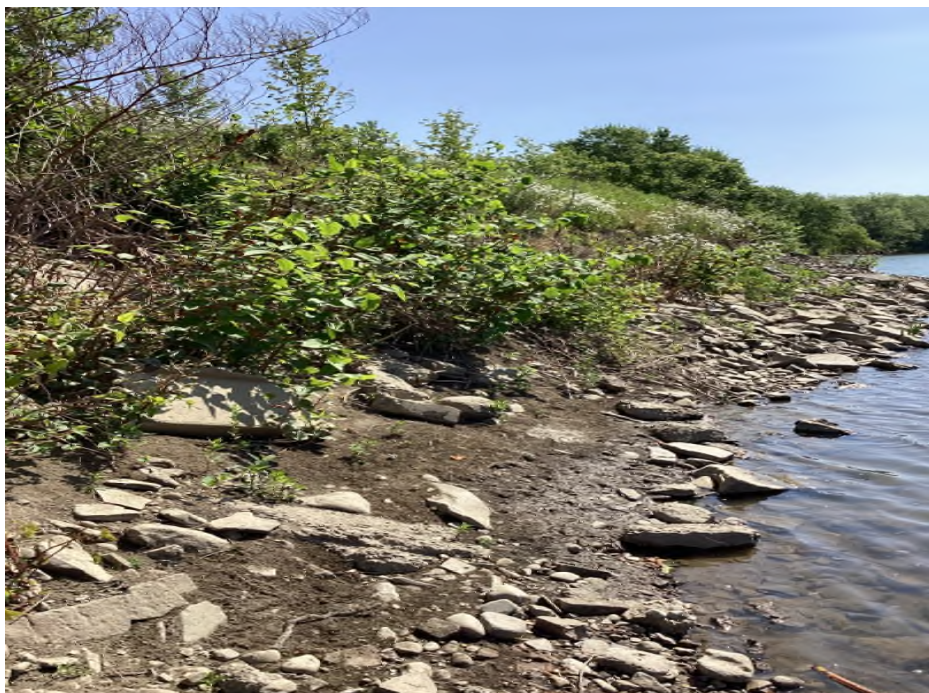
Photo: 2
Location:
Transloading Bank Area

During the May 30, 2023 visit, the spatial extent of Japanese knotweed was observed to be primarily along the margins of the lower bank and outside of restored bank area, with only a few stems found alive in the restored bank and upland area. On the downstream end of the restored bank area, the maximum height of the Japanese knotweed was approximately 7 feet (see Attachment 1, Photograph Log – Photo # 2). Sparse clumps of Japanese knotweed that were primarily less than 3 feet in height were also observed within the lower bank erosion area (see Attachment 1, Photograph Log – Photo # 7). Near the upstream end of the Transloading Area restored bank and upland area, the Japanese knotweed was either dead or stunted and remnant stalks were observed near top of bank at heights of approximately 3.5 feet (see Attachment 1, Photograph Log – Photos # 13 and # 14). In response to the treatment of Japanese knotweed, other pioneering species such as staghorn sumac (*Rhus typhina*) have established within and adjacent to the Transloading Area bank and upland areas (see Attachment 1, Photograph Log – Photo # 15).

Description:
Japanese knotweed outside downstream end of restored bank. Approximate maximum height was 7 feet.

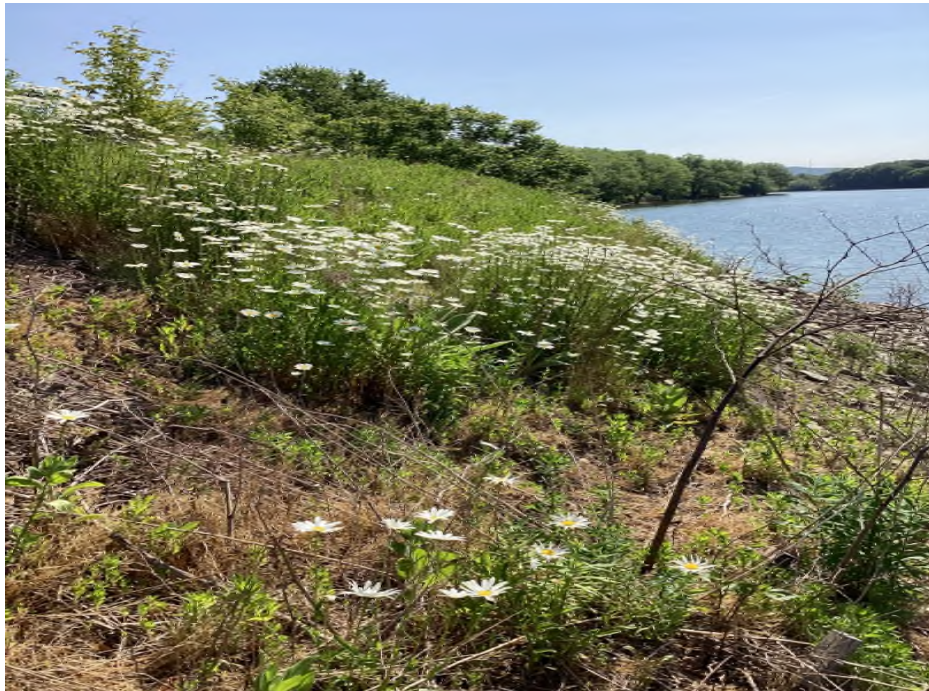
Photo: 3

Well established herbaceous ground cover was observed throughout the restored Transloading Area upland and bank areas. A mix of warm season grasses and wildflowers were present (see Attachment 1, Photograph Log – Photos # 3, # 11, and # 12). Ox-eye daisies (*Leucanthemum vulgare*) were dominant and blooming at the time of the site inspection.

Description:
Downstream end of seeded bank area.

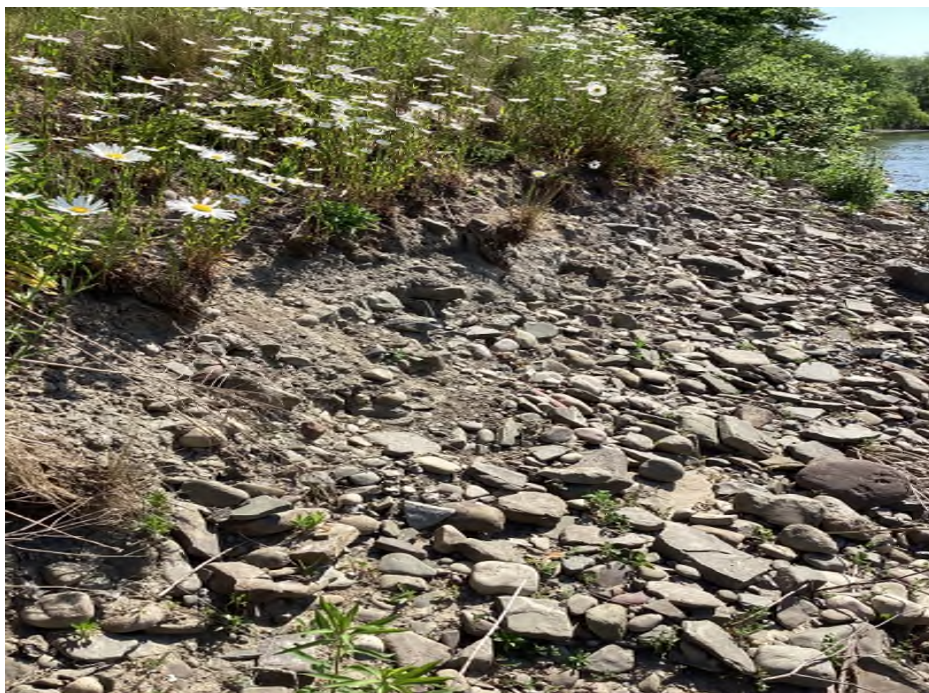
Photo: 4

Within the Transloading Area, past monitoring visits had indicated some minor erosion/sloughing in the lower bank at the upstream end of the restored bank area. During the qualitative site visit, Arcadis further characterized the linear length and range of bank height showing signs of erosion in this area. The lateral extent of the eroded bank area was measured at approximately 43.5 feet with vertical face heights ranging from 1.4 to 4.3 feet. The vegetated bank area root zone is currently helping to prevent additional sloughing. Representative photographs showing the Transloading Area bank and lower bank erosion area are provided in Attachment 1, Photograph Log – Photos # 4 through # 7. Since the November 2022 inspection, no significant increase in the lateral or vertical extent of the erosion was observed.

Description:
Downstream end of lower bank erosion area.

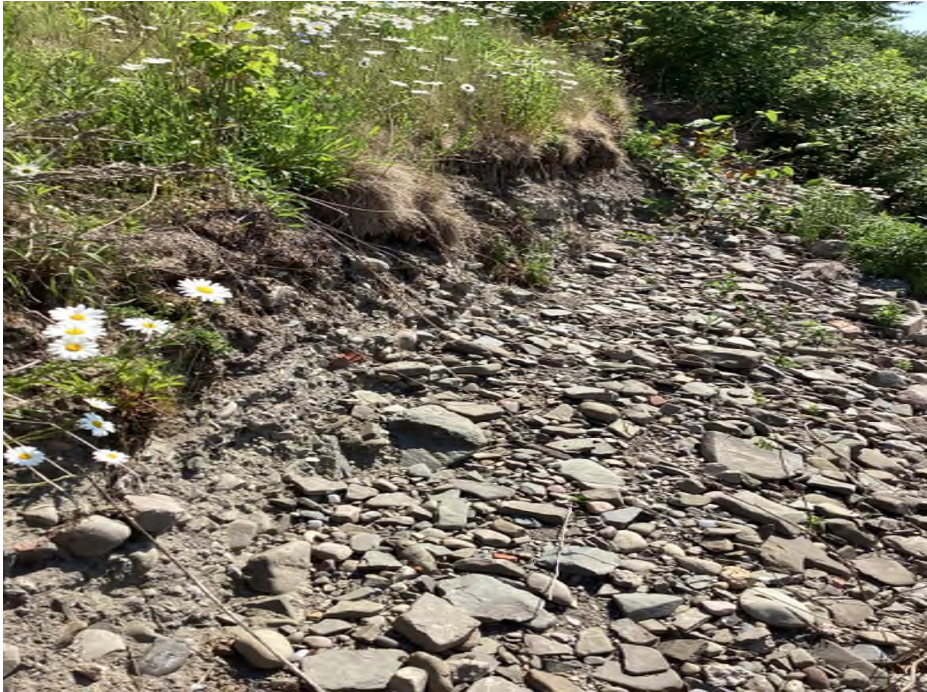
Photo: 5

Description:
Midpoint of lower bank
erosion area.

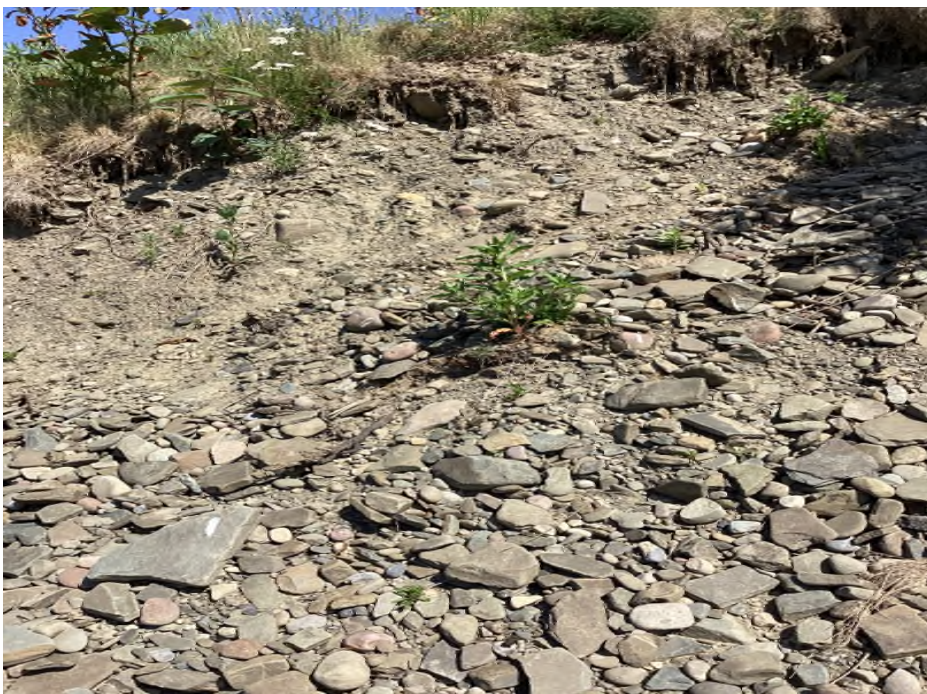
Photo: 6

Description:
Upstream end of lower bank
erosion area.

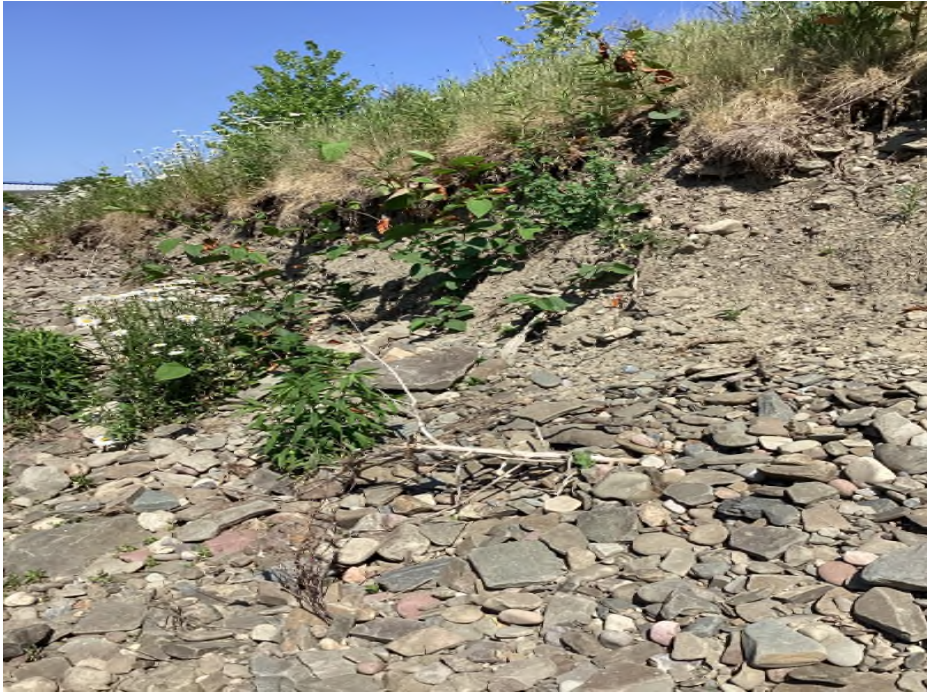
Photo: 7

Description:
Upstream end of lower bank erosion area.

Notes:
Looking northwest along extent of lower bank erosion

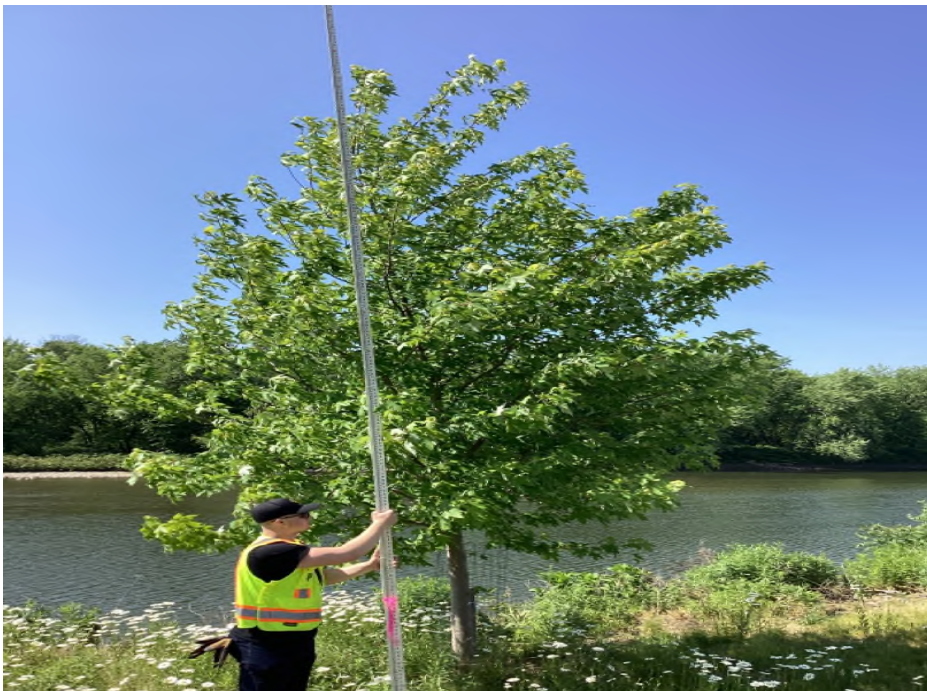
Photo: 8

Description:
Red maple height being measured with stadia rod.

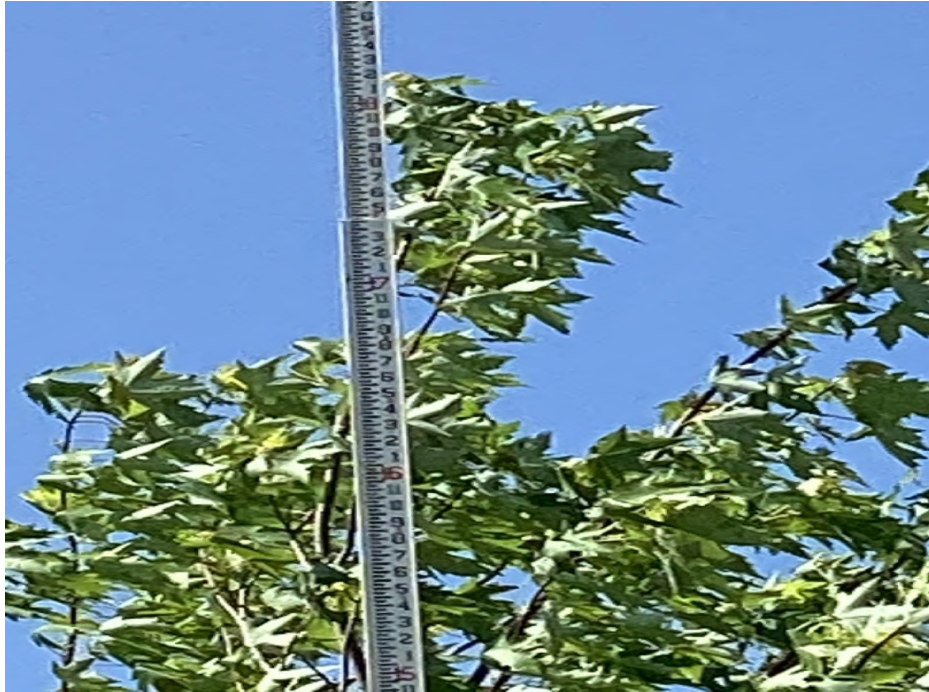
Photo: 9

Description:
Measurement at top of red maple.

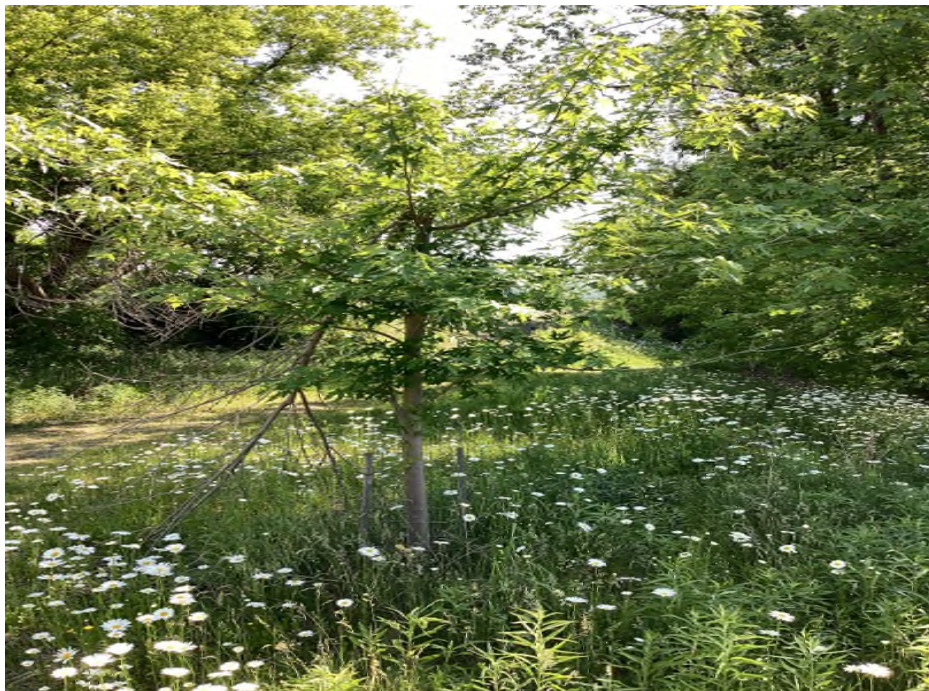
Photo: 10

The Transloading Area and original/former Transloading Area tree inspection indicated healthy specimens that were fully leaved, with no herbivore damage, tree cages intact, and no presence of red gall. One silver maple in the Transloading Area (see Attachment 1, Photograph Log – Photo # 10) had damage to its crown that was possibly caused by wind damage or other natural causes; otherwise, this specimen was healthy. Table 1 provides the tree species and approximate heights found within each area. Tree heights were estimated using a stadia rod (see Attachment 1, Photograph Log – Photos # 8 and # 9). Red maples ranged in height from 15.0 to 25.5 feet (estimated as stadia rod extent was to 25 feet). Silver maples at the Transloading Area ranged in height from 19.2 to 23.3 feet. One damaged silver maple was measured at 13.0 feet tall, however this tree is not in the immediate vicinity of any existing Japanese knotweed encroachment. Silver maples at the original/former Transloading Area ranged in height from 16.0 to 22.1 feet (see Attachment 1, Photograph Log – Photos # 16 and # 17).

Description:
Silver maple with a broken crown

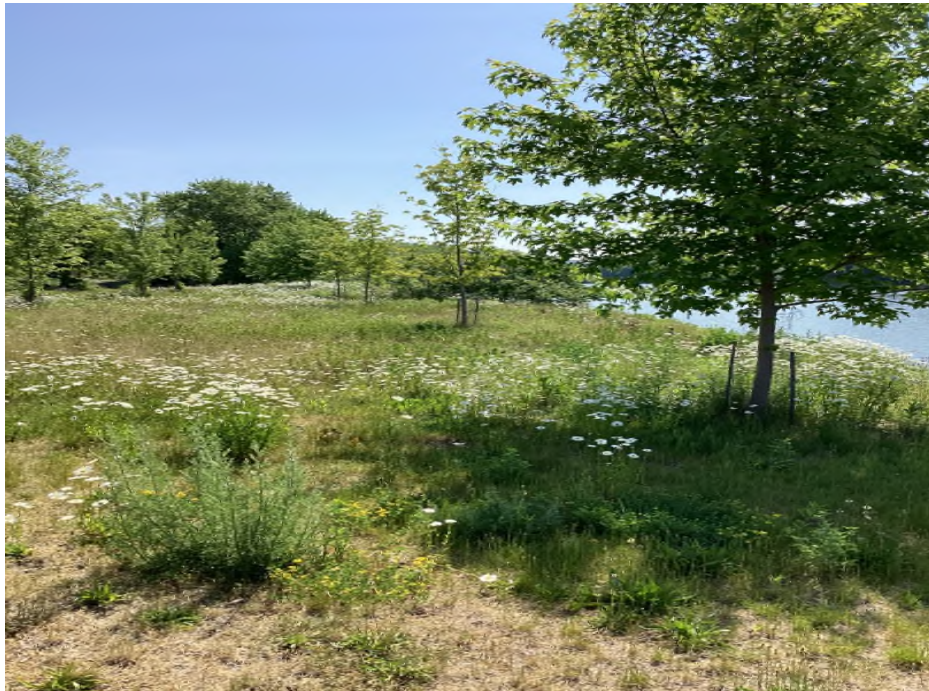
Photo: 11
Location:
Transloading Area
Description:
Top of bank and upland seeded area.

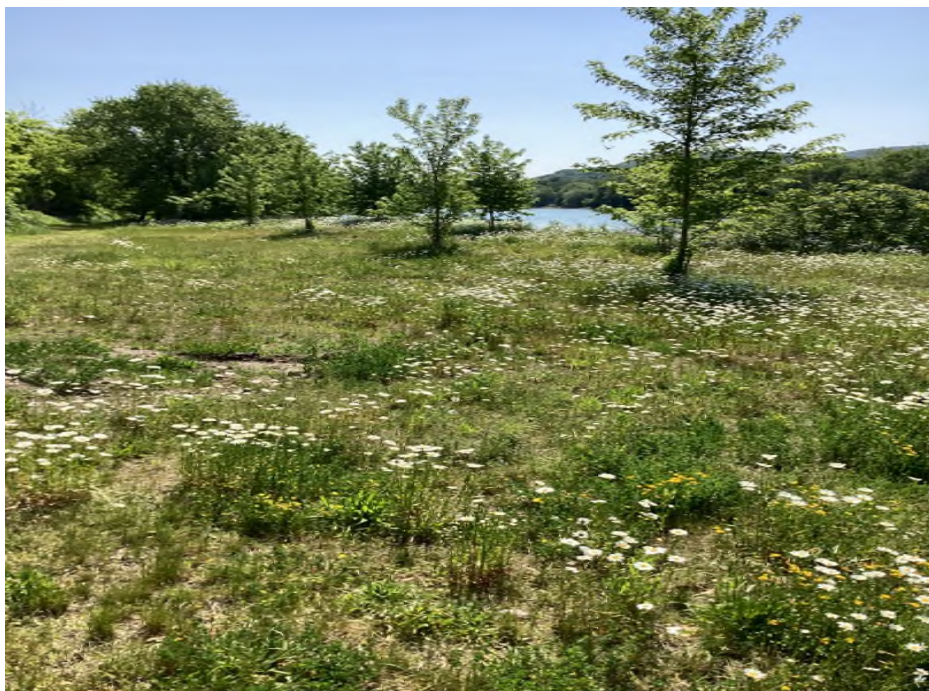
Photo: 12
Location:
Transloading area
Description:
Top of bank and upland seeded area near access road.

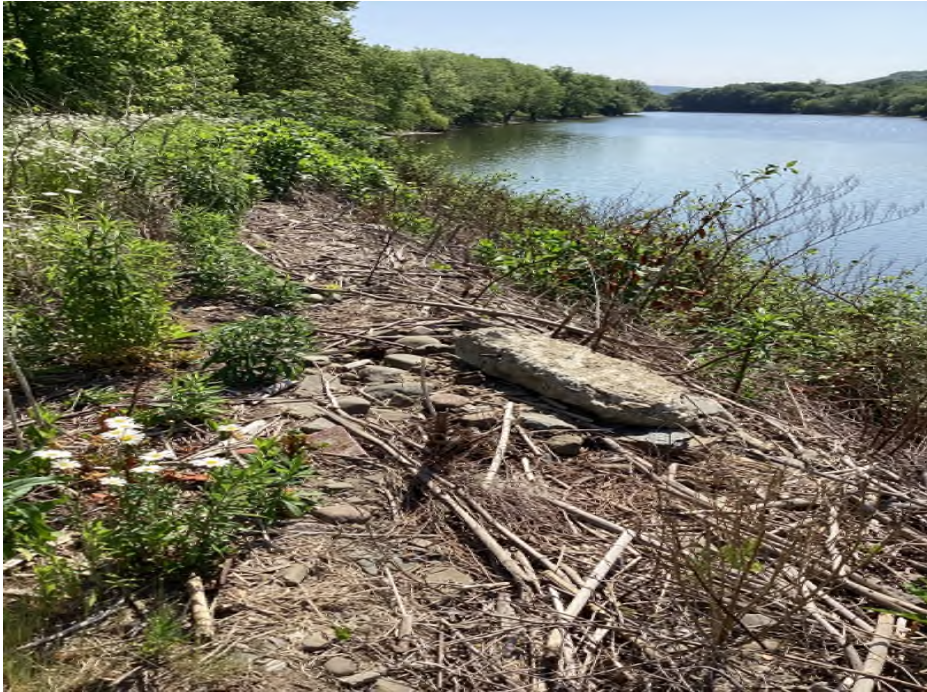
Photo: 13

Description:
Top of bank area with
previously treated knotweed.
Some remnant stalks on
lower bank.

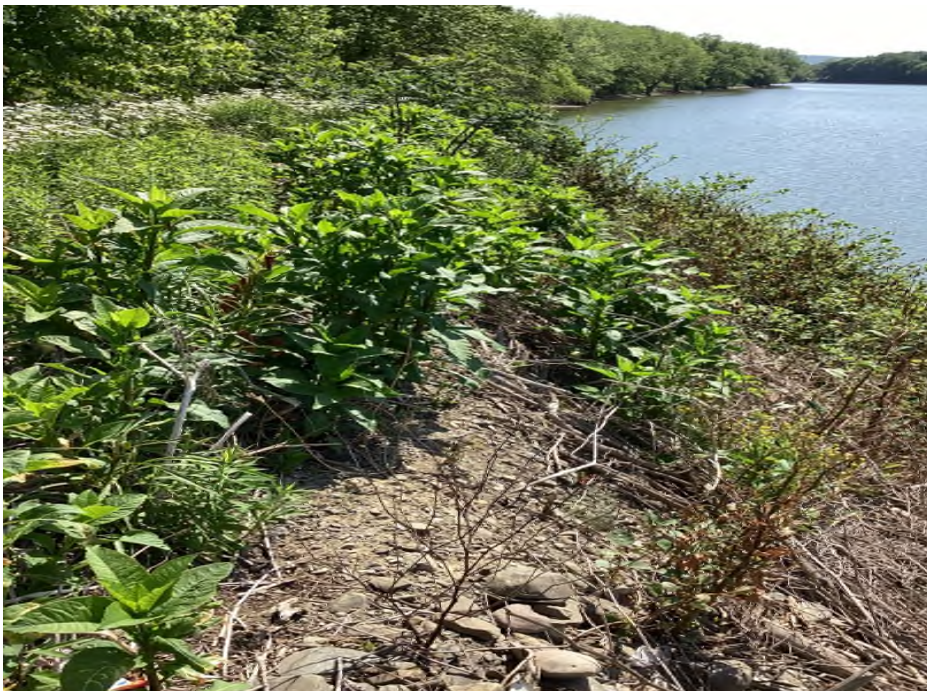
Photo: 14

Description:
Top of bank near upstream
end of restoration area.
Knotweed approximately 3.5'
tall

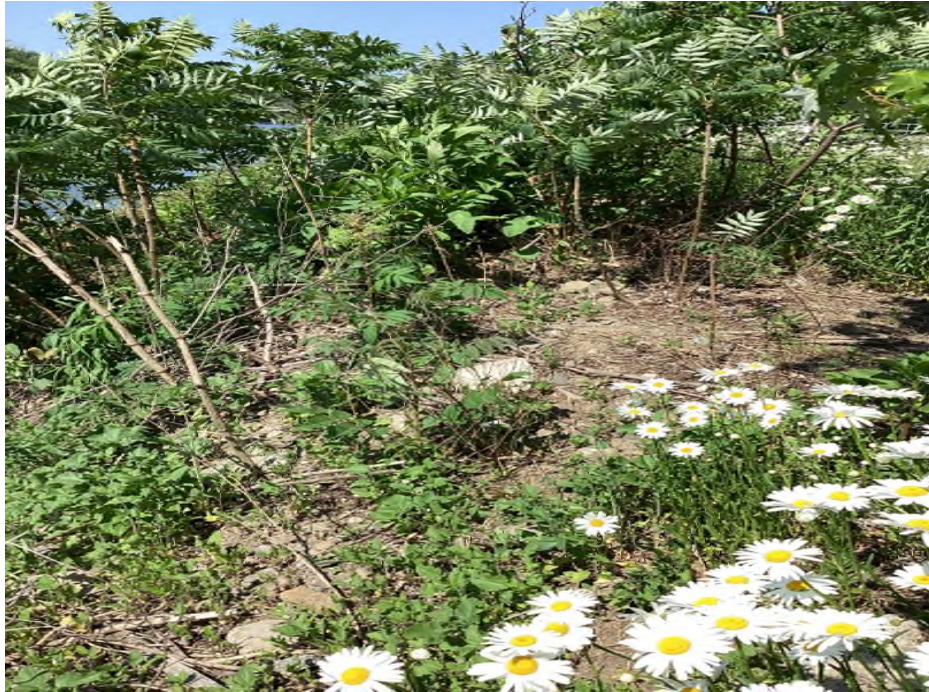
Photo: 15

Description:
Top end of bank area looking downstream to naturally recruited sumac stand.

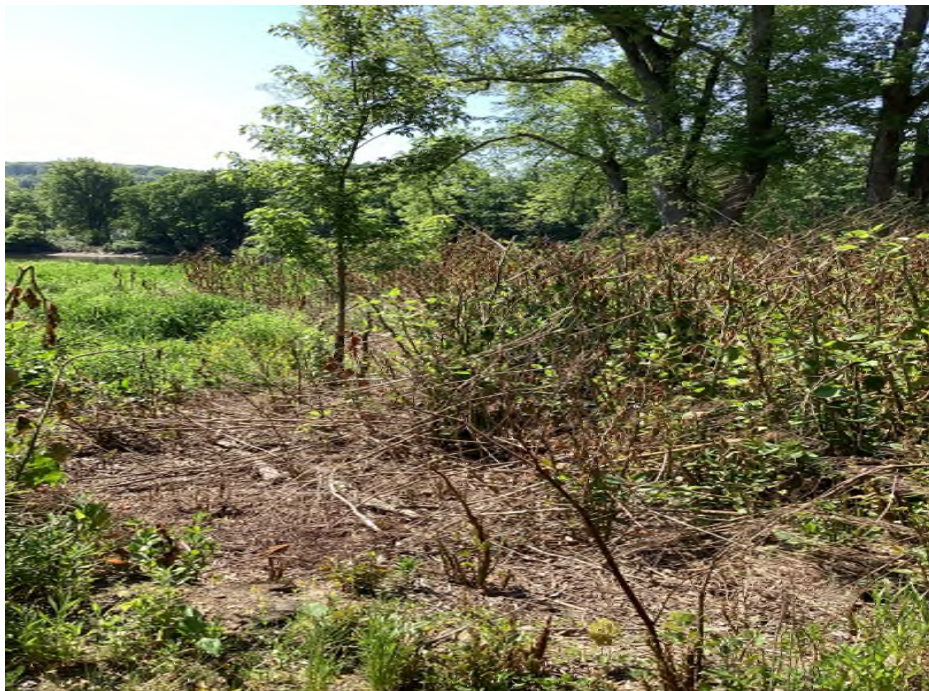
Photo: 16

In the original/former Transloading Area the Japanese knotweed was also encroaching on the silver maples. With the use of the same foliar herbicide application, the Japanese knotweed stands, adjacent to restoration areas, have largely been reduced or retreated away from the silver maples (see Attachment 1, Photograph Log – Photos # 16 through # 20). The remnant Japanese knotweed stalks that are close to the lone silver maple (as shown in Photo # 16) were approximately 3 to 5 feet in height.

Description:
Silver maple on right of access road with previously treated knotweed to the west

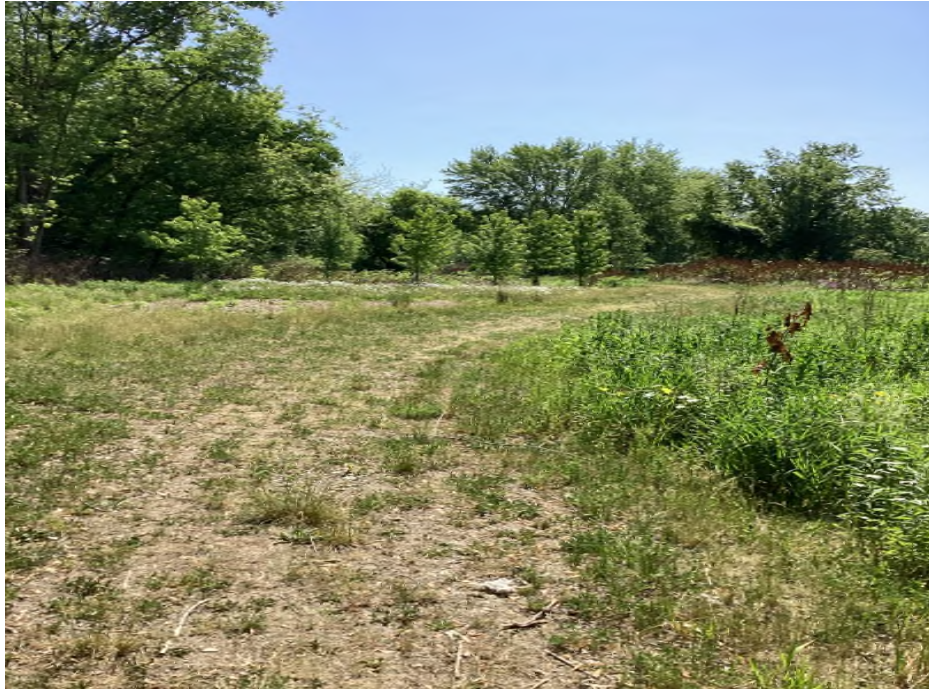
Photo: 17

Description:
Silver maples on left side of
access road.

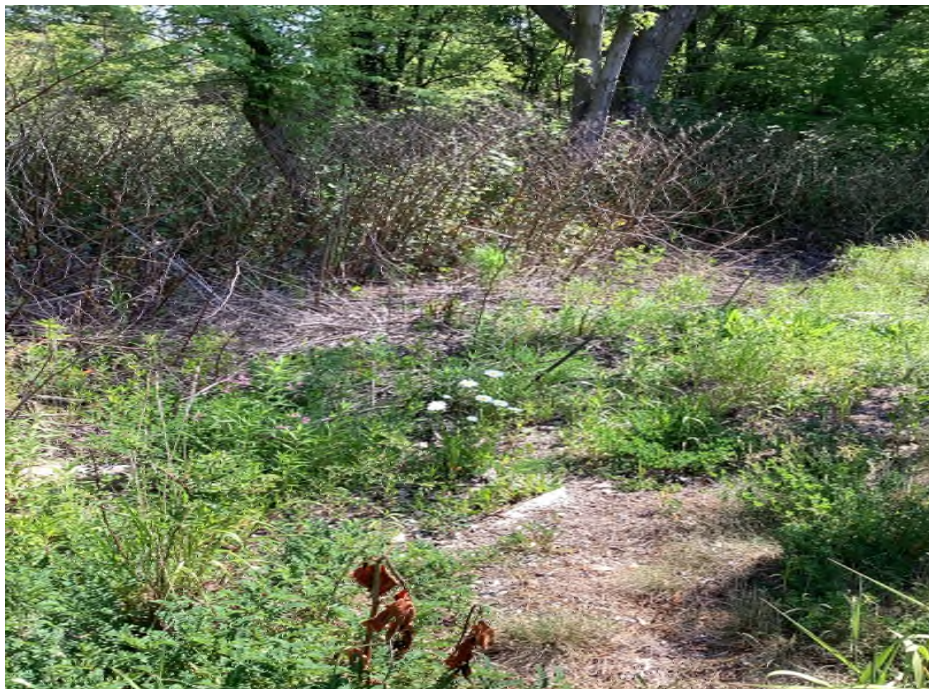
Photo: 18

Description:
Treated knotweed stand to
northwest of planted silver
maples.

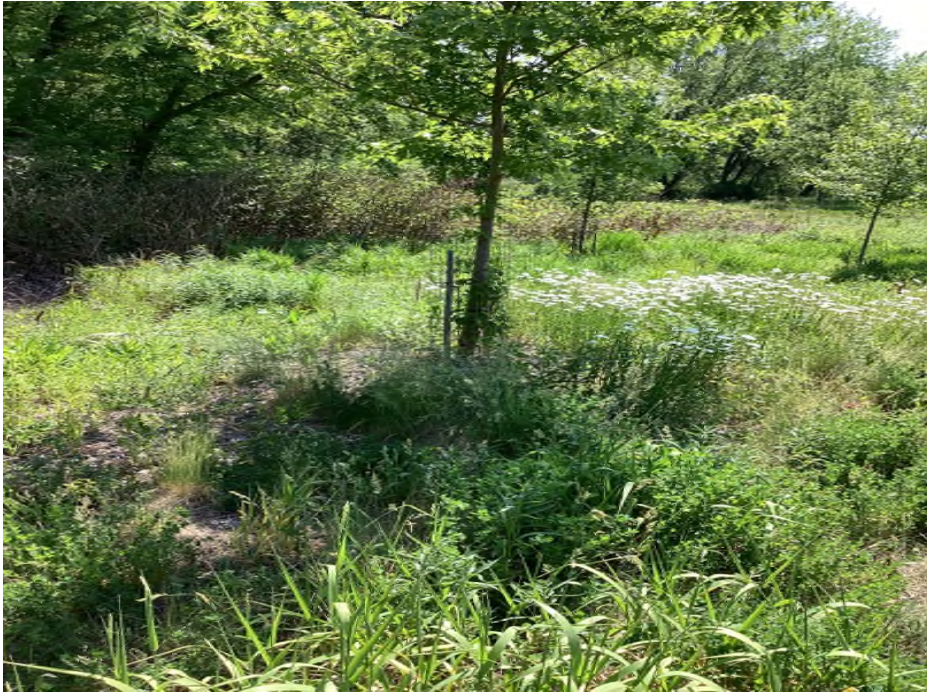
Photo: 19

Description:
Silver maple stand with
remnant treated knotweed
stand in wood line.

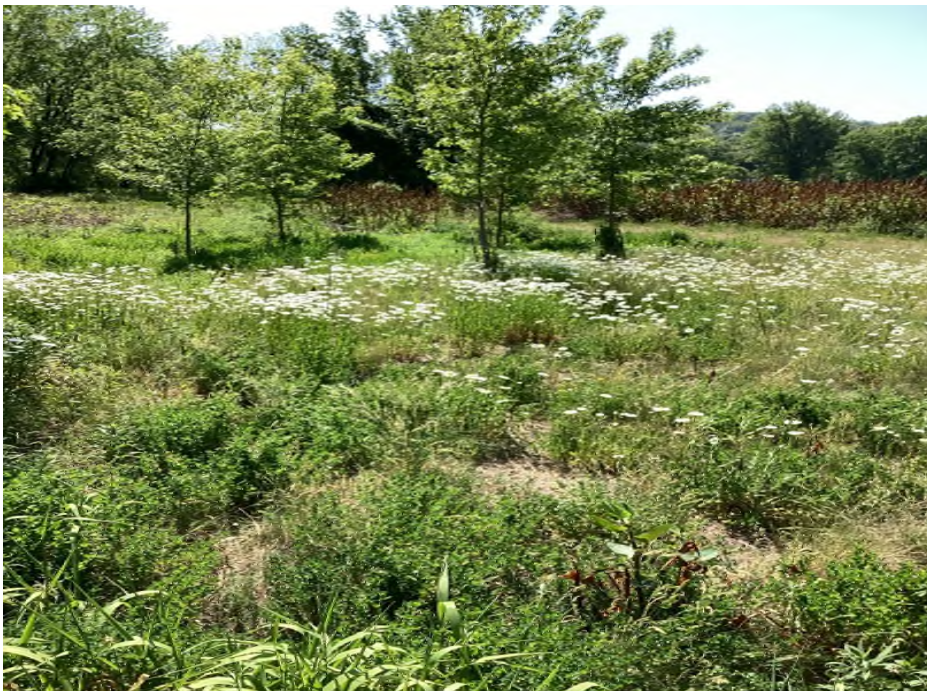
Photo: 20

Description:
Silver maple stand with
treated knotweed stand
towards river.
