Our Ref: 30178743.00038
Date: December 1, 2023
Subject: 2023 Transloading Area Restoration Monitoring Report
NYSEG Binghamton Court Street Former Manufactured Gas Plant Site
NYSDEC Site No. 7-04-031

NYSEG
COURT STREET FORMER MGP SITE
BINGHAMTON, NEW YORK
**2023 TRANSLOADING AREA RESTORATION
MONITORING REPORT**

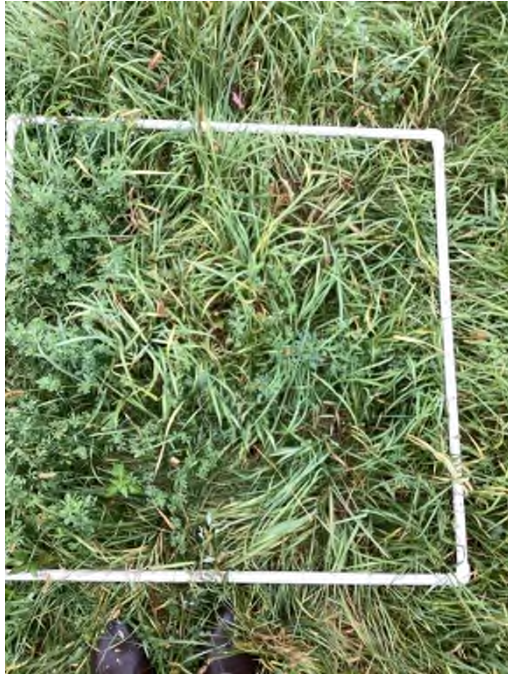
Photo: 1

Quadrat #1, Upland quadrat
(see Figure 1)

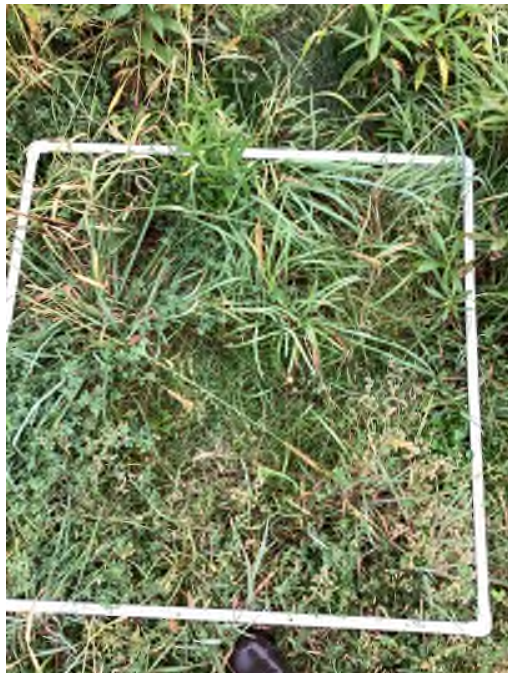
Photo: 2

Quadrat #2, Upland quadrat
(see Figure 1)

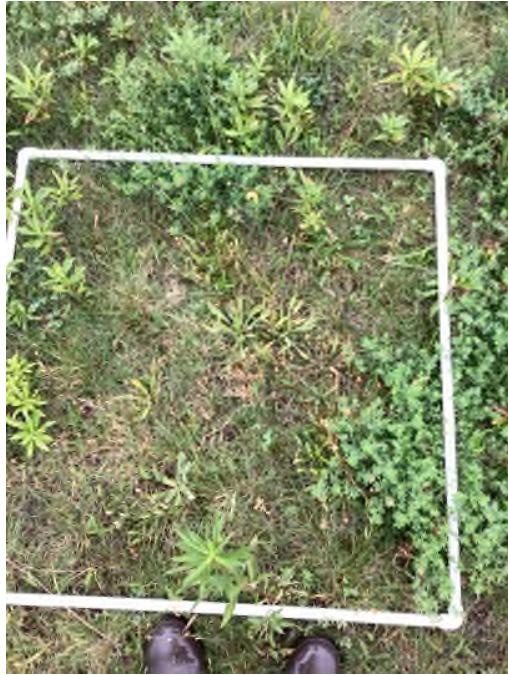
Photo: 3

Quadrat #3, Upland quadrat
(see Figure 1)

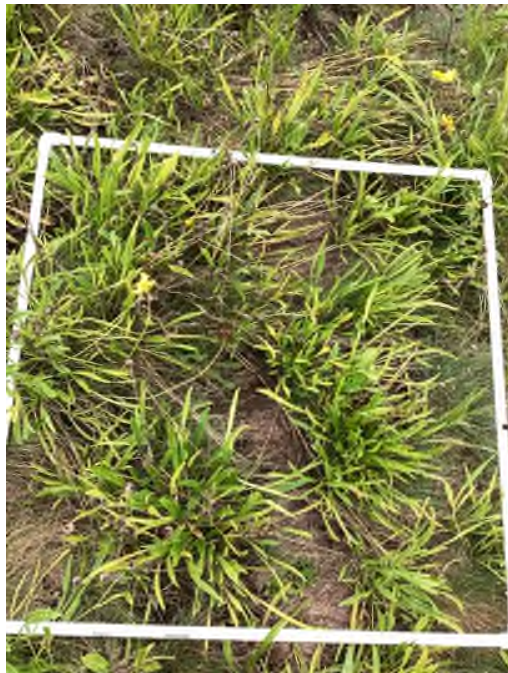
Photo: 4

Quadrat #4, Bank quadrat (see
Figure 1)

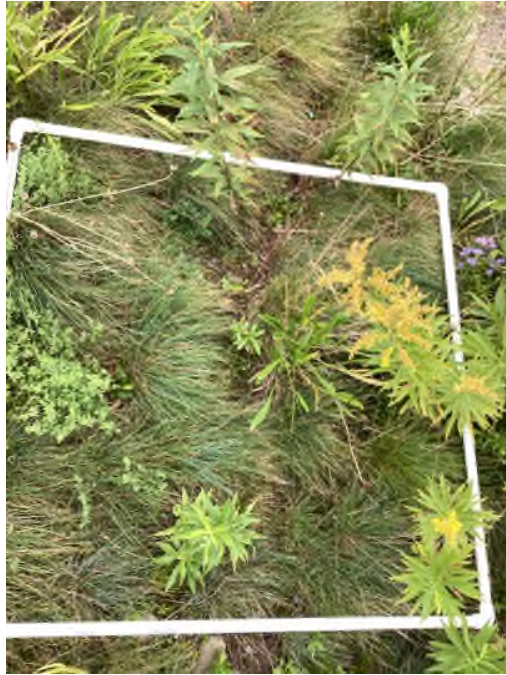
Photo: 5

Quadrat #5, Bank quadrat (see Figure 1)

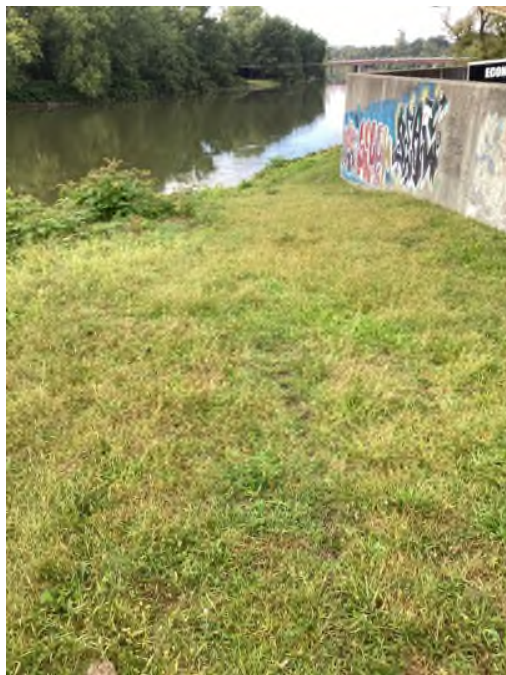
Photo: 6

Along flood wall and maintained grass corridor

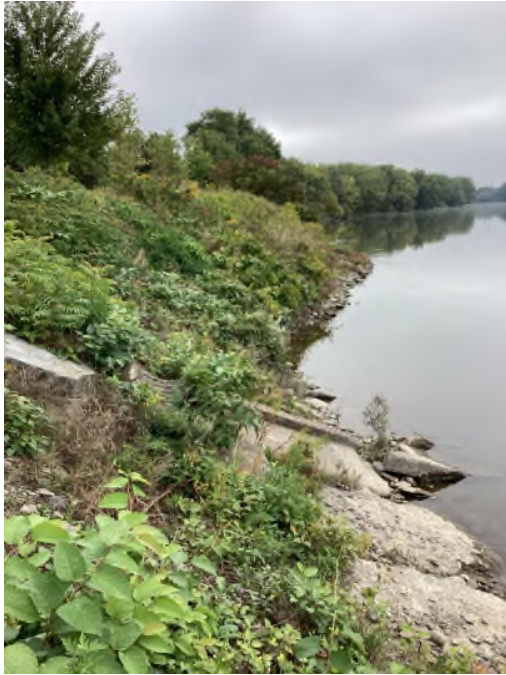
Photo: 7

Looking at downstream end of
Transloading Area

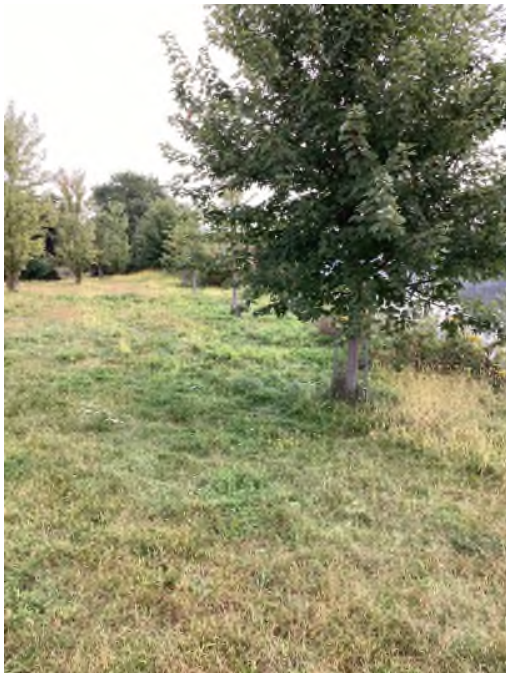
Photo: 8

During both the qualitative assessment on May 30, 2023, and the quantitative assessment on September 21, 2023, the six silver maples and eight red maples planted (or replanted) in the Transloading Area appeared to be in good health, were fully leaved with beaver cages intact, and exhibited no signs of stress or herbivory. Within the Transloading Area, one silver maple had recovered from a broken crown observed in the spring and was fully leaved and appeared to be healthy. Tree photos are included in the photograph log provided as Attachment 1 (see Photos 8 and 9).

Southwest corner of restored
upland in Transloading Area

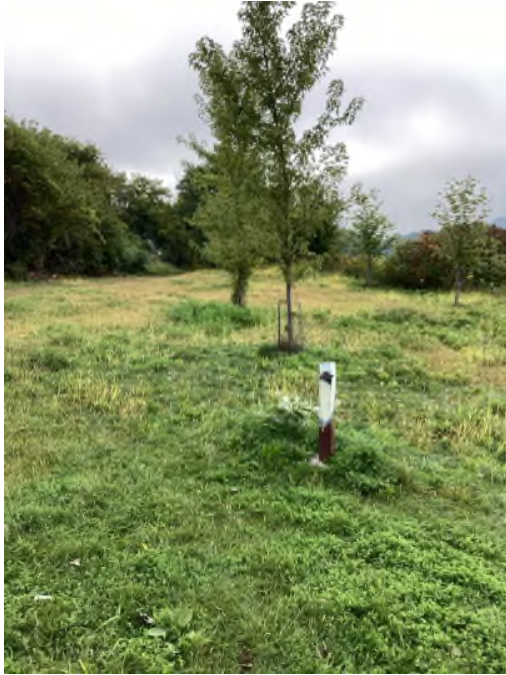
Photo: 9

Northwest corner of restored upland in Transloading Area

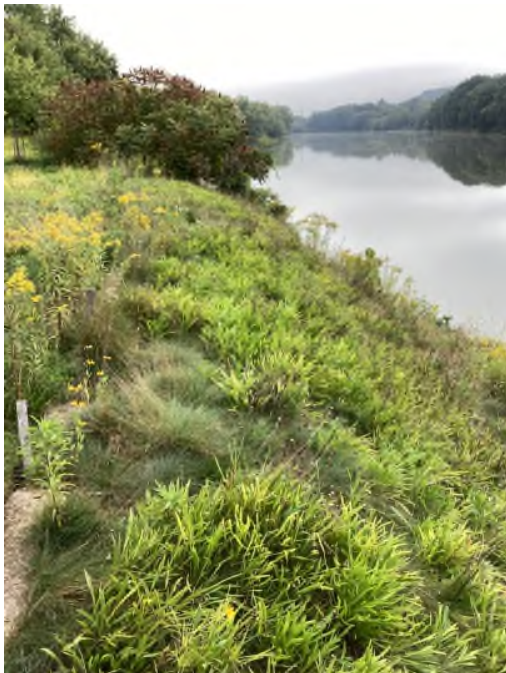
Photo: 10

Restored bank in Transloading Area

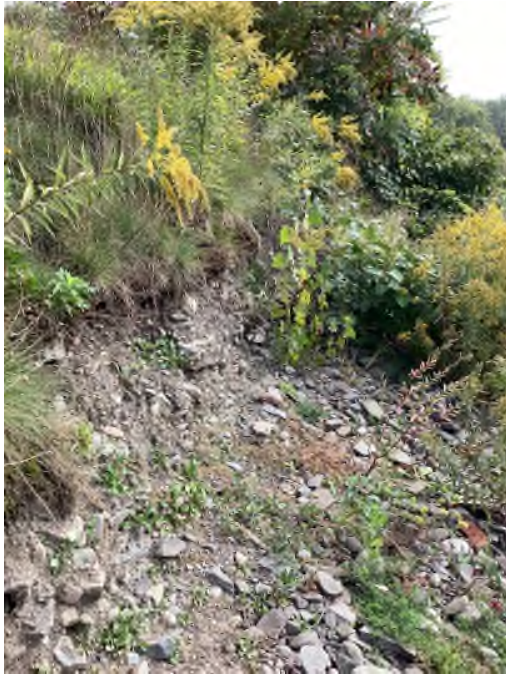
Photo: 11

As previously mentioned, qualitative bank inspections were conducted by Arcadis in May and September 2023 to document the stability of the restored rip rap and bank areas at the Transloading Area. The restored area appears to be stable and the remaining erosion control fabric netting, and coir logs are stable and functioning. Riverbank erosion was noted during the May 2023 visit near the upstream end of the restored bank area. The bank erosion area extended linearly approximately 43.5 feet and had an exposed bank erosion face height that ranged from 1.4 to 4.3 feet. During the September 2023 inspection, no further expansion, settlement, or soil instability was observed within the restored bank area or within the previously observed riverbank erosion area. Bank photos are included as part of the photograph log provided as Attachment 1 (see photos 11, 12, and 13).

- Bank stability issues were observed in a small upstream portion of the restored bank area, likely caused by natural high-water and/or ice scour conditions from past winters. The remainder of the bank area is stable and functioning as designed with continued bank monitoring to coincide with ongoing site monitoring activities.

Downstream end of bank erosion in Transloading Area

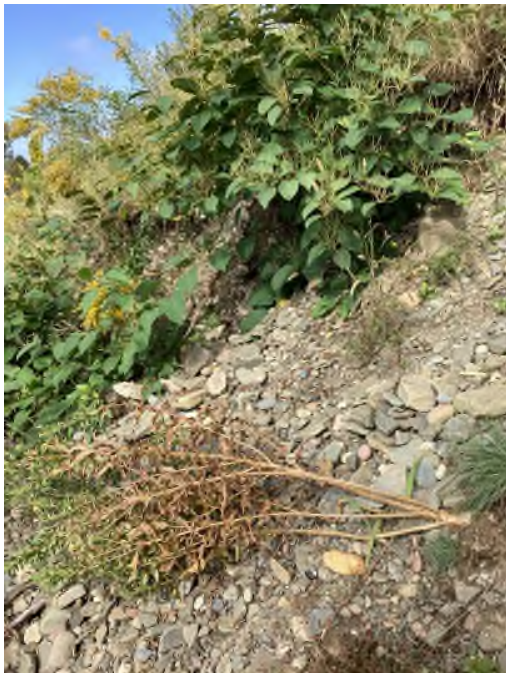
Photo: 12

Upstream end of bank erosion in Transloading Area

Noted bank erosion in upstream end of restored bank area; primarily below the vegetated upper bank. Herbaceous vegetation cover is good and stabilizing with increase in rooted vegetation and natural recruitment of Staghorn Sumac. Rip-rap is in place. Japanese Knotweed present is stunted in growth.

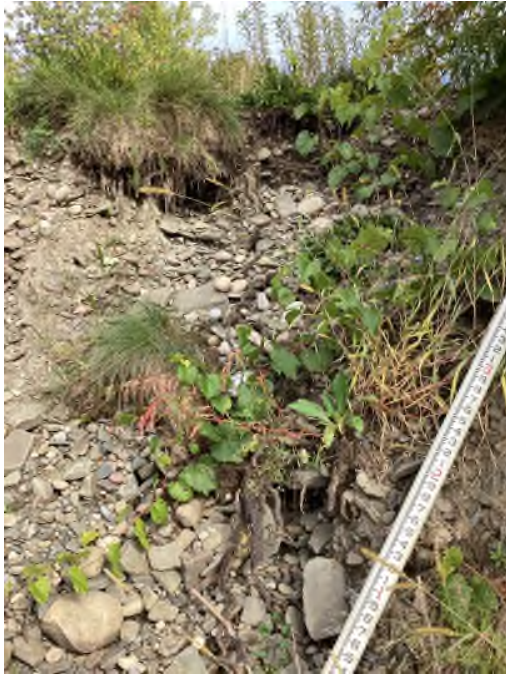
Photo: 13

Upstream end of bank erosion

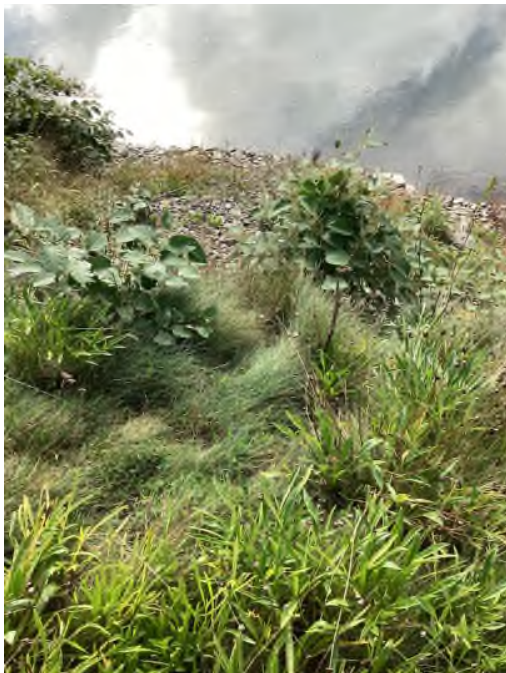
Photo: 14

Japanese knotweed on edge of
bank restoration area

Transload Area - Japanese Knotweed is limited primarily to lower bank area. Only a few stunted stems on edge of bank restoration.

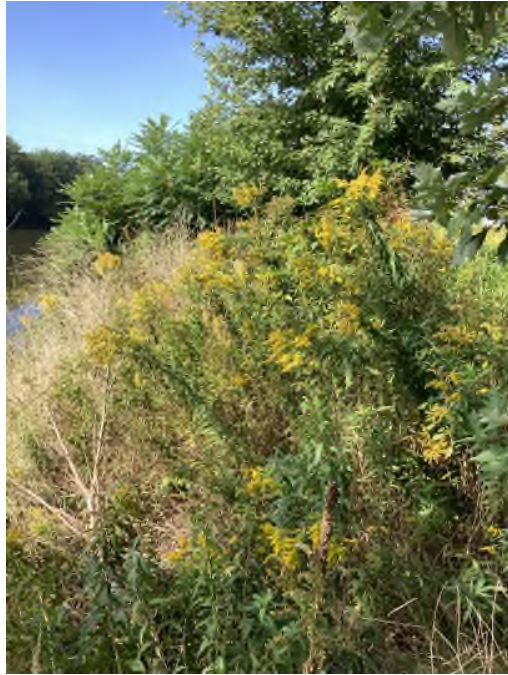
Photo: 15

Although Japanese knotweed (*Polygonum cuspidatum*) was not observed in the measured quadrats, as detailed below, this invasive species is present throughout the area. Previous invasive species control measures used along the Transloading Area perimeter have decreased the encroachment and stunted Japanese knotweed growth (see Attachment 1, photo 14) and have promoted native recruitment of staghorn sumac (*Rhus typhina*) to establish in areas formerly covered by this invasive species (see Attachment 1, photo 15).

Upstream end of bank area
adjacent to Transloading Area

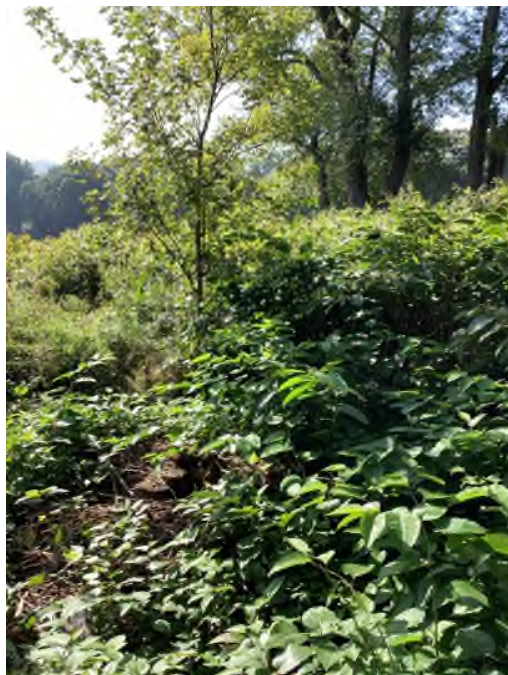
Photo: 16

All trees at the original Transloading Area inspected during the September 21, 2023, assessment were found to be in good health and fully leaved with beaver cages intact. Tree photos are included in the photograph log provided as Attachment 1 (see Photos 16, 17, and 18).

Japanese knotweed near silver
maple in Former Transloading
Area

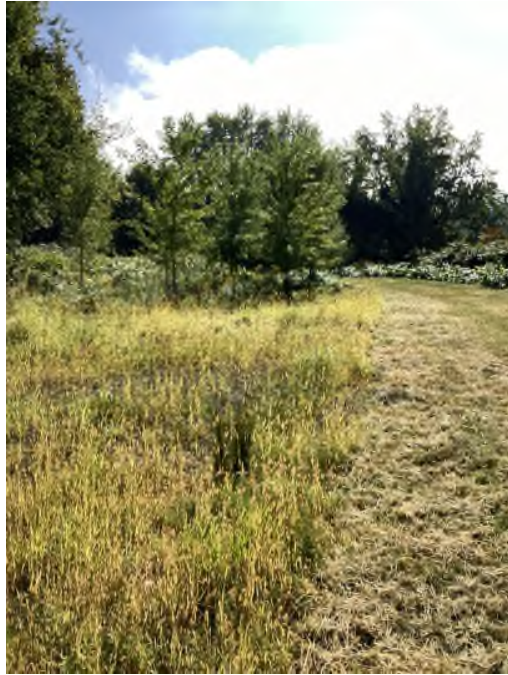
Photo: 17

Silver maples in Former
Transloading Area

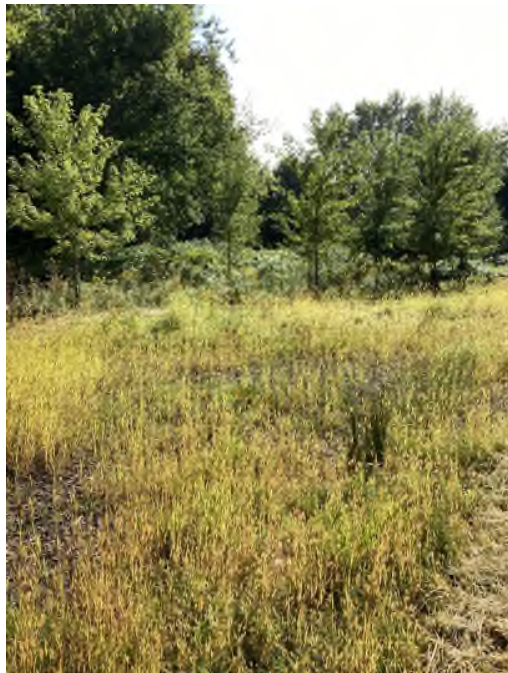
Photo: 18

Silver maples in Former
Transloading Area
