CERTIFICATION OF COMPLETION

**FINAL CORRECTIVE MEASURES ADDRESSING
SOIL AND SEWER CONTAMINATION**

FORMER BORDEN RESIN FACILITY – BAINBRIDGE, NEW YORK

September 2001

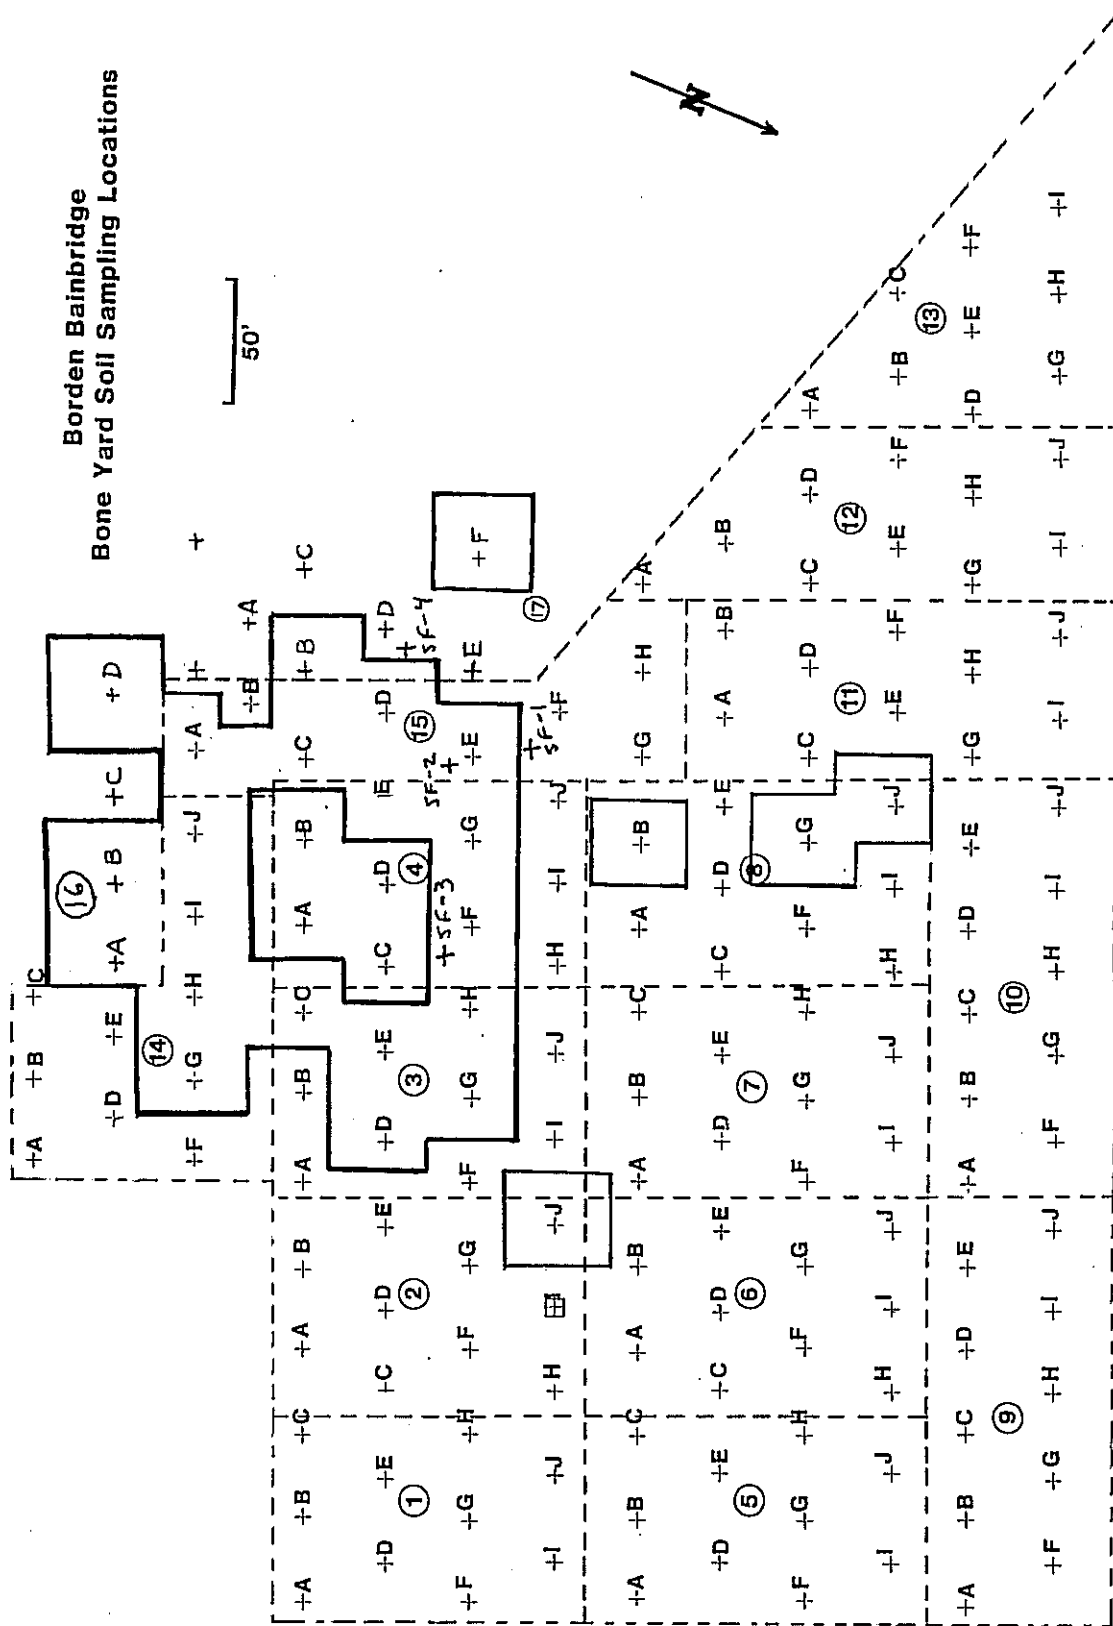
Former Borden Resin Facility - Bainbridge, New York
Figure 3
Bone Yard Sample Grid and Excavation Limits

After excavation of the Bone Yard in accordance with the limits specified in the Plan, verification samples were collected from the original grid sample locations. Based upon the results of laboratory PCB analysis, four of 25 grid locations did not achieve the remedial criterion of 25 mg/kg PCBs (grid locations 4E, 14I, 15C, 16A). Additionally, the certifying engineer observed the excavation at this time and specified four additional verification sample locations due to visible evidence of potential contamination (i.e., fiber drums containing off-spec resin, black

soil). Two of these engineer-specified additional samples (SF-2 and SF-3) did not achieve the remedial criterion. Therefore, a total of six areas in the Bone Yard required re-excavation.

An additional one foot of soil was excavated from areas exhibiting PCB concentrations above the remedial criterion. Upon re-excavation, all locations achieved the remedial criterion with one exception. Sample SF-2 (from the vicinity of 15E) did not achieve the remedial criterion. A third round of excavation was required before sample SF-2 achieved the remedial criterion.

Bone Yard grid locations and the horizontal extent of excavation are illustrated on Figure 3. Table 1 summarizes the results of contractor verification sampling and final excavation depths at each excavation grid location required to achieve the remedial criterion of 25 mg/kg PCBs. Note that where verification samples exceeded the remedial criterion (bold type), subsequent samples (collected after re-excavation of an additional one foot of soil) met the remedial criterion.

After confirmation that all contaminated soils above the remedial criterion were removed, the Bone Yard excavations were backfilled with imported fill and re-graded to mitigate potential fall hazards.

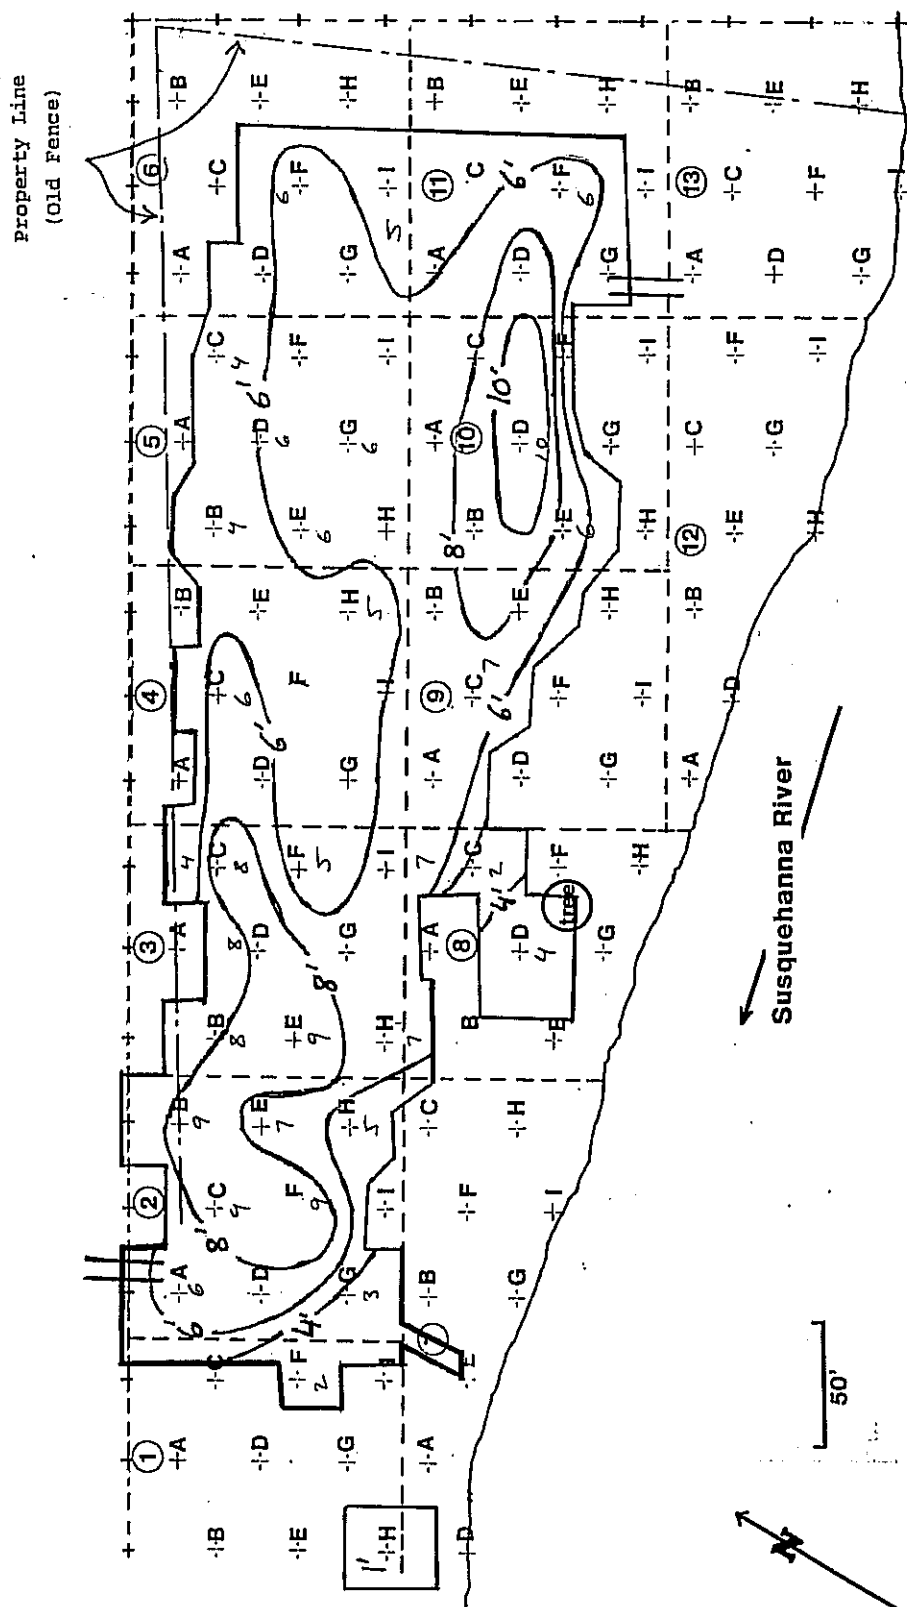
Former Borden Resin Facility - Bainbridge, New York
 Figure 5
 River Lagoon Sample Grid and Excavation Limits

After excavation of the River Lagoon in accordance with the limits specified in the Plan, verification samples were collected from the original grid sample locations and analyzed for PCBs. Based upon the results of PCB laboratory analysis, the remedial criterion of one mg/kg PCBs was not achieved at 21 of 44 grid locations after removal of the material specified in the Plan. Additionally, excavation revealed the former bottom of the lagoon as evidenced by a visible sludge layer. The sludge layer consisted of a black material, a reddish layer, and/or a white material (thought to be lime used to dry the sludge) with a thickness varying between two and 18 inches. The sludge layer was determined by subsequent laboratory analysis to contain the highest concentrations of PCBs (e.g., some locations > 100 mg/kg PCBs). Below the sludge layer was a low permeability silt-clay layer (i.e., the original bottom of the lagoon) which was determined by multiple analyses to be uncontaminated by PCBs. Above the sludge layer was an overburden soil material (i.e., material used to backfill the lagoon) determined to be marginally contaminated with PCBs.

In addition to the sludge layer, excavation revealed an area containing approximately five buried drums in the vicinity of the former spillway near grid location 10G. The drums were not intact, but apparently contained a semi-solid material, some of which hardened upon exposure to the atmosphere. Based upon historic waste management at the resin facility and subsequent laboratory analysis, the drums were determined to contain phenolic material, presumably off-spec resin. The drums and contents were ultimately disposed of with contaminated soil as non-hazardous waste. Waste characterization and disposal were outside the scope of certifying engineer activities.

Table 3 summarizes the final verification sample data for each grid location in the River Lagoon. The visual criterion (i.e., native clay layer) was achieved at all 72 grid locations based upon contractor observations, limited certifying engineer and NYSDEC observations, and limited photographic observation. [It was not possible for the certifying engineer or NYSDEC to observe the clay layer at many locations due to inundation and/or backfilling required to provide access to the excavator.] Additionally, all 32 native clay layer samples submitted for laboratory confirmation achieved the remedial criterion of one mg/kg.

Figure 5 illustrates the horizontal and vertical limits of the final River Lagoon excavation. The horizontal limits of excavation, confirmed in the field by the certifying engineer, are not significantly different than the horizontal limits specified in the Plan. However, the depth of excavation increased significantly over the excavation depths specified in the Plan. Apparently the original soil sampling program "missed" much of the sludge layer, perhaps because the layer was too soft for consistent collection in the split-spoon sampler. Note that the excavation depths illustrated in Figure 5 are based upon contractor-reported measurements. The certifying engineer verified that contractor-reported depths meet or exceed the excavation depths specified in the Plan.

To complete corrective actions at the River Lagoon consistent with the discovery of the above-discussed scenario, a modified remedial approach was agreed upon. (The modified approach was documented in letters from the remediation contractor to NYSDEC dated November 1 and November 9, 1999. NYSDEC provided written approval of these documents on November 2 and November 15, 1999.) Utilizing the modified approach, the overburden material was excavated, stockpiled, sampled, and disposed of as either hazardous or non-hazardous waste. Next, the sludge layer was similarly excavated and disposed of. Excavation to the native clay

After confirmation that all contaminated soils were removed, the River Lagoon was re-graded to remove steep scarps that may have been hazardous to people or livestock.

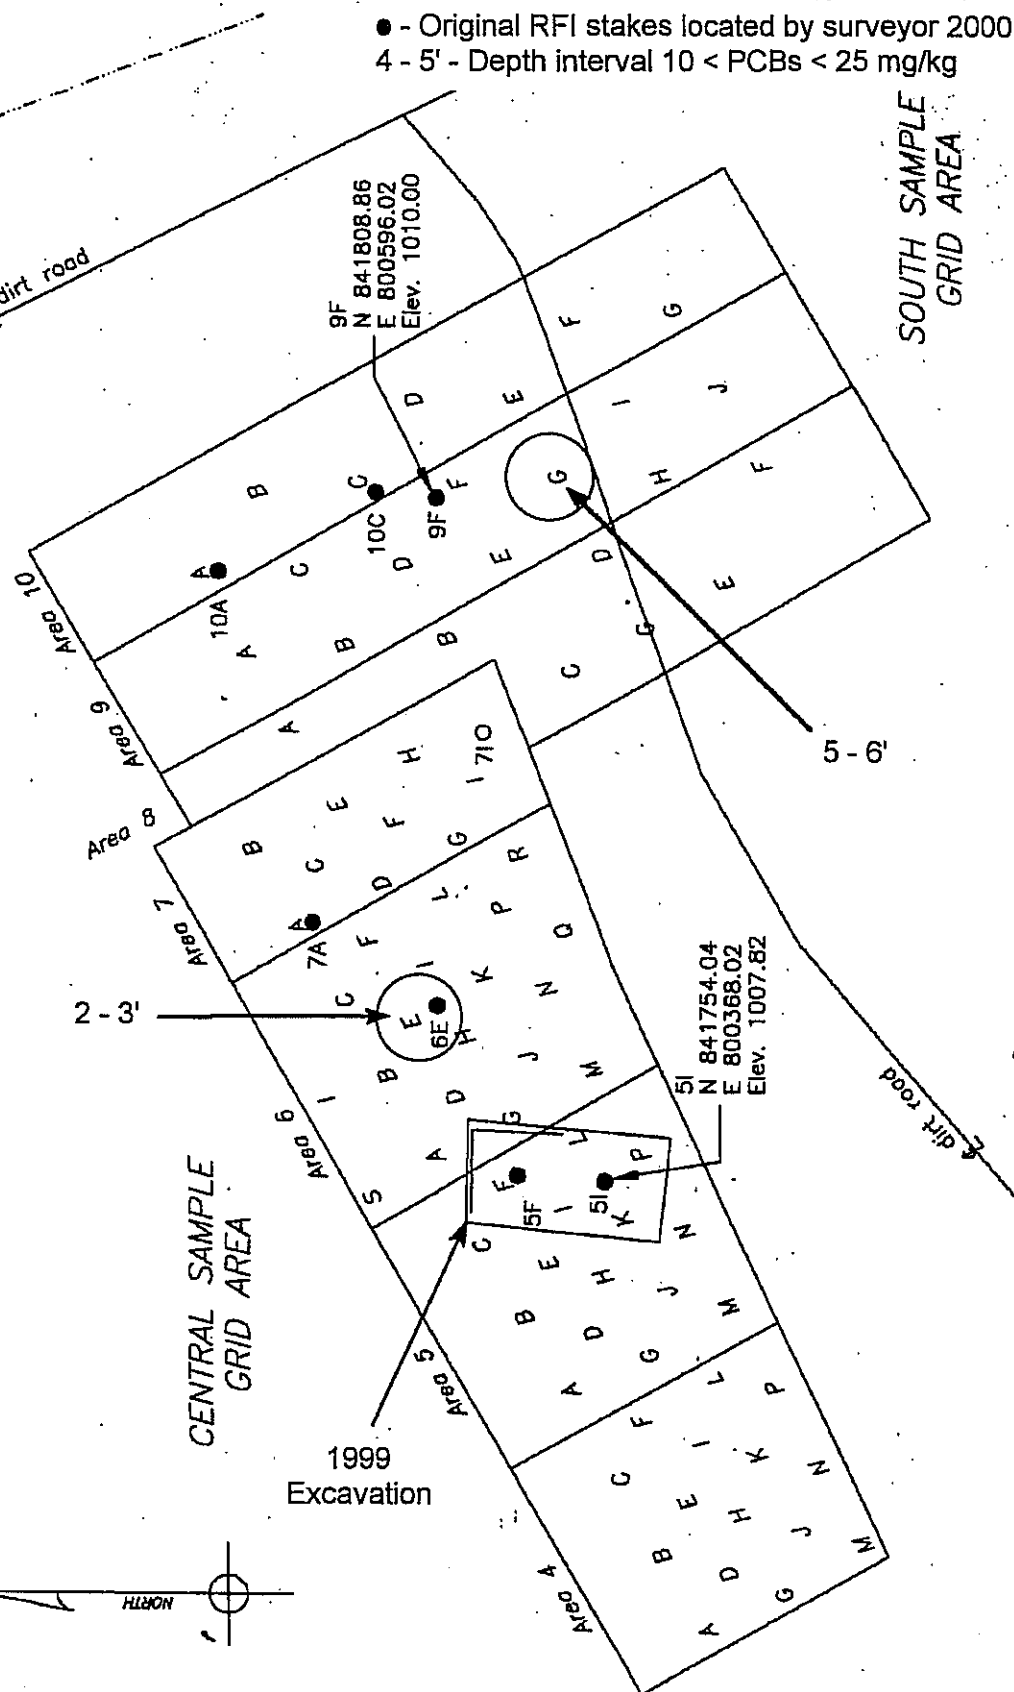
Central and South Trenches Excavation and Areas Exhibiting 10 < PCBs < 25 mg/kg

After excavation of the Central Trenches in the Land Application Area in accordance with the limits specified in the Plan, verification samples were collected from the original grid sample locations. Based upon the results of laboratory PCB analysis, grid location 5I did not achieve the remedial criterion of 25 mg/kg PCBs. An additional foot of soil was removed from location 5I and the location was re-sampled. As illustrated below, all final post-excavation samples achieved the remedial criterion:

Figure 6 illustrates the sampling grid and remediation excavation locations in the Central Trenches area. After sampling data demonstrated that the remedial criterion of 25 mg/kg PCBs was achieved throughout the Trenches, approximately 100 tons of imported backfill was placed at grid location 5I, and the area was re-graded to mitigate potential fall hazards.

Because the remedial criterion of 25 mg/kg exceeds the unrestricted landuse criterion of 10 mg/kg, landuse restrictions such as deed notification, fencing, and posting will be required in the Trenches area. Figures 6 and 7 illustrate the post-remediation areas and depths in the North, Central, and South Trenches areas exceeding the unrestricted landuse criterion (i.e., PCBs between 10 and 25 mg/kg). If unrestricted landuse is desired in the future, these areas would have to be remediated. Surveyed benchmarks are provided on Figures 6 and 7 to facilitate identification of these areas for future remediation, if desired.

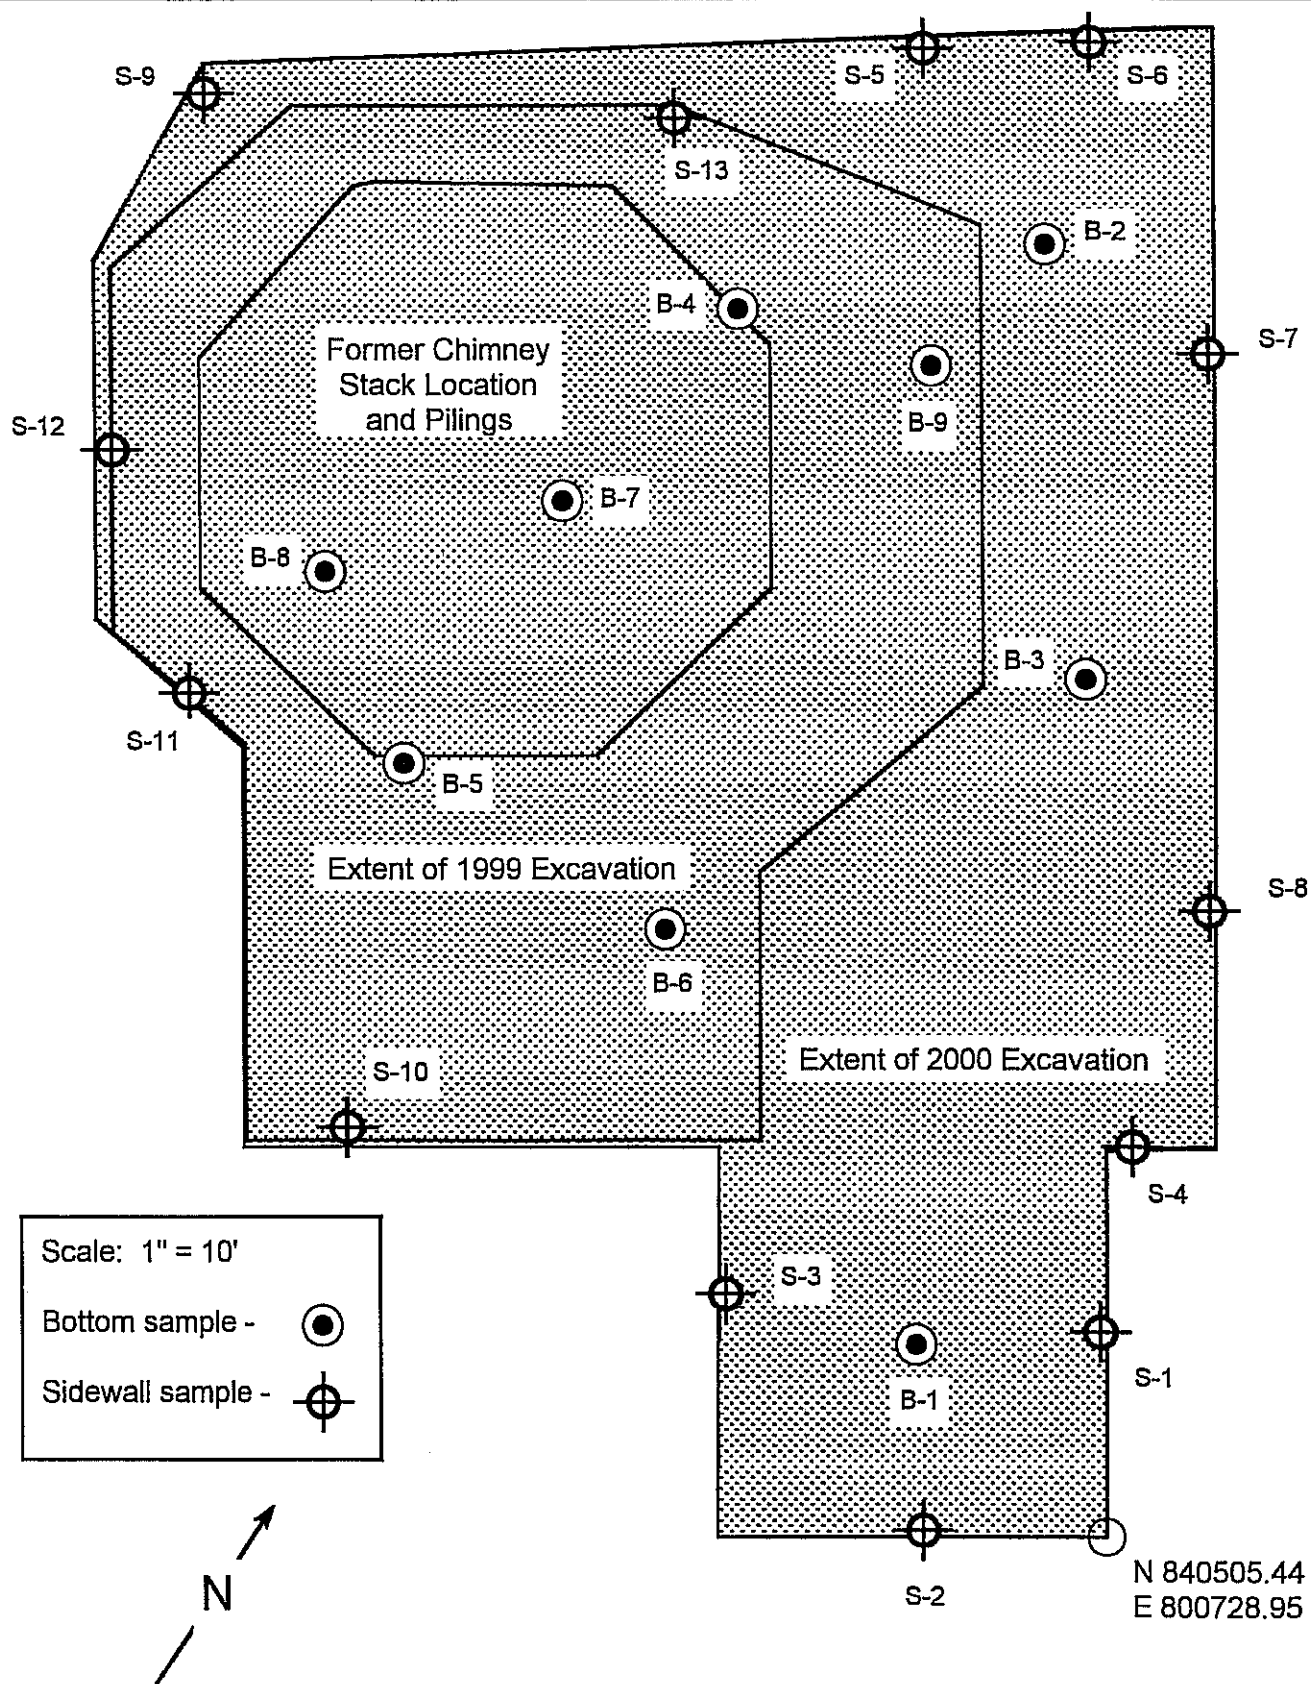
Former Borden Resin Facility - Bainbridge, New York
Figure 8
Final PCB Area Excavation and Verification Sample Locations

Corrective measures in the PCB Area were primarily the removal of coarse-grained fill, pipe fragments, rubble, and wooden pilings that had become contaminated with PCB-containing oil. The underlying native silt-clays were determined by prior sampling to be uncontaminated.

In 1999, after initial excavation of contaminated material in accordance with the Plan, verification samples were collected and analyzed for PCBs. Based upon initial verification sampling, the remedial criterion of 10 or 25 mg/kg PCBs was not achieved throughout the excavation. Additionally, the remediation contractor was unable to cut off the contaminated portion of the 104 wooden pilings within the excavation as planned, due to the expansion of the wood during cutting and resultant binding of the saw blades. Subsequent sampling of the pilings demonstrated that the most significant PCB contamination was limited to the surface of the pilings. Drill shavings from the core of the pilings were only marginally contaminated.

Figure 8 illustrates the horizontal limits of the 1999 and 2000 PCB Area excavations, as well as final bottom and sidewall verification sample locations. The final depth of the PCB Area excavation was approximately seven to eight feet. Final verification results for the 22 excavation samples and three wooden piling cores are summarized in Table 4. All analytical results are below the un-restricted clean-up criterion of 10 mg/kg PCBs.

To account for actual field conditions, excavation of contaminated materials was continued in an iterative process of re-excavation and re-sampling until the clean-up criterion was achieved. Additionally, a modified remedial approach was agreed upon to address the wooden pilings. The modified approach developed by the remediation contractor (letter of November 1, 1999)

After all significantly contaminated materials were removed from the PCB Area, the excavation was restored to the original grade and topography with site-derived concrete rubble (e.g., chimney stack and building foundation rubble) and imported fill. Given that all residual PCB concentrations are less than the unrestricted landuse criterion of 10 mg/kg PCBs, no further restrictions or requirements apply to the PCB Area. However, to facilitate relocation of the excavation if necessary in the future, the surveyed coordinates of a corner of the excavation are provided on Figure 8.

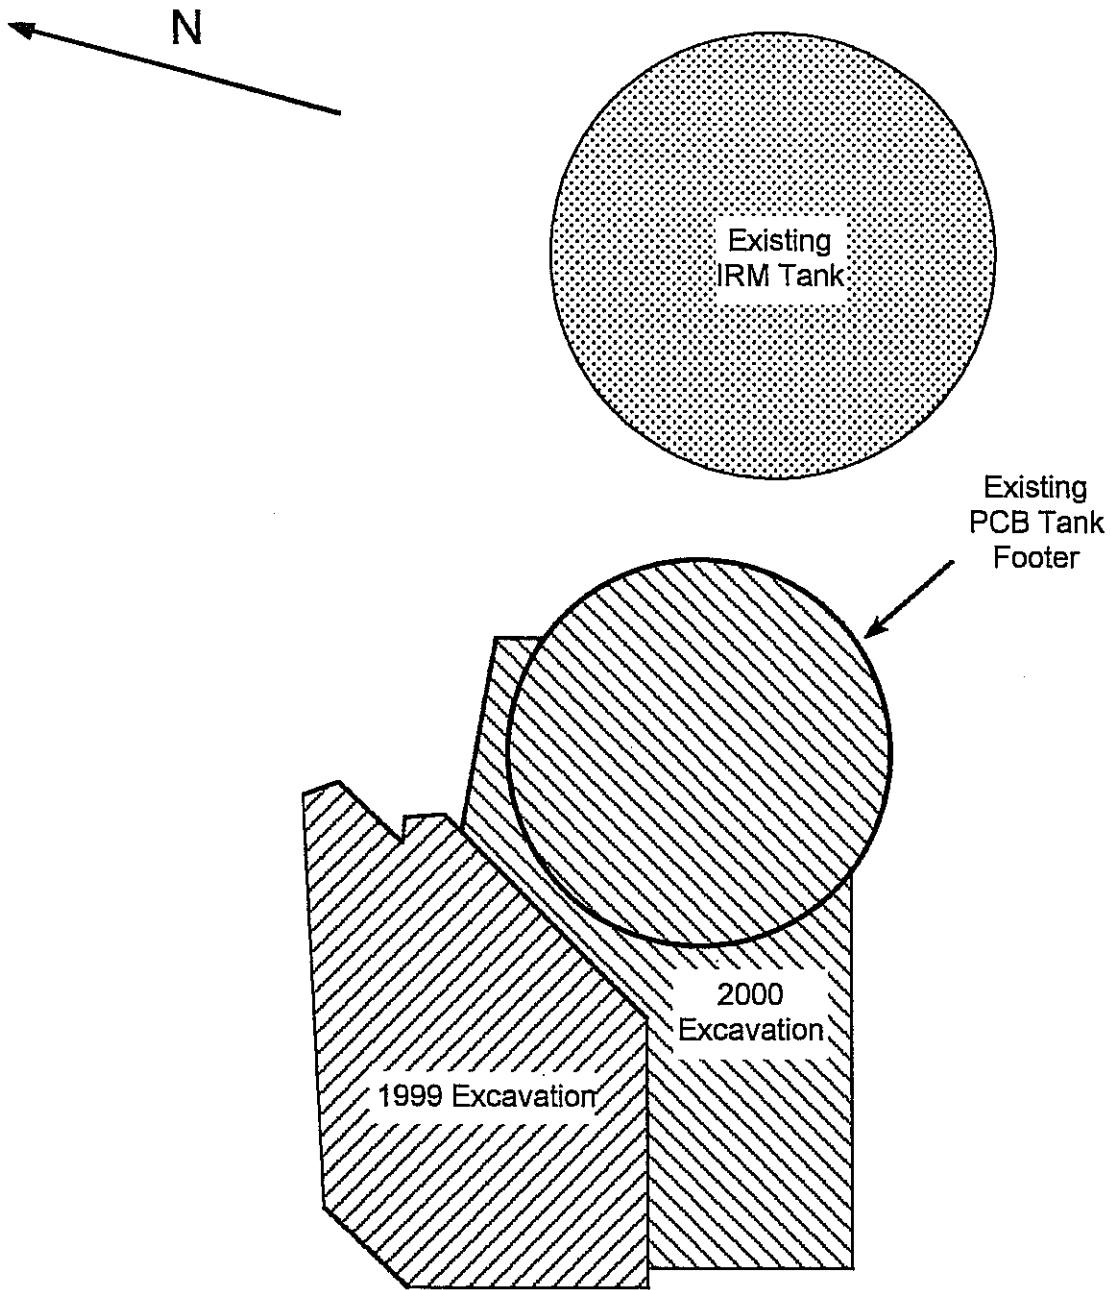
Former Borden Resin Facility - Bainbridge, New York
Figure 10
Final Extent of Phenol Recovery Area Excavation

Figure 9 is a sketch of the 1999 excavation, excavation sample locations, and headspace results. The remedial criterion of 50 ppmv was achieved at all excavation perimeter locations except in the vicinity of the PCB Tank. Elevated soil vapor concentrations in this area coincided with visual purple staining of the unsaturated soils. Excavation was terminated in 1999 due to concerns about compromising the structural integrity of the PCB Tank.

In 2000, the PCB Tank and the adjacent concrete building pad foundation were removed to allow continued excavation of contaminated soil (Section 4.3). Soil excavation was extended to approximately seven feet below grade, and laterally outward until visual and odor indications of contamination were removed. (During the 2000 excavation, PID readings were determined to provide inaccurate indications of the extent of significant contamination. For example, numerous samples exhibited headspace readings of approximately 1,000 ppmv, yet did not exhibit other signs of contamination such as staining or odor. Additionally, several of the verification sample locations that achieved the clean-up criterion in 1999 were re-tested and failed in 2000. Different instruments were used in 1999 versus 2000, which may partially explain the discrepancies.) The final extent of the Phenol Recovery Area excavation, including the area beneath the former PCB Tank, is illustrated on Figure 10.

After SVE treatment was completed, the original excavations were partially backfilled with treated soil and decontaminated concrete. Backfilling of the excavation will be completed in the near future to allow re-installation of monitoring well MW-29, which was destroyed during excavation. Corrective measures addressing groundwater contamination in the Phenol Recovery Area are on-going (i.e., pump-and-treat, pilot-scale bioparging), and are outside the scope of this certification. However, groundwater monitoring conducted in the Phenol Recovery Area after soil excavation indicates that groundwater contaminant levels have declined significantly in the vicinity of the excavation.

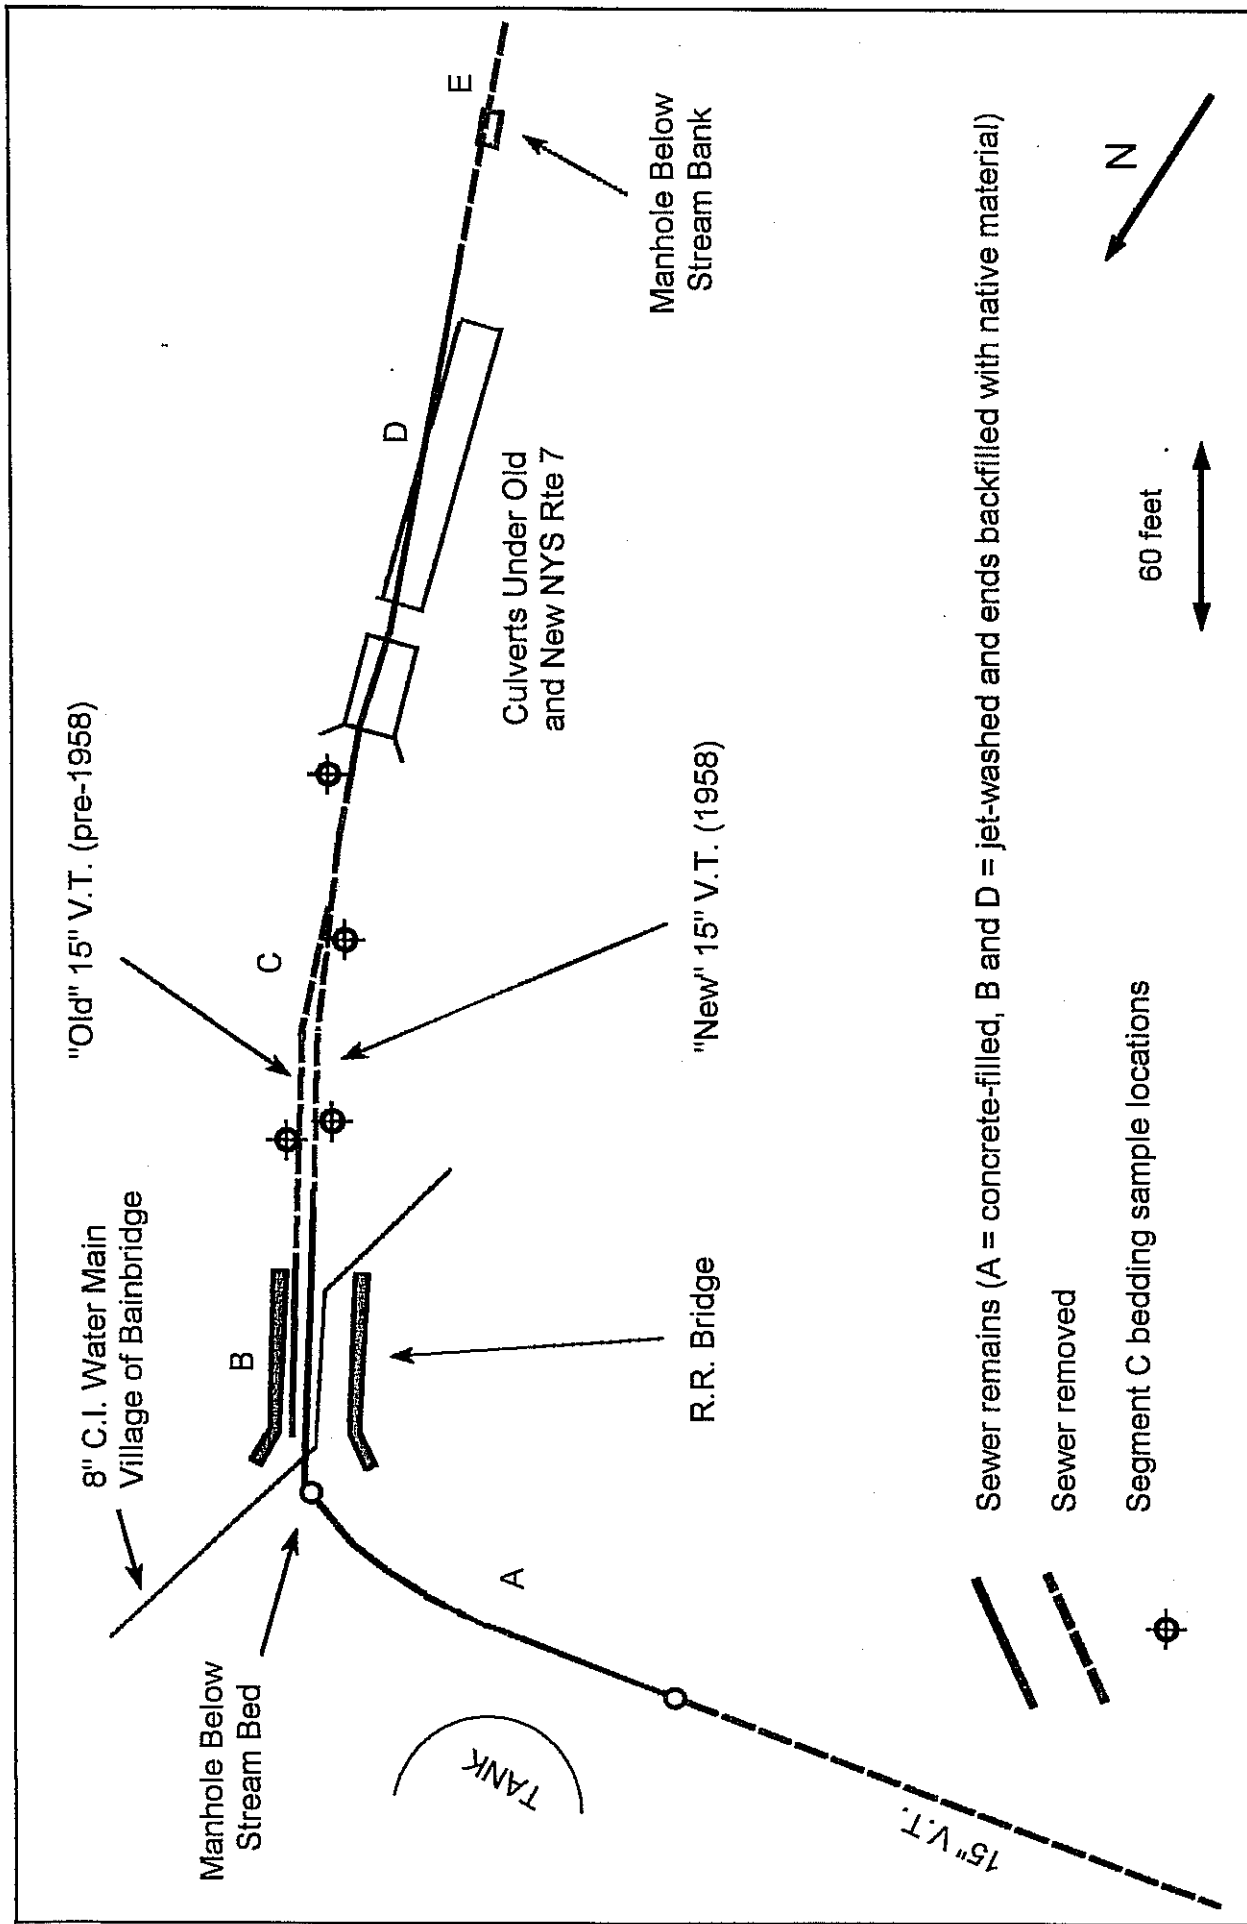
Former Borden Resin Facility - Bainbridge, New York
 Figure 13
 Eastern Sewer - North of Route 7
 (base map adapted from 1958 facility sewer map)

Segment A. Sewer Segment A ran from a manhole at the former on-site wastewater treatment system (Phenol Recovery Area) to a buried manhole in Beatty Creek (Figure 13). (Note that the sewer segment upstream of Segment A, between the resin formulation facilities and the Phenol Recovery Area, was previously removed during Interim Corrective Measures in 1991.) Based upon an interview with former Borden employee Cliff Reynolds, Segment A had been grouted with concrete soon after facility closure (late 1980s) due to leakage of sewer water from the lower manhole located in the creek bed. The leak was presumably attributable to downstream blockage of the sewer pipe. Reynolds reports that he observed concrete being pumped into the upper manhole and flowing to the lower manhole, indicating that the sewer pipe was filled completely. In 1999, MACTEC excavated to the sewer near the upper manhole and visually confirmed that the sewer was full of concrete at this location. An exploratory excavation was not completed at the lower manhole due to the close proximity of Village water and sewer lines. No additional corrective measures were deemed necessary to address Segment A.

Segment B. Sewer segment B runs beneath the stream bed and beneath the railroad bridge (Figure 13). This run coincides with the location of Village of Bainbridge sewer and water lines. In 2000, MACTEC breached Segment B 21 feet south of the railroad crossing, installed a temporary manhole, and jet-washed this segment approximately 70 feet northward until refusal. Presumably, refusal was due to concrete placed in the line while filling Segment A. Due to the high flow of stream water infiltrating into the pipe (despite stream diversion as described above), it was not possible to video this segment. However, MACTEC reports that throughout the jetting process, visible sludge/sediment was absent. Therefore, it is concluded that Segment B

Segment C. Sewer segment C ran beneath the stream bed between the railroad crossing and Route 7 (Figure 13). In 2000, this segment was excavated and removed by MACTEC, and sewer pipe and sludge were disposed of as non-hazardous waste (based upon characterization sampling). During excavation, a second 15-inch vitrified tile sewer was discovered. A 1958 facility sewer map indicated that the second sewer was an abandoned line that tied into and ran parallel to segments B and C of the known line (Figure 13). According to the drawing, the known line was the "new" line, presumably installed due to damage or plugging of the "old" (pre-1958) abandoned line. A sample of sludge was collected from the abandoned sewer line and determined to be contaminated. Therefore, the abandoned sewer segment was also excavated and removed. MACTEC reports that the entire abandoned line was removed, based upon encountering the ends of the pipe just south of the railroad crossing and at a "Y" connection into the known line. Additionally, the former Village utilities superintendent, Tim Mayes, reported that the portion of the abandoned line under the railroad crossing was exposed during installation of the Village sewer line in approximately 1995. The Village flushed out this segment and used it as a conduit/sleeve for the Village sewer, thus simplifying their installation under the railroad crossing.
