February 9, 1999

Subject: **Semi-Annual Groundwater Monitoring and IRM Report  
Former Borden Resin Facility  
Bainbridge, NY  
LAW Project No. 50700-8-0985**

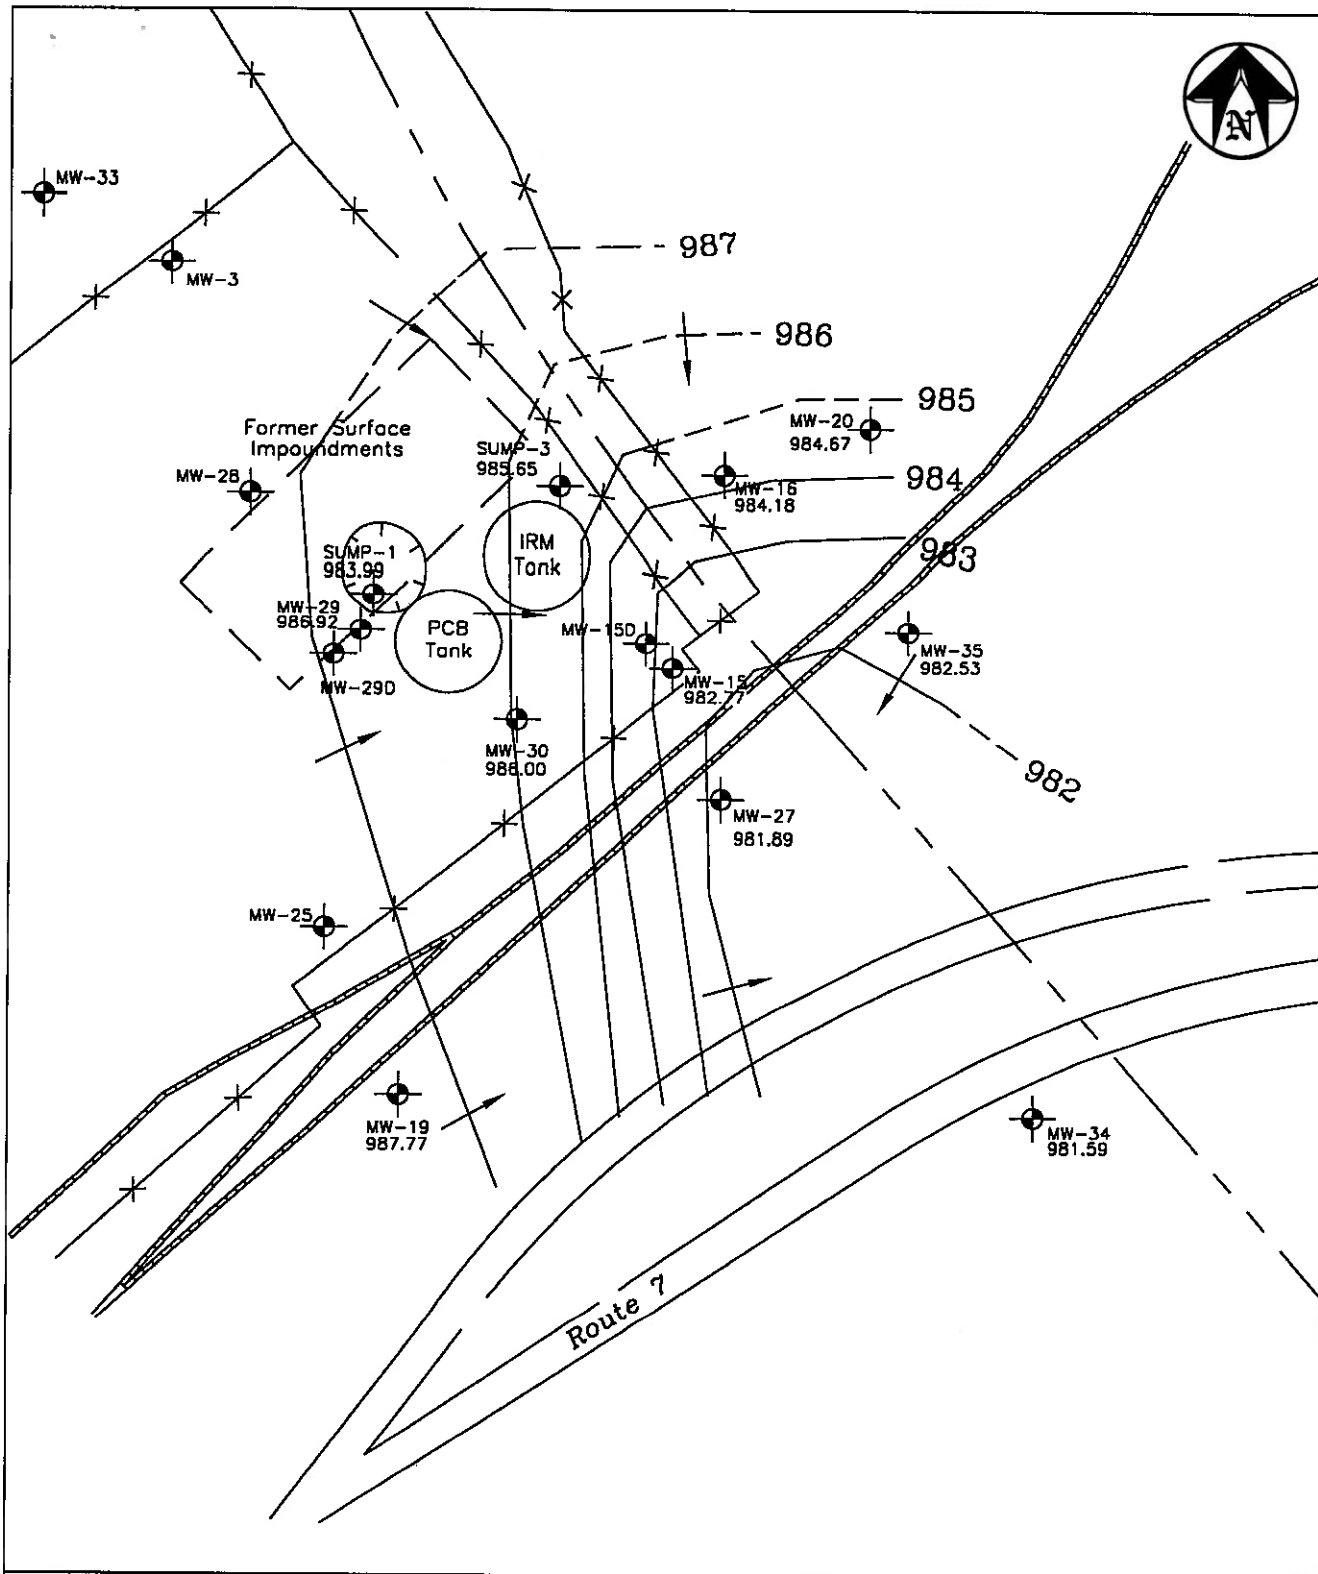
Groundwater elevations are tabulated in Table 1, and water table contours and flow lines are illustrated on Figure 1. Water table contours reflect IRM pumping conditions (see below). These data indicate that the groundwater in the Phenol Recovery Area generally discharges to Beatty

Creek. However, groundwater is being captured by the IRM in the immediate vicinity of the groundwater collection well (Sump 1). The limited extent of the cone-of-depression and decreased yield of Sump 1 relative to previous periods (see below) are attributed to below normal rainfall (i.e., depressed water table), and perhaps to sediment and/or minerals fouling of the slots of the collection sump.

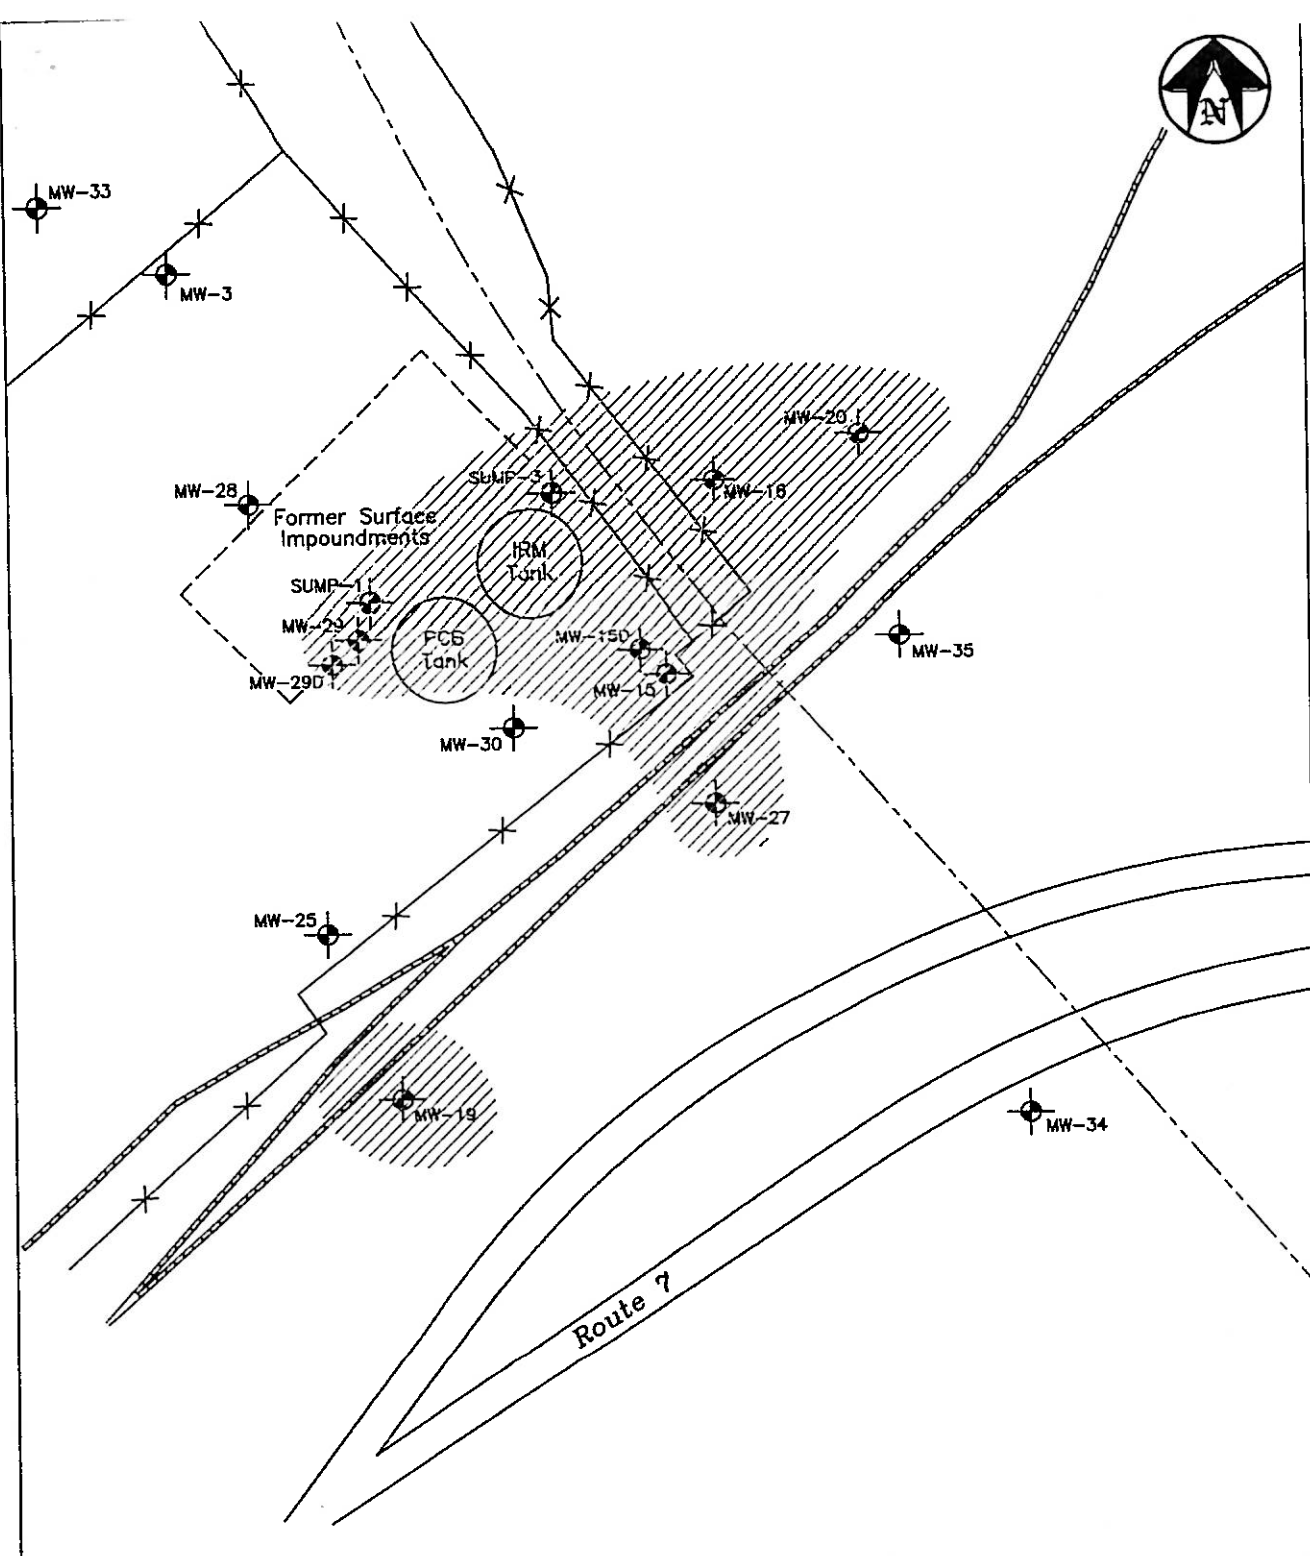
Figure 2 illustrates the extent of the contaminant plume (August 1998) in excess of groundwater clean-up criteria. The most significant contamination is downgradient of the former surface impoundments and phenol recovery unit. Lesser concentrations (e.g., 64 ug/L) are found across Beatty Creek and at MW-19.

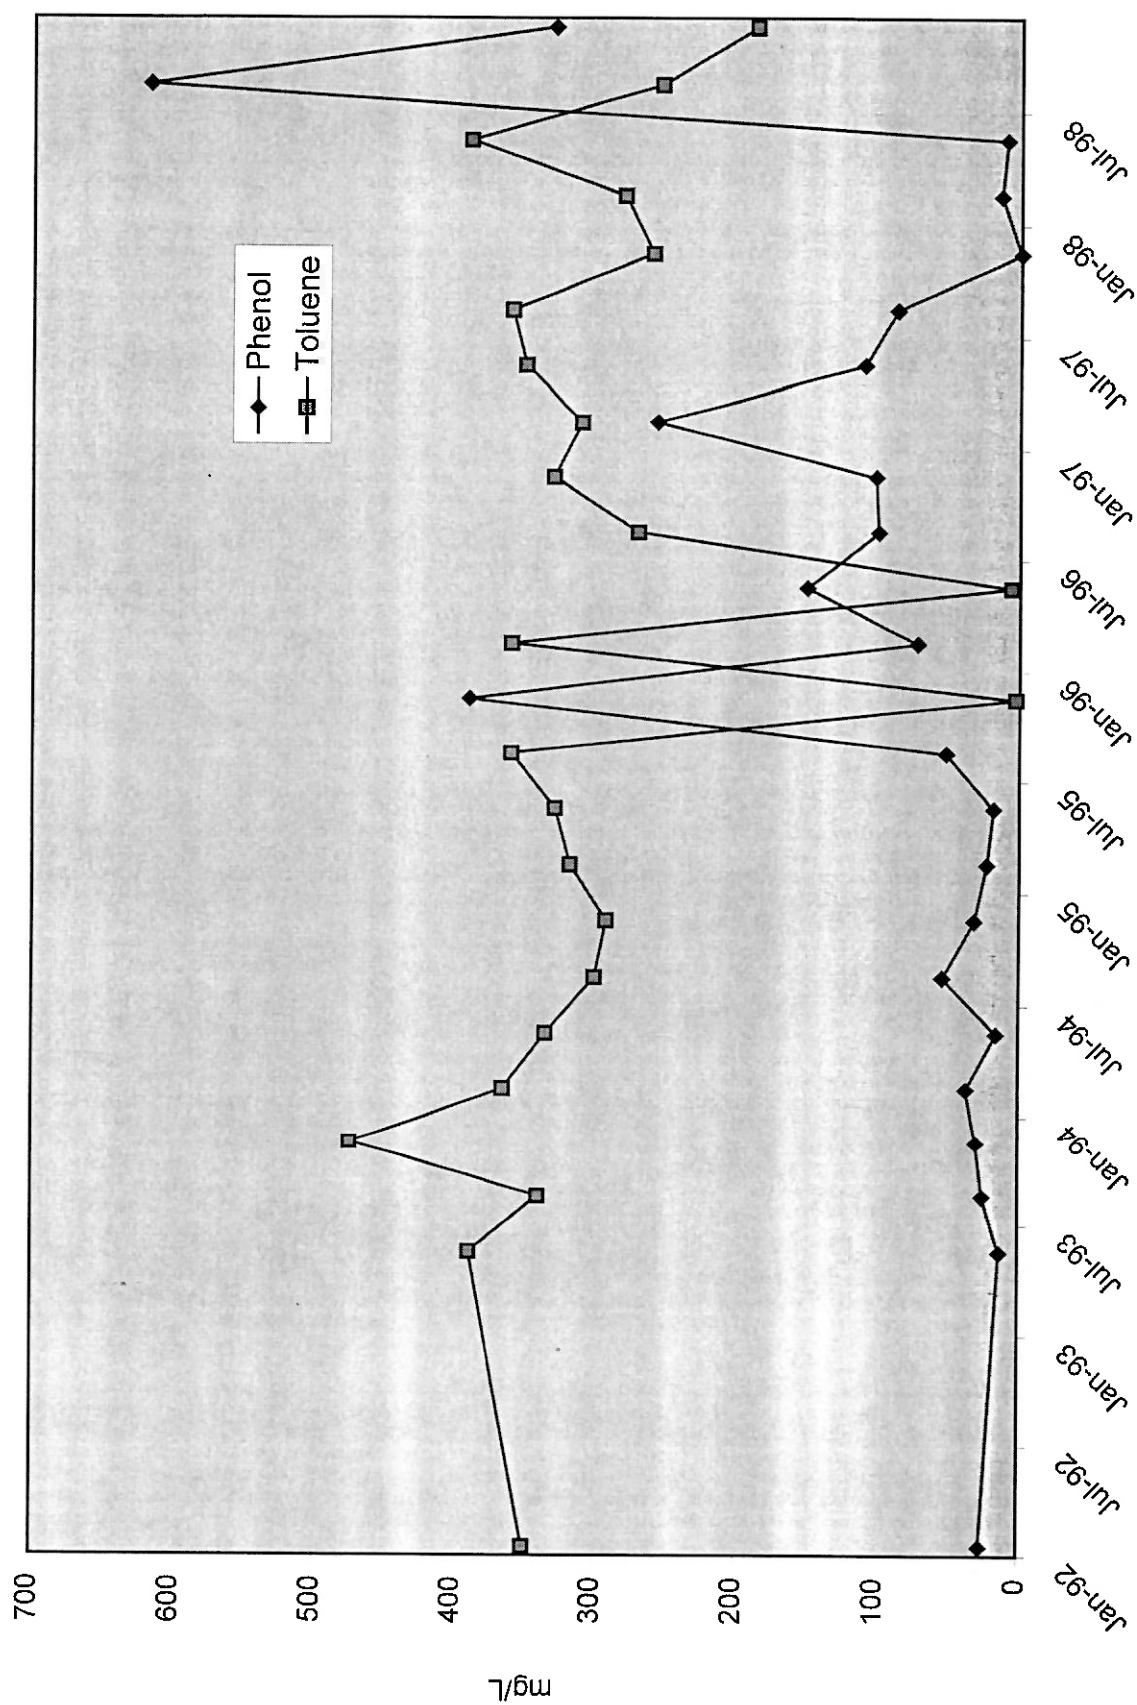
Figure 3 illustrates historic concentration trends at the most contaminated sample location, MW-29. Recent data suggest a declining trend for toluene, and an increasing trend for phenol.
