Gladding Cordage

Rewiring the Controls and rehabbing the Monitoring wells

South Otselic

30 May 2007

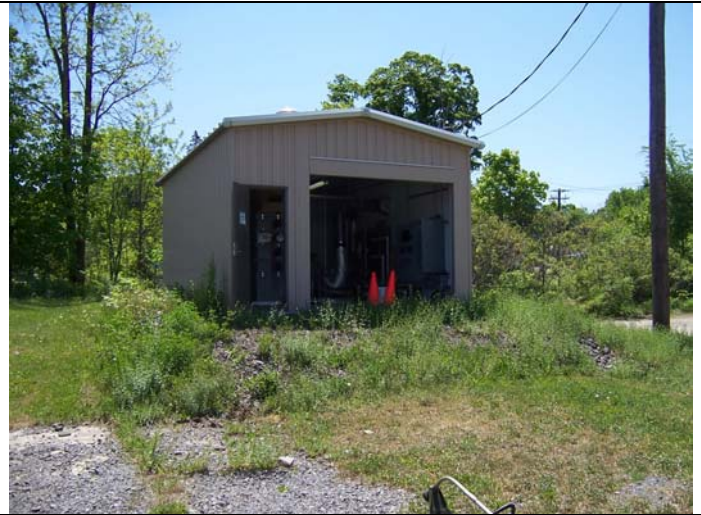
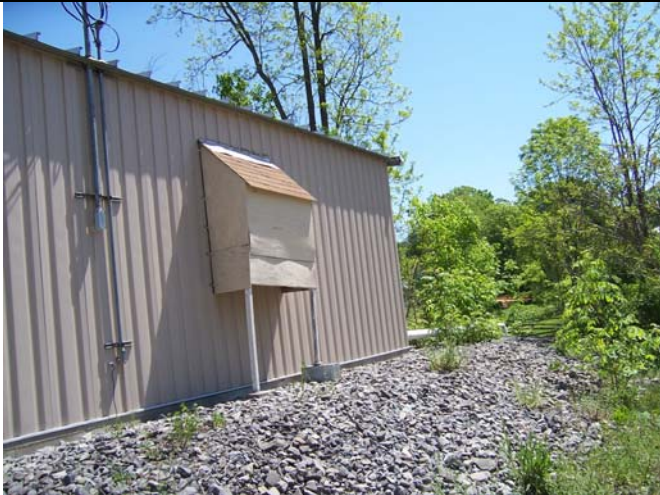
When the work crew arrived the system was shut down. The landscaping around the building was over grown.

Upon initial walk through it was noted that the structure designed to muffle the blower intake was in disrepair and was in need of rebuilding. Measurements were taken to work on a design back at central office.

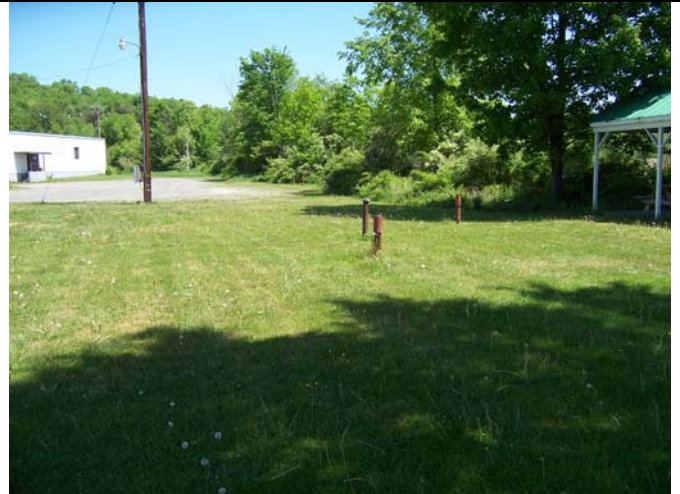
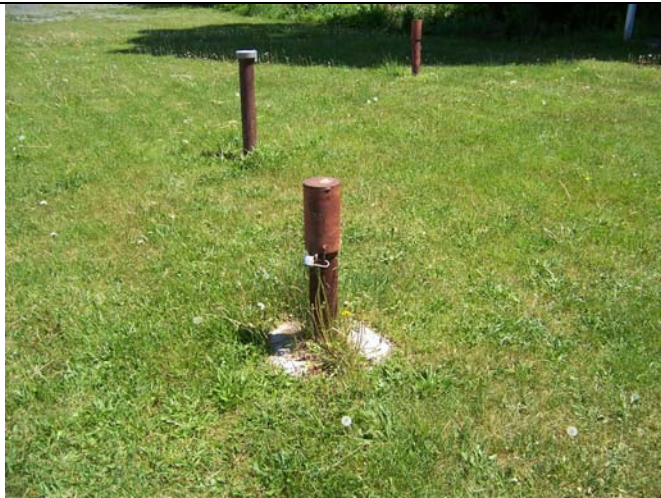
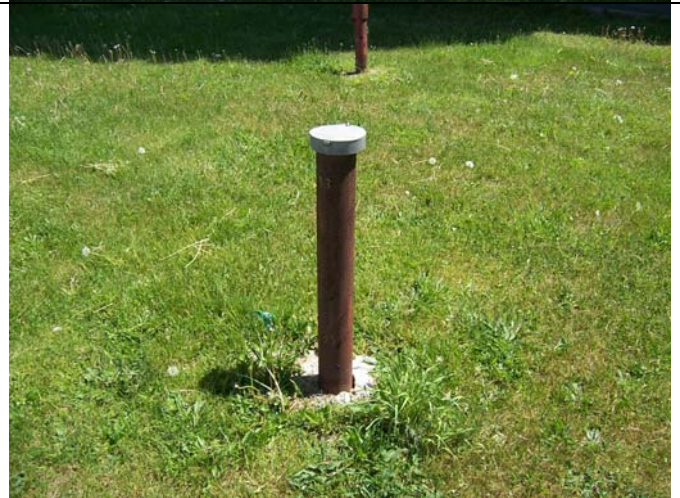
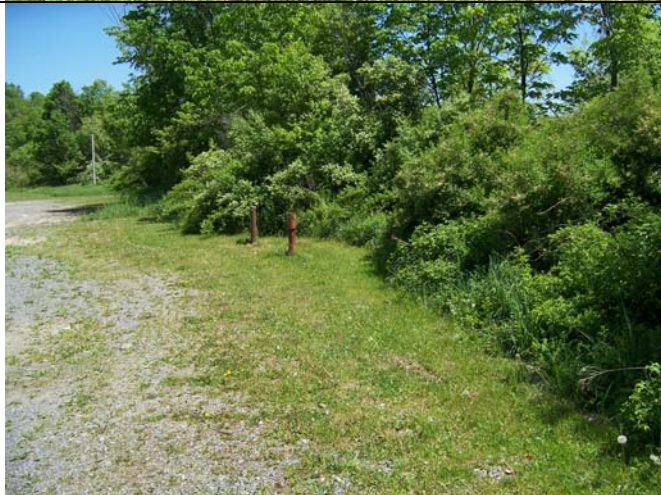
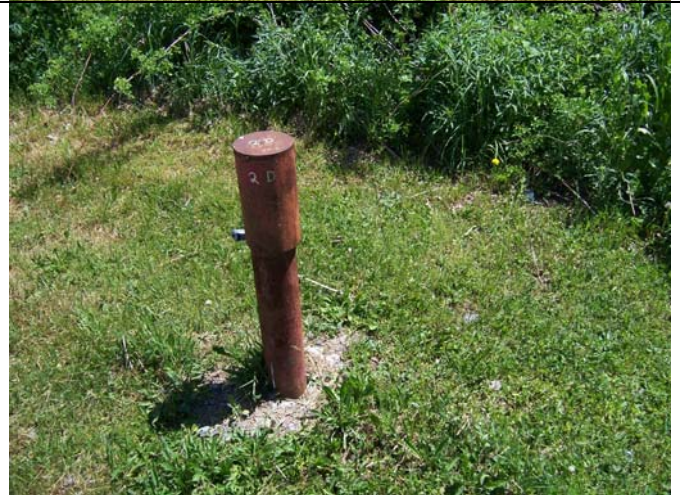
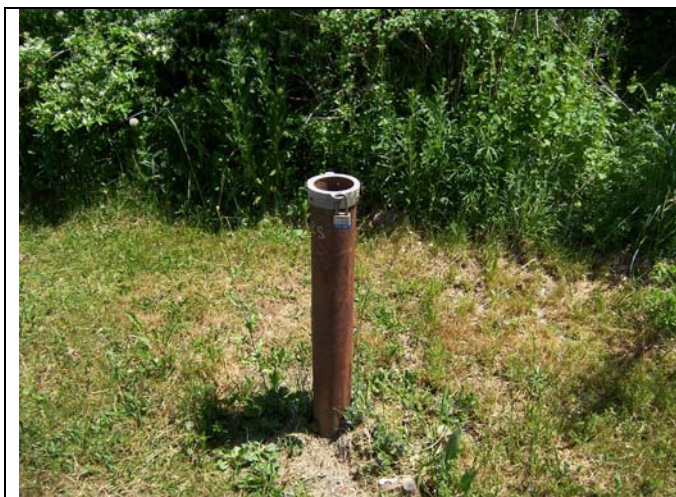
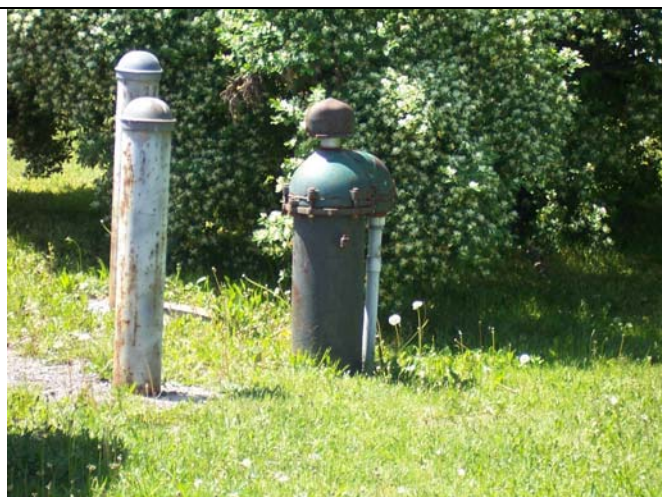
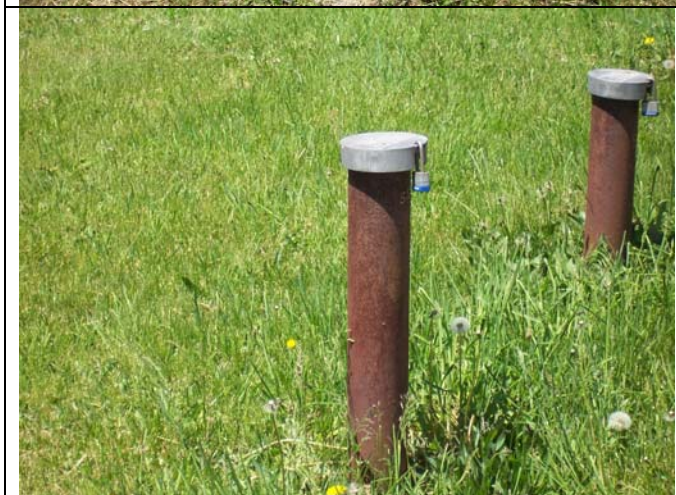
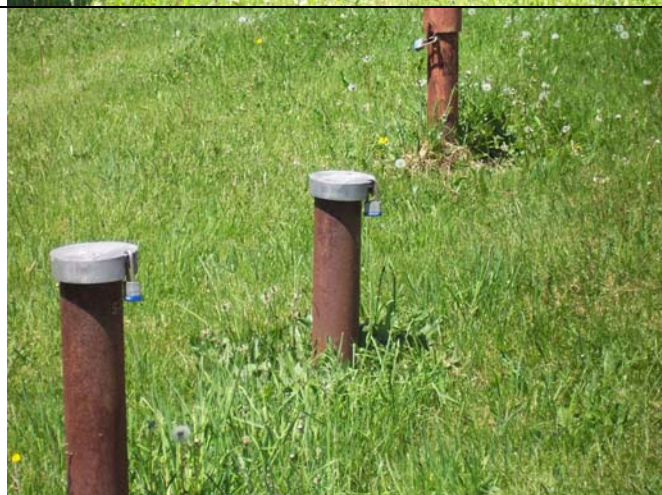
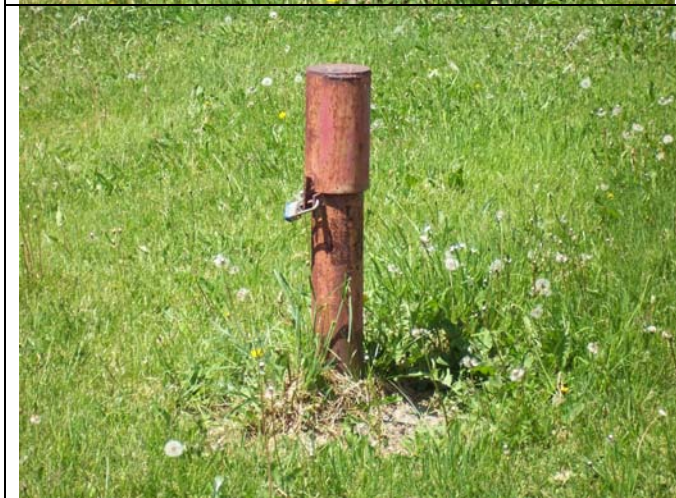
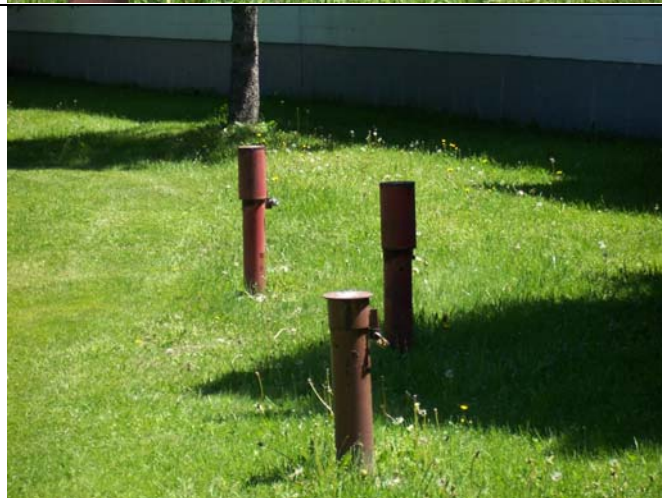
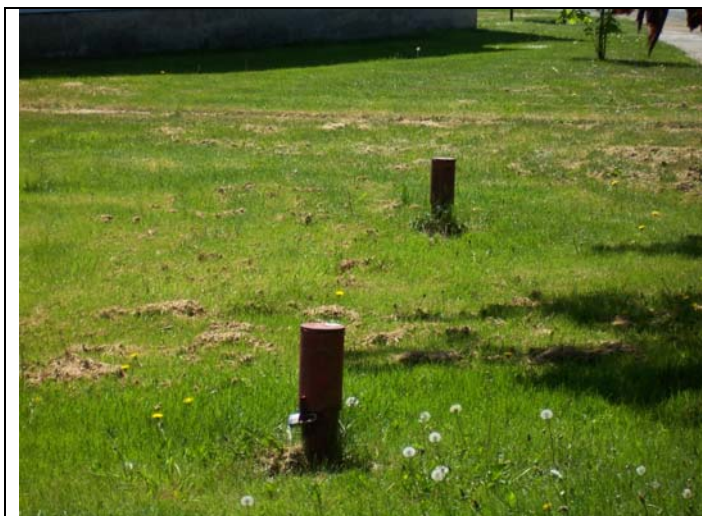
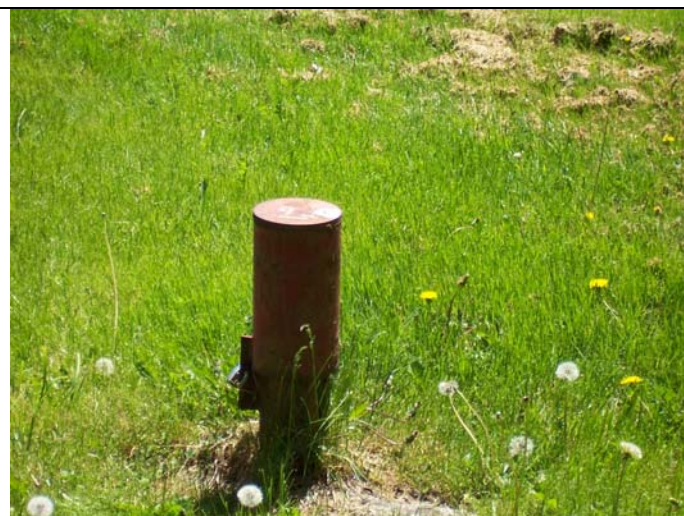
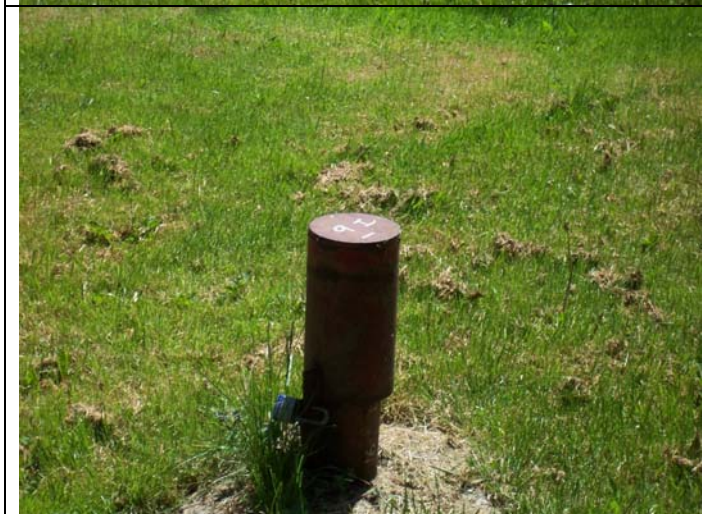
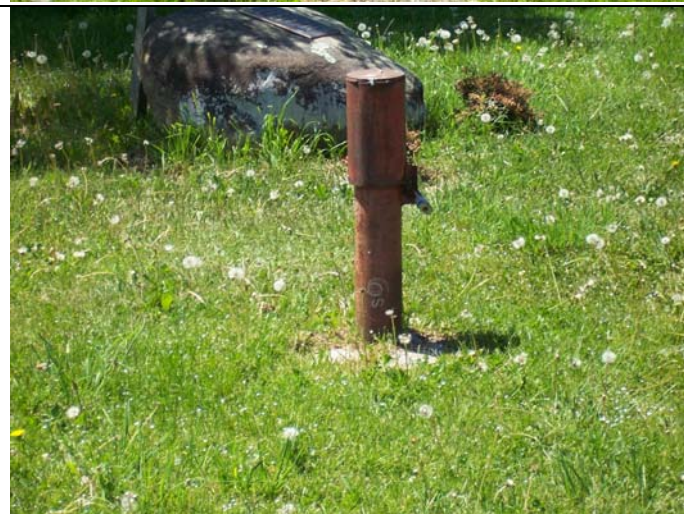
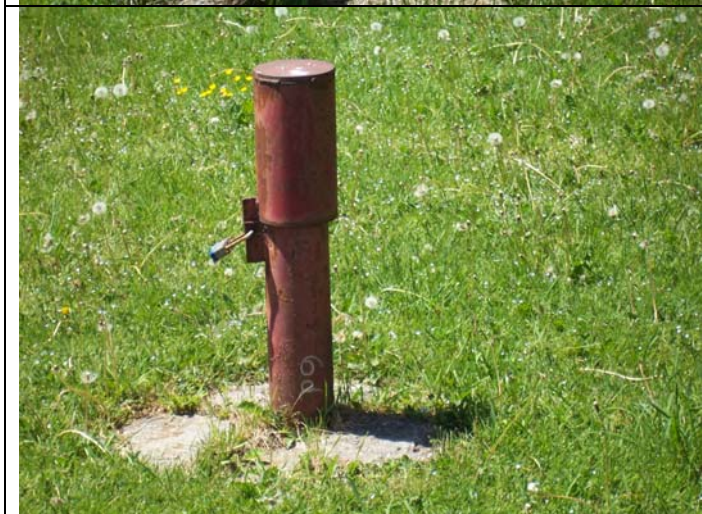
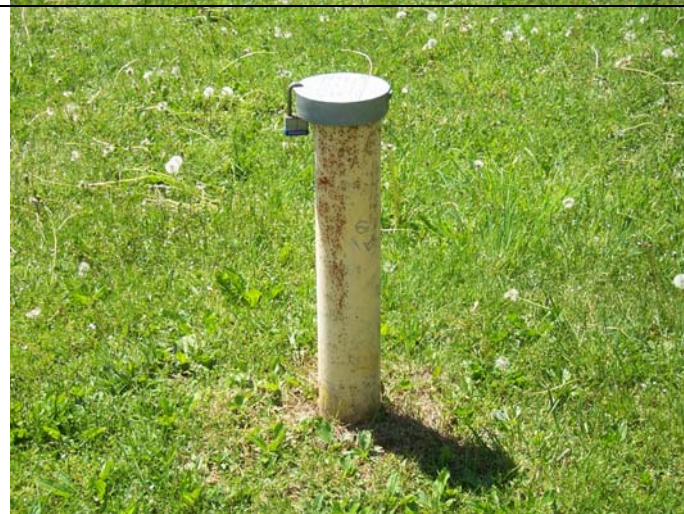
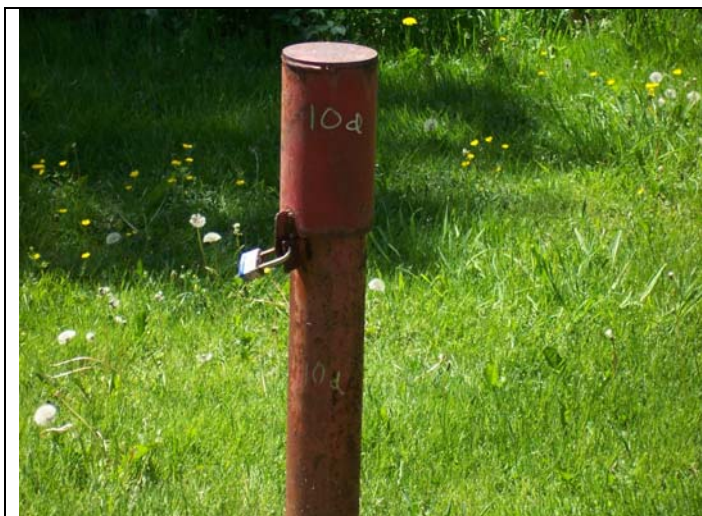
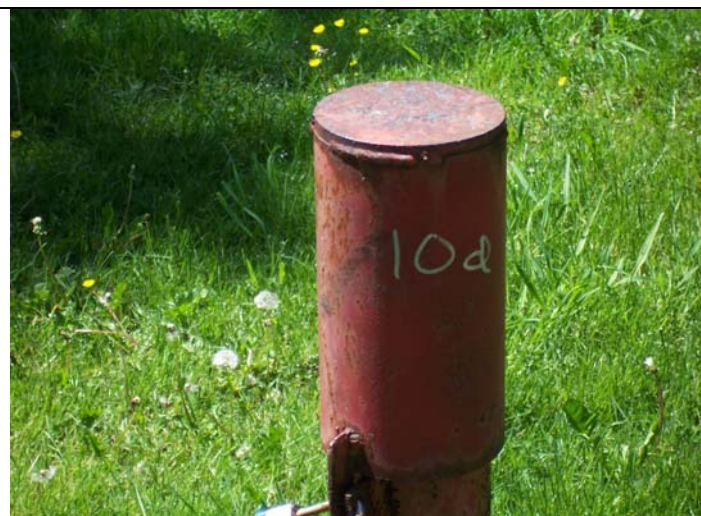
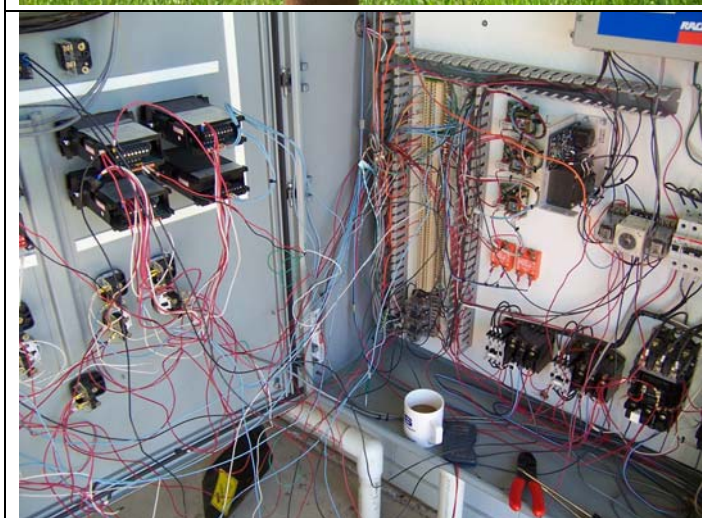
All the monitoring wells were in need of rehabilitation. Will Welling was in charge of the painting of the monitoring wells.

Will Completed the rehabilitation of the monitoring wells. Each well was scraped, painted silver, and stenciled with the monitoring well number in green enamel. Silver paint was chosen because it does not conflict with any utility mark-out colors.
