Painting Gladding Cordage's Monitoring Wells

Monitoring Well Inventory, 5/30/2007

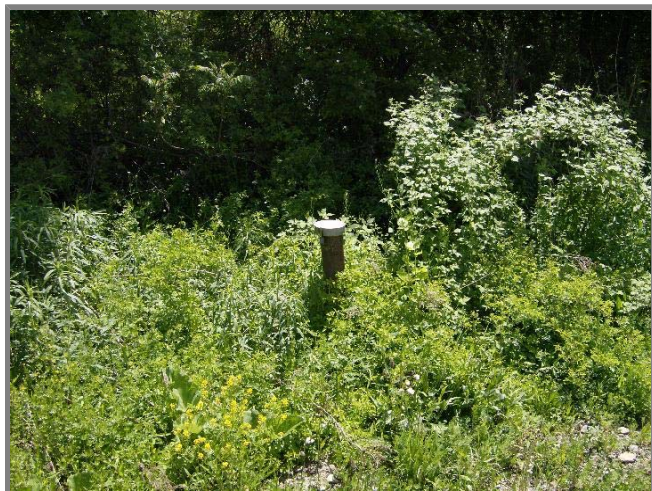
TW-1 before clearing and preparation

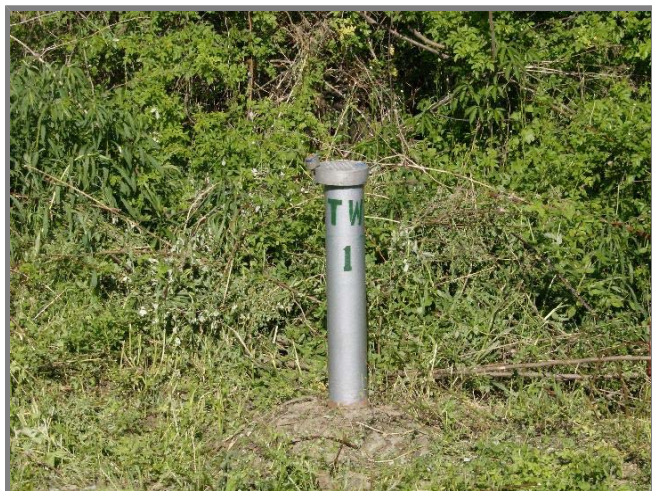
TW-1 after painting

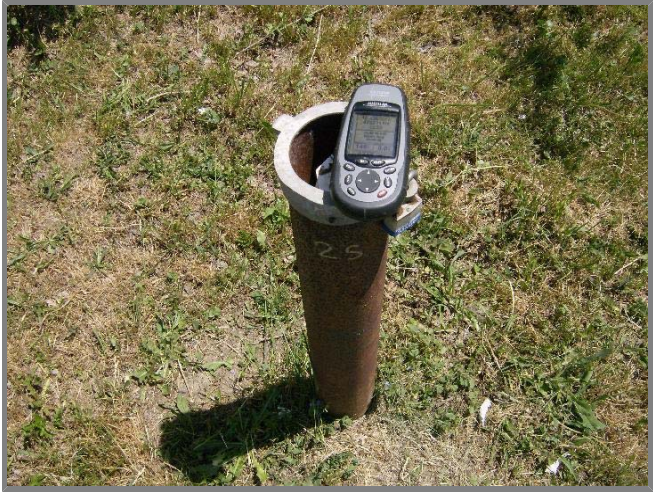
TW-2S before

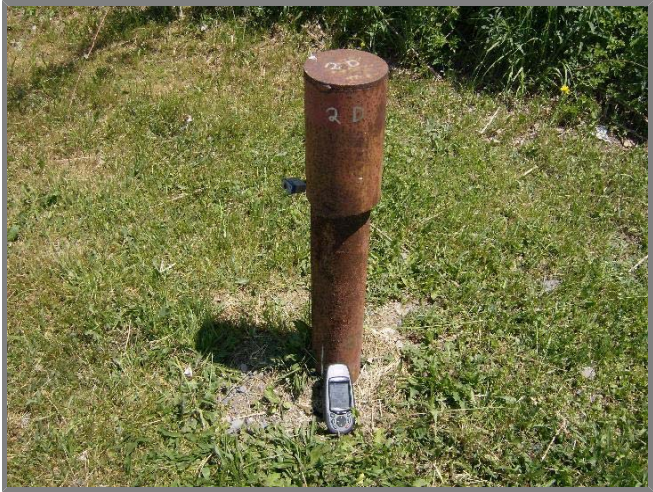
TW-2d before

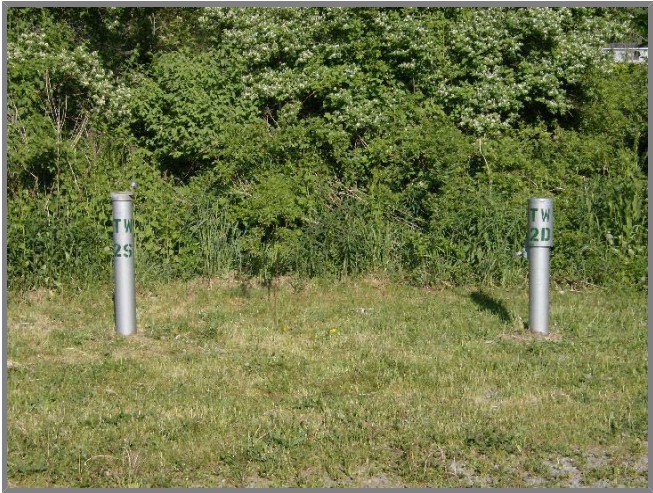
TW-2s and TW-2D after painting

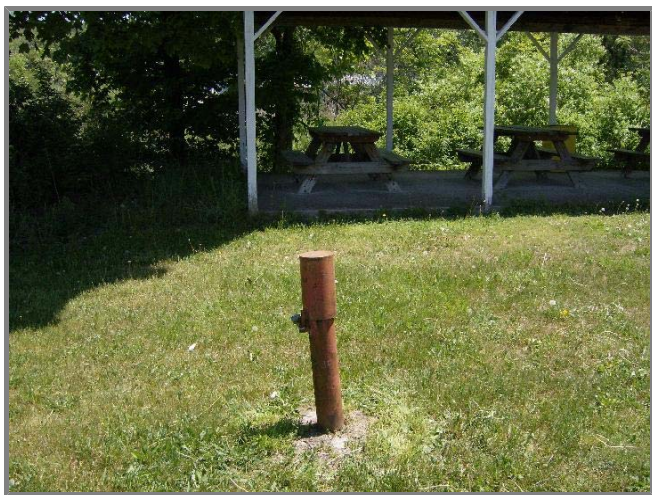
TW-3i before

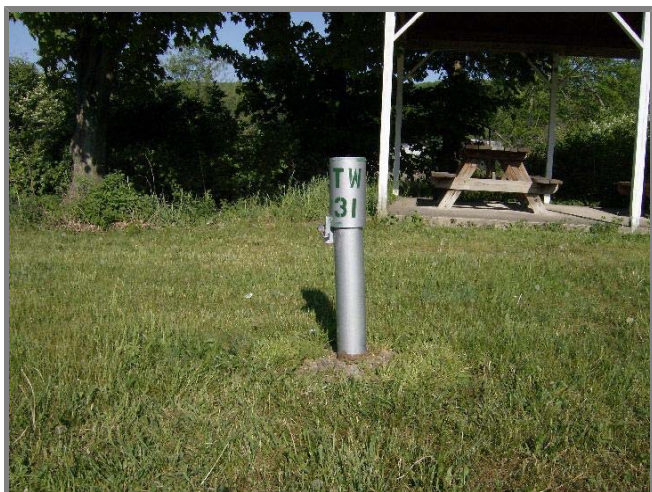
TW-3i after painting

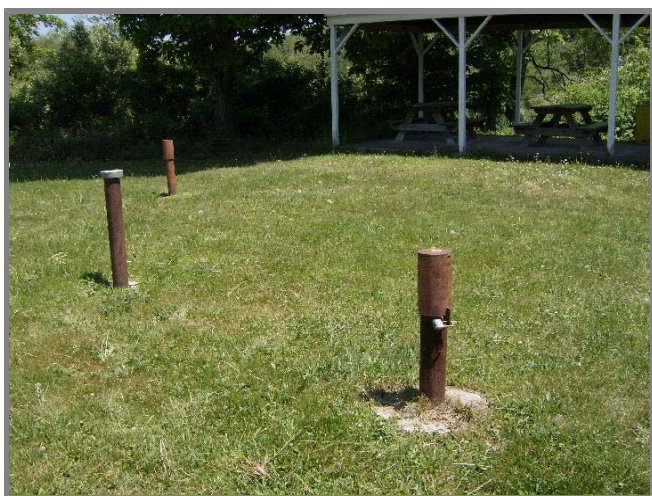
Combined shot of TW-3i, TW-3s, and TW-3d before

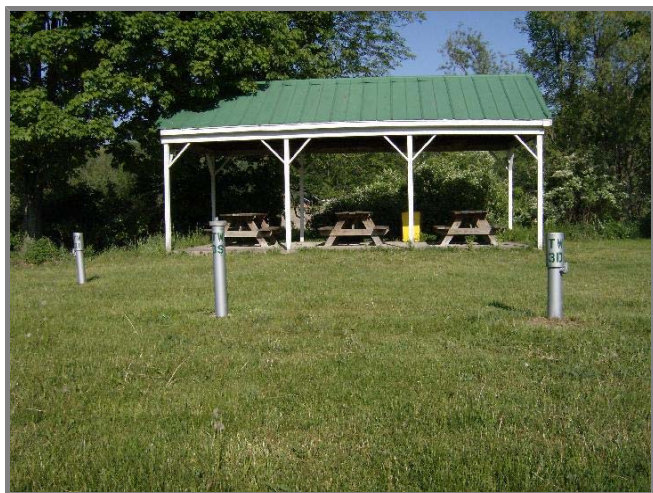
Combined shot of TW-3i, TW-3s, and TW-3d after

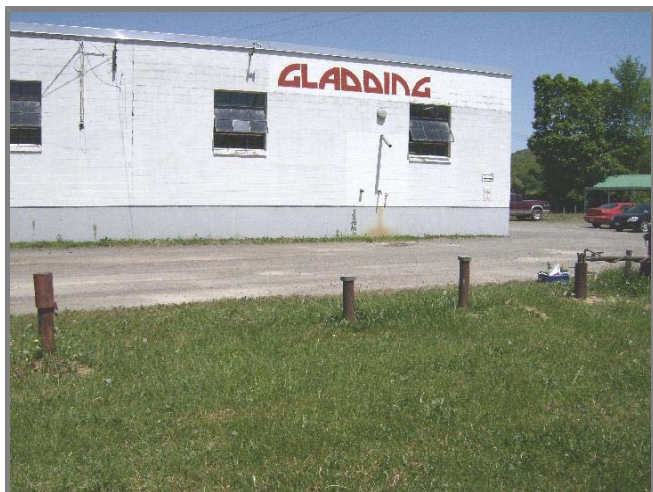
Combined "before" shot, of TW-5d on left, TW-5i in middle and TW-5s on right.

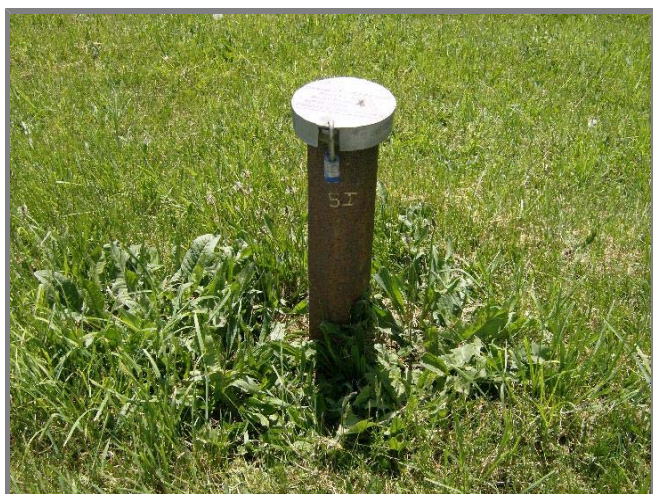
TW-5i before

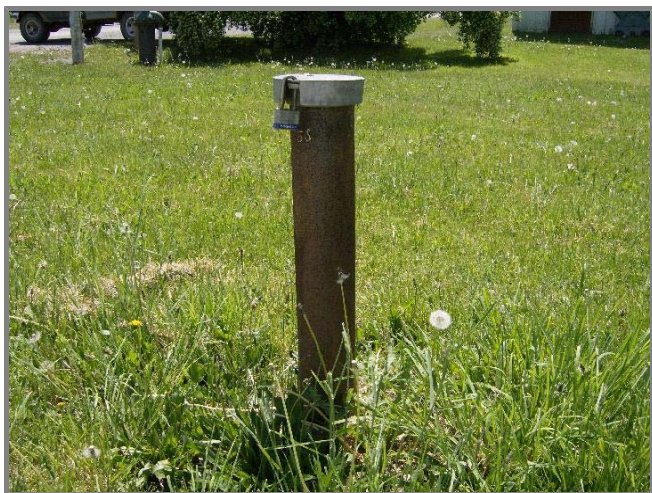
TW-5s before

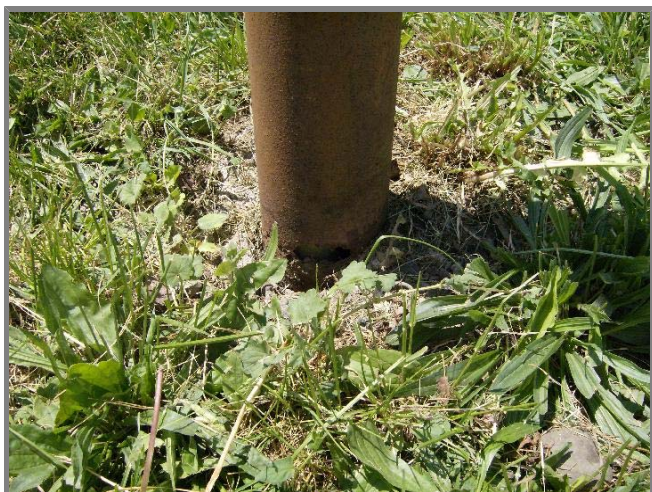
TW-5s has a rust hole at the base of the protective casing, not very visible in this photo, but the hole is oval-shaped, about two inches across.

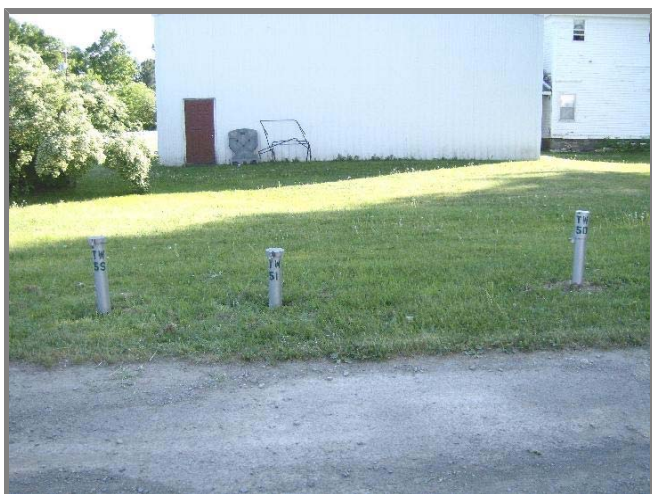
Combined "after" shot, from the other side, of TW-5s on left, TW-5i in middle and TW-5d on right.

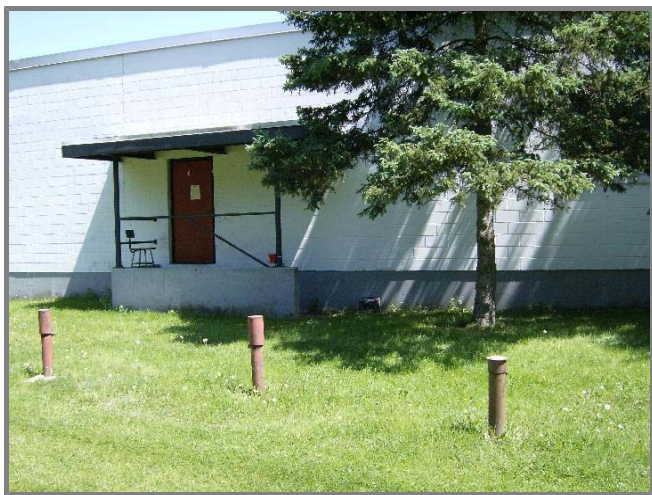
The TW-7 series "before"

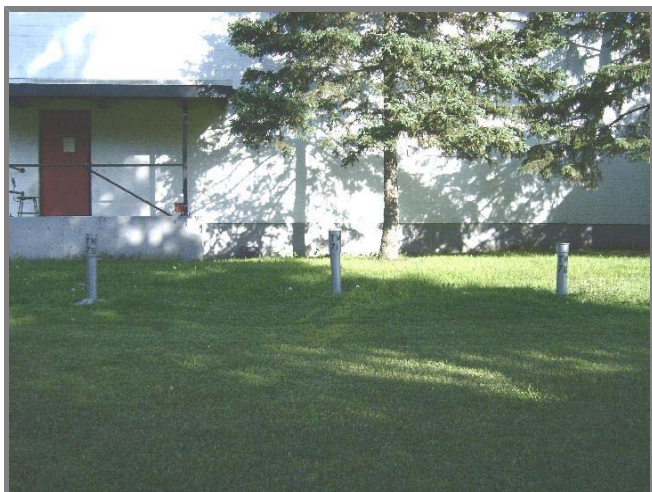
The TW-7 series after painting. Order: s, i and d on right. I did not sound these wells. I opened it to see if there was a name inside the pro casing but there was not. TW-7d's lock is in place but not locked. I could not close it-- too rusty. I had some doubt as to the names of these wells. If I have mis-labelled them, the "i" or "d" will have to be re-painted as appropriate.

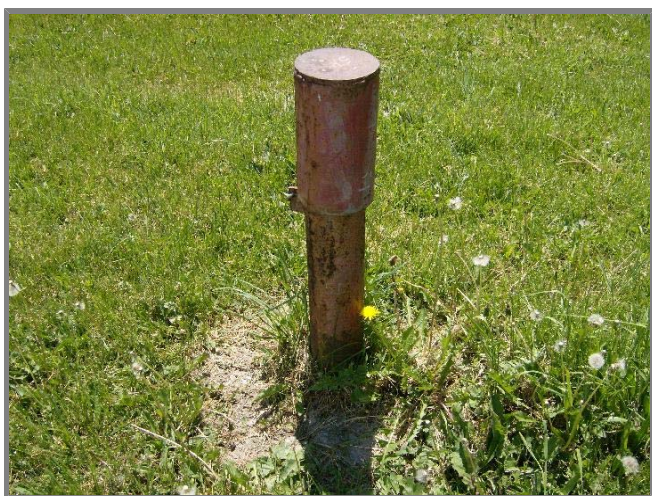
TW-7d before

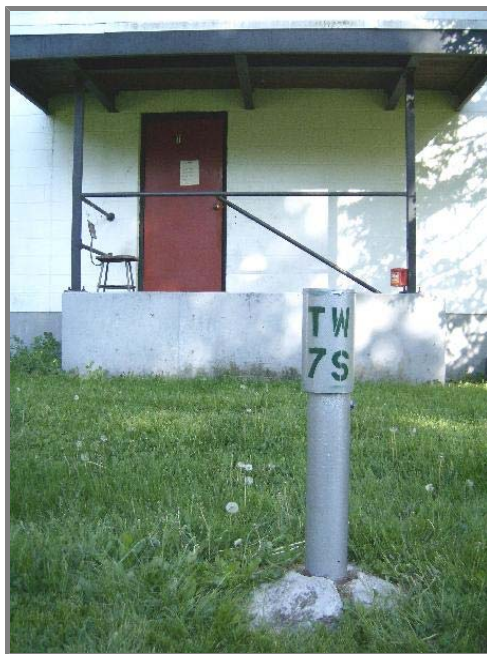
TW-7s after

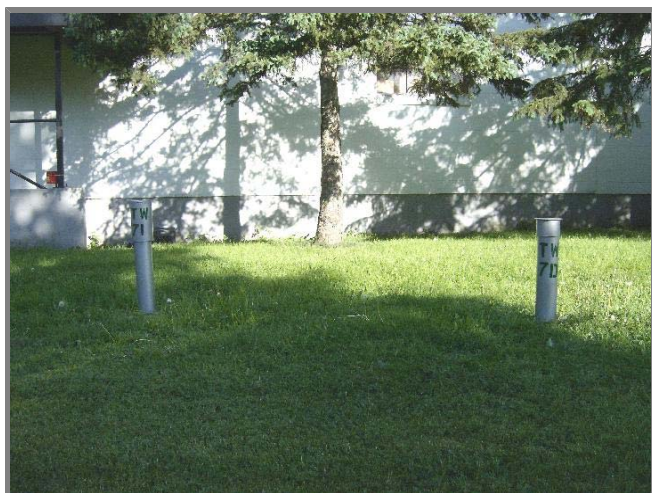
TW-7i and TW-7d after

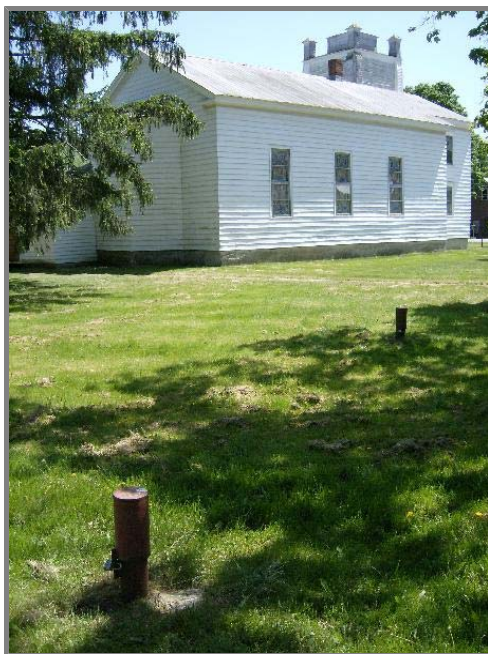
TW-9d and TW-9i before

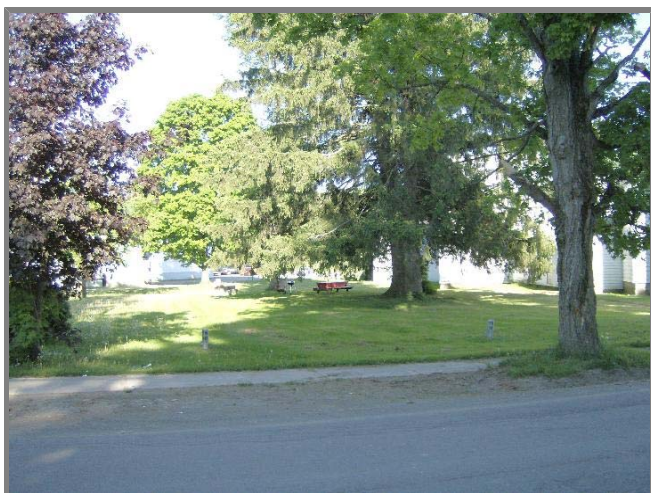
TW-9d and TW-9i after

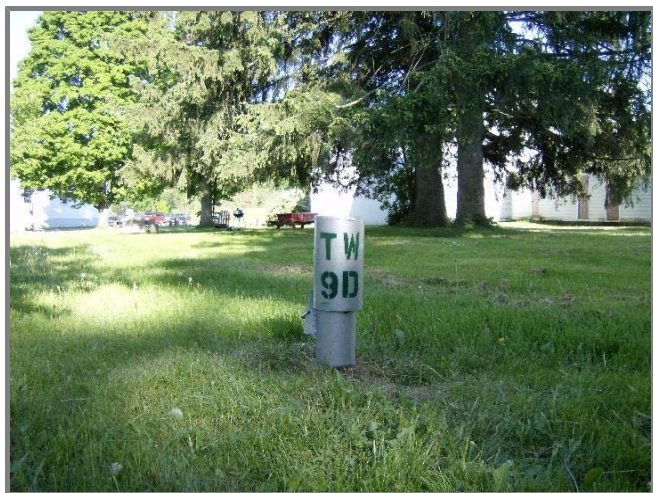
TW-9d after

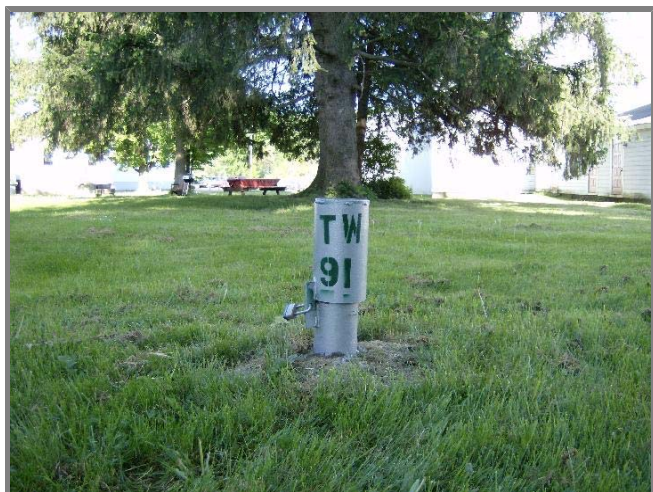
TW-9i after

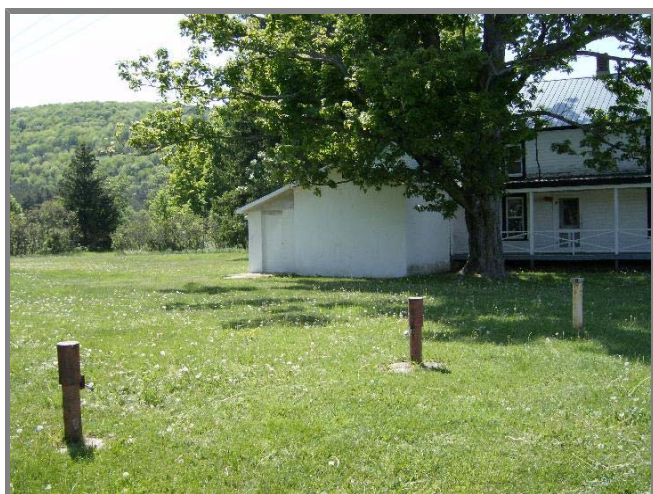
TW-6s left, TW-6d center, and TW-6i right, "before" shot

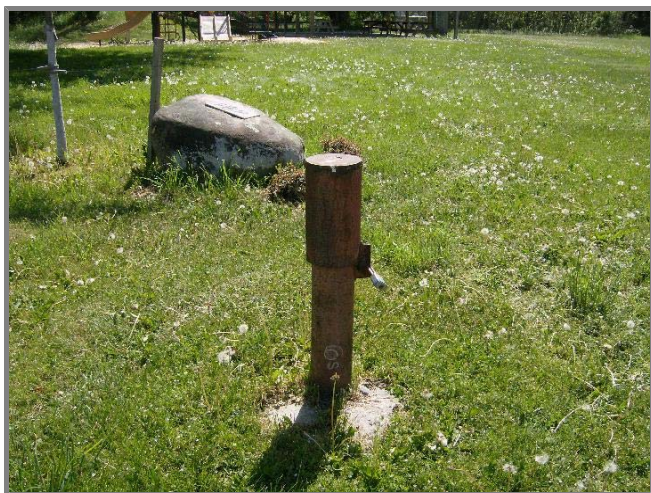
TW-6s before

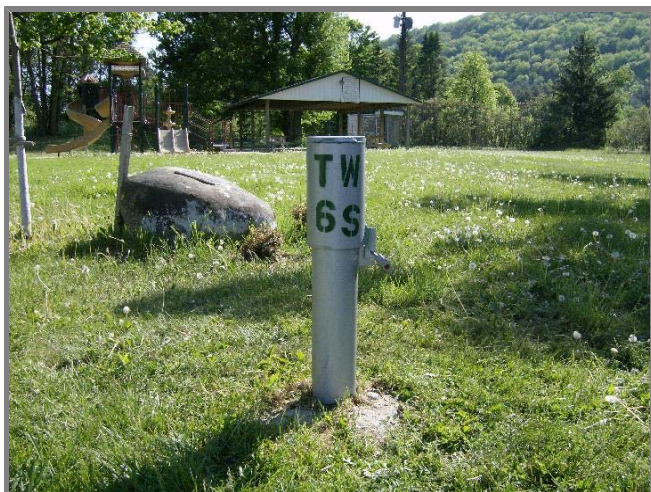
TW-6s after

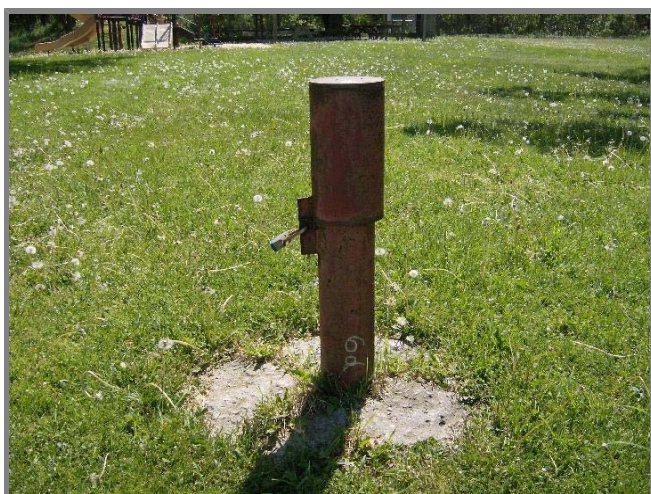
TW-6d before

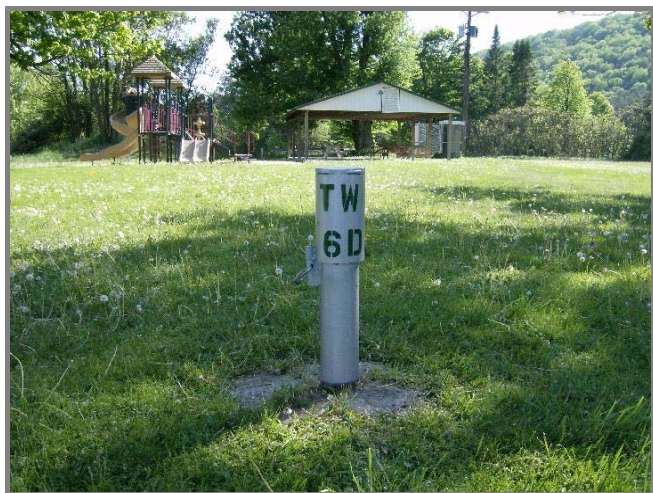
TW-6d after

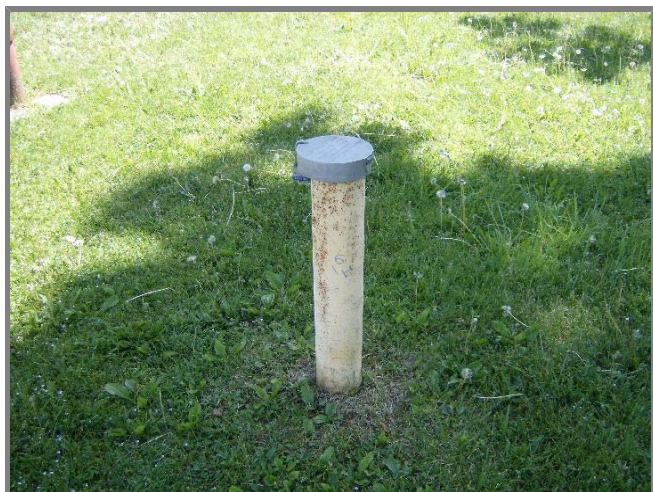
TW-6i before

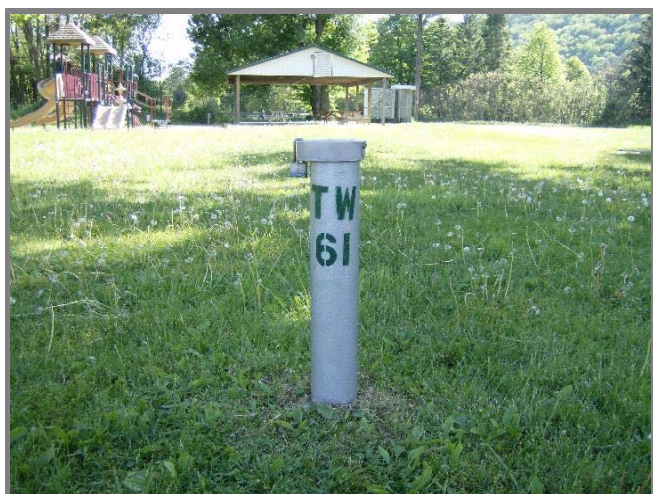
TW-6i after

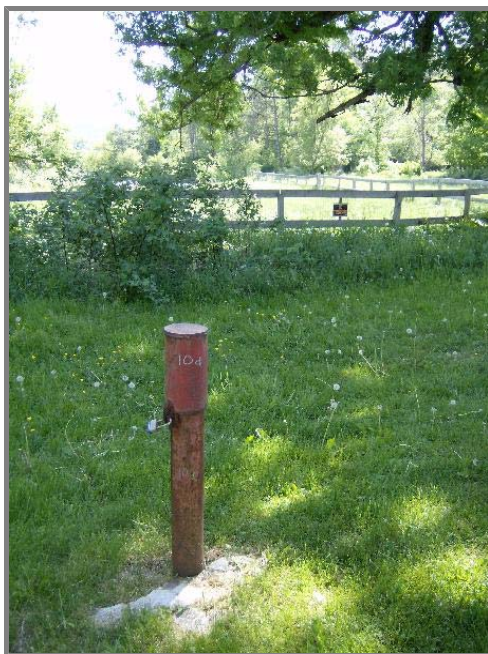
TW-10d before

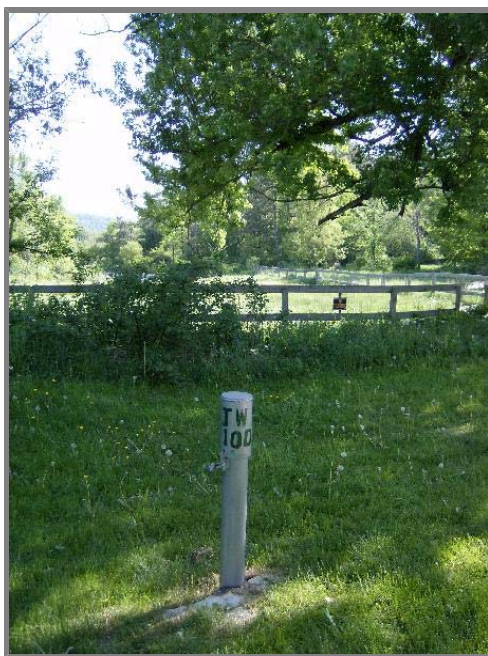
TW-10d after

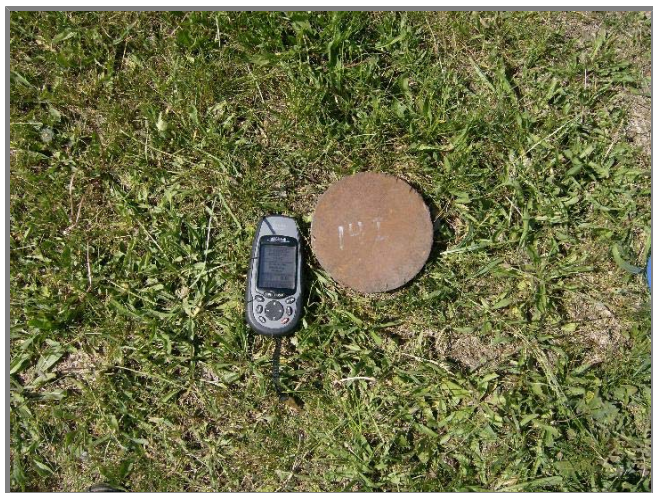
TW-14i before. I painted this flush cover but did not label it and did not photograph it after painting.

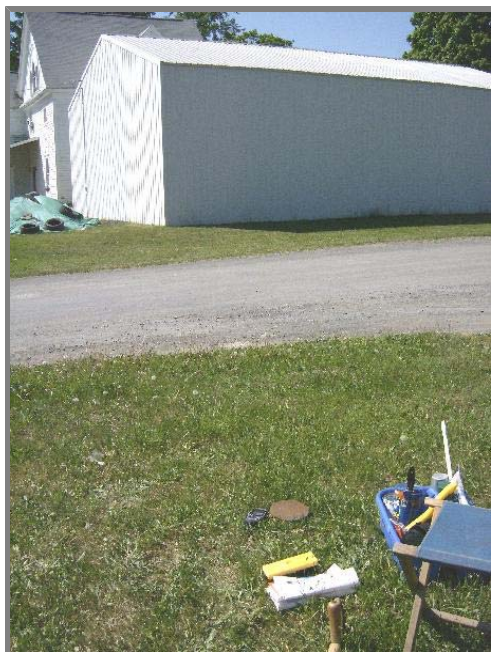
Location of TW-14i showing church building proximity in back, across the Gladding driveway

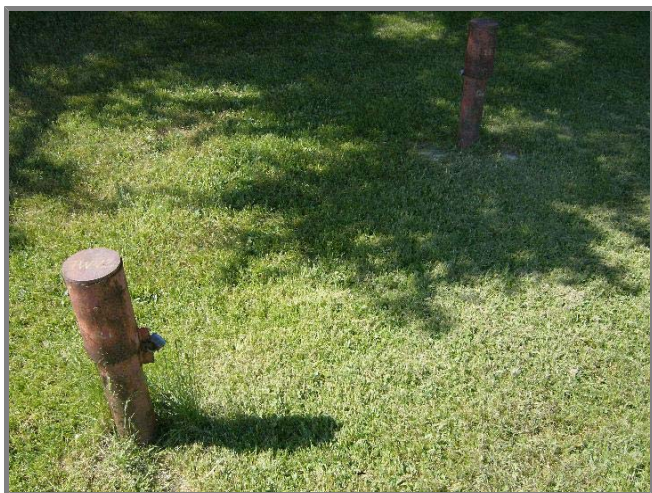
TW-12i and TW-12d (dark in back) "before" shot

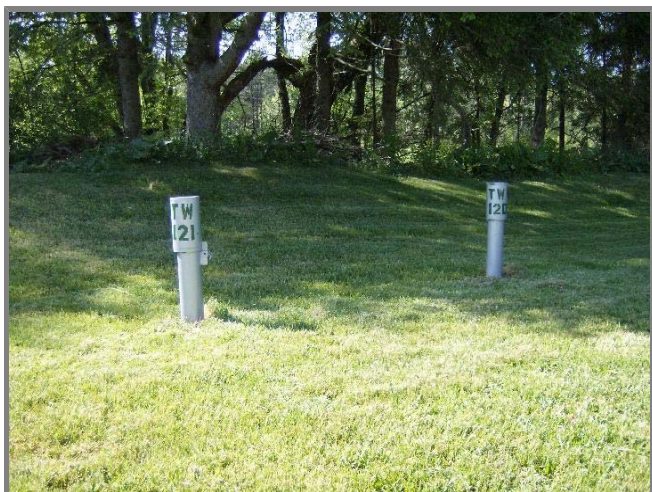
TW-12i and TW-12d "after" shot
