Gladding Cordage Well Rehab. and Panel Wiring Work

Monitoring Well Inventory. Written 10/9/2007 by WB Welling, EG 2. 10/04/2007

Photos with Notes

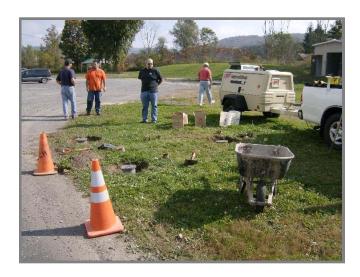
Work began to place the flush wells inside proper road boxes with concrete collars. Jason form AzTech and Jeremy from Malcolm Pirnie were at work when we arrived at approximately 10:30AM on 10/04/2007.

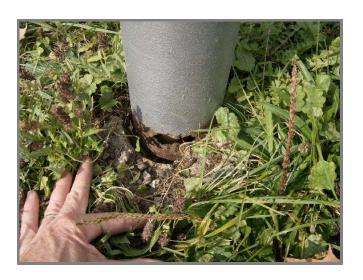
A couple of other wells required work this day. TW-5S shown in this photo has a rust hole in the protective casing. AzTech used the hole with a lever and jacked the casing off the well. They replaced the casing with a new stick-up.

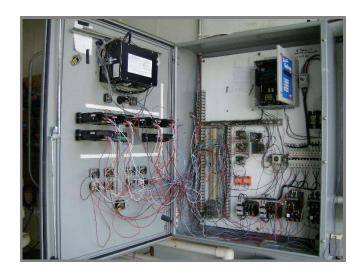
One of the tasks of the day was to clean up the wiring in the control pannel. At day's end the inside was neat as a pin.

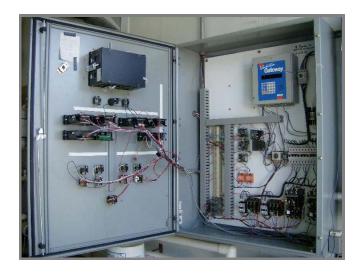
This is the "after" shot. The reason for the re-wiring and eventual cleanup was to simplify the controls to make the system operate more reliably.

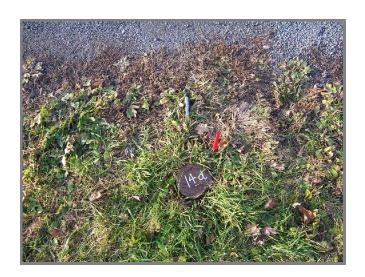
TW-14d as photographed in 2005.

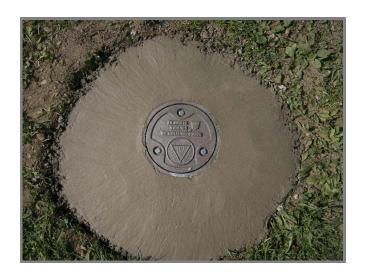
(Left) TW-14d, new roadbox and collar just emplaced on 10/4/2007. TW-14d is the well on the right in the above photo.

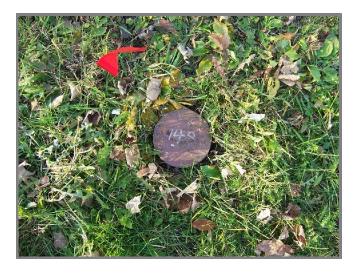
TW-14s in 2005.

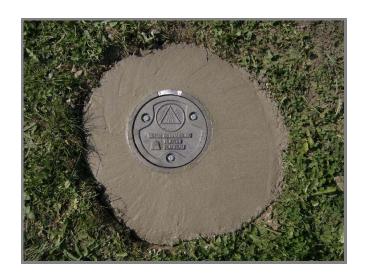
(Left) TW-14s, new roadbox and collar just emplaced on 10/4/2007. TW-14s is the well on the left in the above photo.

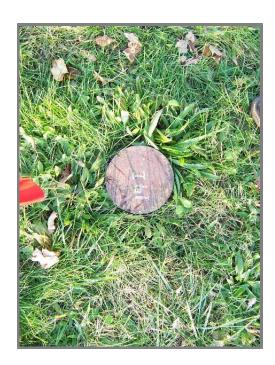
TW-14i in 2005.

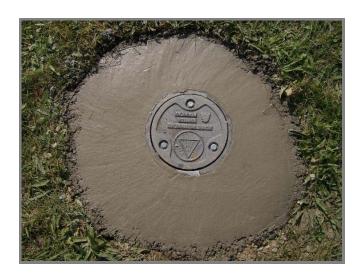
TW-14i, new roadbox and collar just emplaced on 10/4/2007. TW-14i is the well nearest the camera in the above photo.

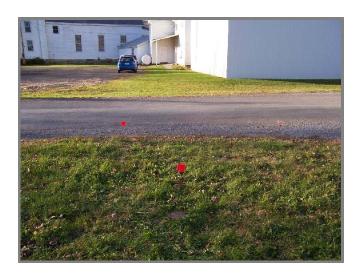
The 14 Series in 2005. Almost impossible to see in 2005! Wells in this photo are marked by red flags and even they are hard to see!

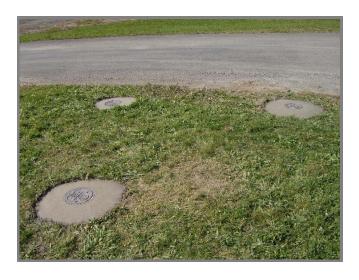
The 14-Series wells in November 2005 when sampling bags were placed in the wells for annual sampling. TW-14D is on the right, TW-14I is closest to the camera. TW-14S is located near the flag on the left.

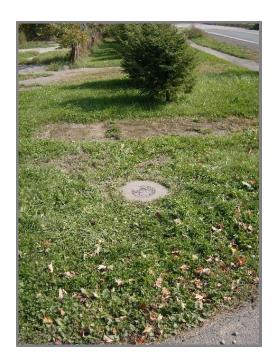
TW-4I is tho only remaining well from this series which once also included TW-4S and TW-4D.

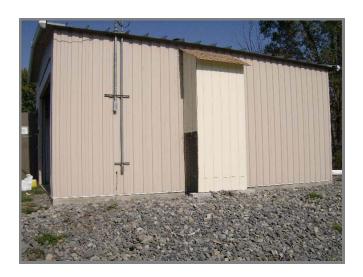
painted enclosure after our second coat which was applied 10/4/07
