Date: April 30, 2021
Our Ref: 30055695
Subject: Gladding Cordage Health and Safety (H&S) Diagnostic Audit
NYSDEC Site No. 709009
Contract No. D009804-11

Gladding Cordage – H&S Audit
NYSDEC Site No. 709009

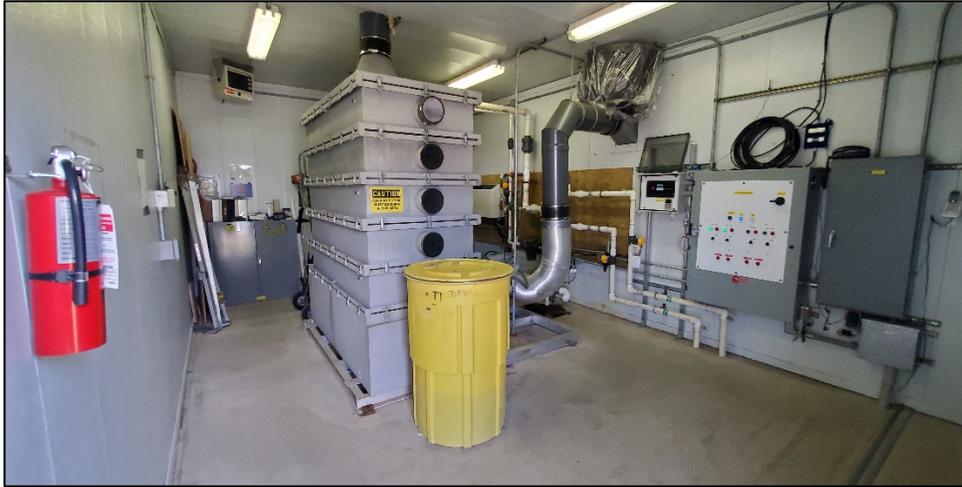
Photograph: 1

Description: Interior view of Treatment System building.

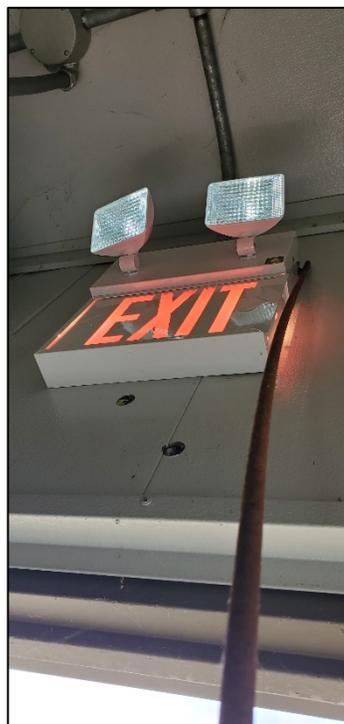
Photograph: 2

Description: Exit Sign located above entry door.

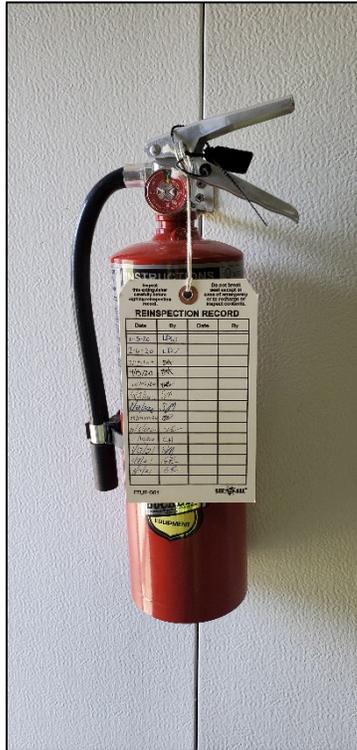
Photograph: 3

Description: Fire Extinguisher with inspection record.

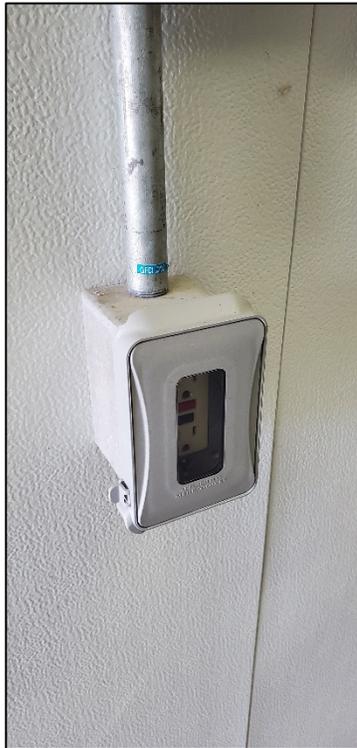
Photograph: 4

Description: Ground-fault circuit interrupter (GFCI) outlet.

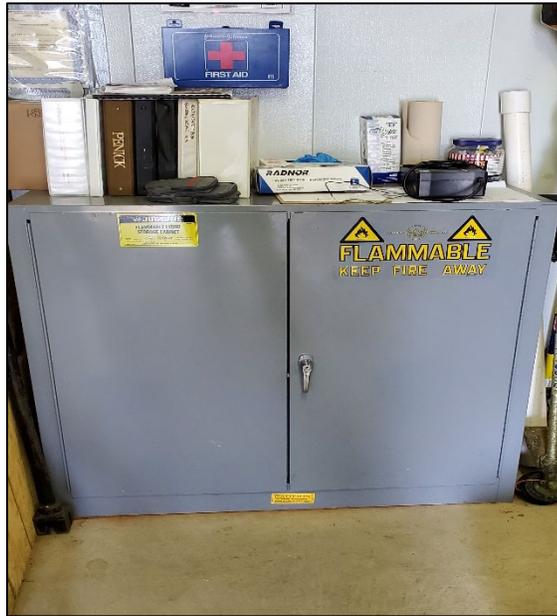
Photograph: 5

Description:
Flammable Storage
Cabinet.

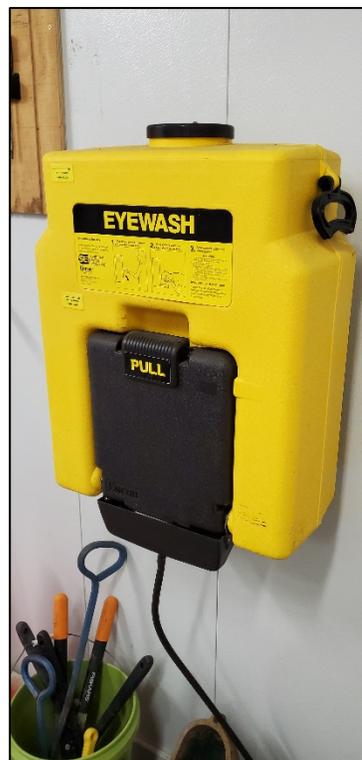
Photograph: 6

Description: Eyewash
Station.
