APPENDIX R
DAILY FIELD REPORTS – IRON WALL PROJECT

S&W Services Daily Field Reports

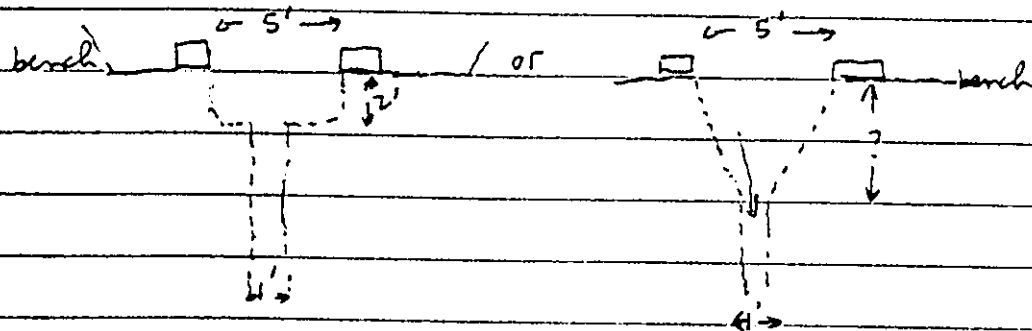
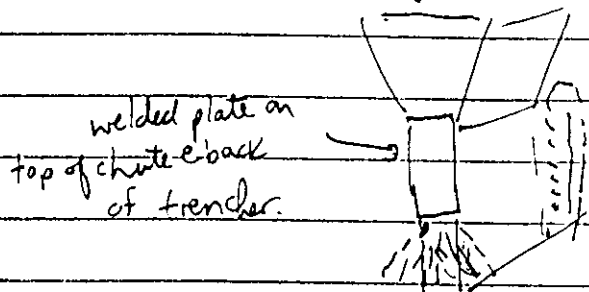
but still question as to configuration of iron, especially in last 70-75 ft section.

- open area/caving between timbers - 4 to 5 ft wide at bench level, how far down does this extend? Did a lot of iron end up in "cave" area & is not going to depth?

- lots of iron came out immediately below plate at top of chute opening & entered wide excavation - was this iron moved via "trenching action" into bottom of trench as per design, or did it

"pancake" out into "cave area" & not move to depth?

(i.e. not flowing)
