Subject: **NAPL Recovery – Status Report for September 2015**
Site #: 7-09-011
NYSEG – Norwich Former MGP Site

On behalf of New York State Electric and Gas Corporation (NYSEG), AECOM has prepared this monthly status report to describe events associated with non-aqueous phase liquid (NAPL) recovery at the Norwich Former Manufactured Gas Plant (Site) in Norwich, NY. This letter provides a summary of activities at the Site during the month of September 2015. Figure 1 shows the layout of the NAPL recovery system.

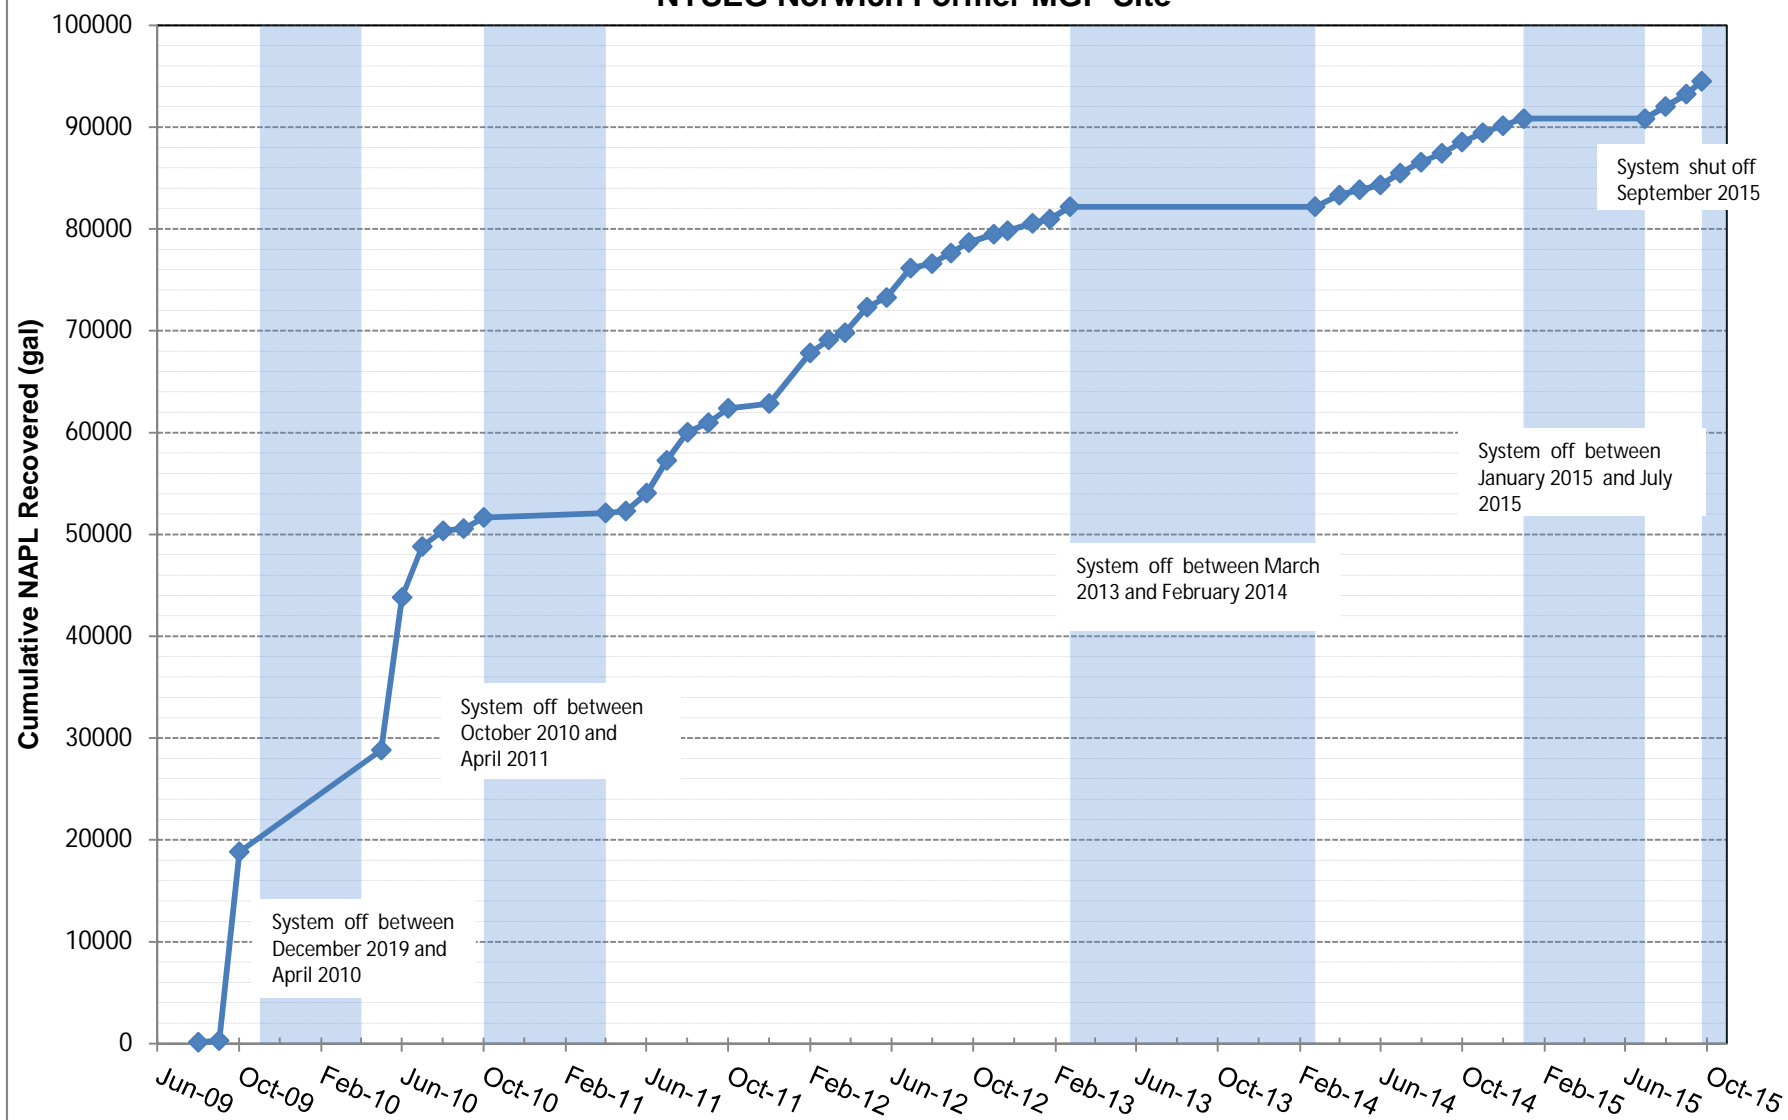
Figure 2
Cumulative NAPL Recovery (2009 - July 2015)
NYSEG Norwich Former MGP Site

During system operation throughout the month of September, the NAPL collection system recovered 1277 gallons of total fluids (NAPL and water) for a total volume of 94,517 gallons to date. The total fluids recovery rate was approximately 43 gallons per day (gpd). A summary of recovered fluids in the month of September is provided below and a cumulative NAPL recovery summary is provided in Figure 2.

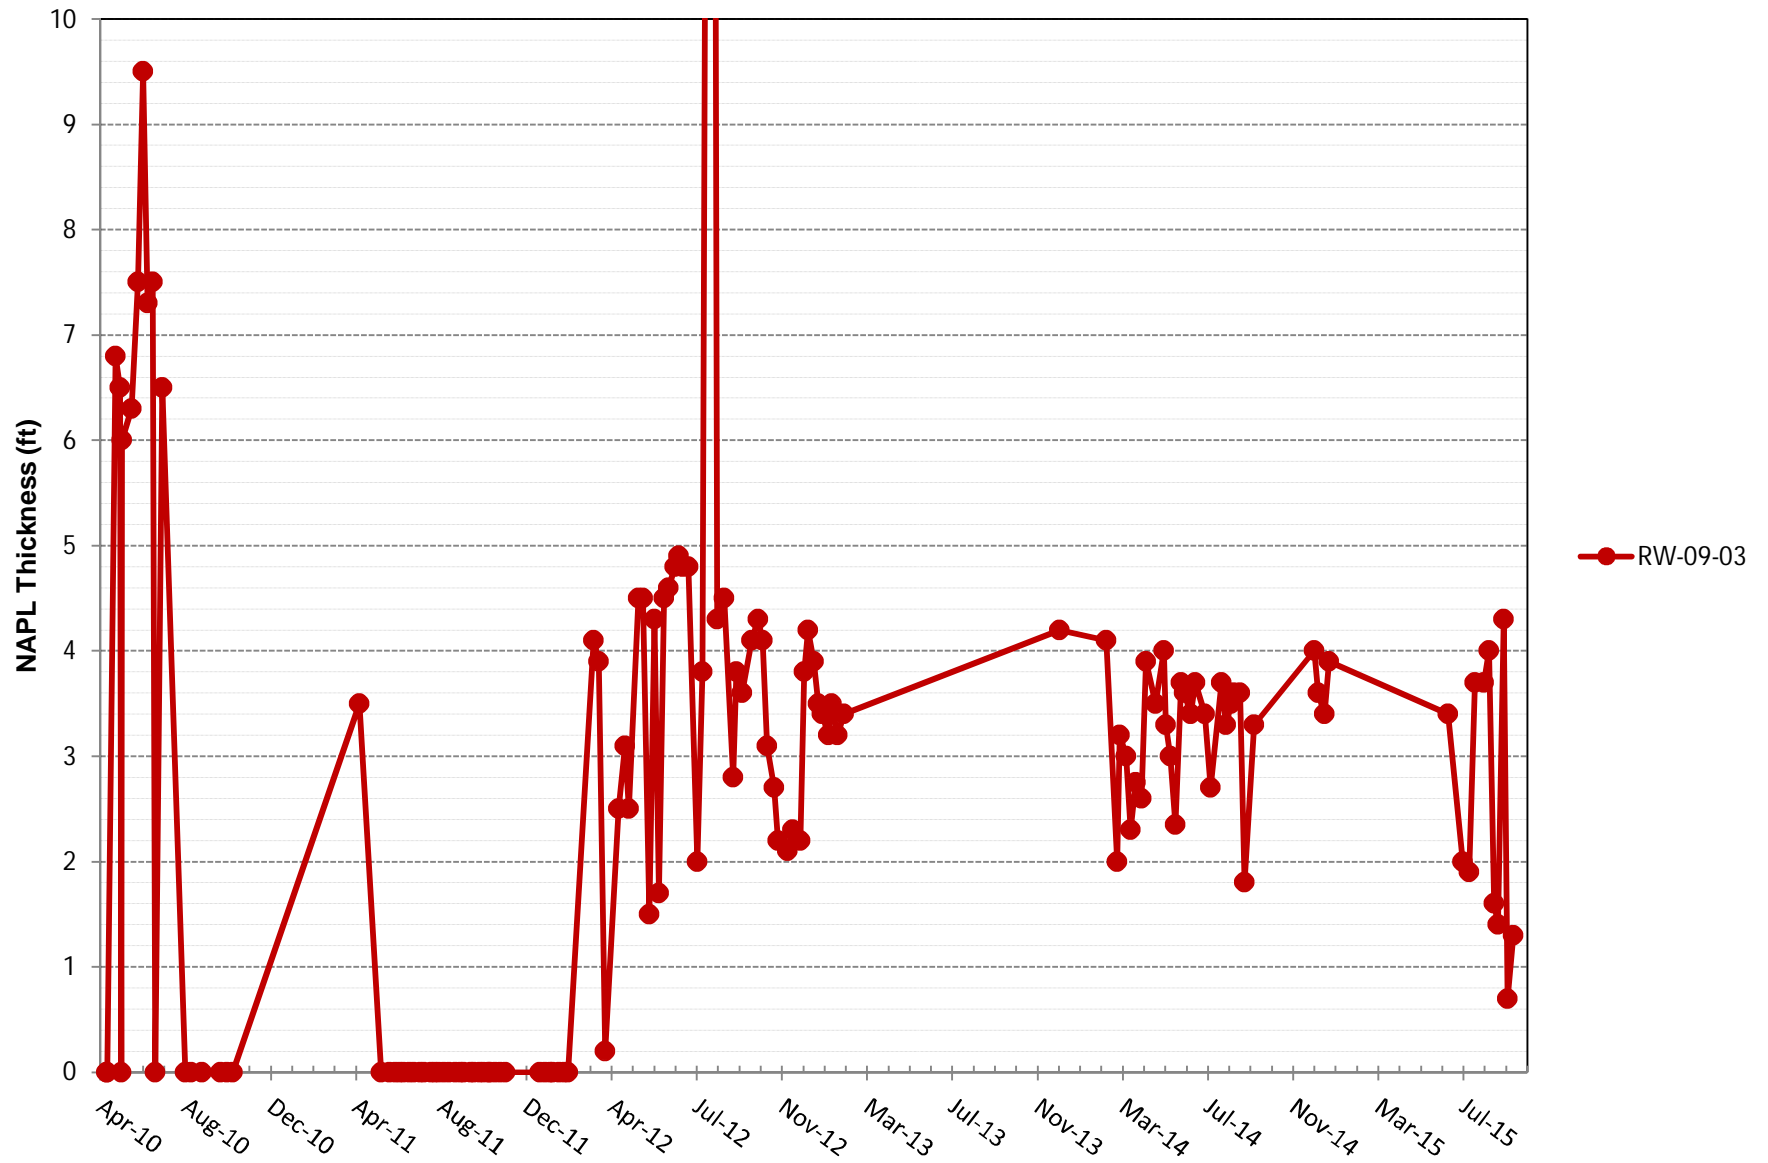
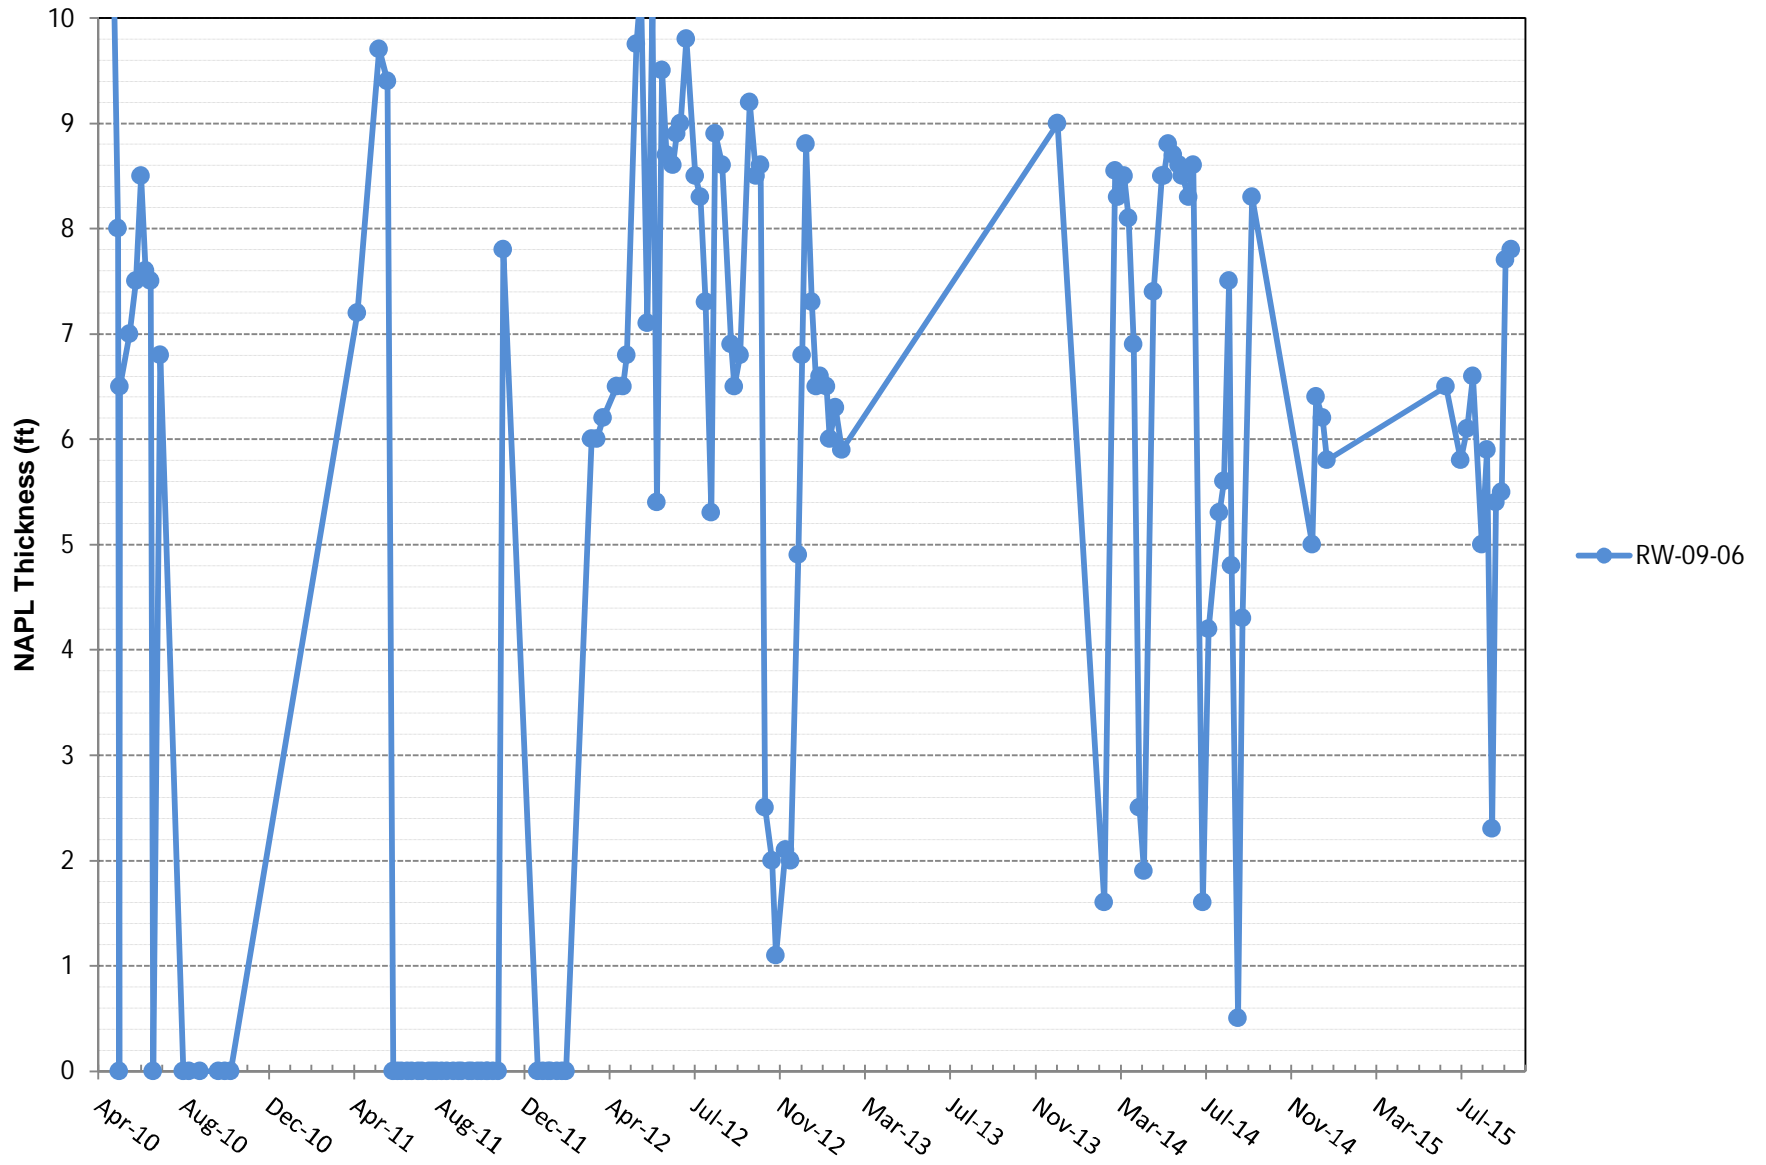
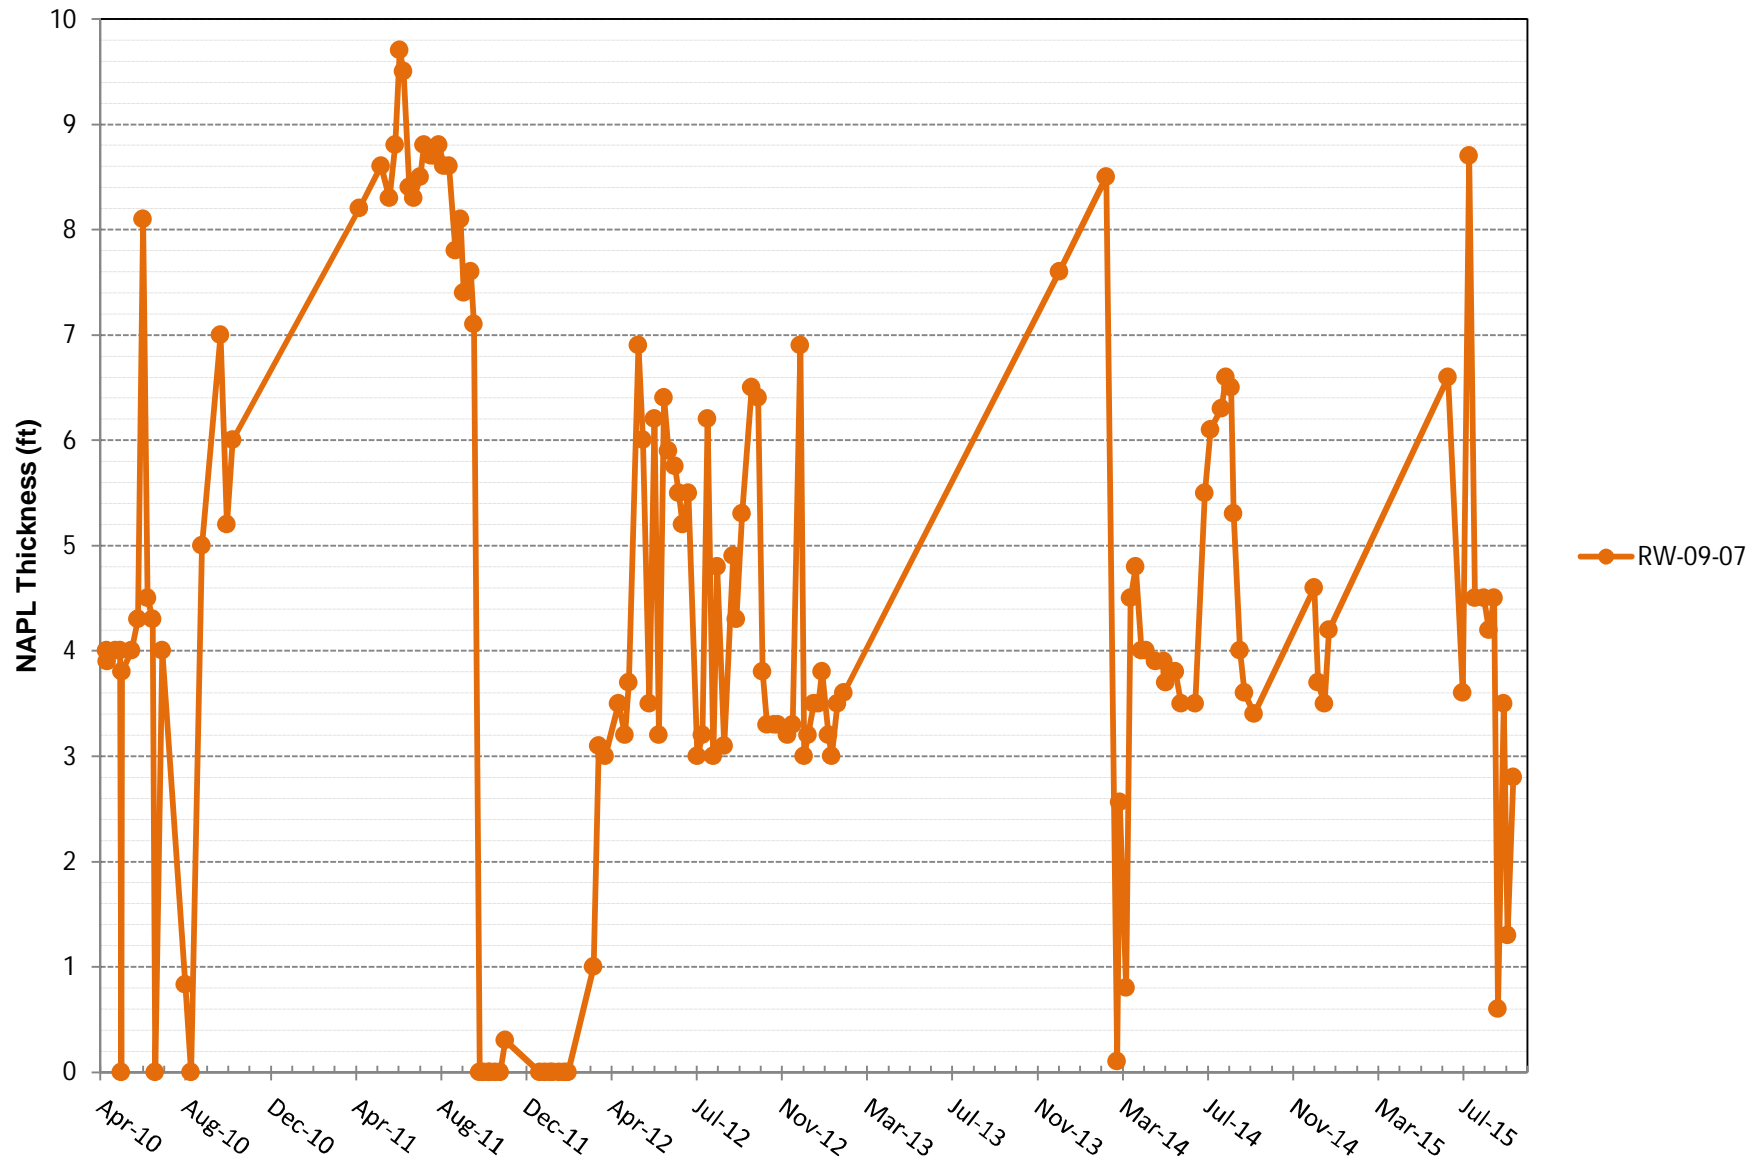
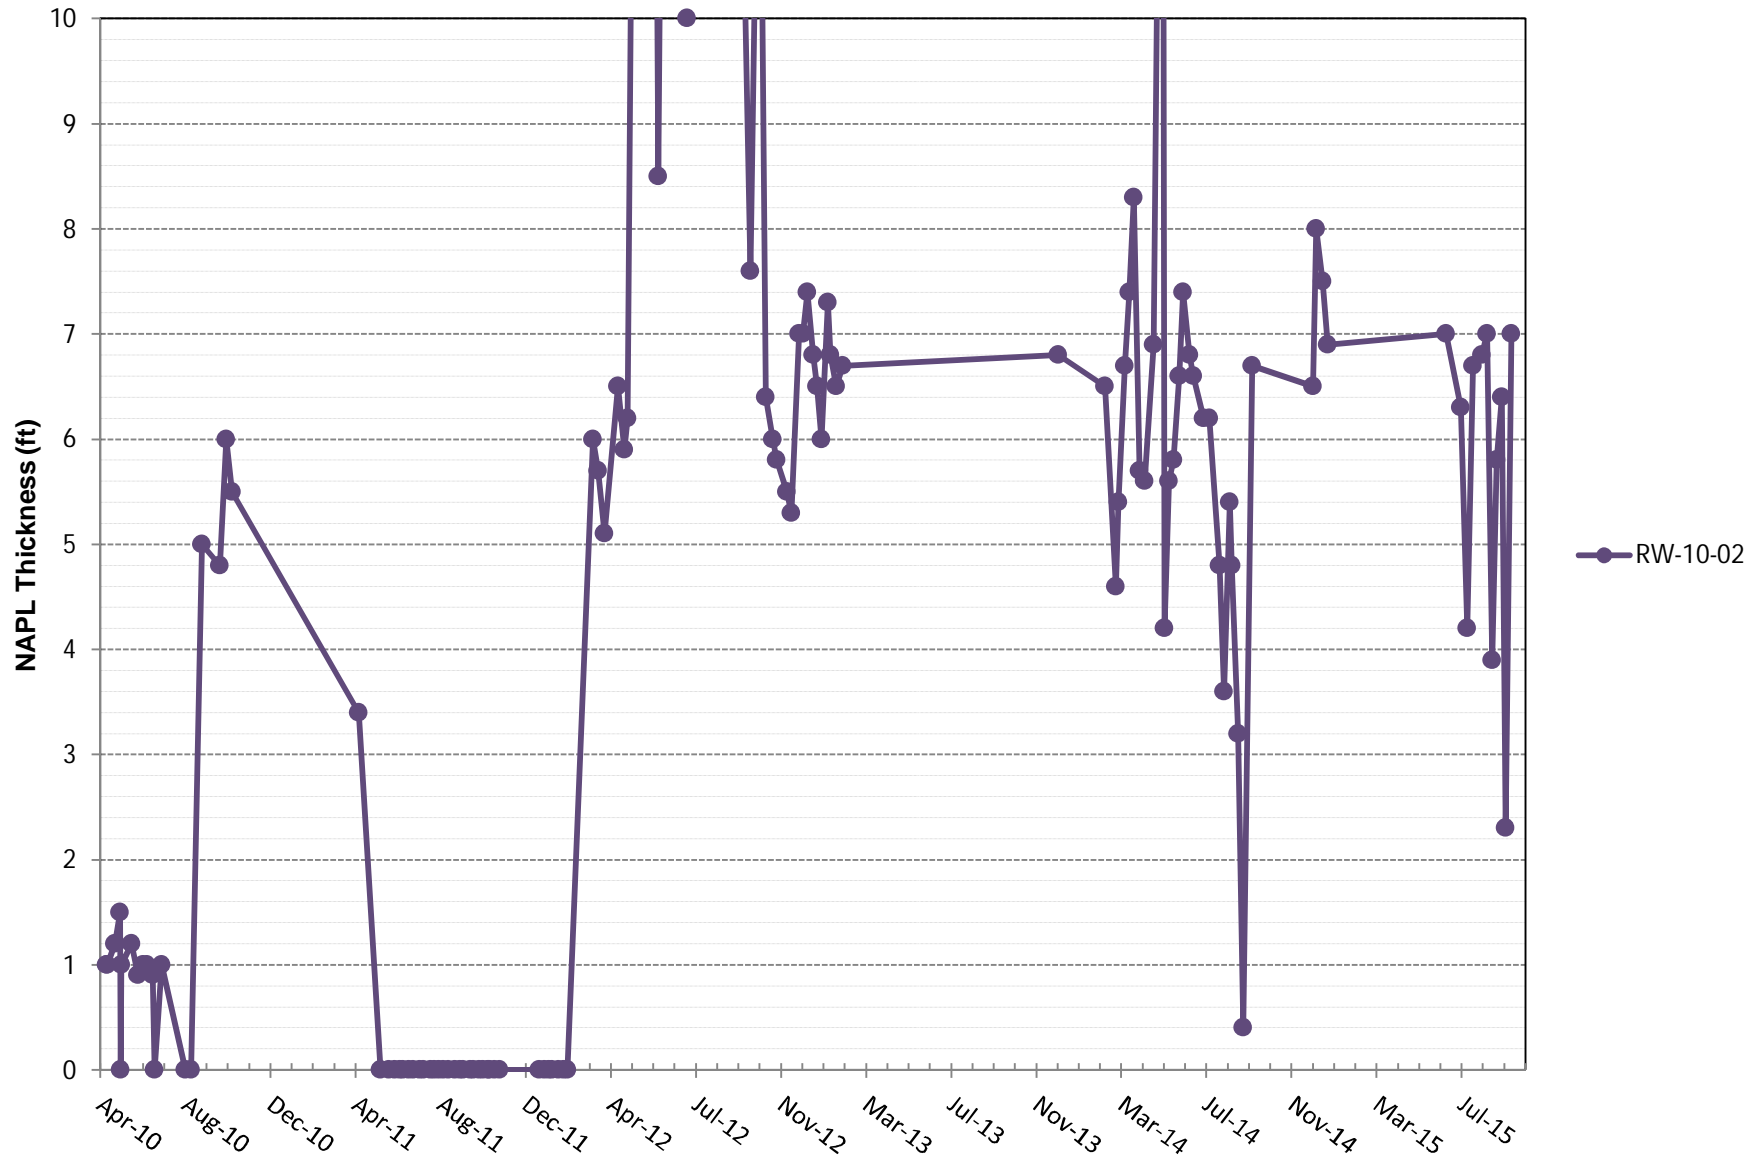
Measurements of NAPL thickness were taken as part of Site visits on September 2, September 10, September 15, and September 23 (see Table 1). As proposed in the March 2012 Status Report, a weighted steel tape with Kolor Kut[®] was used to gauge the wells for NAPL. Thicknesses are measured while recovery pumps are operational and do not reflect the static NAPL thickness in each well. Thicknesses of NAPL in each currently active recovery well are shown in Figures 3 through 6 and thicknesses of non-recovery wells are shown on Figures 7 through 12.

During the September 10th Site visit it was noted that the pump in well RW-09-07 was malfunctioning. At this time, the pump in RW-09-07 was shut off due to a severed discharge line. This is believed to be the result of a blockage caused by a more viscous tar than typically encountered. Once the problem has been resolved pumping from RW-09-07 will resume. On September 23rd, the collected coal tar reached the allowable volume within the tank trailer. The system has been turned off and will renew operation upon replacement of the current tank trailer.

NAPL recovery and monitoring will be reestablished following replacement of the current tank trailer.
