## TECHNICAL MEMORANDUM

**Re:** Drum Inventory and Location Survey

This technical memorandum describes the work efforts completed during the drum inventory and location survey for the property located on the southwest side of the Rosen Site, which is owned by the City of Cortland.

CITY OF CORTLAND PROPERTY  
DRUM INVENTORY AND LOCATION SURVEY  
CORTLAND, NEW YORK

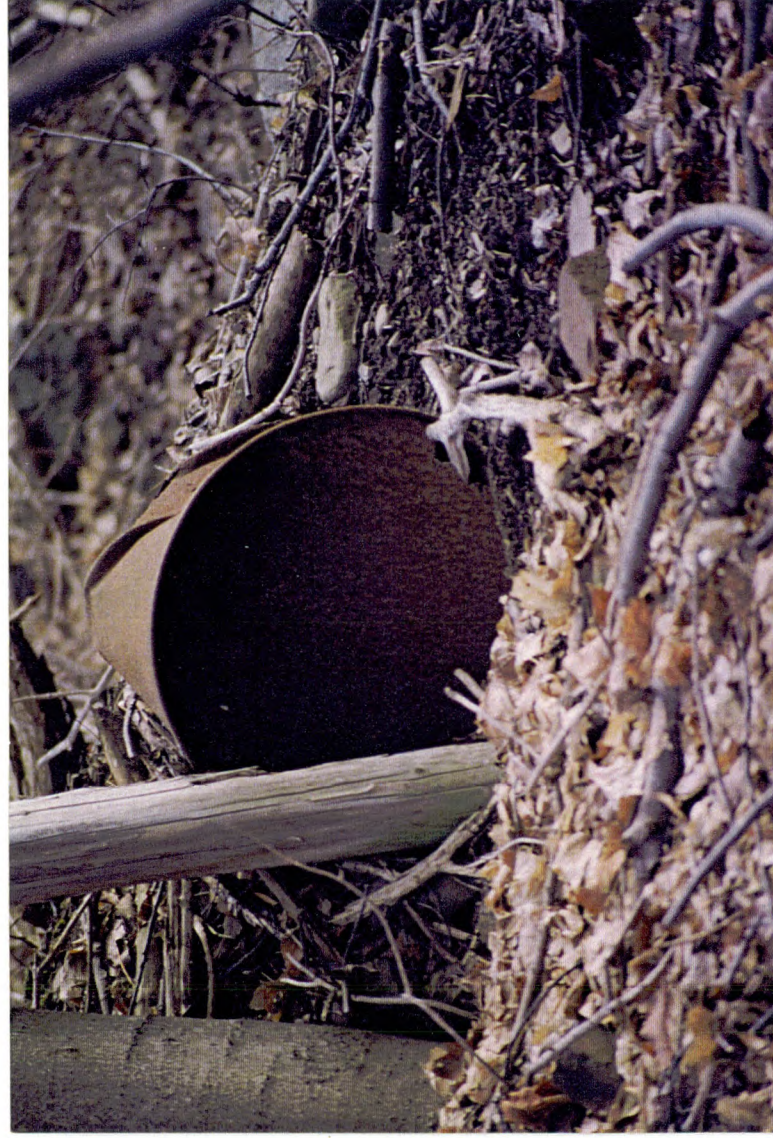
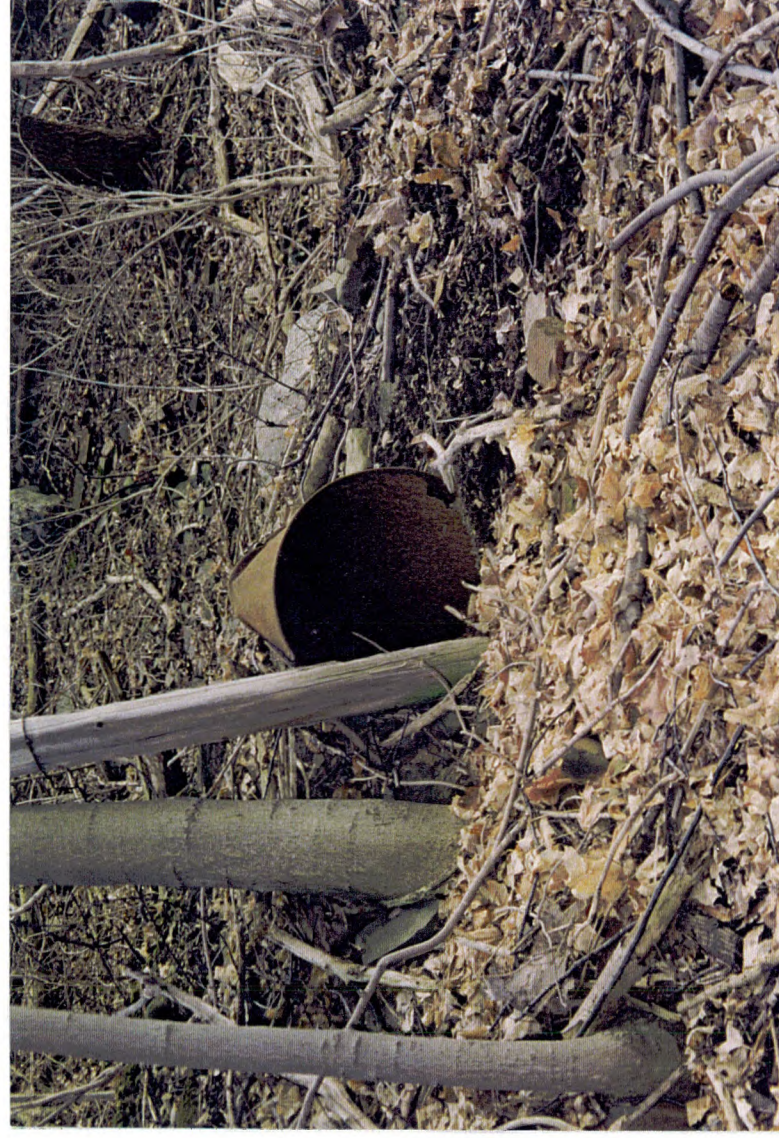
Drum Designation	Description
Drum #1	The 55-gallon drum is resting against an old wooden post with barbed wire. The wooden post is leaning against a tree. The drum was very rusted, crushed on one end, and had an opening in the other end, which faced downslope.
Drum #2	The 55-gallon drum is rusted and partially buried. One end is missing.
Drum #3	The 55-gallon drum is rusted, partially buried, and has an opening on the end facing downslope.
Drum #4A	The 55-gallon drum is almost completely buried, rusted, and open-ended.
Drum #4	The rusted 55-gallon drum is partially buried with the open end sticking up out of the ground surface.
Drum #5	The rusted 55-gallon drum is laying on its side on top of the ground surface. It has an opening on the side facing up.
Drum #6	The rusted 55-gallon drum is laying on its side and appears to have openings on the sides facing up and down and on the end facing downslope.

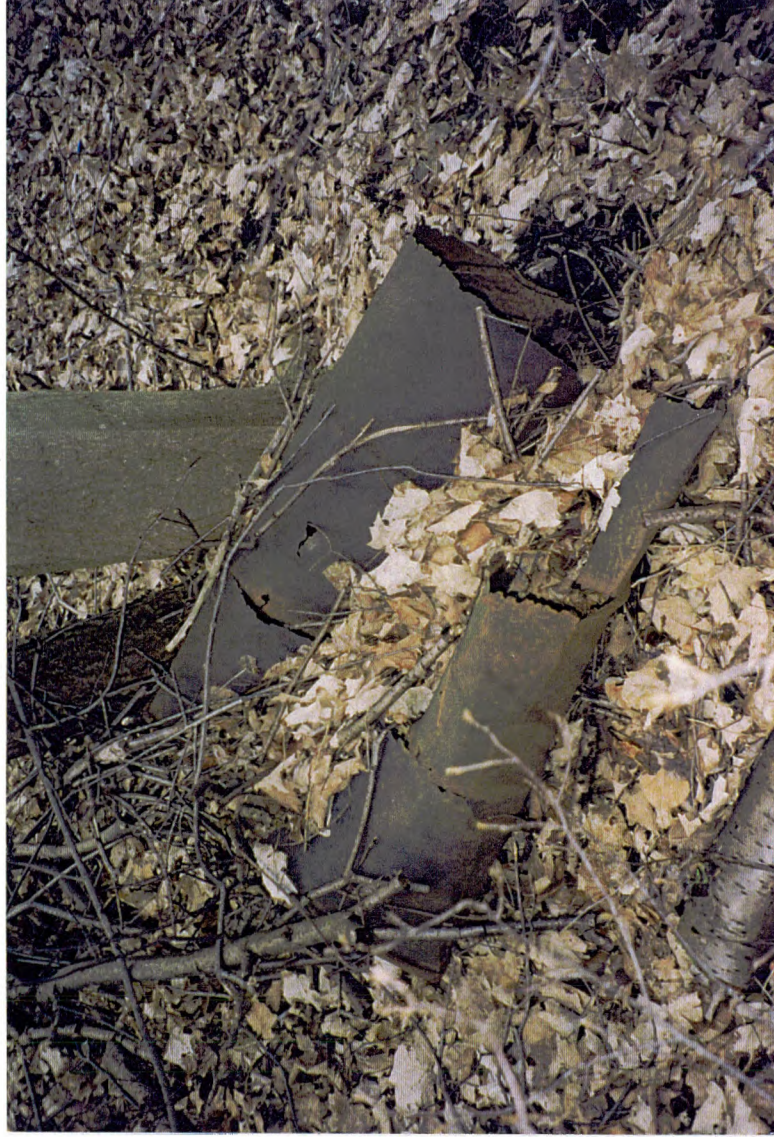
Drum #7	The rusted 55-gallon drum is crushed and split open. It is missing the end facing downslope.
Drum #8	The rusted 55-gallon drum is laying on its side on top of the ground surface. It is slightly bent on one end.
Drum #9	The rusted drum is partially buried on its side and is crushed. The end facing downslope appears open.
Drum #10	The rusted 55-gallon drum is partially buried on its side with an opening on the end facing downslope.
Drum #11	The rusted drum is severely crushed.
Drum #12	The rusted drum is severely crushed.
Drum #13	The rusted drum is mostly buried on its side and severely crushed. The side towards the ground appears split open.

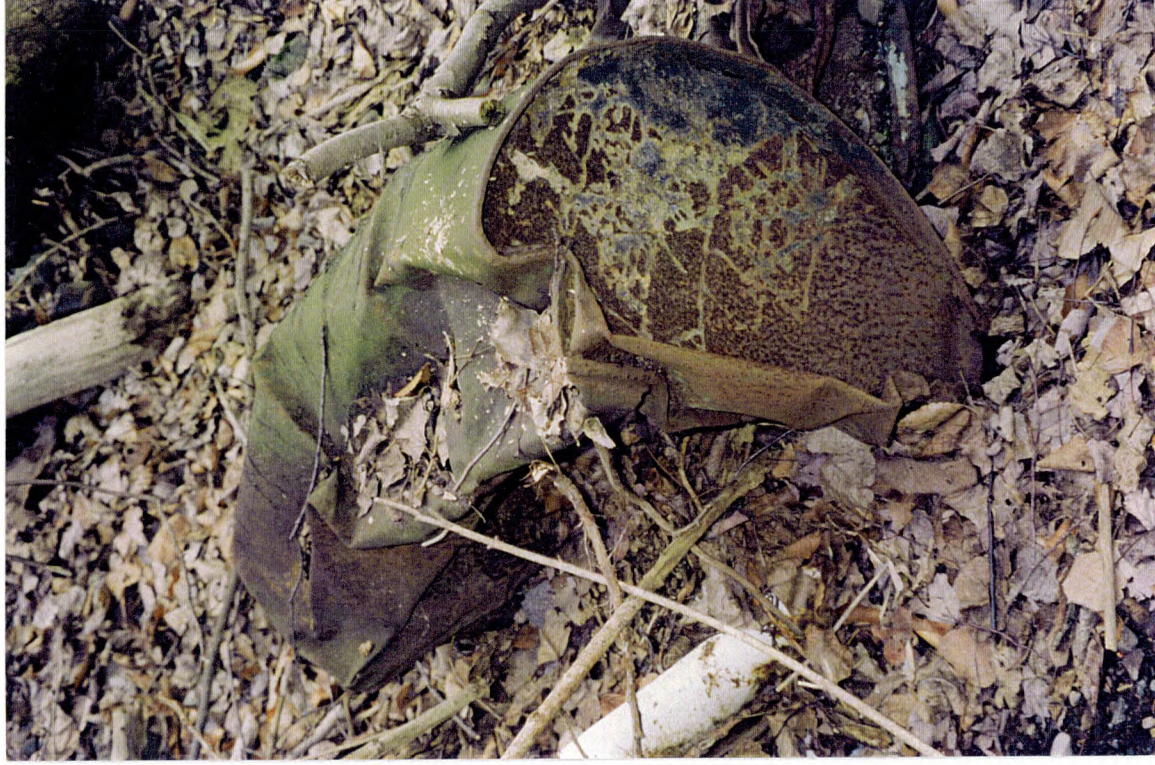
Drum Designation	Description
Drum #14	The rusted drum is laying on its side and is severely crushed.
Drum #15	The rusted drum is laying on its side and is severely crushed.
Drum #16	The rusted 55-gallon drum is laying on its side and appears split open on one end.
Drum #17	The rusted drum is severely crushed and is partially buried.
Drum #18	The partially rusted 55-gallon drum is laying on its side on the ground surface and is open ended.
Drum #19	The partially rusted 55-gallon drum is laying on its side on the ground surface. There is a circular opening on one end.
Drum #20	The partially buried drum is severely rusted and crushed. One end has lettering on it ("STC").
Drum #21	The partially buried drum is severely rusted and crushed.
Drum #22	This drum is quite a distance up on the hillside. It appears rusted and crushed.
Drum #23	This rusted 55-gallon drum is partially buried and laying on its side. Both ends are missing.

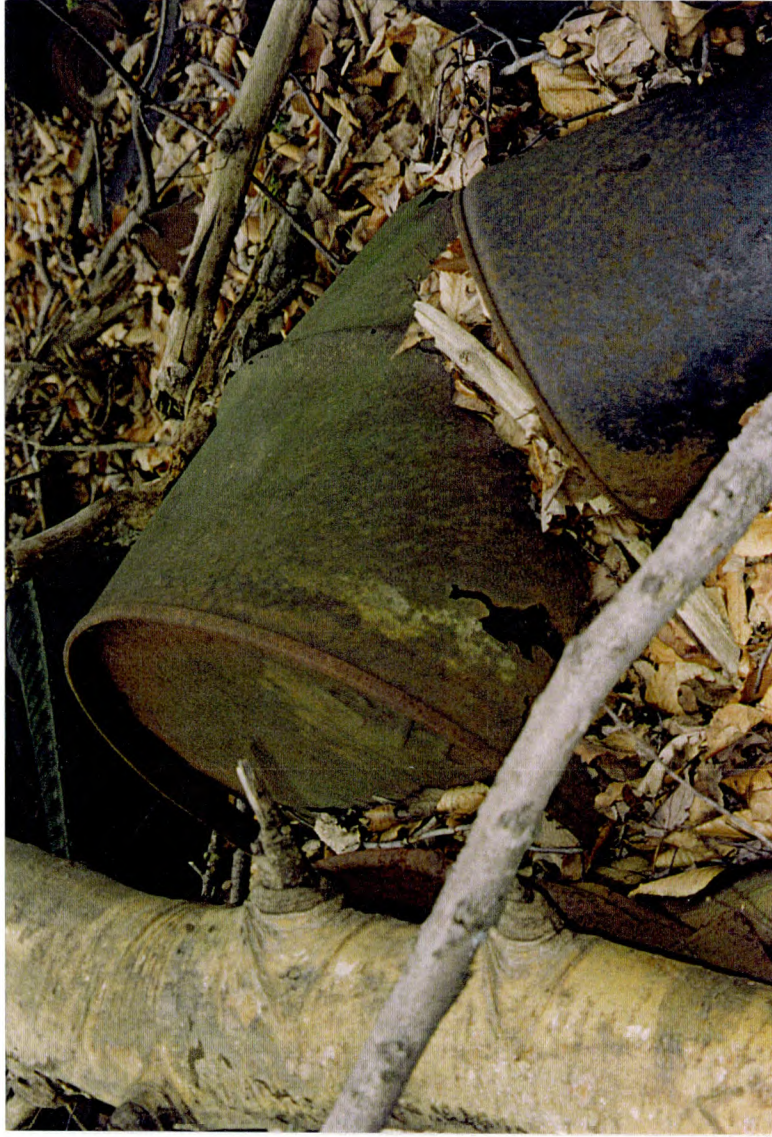
The visible drums or drum fragments appeared very rusted and no labels, lettering, or other markings were observed except on Drum #20 and Drum #24. Drum #20 has the lettering "STC" inscribed on one end. Drum #24 has the following lettering inscribed on one end "DPS5636A". Drum #27 is rusted, severely crushed, and contains a white powder substance, which had leaked out one end. A summary table of the drum or drum fragment number designation and a description of each drum or drum fragment is presented as Table 1. The designations on this table correspond to the drums or drum fragments located on Figure 1.

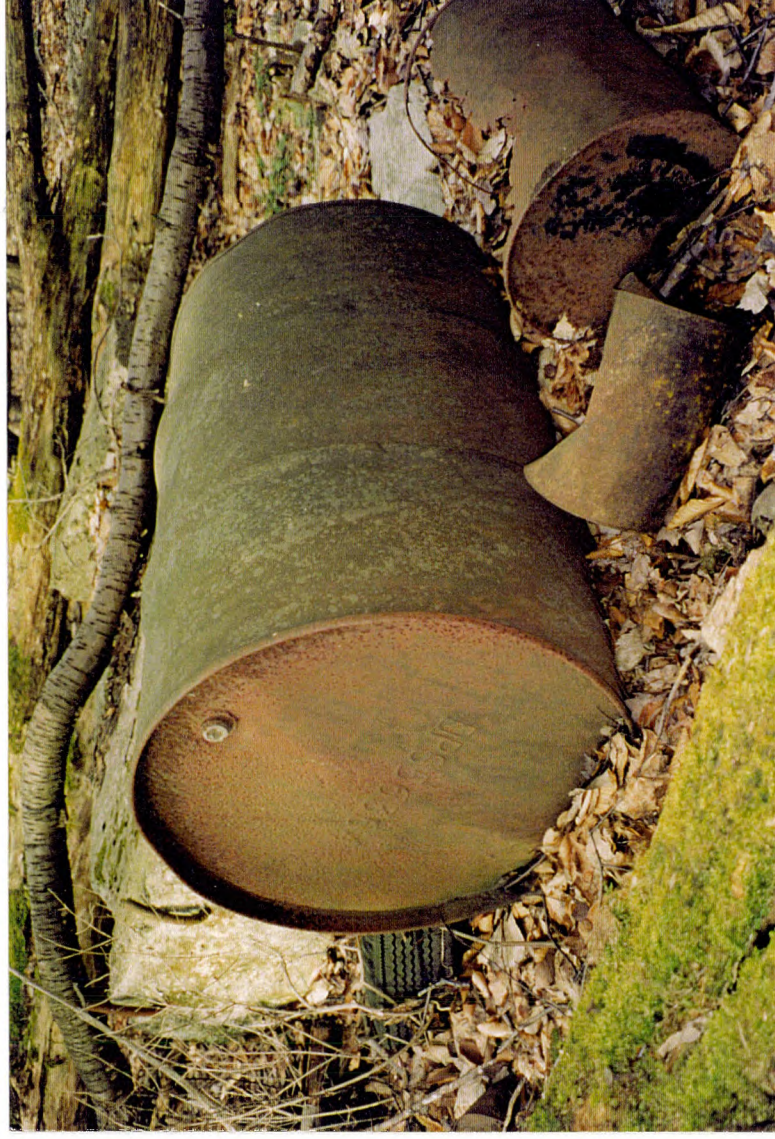
Drum #24	This rusted 55-gallon drum is laying on its side on the ground surface. It has lettering on one of its ends ("DPS5636A").
Drum #24A	The rusted drum is severely crushed and partially buried.
Drum #25	The rusted 55-gallon drum is laying on its side on the ground surface amidst abundant cement pieces.
Drum #26	The rusted 55-gallon drum is laying on its side on the ground surface. There is a circular opening on one end similar to the one observed on Drum #19. There appear to be rusted paint cans on the ground adjacent to this drum.

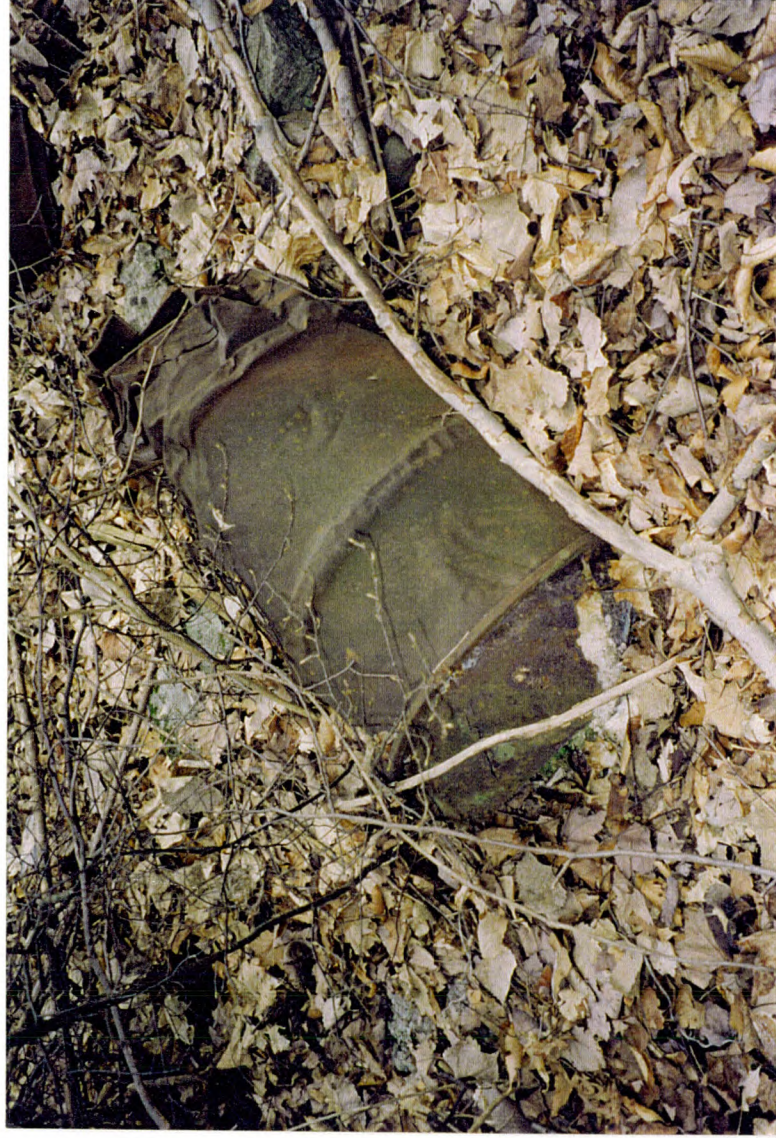
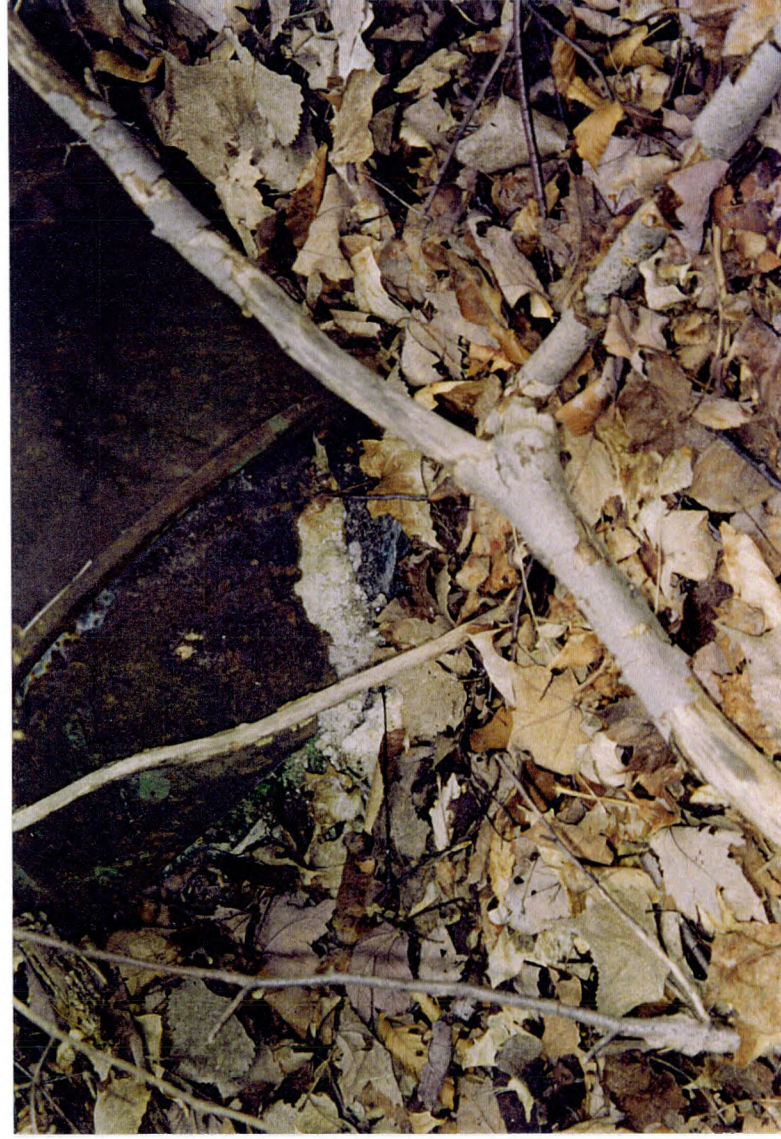
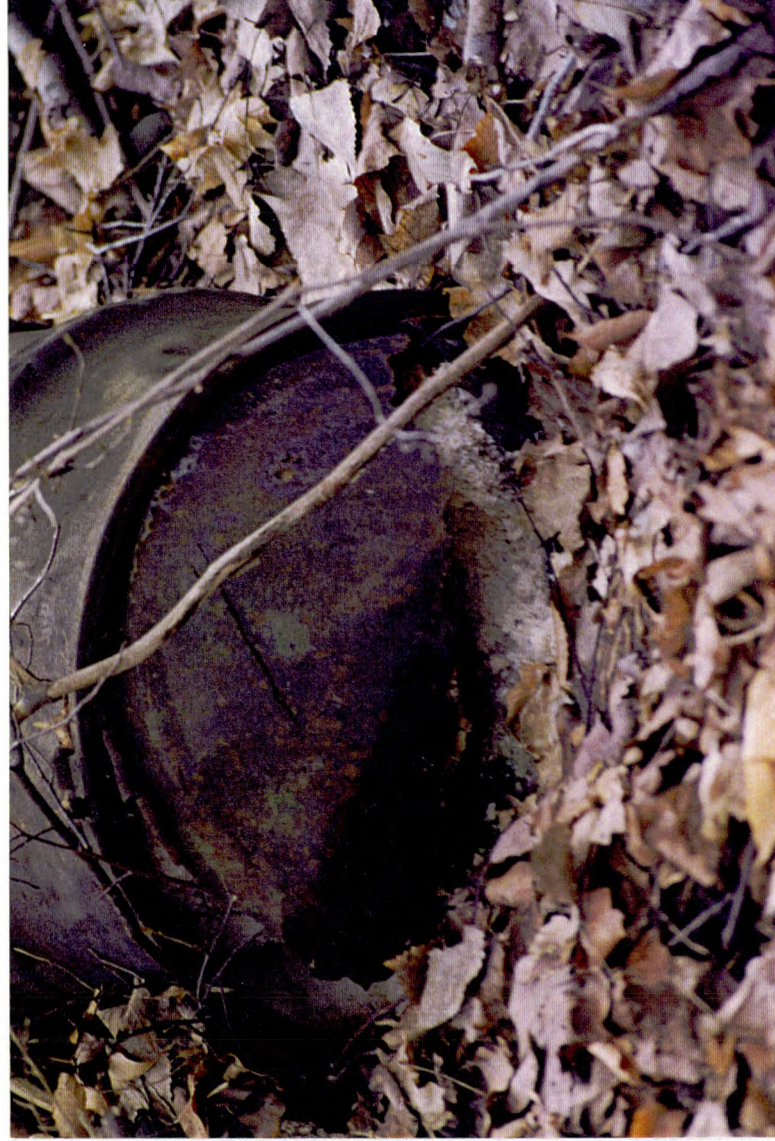
Drum Designation	Description
Drum #27	The rusted drum is severely crushed. There is a white powdery substance inside the drum that is spilling out from the downslope, split open end.
Drum #28	The rusted drum is laying on its side on the ground surface against a tree. Both ends are missing.
Drum #29	The rusted, partially buried drum is laying on its side with a rotten fallen tree over the top of it. The downslope end is open.
Drum #30	The rusted 55-gallon drum is near the top of the hillside before it flattens out. It is resting against a tree, which is downslope of the drum. It appears the drum is partially buried and the downslope end is missing.
Drum #31	The rusted 55-gallon drum is laying on its side on the ground surface. The downslope end is missing and it contains openings on the side facing up.
