Date: July 10, 2023  
Our Ref: 30169483  
Subject: 2023 Qualitative Site Inspection  
NYSEG Cortland-Homer Former MGP Site  
Site No. 7-12-005

On behalf of the New York State Electric & Gas Corporation (NYSEG), this Site Inspection Letter has been prepared for the Cortland-Homer Former Manufactured Gas Plant (MGP) site, Operable Unit No. 2 (OU-2) located in Homer, New York (the site). This letter presents the results of the 2023 qualitative monitoring event including, adaptive management and corrective action recommendations to support meeting the Year 1 performance criteria and has been prepared in accordance with the Preliminary Monitoring and Maintenance plan included as Appendix G to the April 2020 Remedial Design Report (Remedial Design).

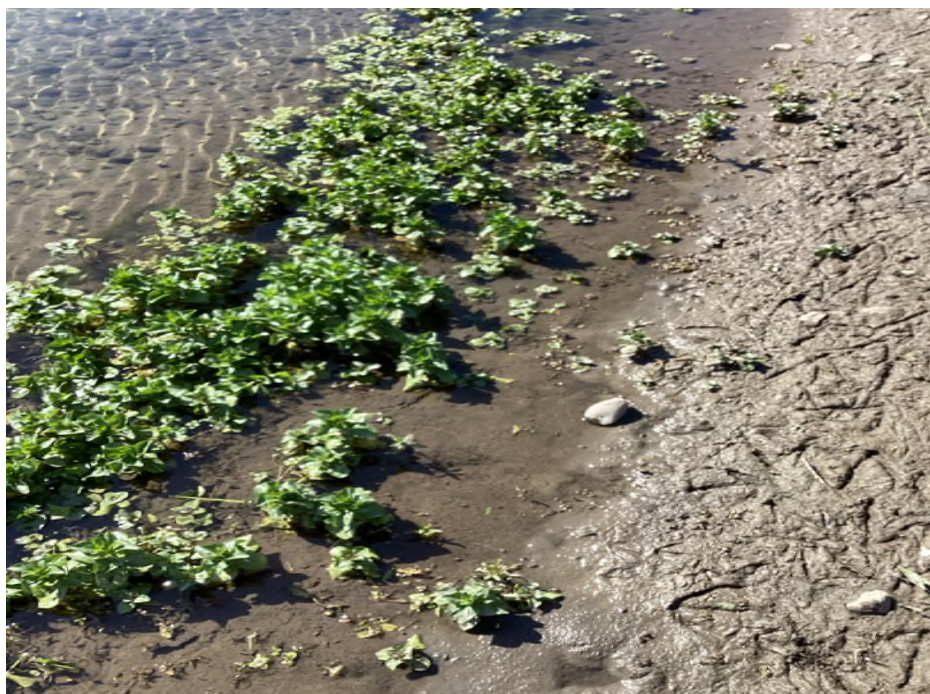
**Photo: 2**

Within portions of the emergent vegetation planting zones and along other portions of the shallow and depositional shoreline edges of the river natural recruitment of watercress (*Nasturtium spp.*) was observed (Attachment 1B, Photo 2). Both the Arrow arum and American bur-reed plantings were not observed in most of the targeted emergent planting zones for Area 1. High flow conditions may have disturbed the emergent planting areas in this area. Additional monitoring during the quantitative visit will further determine whether any planted species survived.

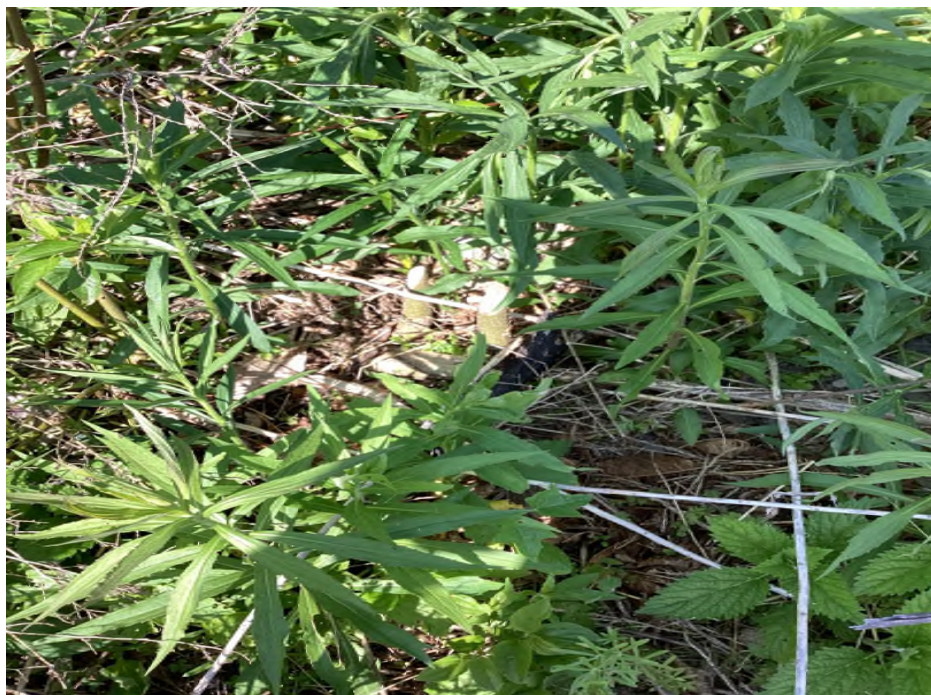
**Photo: 3**

Herbivory was the only evident sign of stress observed in Area 1. The northeast portion of the bank and floodplain planting areas along the eastern bank showed signs of heavy herbivore damage to shrubs that may have been from deer browse based on the abundant tracks found in this area (Attachment 1B, Photo 11) and poor live stake survival (Attachment 1B, Photo 12). One example of herbivore damage was documented on the western shore (Attachment 1B, Photo 3), showing a beaver chew on a willow shrub.

**Description:**  
Woody stems of willow  
with signs of beaver  
damage, western  
inundated area.

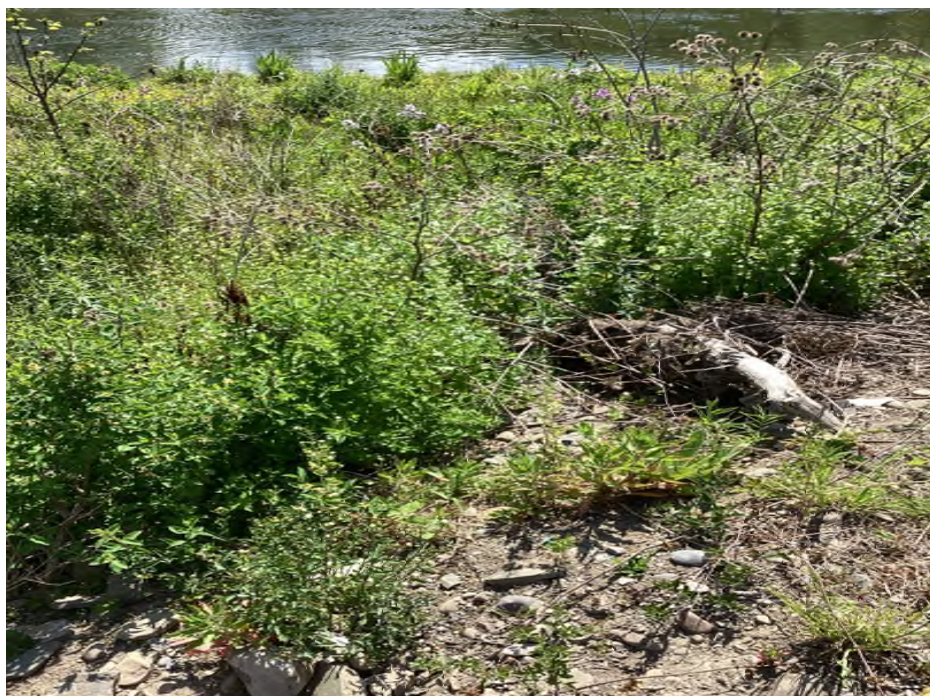
**Photo: 8**

The primary invasive species identified in Area 1 are garlic mustard (*Alliaria petiolata*) (Attachment 1B, Photo 8) and a species of non-native honeysuckle (*Lonicera spp.*), which was sparsely observed within the area. A significant stand of garlic mustard was observed along the western bank below the downstream bridge. Potential nuisance species, yellow rocket (*Barbarea vulgaris*), was observed along portions of the western shoreline (Attachment 1B, Photo 1).

- Invasive Species – Invasive plant species garlic mustard (*Alliaria petiolata*), non-native honeysuckle (*Lonicera spp.*), and nuisance species yellow rocket (*Barbarea vulgaris*) were observed in the restored areas. Proactive invasive plant species management will be implemented in September 2023 to prevent further establishment within the restored planting areas.

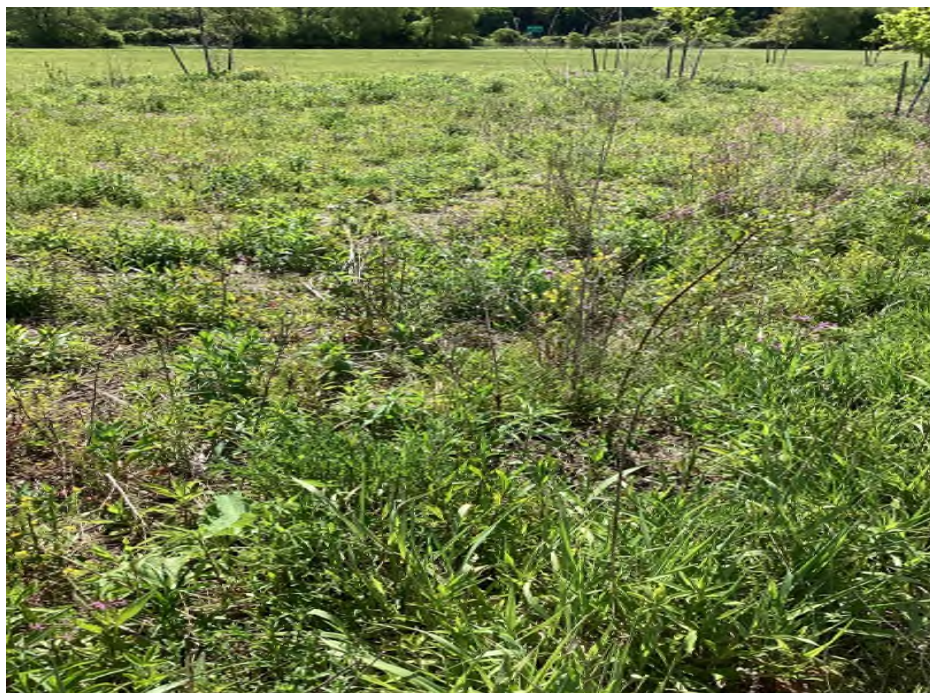
**Photo: 11**

**Description:**  
Area of heavy shrub  
herbivore damage on  
eastern shoreline.

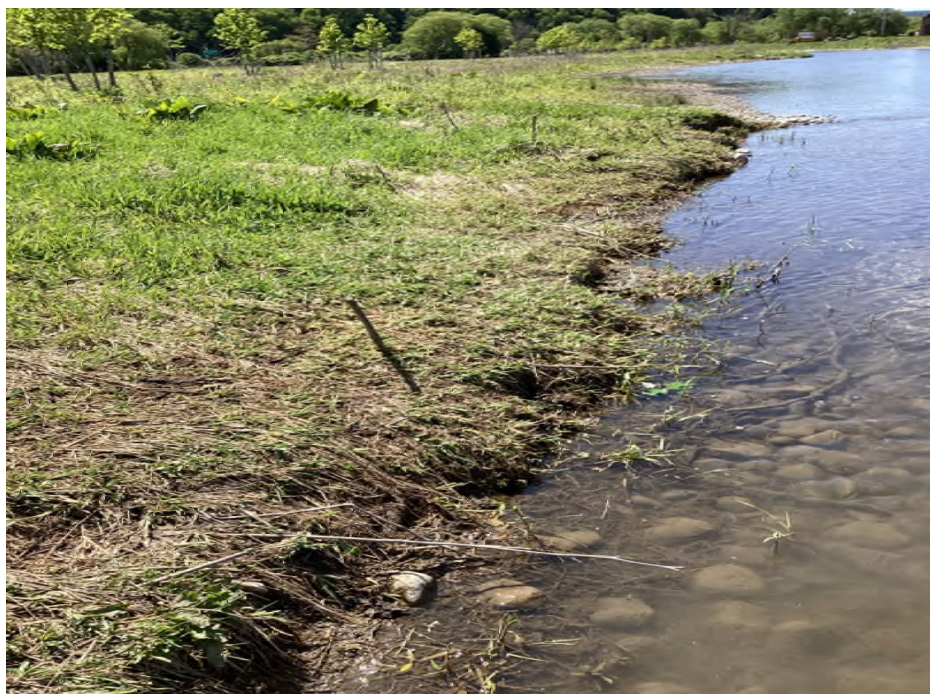
**Photo: 12**

In general, live stakes appeared to be successful along the western shoreline lower bank areas with evident budding and leafing and limited mortality observed. Approximate survival of the black willow, red-osier dogwood, and silky dogwood stakes is estimated to be 40 to 50% across both shorelines. A large portion of live stakes installed on the western shoreline were either not budded out or damaged from high flows and herbivore activity. One example of poor live stake success along the eastern shoreline is shown in Photo 12 (Attachment 1B).

- Herbaceous cover – Herbaceous planting areas will likely not meet the performance criteria (85% cover). Fall reseeded of these areas is recommended.
- Emergent vegetation and live stakes – Observations indicate the need to monitor their establishment, as loss was evident during this inspection. Recommendations will be determined following the quantitative inspection.

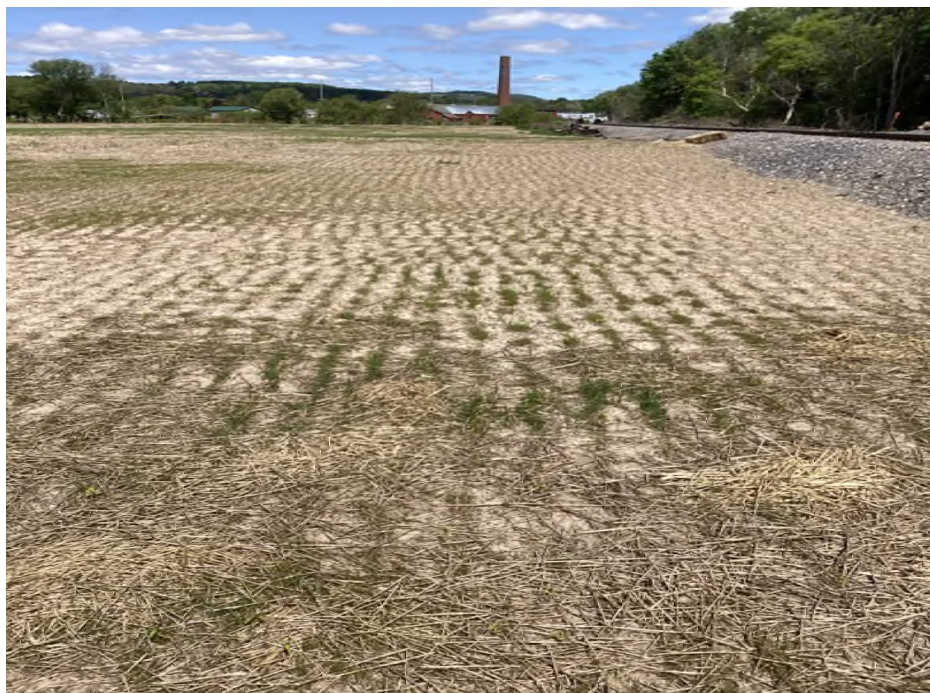
**Photo: 13**

Overall herbaceous cover appeared in poor condition with large portions of the restoration area showing limited ground cover. In the upland laydown area, herbaceous cover has not been successfully established (Attachment 1B, Photo 13). Avian species known to nest in barren, rocky areas (Killdeer) were observed nesting in the upland restoration area. The floodplain tree and shrub planting area were also observed to have sparse herbaceous cover (Attachment 1B, Photo 14). Herbaceous cover between top of bank and transitional areas was estimated between 35 to 50%. Areas where herbaceous seed mixes were applied appeared to lack sufficient moisture for plant survival with dry, exposed soil prevalent. Herbaceous cover was improved on the northern banks of Area 2, suggesting there is greater water availability or protection from prolonged, intense sun exposure. Observations of emergent plantings had some arrow arum (*Peltandra virginica*) developing on the east bank (Attachment 1B, Photo 17).

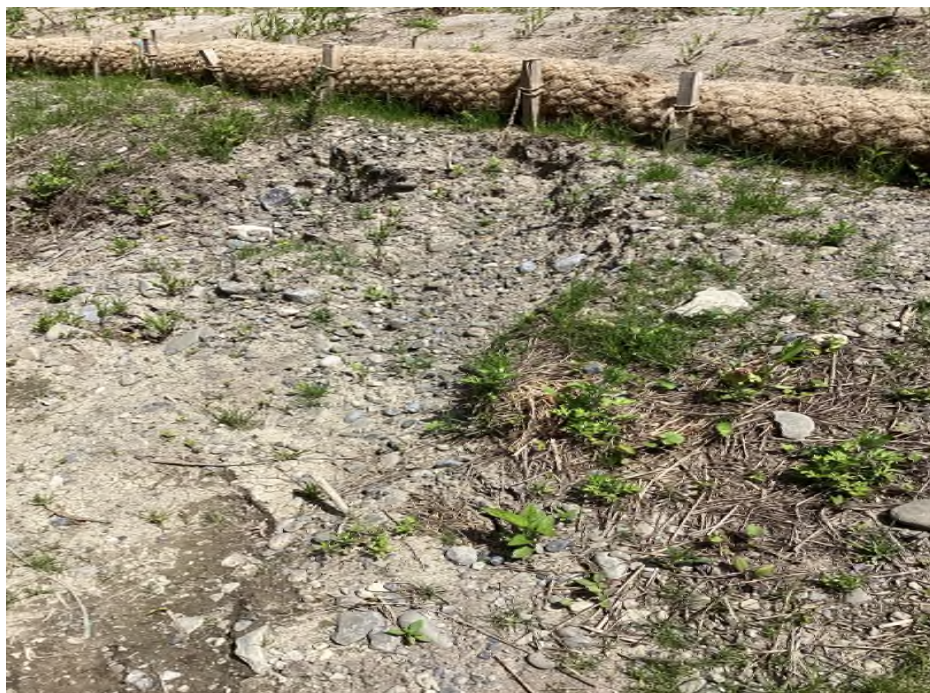
**Photo: 15**

General soil stability was observed to be in good condition with rip-rap cover along portions of the lower bank and coir logs installed on bank slopes. Coir logs appeared intact and were in their installed locations. Some instances of minor erosion were documented on banks, including sloughing in the transitional/lower bank below installed coir log (Attachment 1B, Photos 15 and 19).
