August 28, 2013

**RE: Site Services Status Report
South Hill Dump Site
South Hill Road
Cortlandville, Cortland County, NY
NYSDEC Site No. 712009**

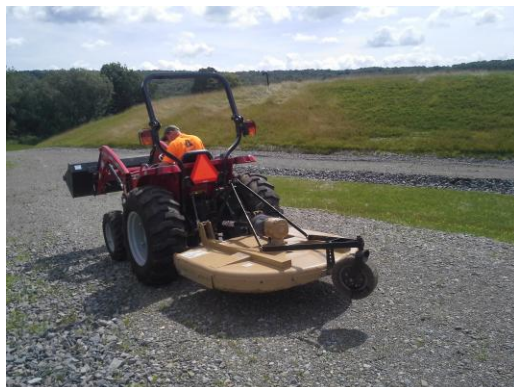
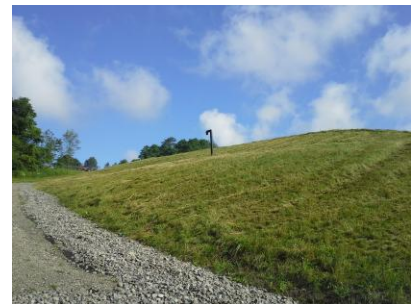
Aztech performed mowing and trimming activities at the site using a Massey Ferguson 1635 tractor with brush hog/mower attachment, walk behind brush hog unit, walk behind mower, and weed whacker. The extents of the mowing were detailed in the SOW and included the landfill, the detention pond area and the immediate areas outside the drainage swales. The landfill and surrounding

vegetated areas were mowed down to between 6 to 10 inches above the existing ground surface. All grass clippings were left in place, and special care was taken not to damage gas vent risers or displace rip rap along slope and drainage areas. In addition, the five empty 55-gallon drums previously delivered to the site by Aztech were removed from the site.

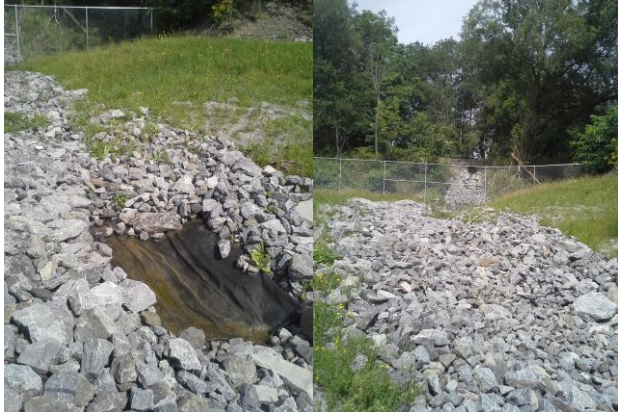
Aztech performed repair activities to several sections of the drainage swale at the site. Misplaced rip-rap from excessive storm water runoff at the site, was relocated back on top of exposed geotextile, as shown in the before and after pictures to the left. Rip rap was relocated by hand from areas downstream of the exposed areas, placing larger stones first then smaller stones. Several exposed areas were discovered and repaired in addition to the two areas described in the SOW.

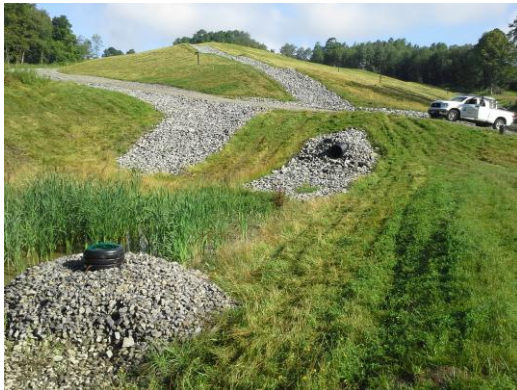
The detention pond outlet structure is shown in the photograph to the left and a detailed drawing is attached to this document in **Figure 3**. The cap to the outlet structure was removed and a 15" diameter hole was cut into the top of the cap to allow for overflow to be able to exit the pipe. Chicken wire was then installed on the top of the cap to prevent debris from entering into the structure as shown in the photograph to the right.
