**FINAL
FIELD ACTIVITIES REPORT
GROUNDWATER MONITORING WELL INSTALLATION
AND LANDFILL INSPECTION
SOUTH HILL DUMP
SITE NO. 712009**

WORK ASSIGNMENT NO. D007619-16

**New York State Department of Environmental Conservation
Division of Environmental Remediation
Remedial Bureau E
Albany, New York**

AUGUST 2014

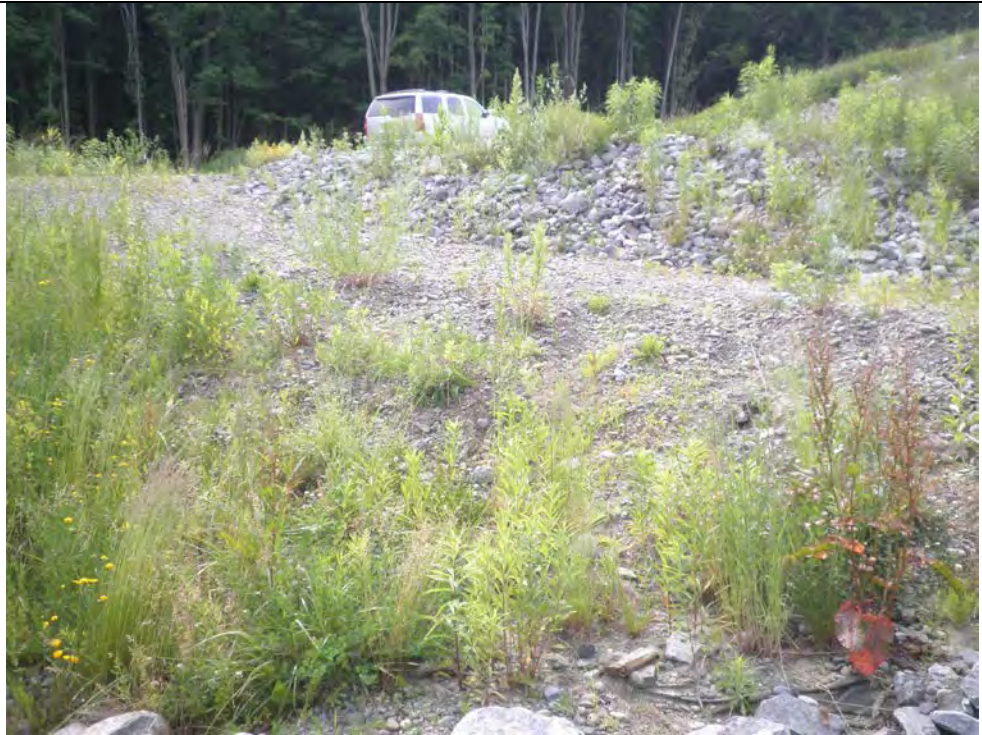
Photo 205

- Two erosion gullies were observed cutting across the perimeter road exiting the southeast corner of the downdrain terminus.
- An erosion gully observed in the southwest extension of the perimeter road starting downgradient of the end of the west drainage swale downgradient of culvert C-3.
- The eastern drainage swale has 9 different areas where the geotextile fabric is exposed. Beginning from South Hill road and ending at the outfall at the property boundary in the southeast property corner. Rip rap appears to slide, exposing the geotextile, which bunches up to a depth of approximately two feet. This observation appears to be most prevalent at the water bars.

Two erosion gullies across perimeter road from the southeast corner of the downdrain terminus near culvert C-1.

MACTEC will prepare a scope of work describing remedial activities needed to address the notable findings identified in the June 2014 landfill inspection and described in Subsection 2.1 of this Report.

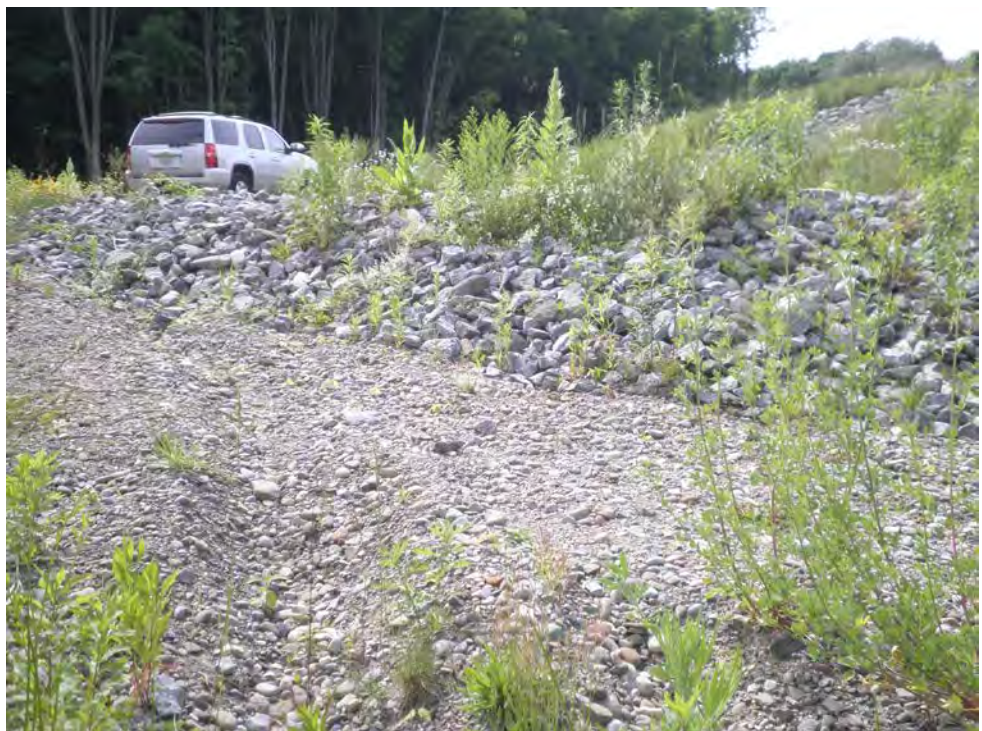
Photo 206

Close up of the gully crossing the road from the downdrain terminus.

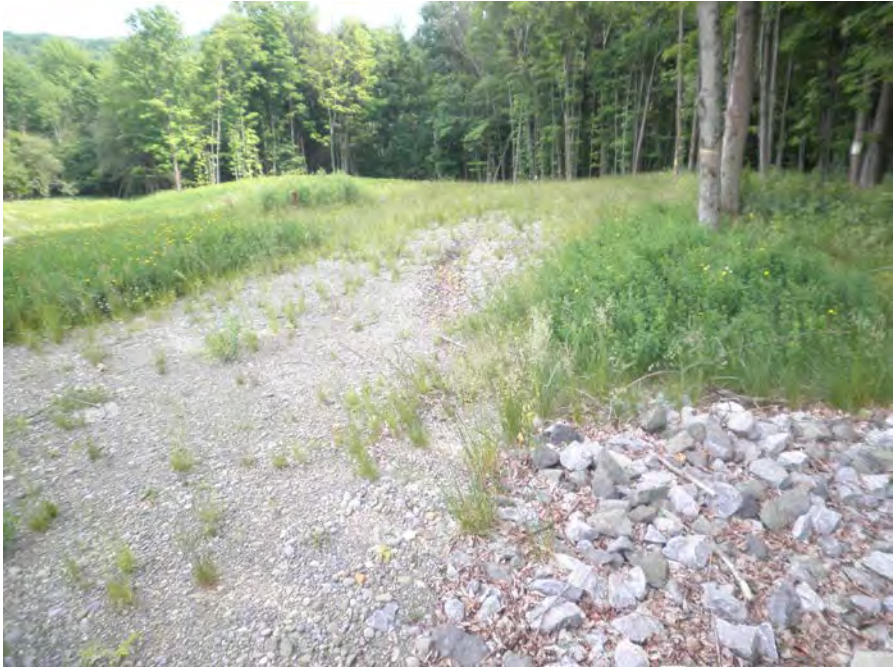
<p>Photo 208</p> <p><u>Description:</u> Erosion gully cutting into the southwest branch of the perimeter road beginning downgradient of the end of the west drainage swale downgradient of culvert C-3.</p> <p><u>Source:</u> MACTEC, July 2014 Site Inspection</p>

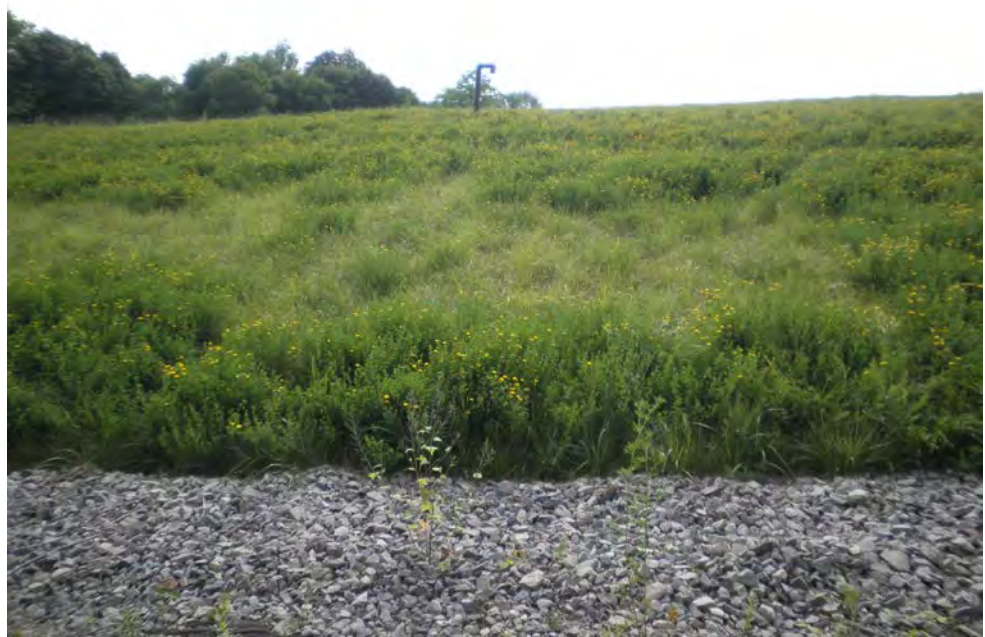
Photo 209

Original seep area
sample location
condition on June
23, 2014. Area dry.
No seep observed.

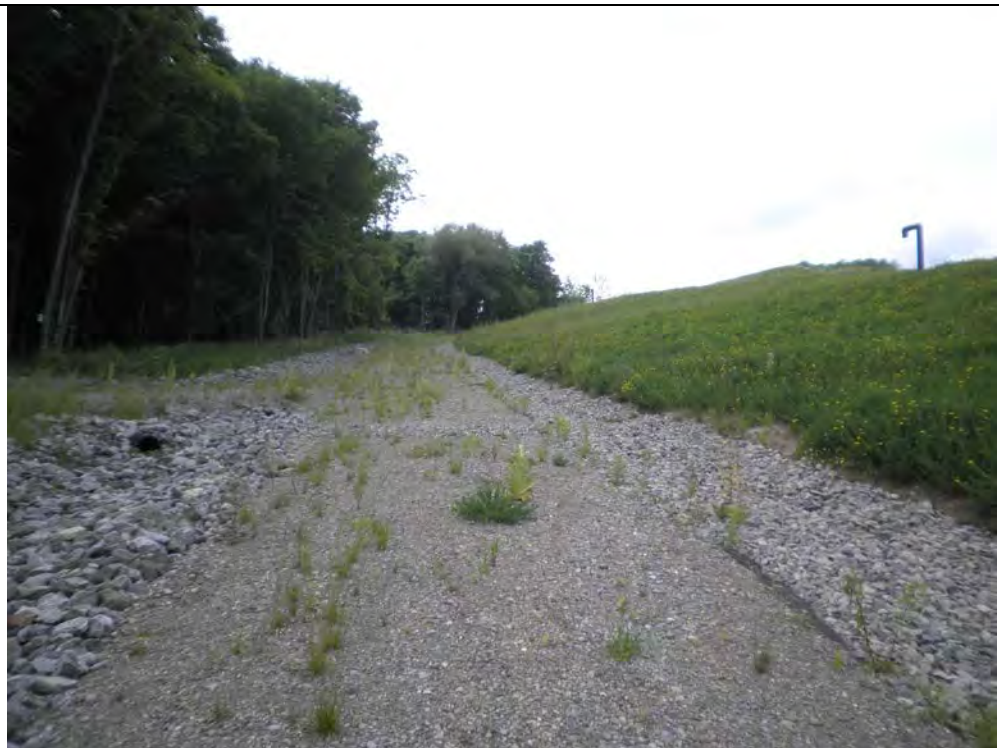
Photo 210

West perimeter
road and west
landfill slope.
Grass and weeds
growing in road.

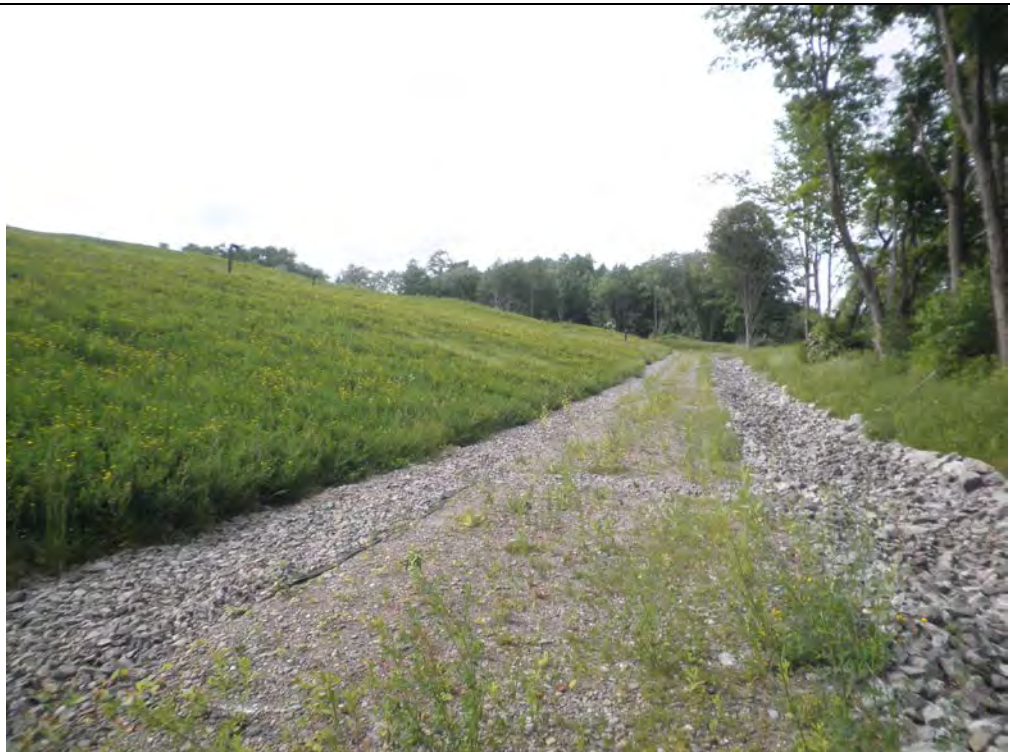
Photo 211

East perimeter road with grass and weeds growing in road. Eastern landfill slope. East drainage swale.

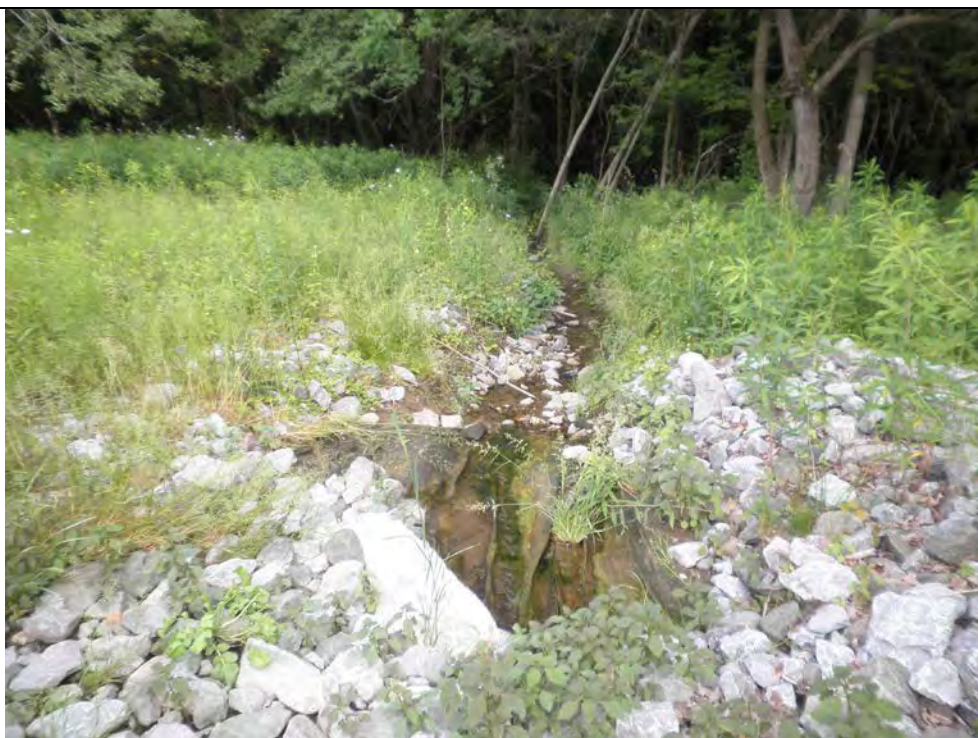
Photo 215

Exposed geotextile as the east drainage swale exits the site property.

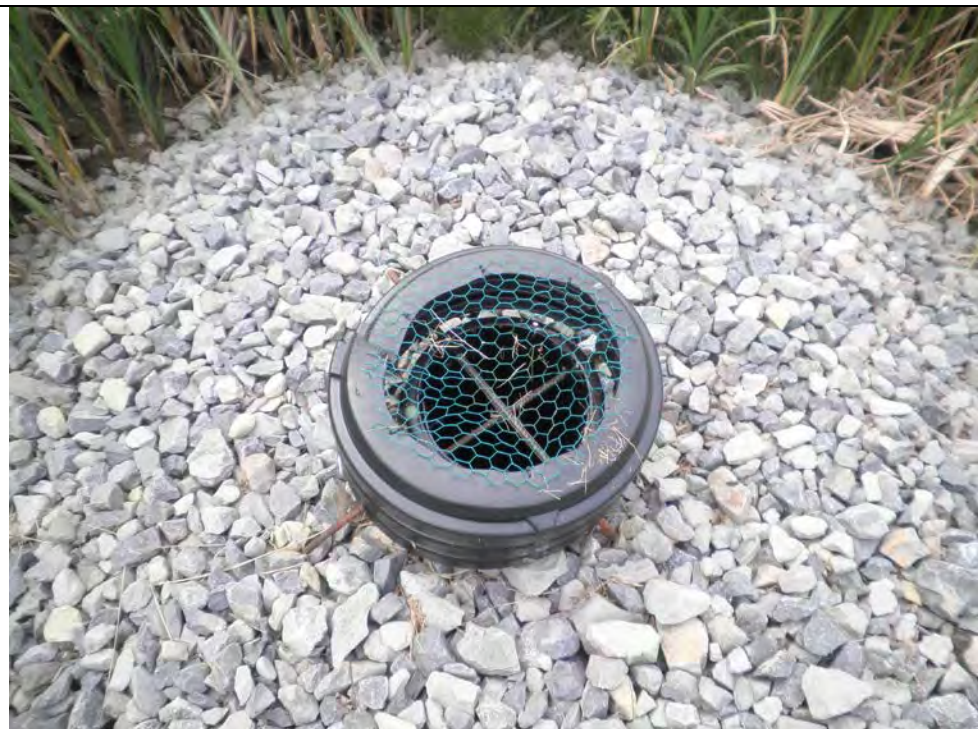
Photo 216

Retention Ponds	<input checked="" type="radio"/> Good	<input type="radio"/> Poor	NA
			Collection System Observations: Detention Basin Outlet Structure - Chicken wire screen clogged with grass and zip ties loose. Grass removed / ties secured.

Detention basin outlet structure after repairing chicken wire zip ties and removing grass clogging screen.

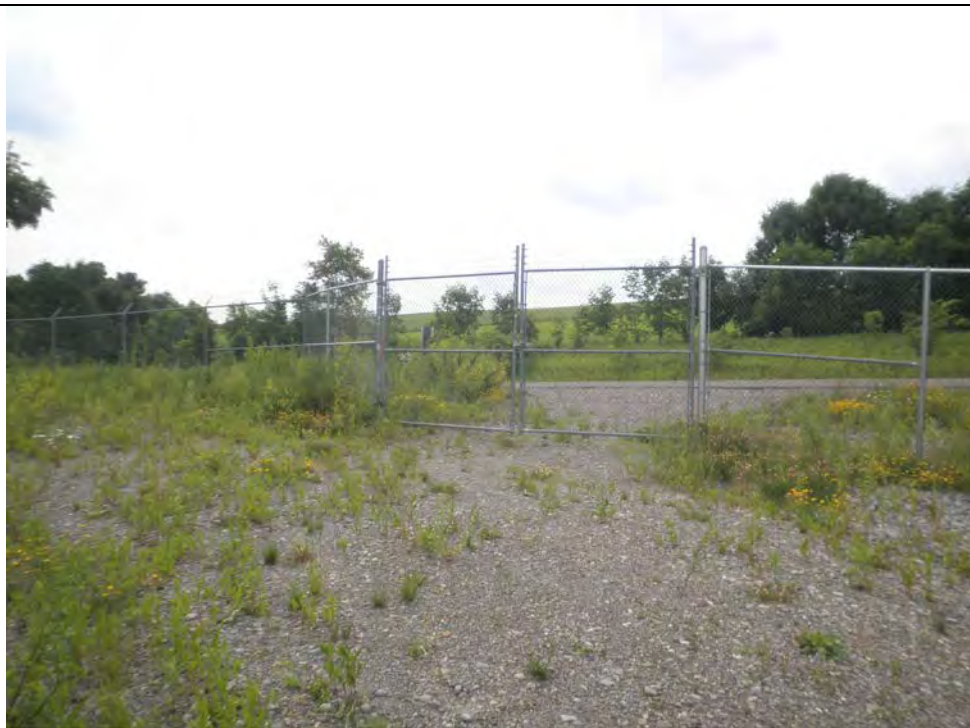
Photo 218

Site entrance gate
and fence. Grasses
and weed growing in
access road.

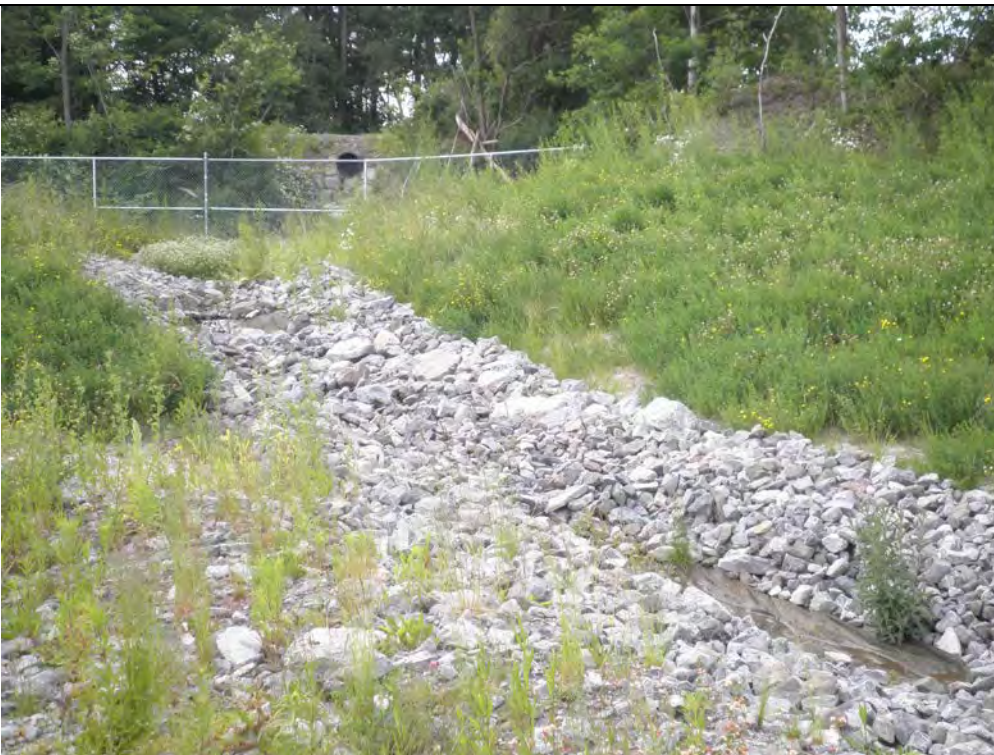
Photo 220

Two exposed geotextile areas at the head of the east drainage swale.

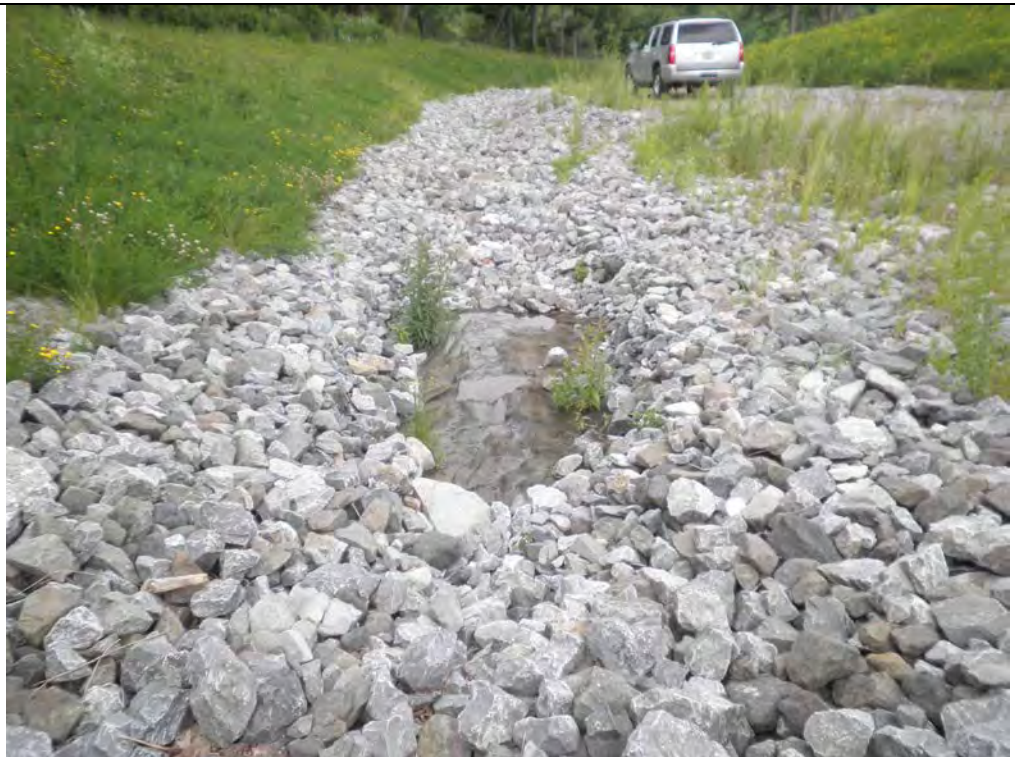
Photo 221

Close up of the exposed geotextile area at the head of the east drainage swale showing rip rap bunching up below the exposed area.

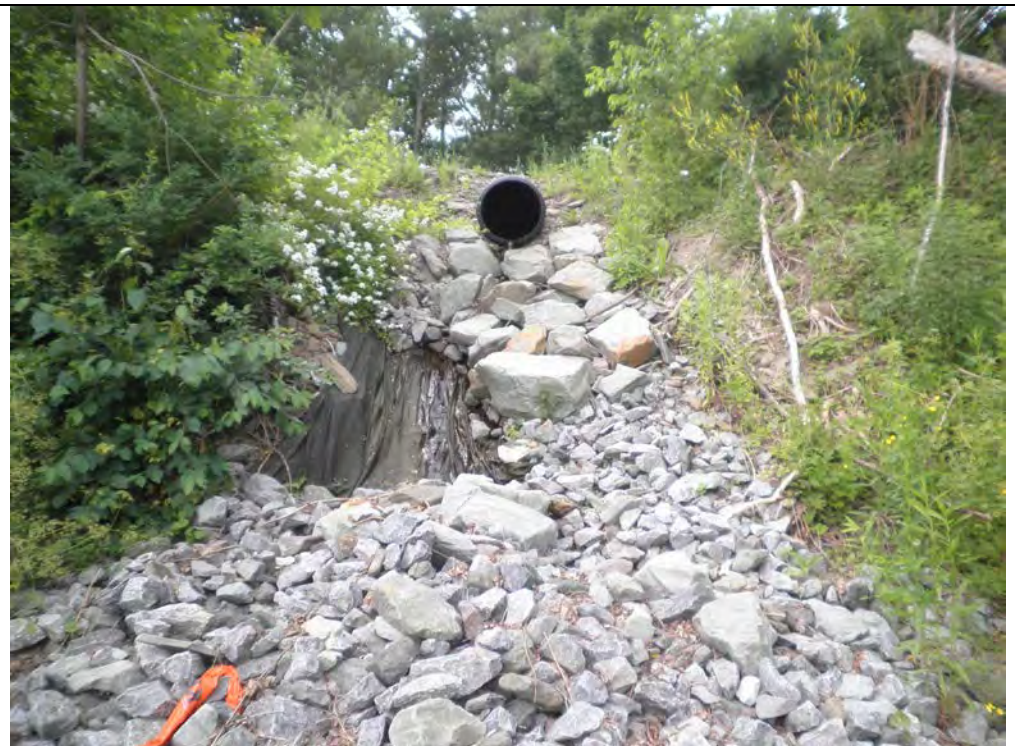
Photo 222

Rip rap sliding down steep slope exposing geotextile fabric at South Hill Road and the head of the east drainage swale.
