Transmittal: So Hill Dump 2014 PRR - Final

The South Hill Dump (Site No. 712009; herein referred to as the Site) is a Class 4 inactive hazardous waste site in the Registry of Hazardous Waste Sites in New York State. It is located in the Town of Cortlandville, Cortland County, New York, approximately two miles south of the Village of McGraw. The Site is comprised of a closed landfill on a 10.9 acre parcel. The Site was remediated in accordance with the Record of Decision (ROD) dated January 2008 (New York State Department of Environmental Conservation, 2008). The Site includes an engineered landfill cover system, which overlies wastes contaminated with polychlorinated biphenyls, volatile organic compounds, and metals. Remedial requirements in the ROD for the Site were established to prevent direct contact with contaminated soil and/or groundwater, and to prevent contaminated surface water and groundwater from migrating off-site. In accordance with the Site Management (SM) Plan (MACTEC Engineering and Consulting, P.C. [MACTEC], 2013), current SM requirements for monitoring the performance and effectiveness of the remedial measures completed at the Site consist of semi-annual Site in

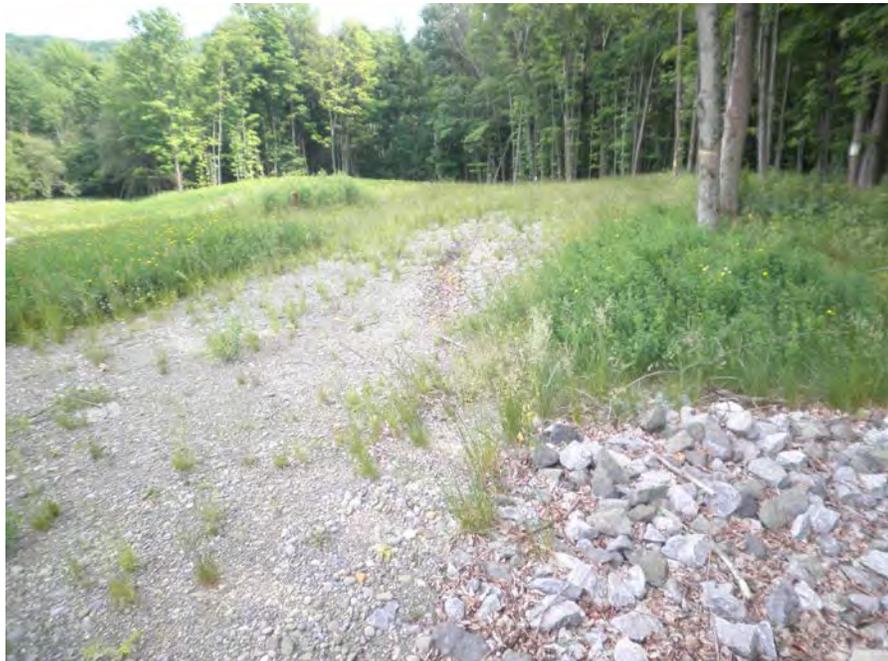
Photo 209

Original seep area
sample location
condition on June
23, 2014. Area dry.
No seep observed.
