**PERIODIC REVIEW REPORT (2015)
SOUTH HILL DUMP
NYSDEC SITE NO. 712009**

WORK ASSIGNMENT NO. D007619-16

**New York State Department of Environmental Conservation
Albany, New York**

**MACTEC Engineering and Consulting, P.C.
Portland, Maine**

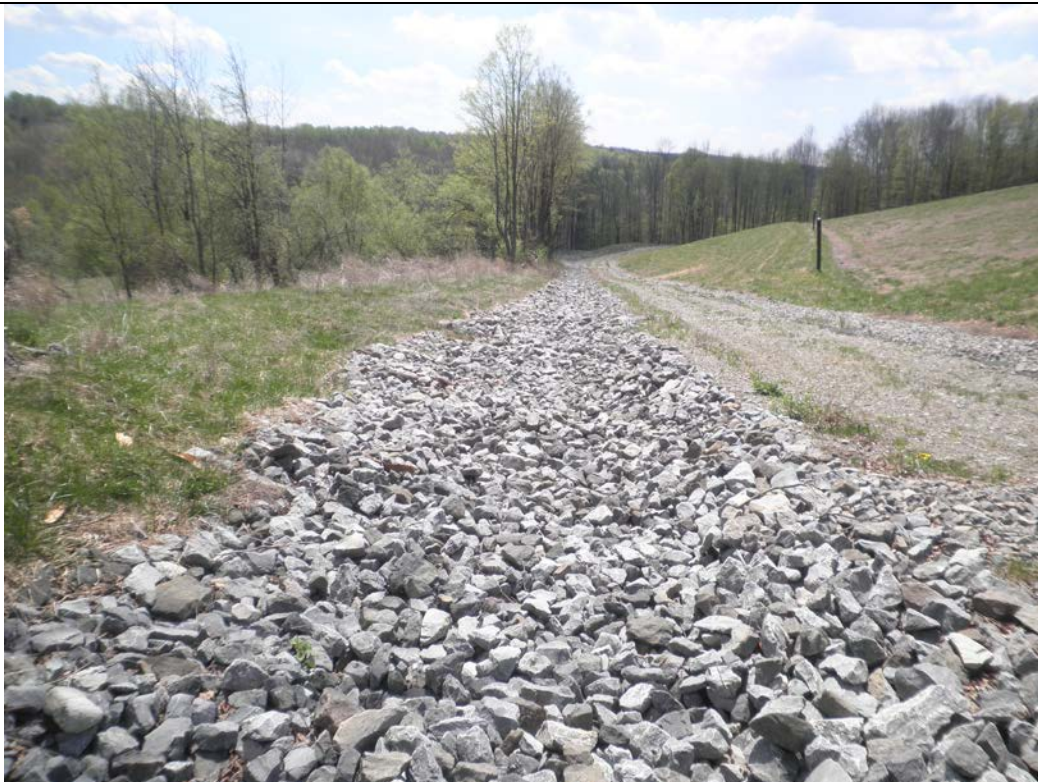
Photo 32

East drainage
swale

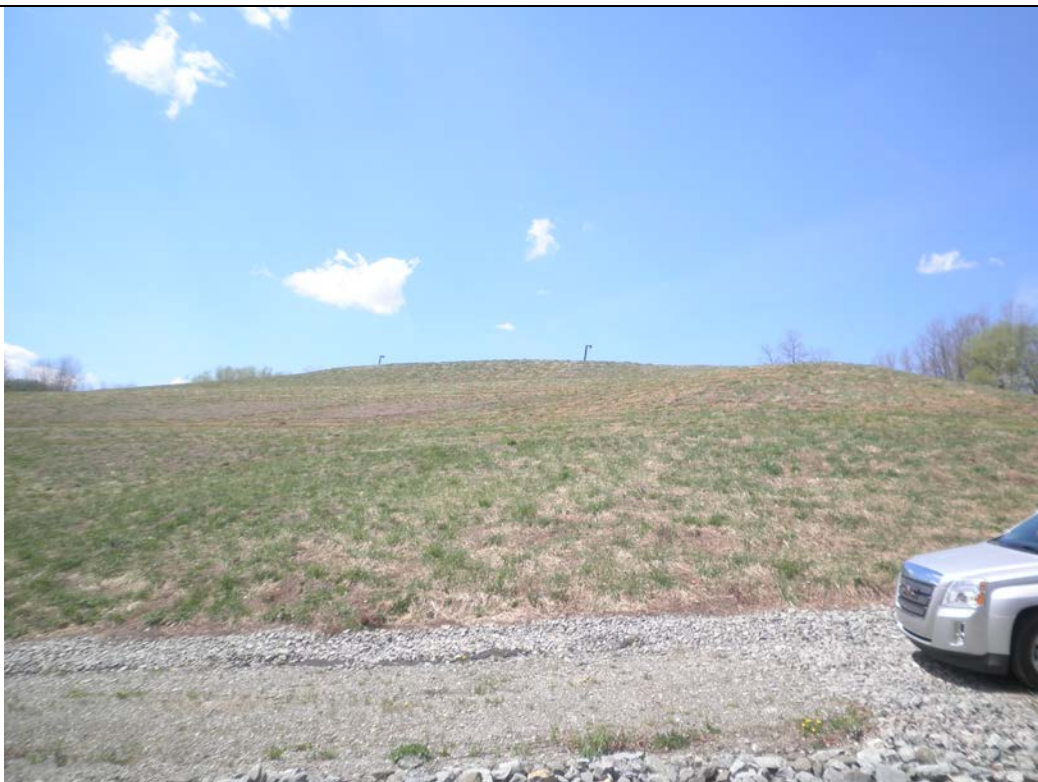
Photo 33

Landfill cover
northeast slope

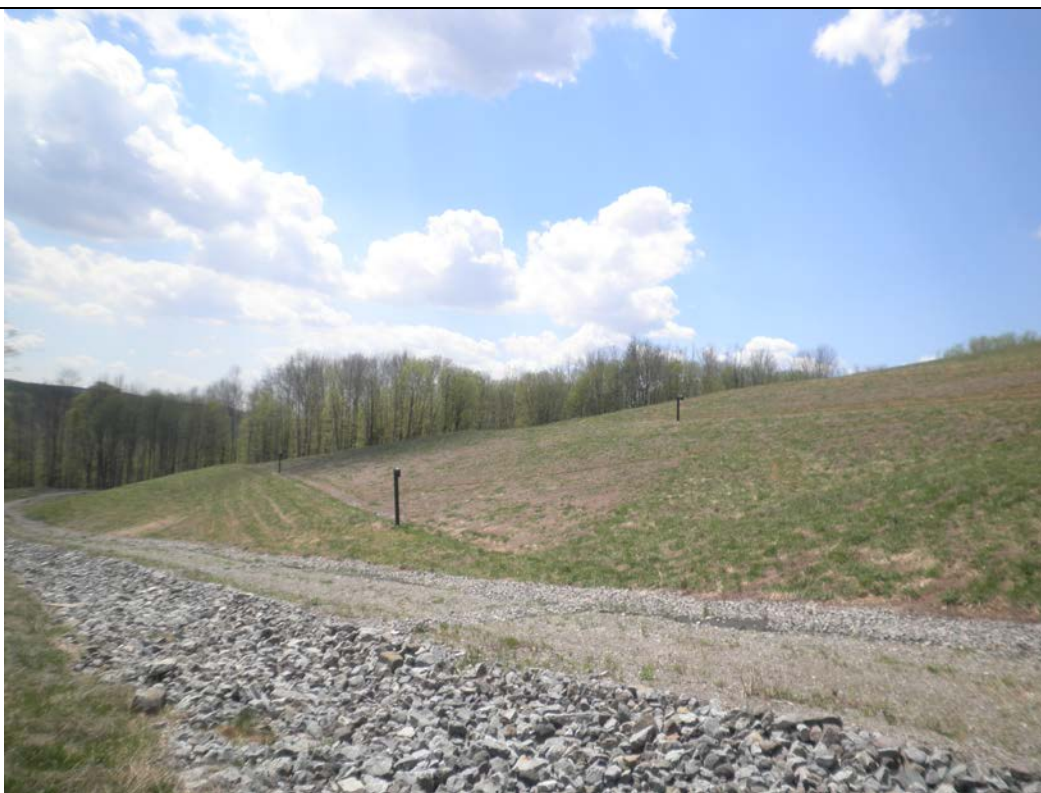
Photo 34

Landfill cover
eastern slope

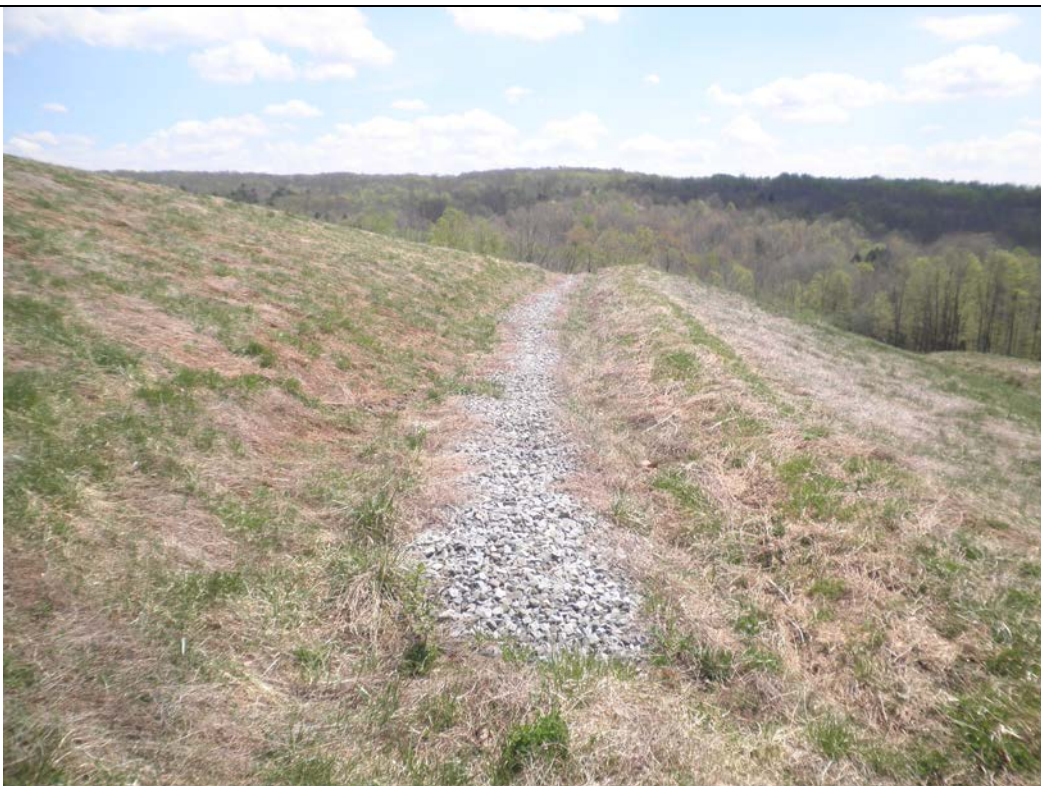
Photo 35

SB-5

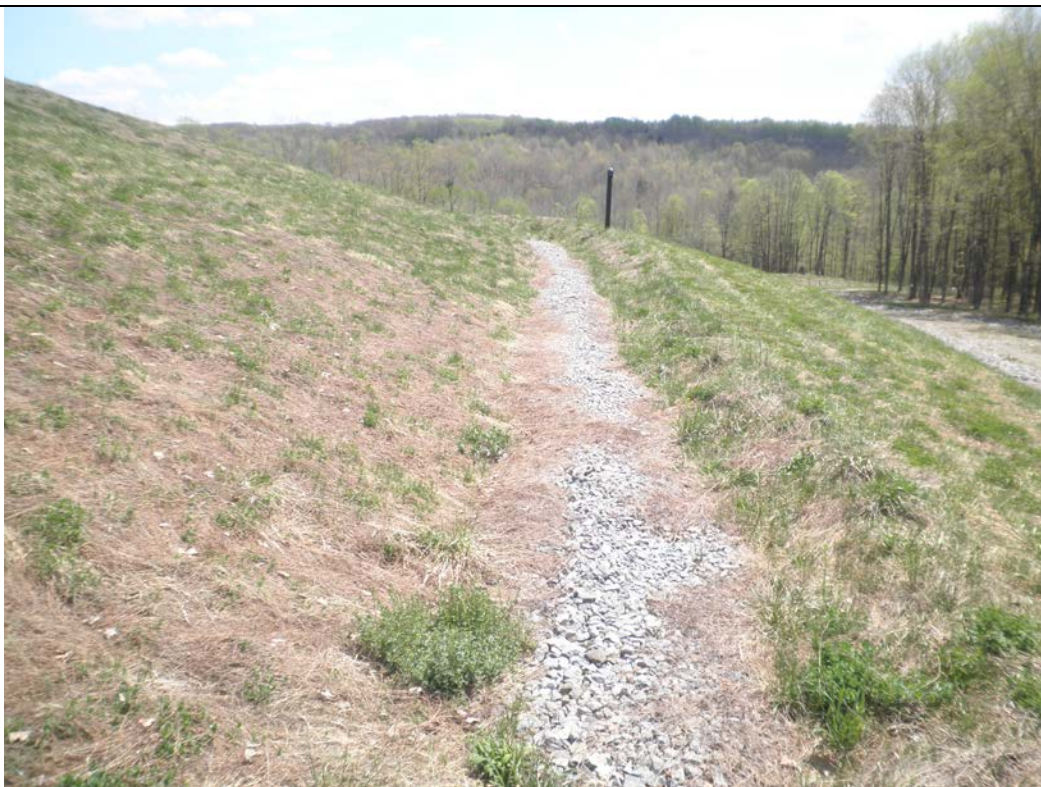
Photo 36

SB-1 and GV-5

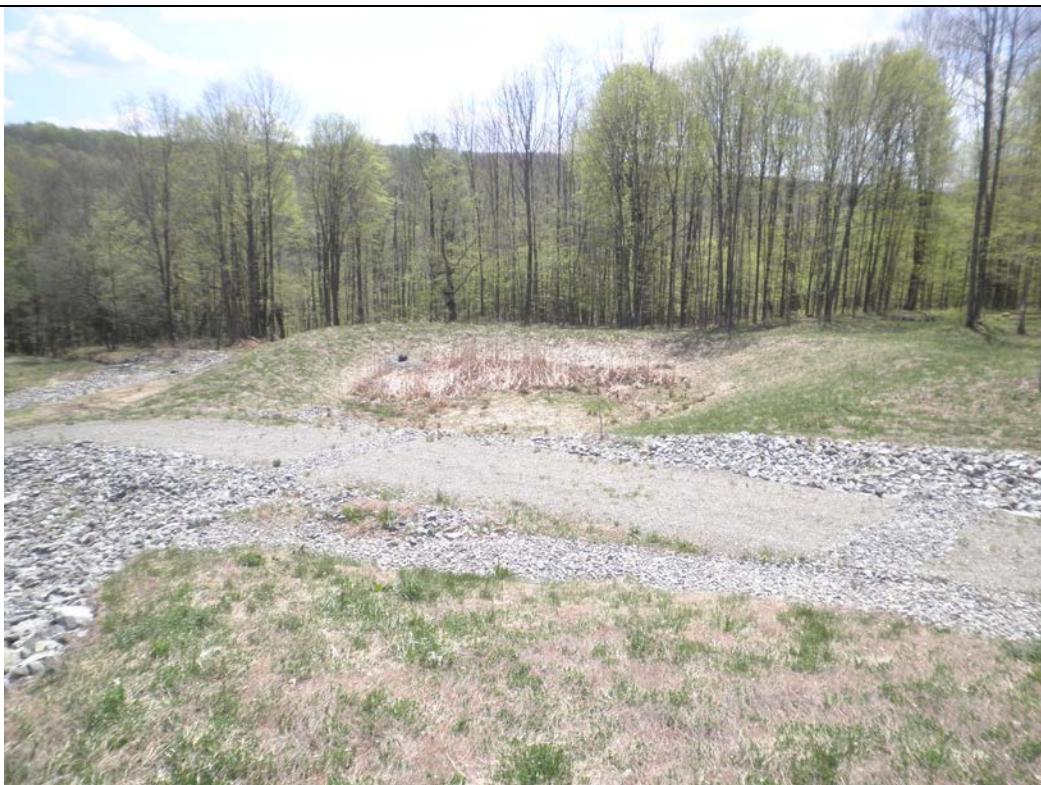
Photo 38

Detention basin

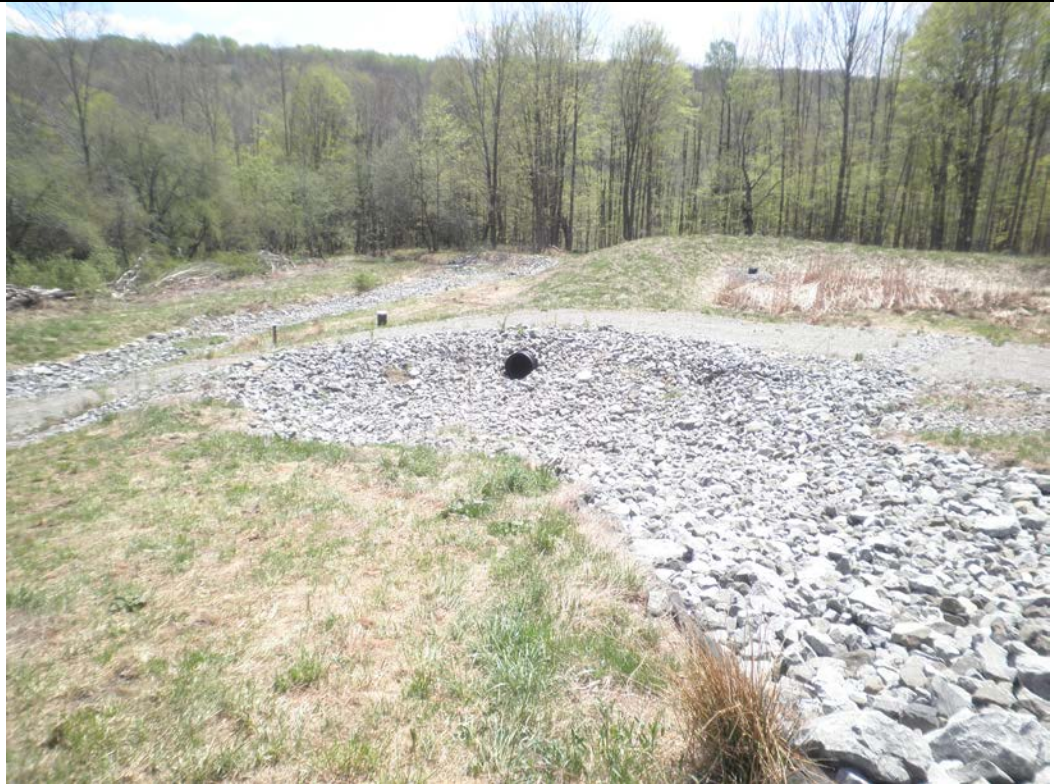
Photo 39

Downdrain
terminus

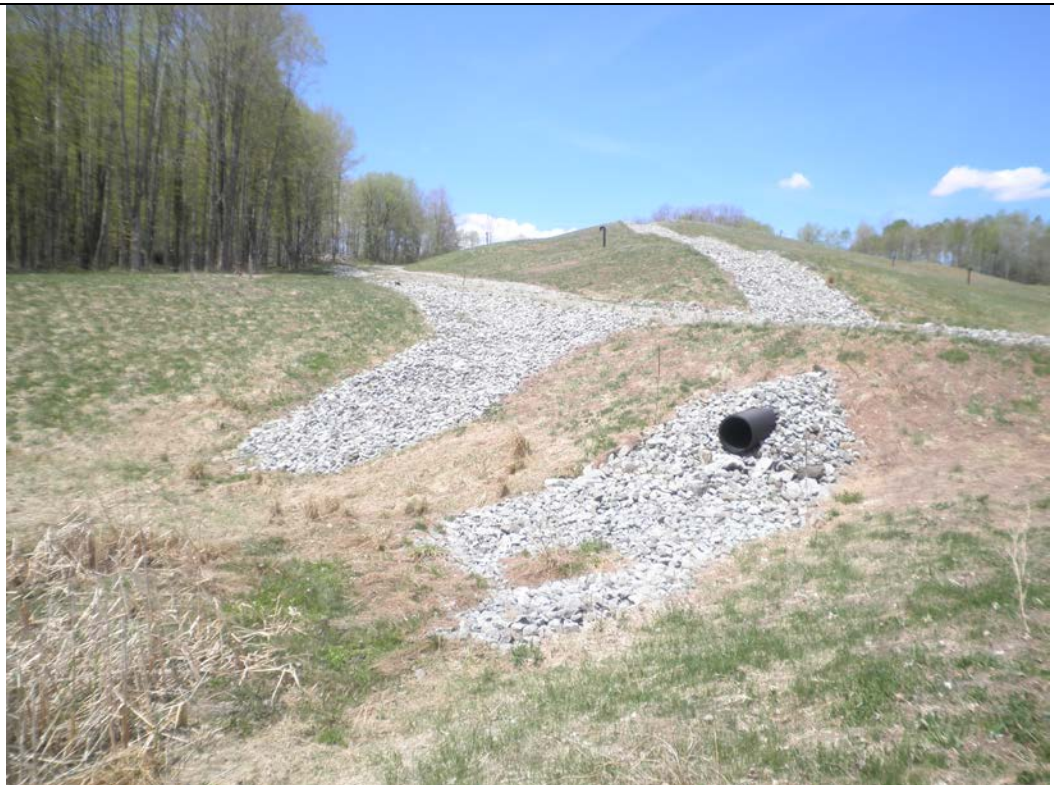
Photo 40

Detention basin
culvert C-1

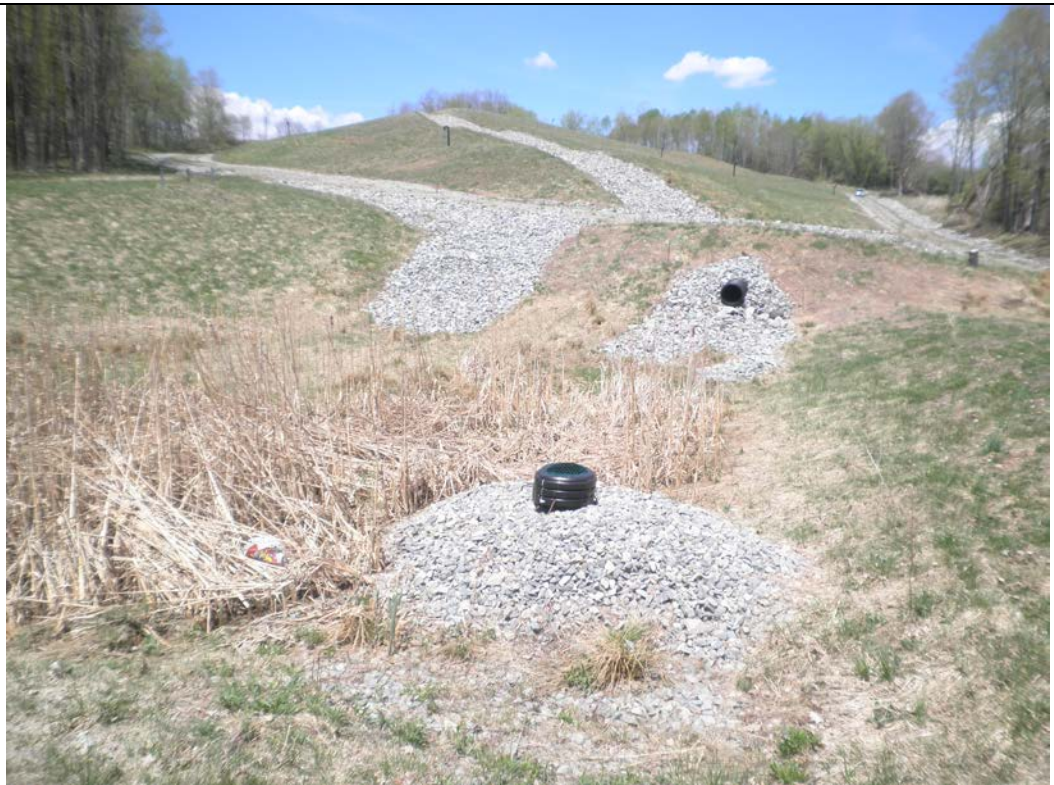
Photo 41

Detention basin
outlet structure

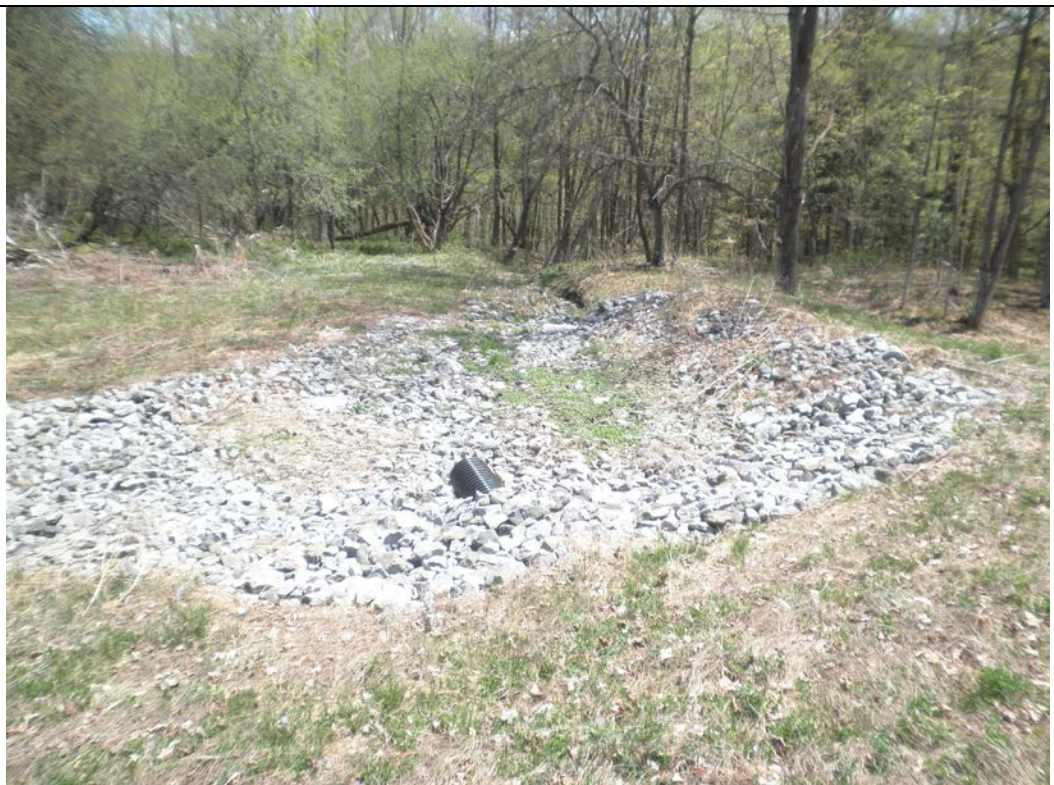
Photo 42

Culvert C-2

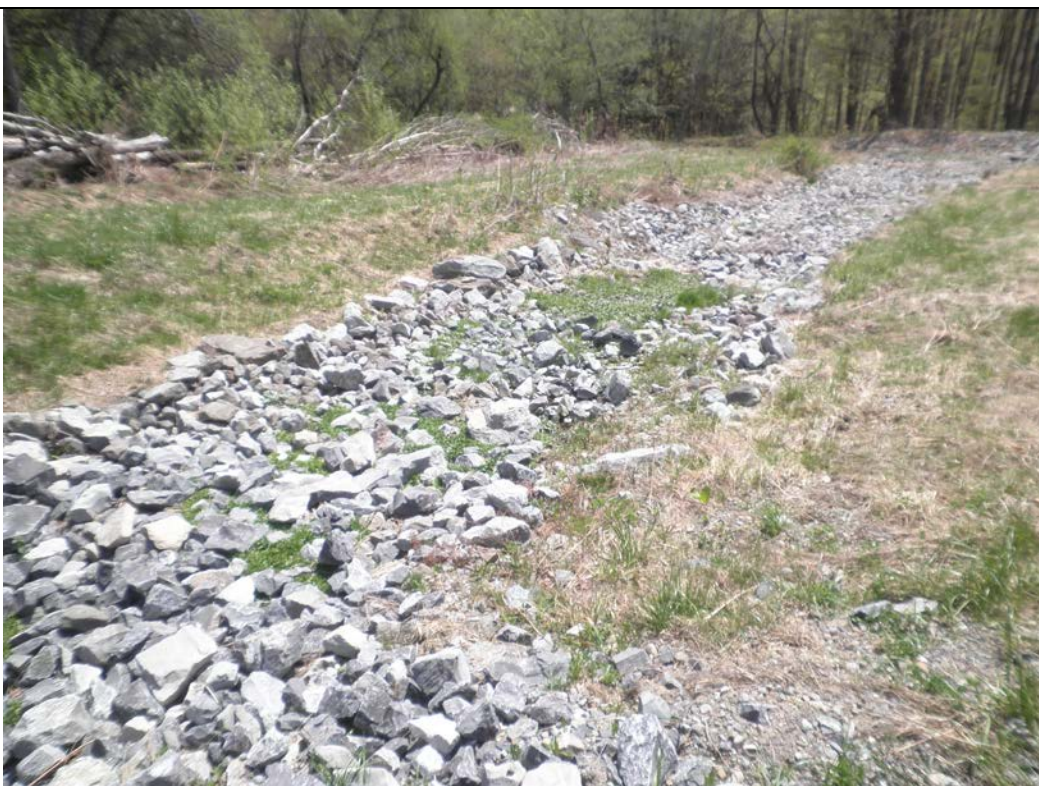
Photo 43

Lower portion of
the east drainage
swale

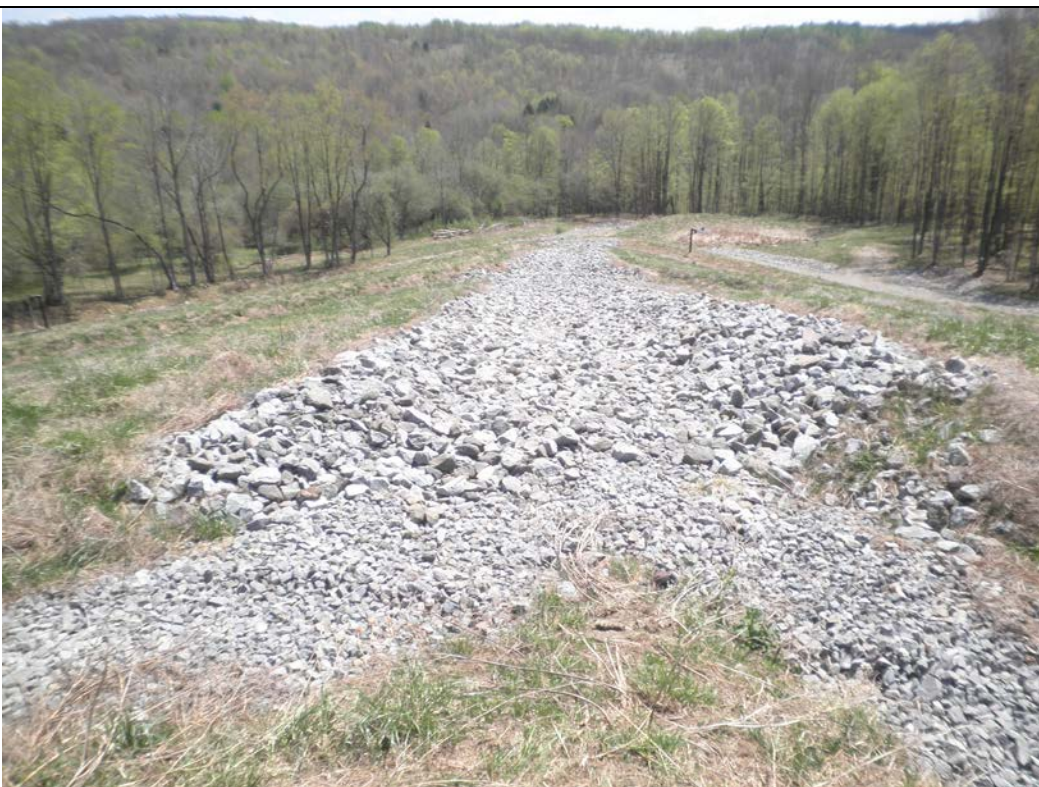
Photo 44

Down drain

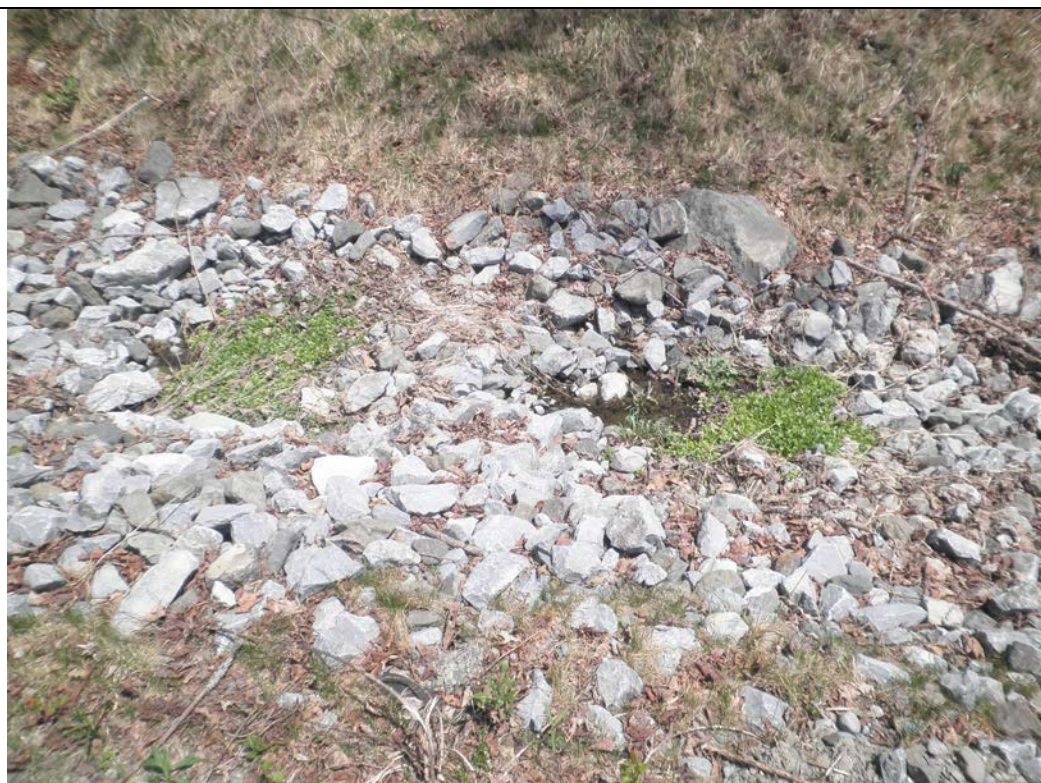
Photo 48

- A small animal burrow is located on the east side slope bench, approximately 32 feet south of GV-4
- The amount of rip rap was relatively thin, and vegetation is growing in eastern drainage swale

Thin area of
riprap with
vegetation
growing in the
east drainage
swale east of
MW-3SR

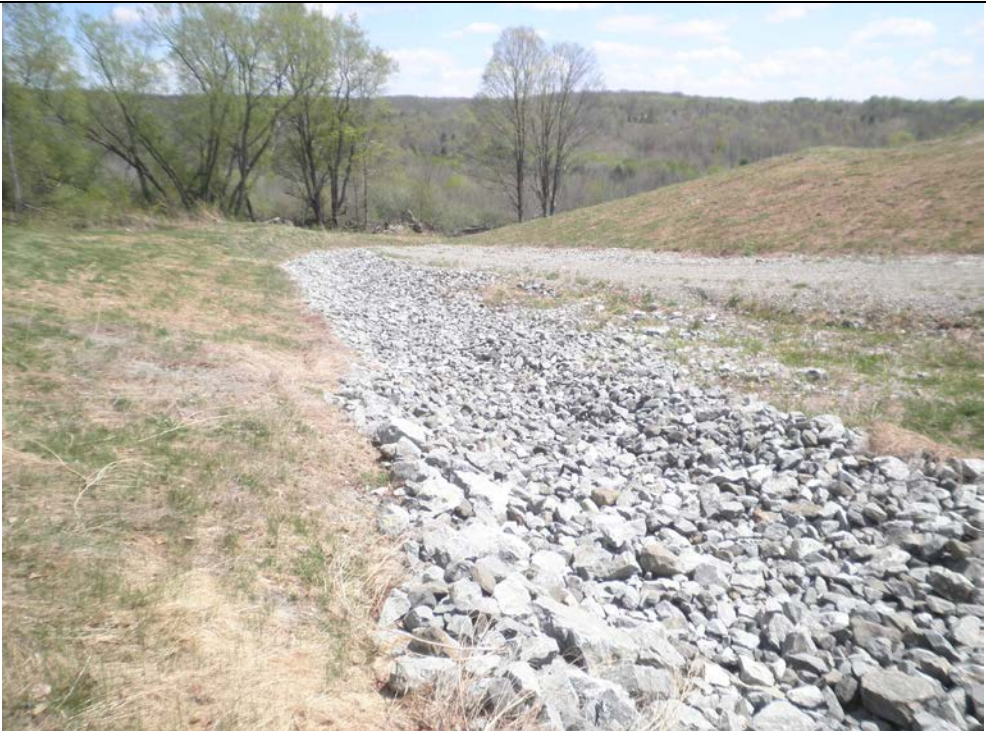
<p>Photo 57</p> <p><u>Description:</u> Thin area of riprap with vegetation growing at the head of the east drainage swale</p> <p><u>Orientation:</u> Facing northwest</p> <p><u>Source:</u> MACTEC, May 2015 Site Inspection</p>	 
<p>Photo 58</p> <p><u>Description:</u> Upper portion of the east drainage swale</p> <p><u>Orientation:</u> Facing southeast</p> <p><u>Source:</u> MACTEC, May 2015 Site Inspection</p>
