**RE: Submission of the 2019 Periodic Review Report  
South Hill Dump, Town of Cortlandville, New York  
CHA Project No.: 34236  
NYSDEC Site No.: 712009**

# 2019 PERIODIC REVIEW REPORT

**South Hill Dump  
Sommerville Road  
Cortlandville, New York**

**NYSDEC Site Number: 712009**

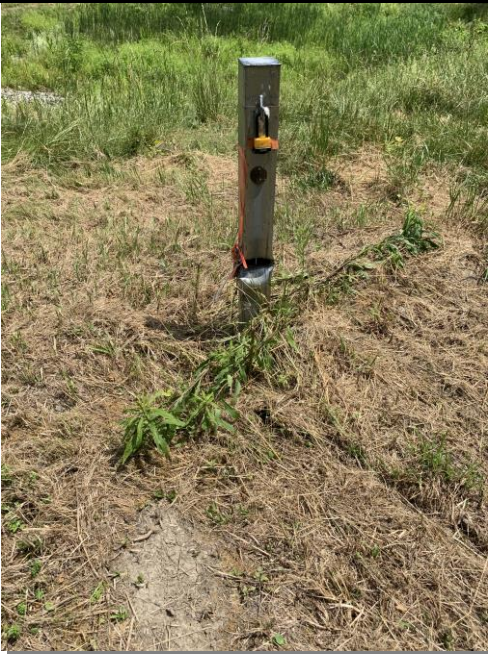
Lawn mowing activities appear to have damaged monitoring wells MW-2B and MW-2D. The twine holding the passive diffusion bag (aka. HydraSleeve®) sampler appears to have been cut from MW-2B. The passive diffusion bag and the rope to retrieve it have fallen to the bottom of the well. Additionally, the stick-up casing for MW-2D appears to have been significantly damaged. The steel casing and the PVC riser have been cut approximately one foot above the ground surface.

The rope attached to the passive diffusion bag (PDB) (aka Hydrosleeve) in MW-2B appears to have been cut by the lawn mowing equipment. The rope has fallen down the well riser and was not able to be recovered during the inspection. The well identification tag was caught between the casing and the well cap.

- The site access controls were satisfactory. There was no evidence of trespassing.
- The surface water conveyance controls were satisfactory, and the eastern drainage swale was in good condition.
- Landfill gas vents and the vegetation surrounding the gas vents appeared to be in good condition.
- Monitoring wells were in good condition with the repair of MW-2D. The passive diffusion bag in MW-2B will be replaced prior to the 2020 sampling event.

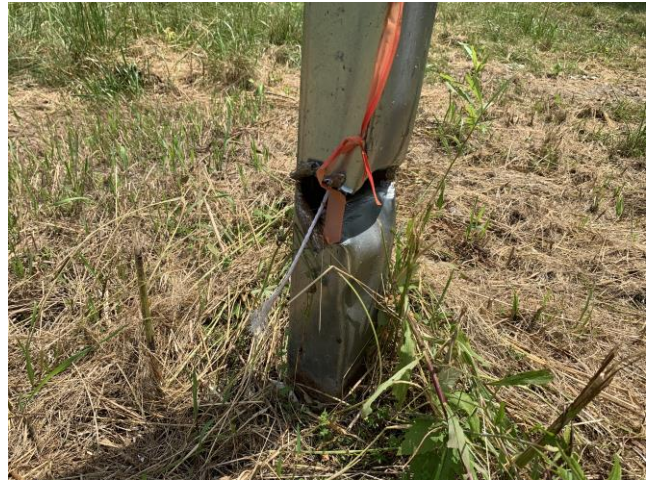
MW-2D appears to have been struck by the lawn mowing equipment.

Repair of MW-2D was scheduled for October 11<sup>th</sup>, 2019. Staff from CHA oversaw the repair and conducted the second semi-annual Site inspection. Results of the October 11<sup>th</sup> inspection indicate the following:

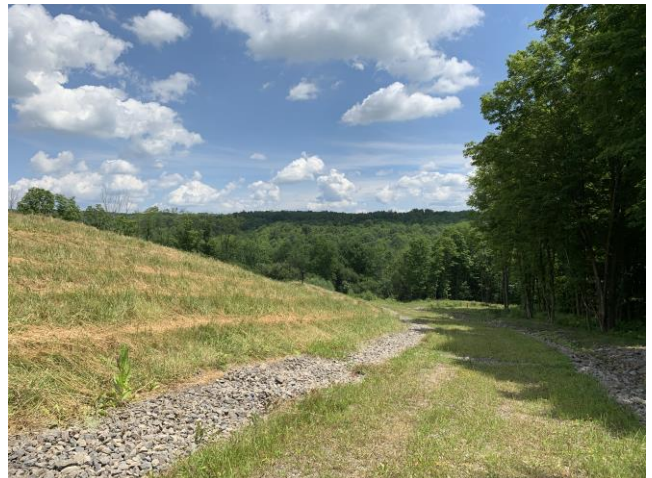
North side of the landfill.

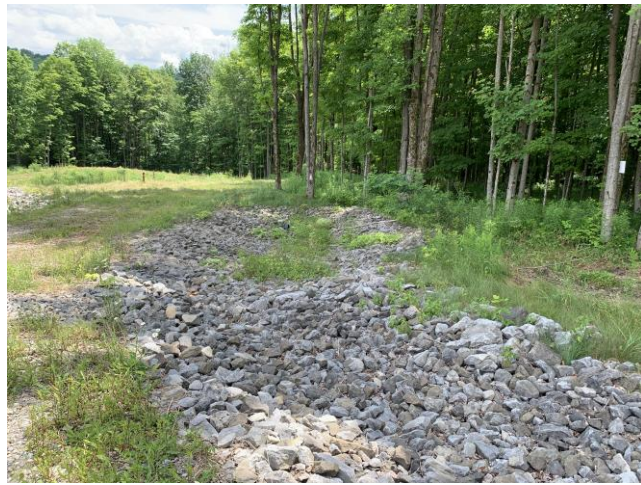
West side of the landfill.

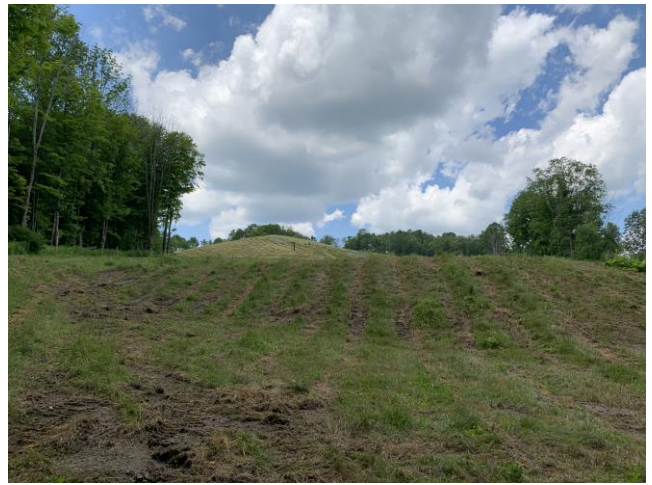
**Drainage swale on the west side of the landfill.**

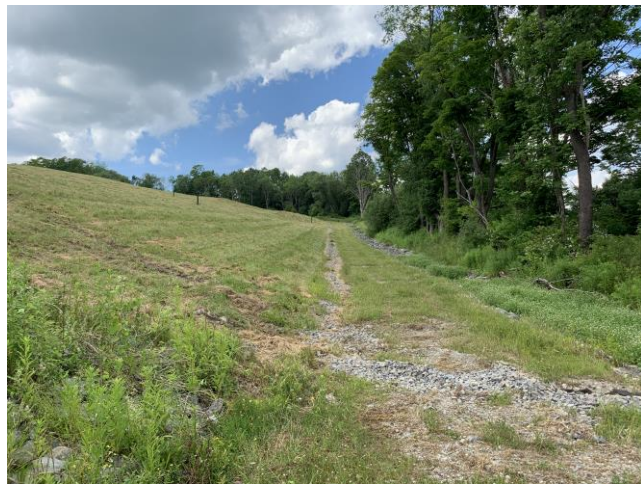
**South side of the landfill.**

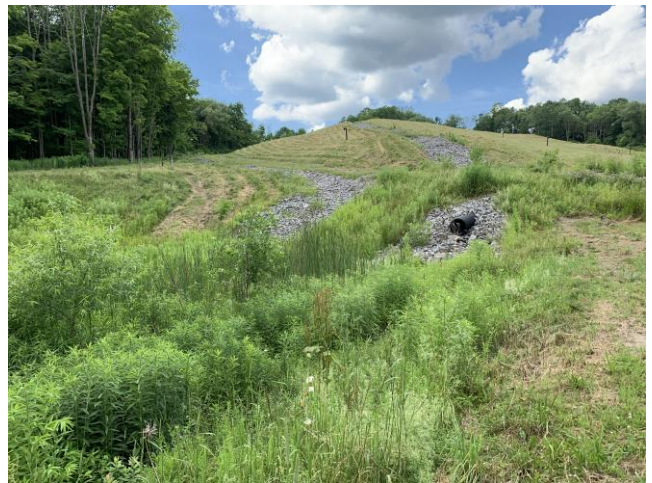
**East side of the landfill.**
