**SUPPLEMENTAL PRE-DEMOLITION
SURVEY FOR HAZARDOUS
BUILDING MATERIALS**

**FORMER NES BUILDING
4119 CANAL ROAD
CANASTOTA, NEW YORK**

Prepared for
New York State
Department of Environmental Conservation
Syracuse, New York

TRC Project No. 198432-0000-00000
February 2013

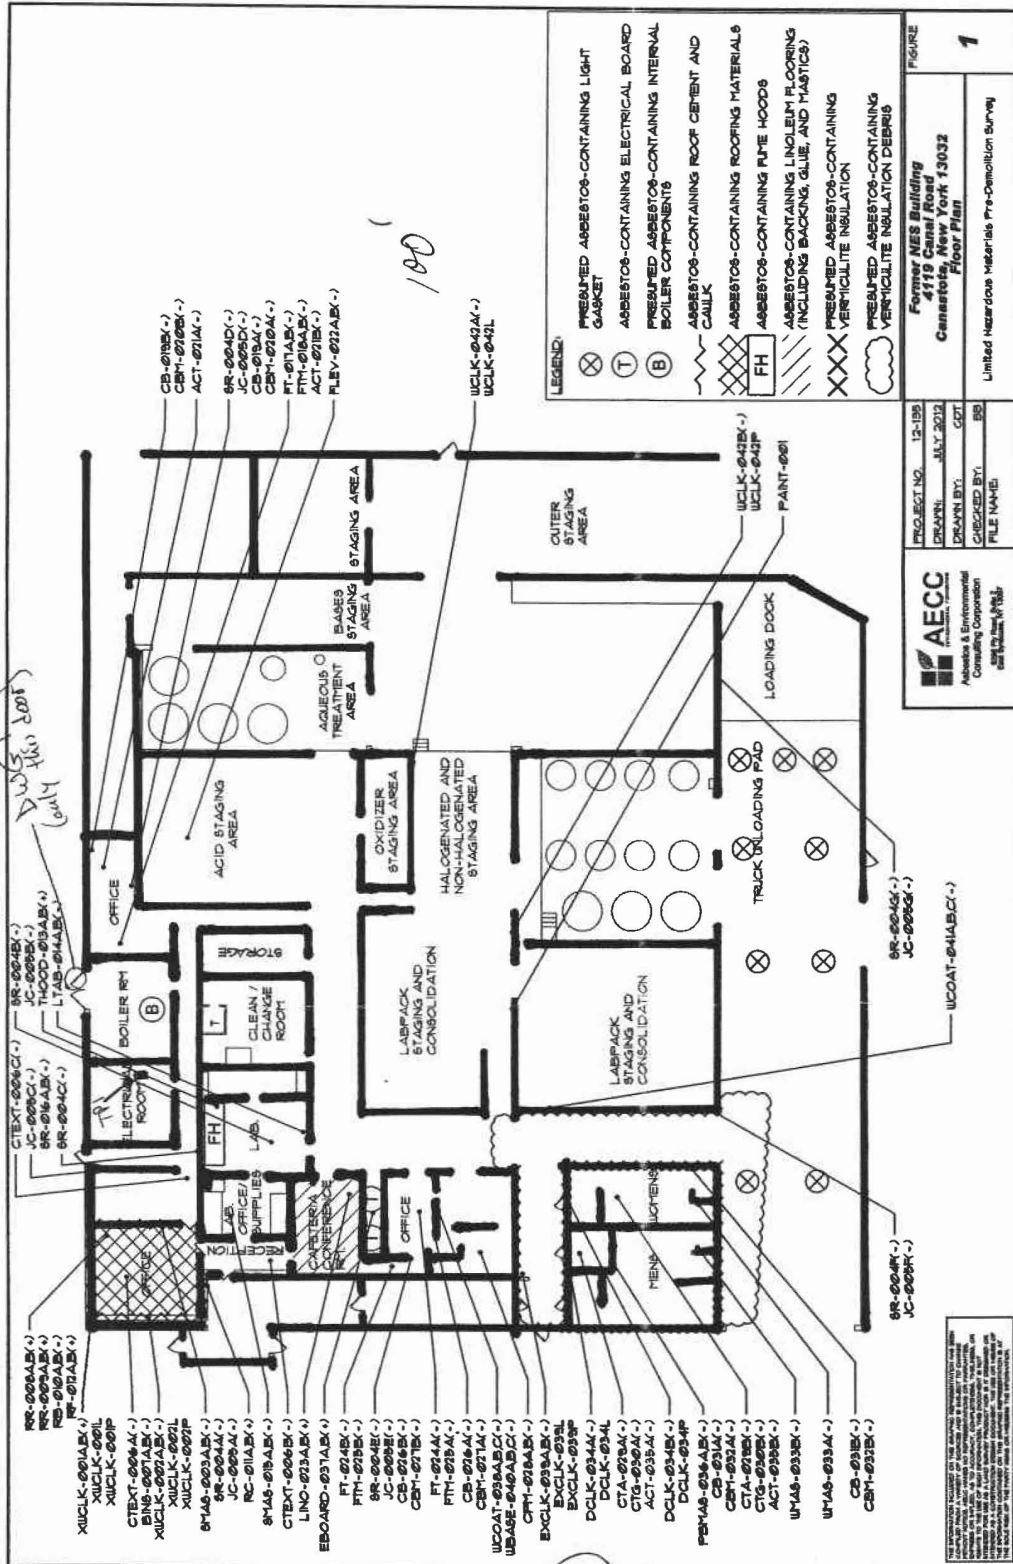
SHEET NO. 1 OF 1

WGL - black, pliable dr wind glaze
 P1 - transformer paper ins.

- metal roof w/ RSI
- all vents/exhaust fans have penetration flashing; unable to access roof; Assume ACM.
- 3 LF/each

RSI - ext rivet sealant

- metal wall panels, 3' x 15'-20', each
w/ \approx 10 rivets w/ RSI (all walls & roof)
