April 11, 2013

Re: Building Demolition Evaluation
Former Haz-O-Waste (Northeast Environmental Services) Site
NYSDEC Site No. 727003
Work Assignment (WA) No. D007620-9
TRC Project No. 198432.0000.0000

PHOTOGRAPHIC RECORD

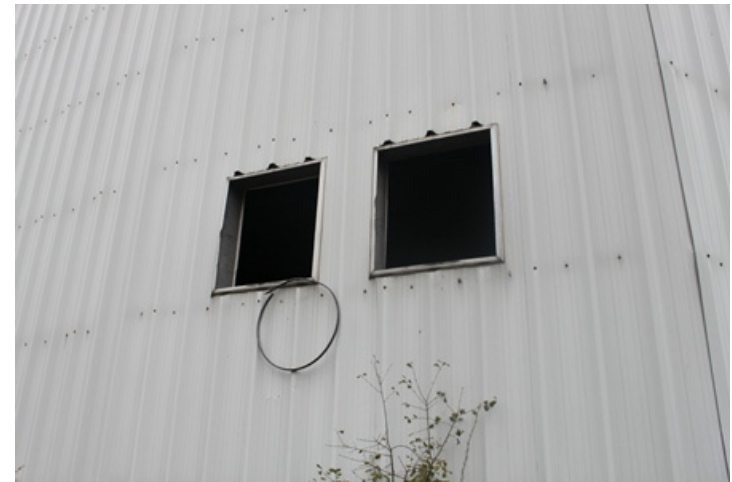
Photo 02 Exposed windows with no glass or pane located on eastern wall of building.

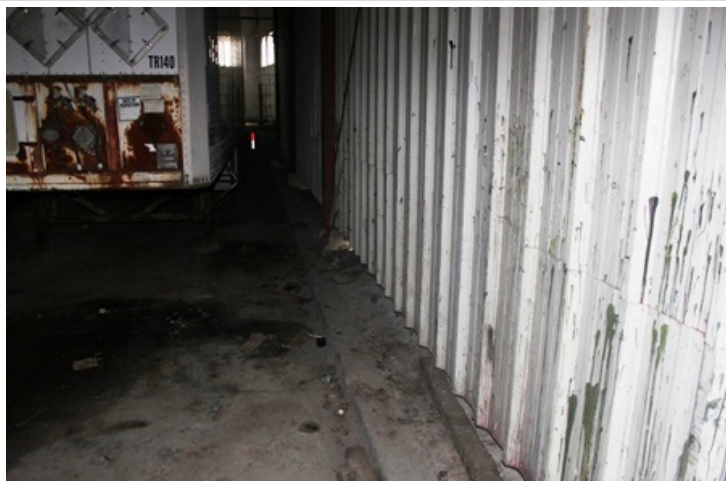
Concrete floor slab elevations and thicknesses vary throughout the building, and floor stains are present in multiple rooms, former storage locations, and former staging areas. The results of laboratory analyses of soil and groundwater samples collected as part of pre-design investigation activities performed in January 2013 have confirmed that the majority of the subsurface VOC contaminant mass at the Site is below the northern portion of the building concrete floor slabs and extends north of the building footprint.

Photo 05 Stained concrete floor slab in Truck Unloading Pad Area.

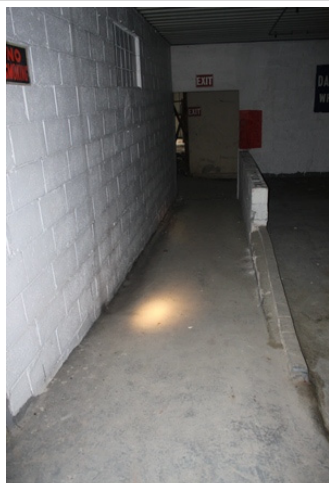
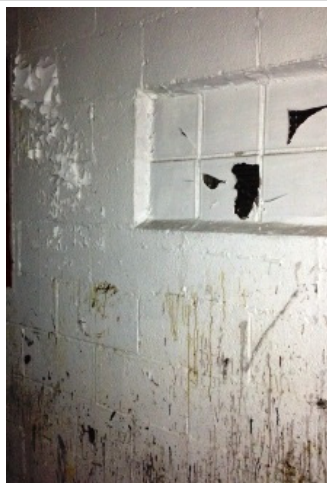
Photo 13 Left: Hallway between Labpack Staging and Consolidation rooms. Concrete walkway is sloped toward building entrance.
Right: Wall staining and broken glass within Halogenated Staging Area.

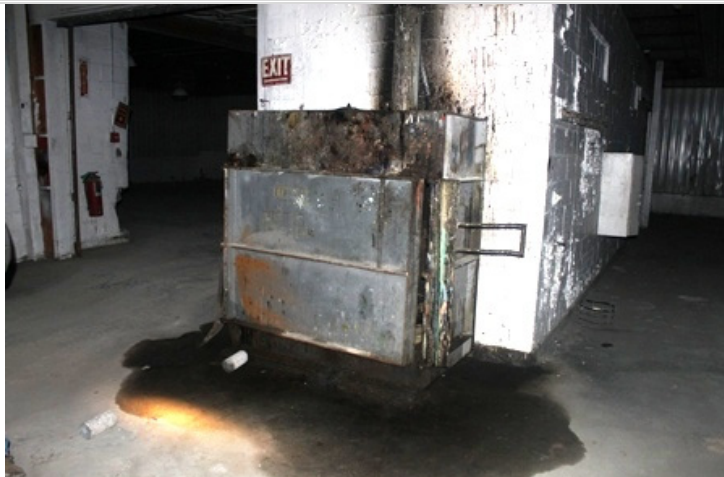
Photo 19 Floor staining near a drum crushing device.

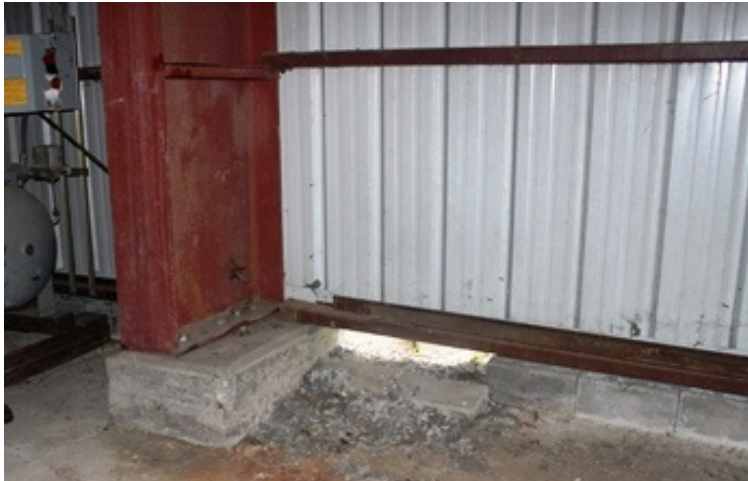
Photo 25 Concrete footing and pre-fabricated metal wall. The wall does not extend to the ground surface. Therefore, the building is not fully enclosed.

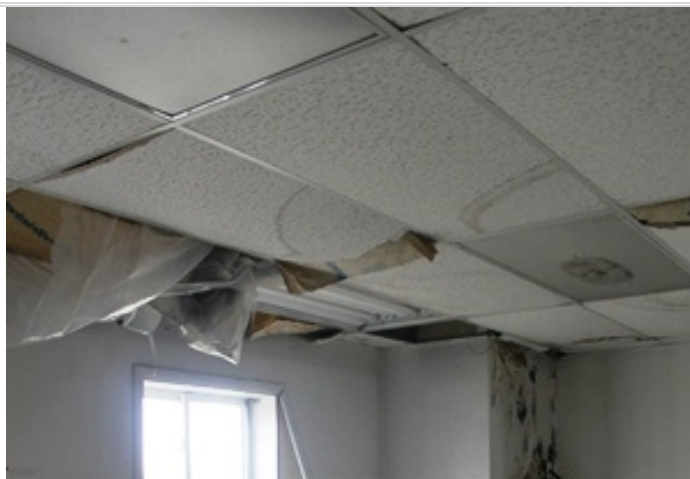
While the building appears to be in fair condition with no obvious evidence of structural issues, roof deterioration and noticeable mold growth are present in the southwestern portions of the building. In addition, the corrugated metal shell of the outer building structure does not completely extend to the ground surface around the perimeter of building, which allows for outside air infiltration into the eastern and northern parts of the building (refer to photographs of the building in Attachment A).

- Visual inspection shows significant evidence of water damage in the southwestern portions of the building, possibly due to the proximity of the Erie Canal and discharge from the drainage ditch that runs parallel to the canal. The water damage indicates the building is susceptible to flooding. Flooding in and around the building during implementation of the remedy could cool the subsurface and reduce the effectiveness/efficiency of ISTR. Demolition of the building and Site stormwater drainage modifications could mitigate the potential for flooding during ISTR.

Photo 31 Office in southwest corner of building; deteriorating roof.

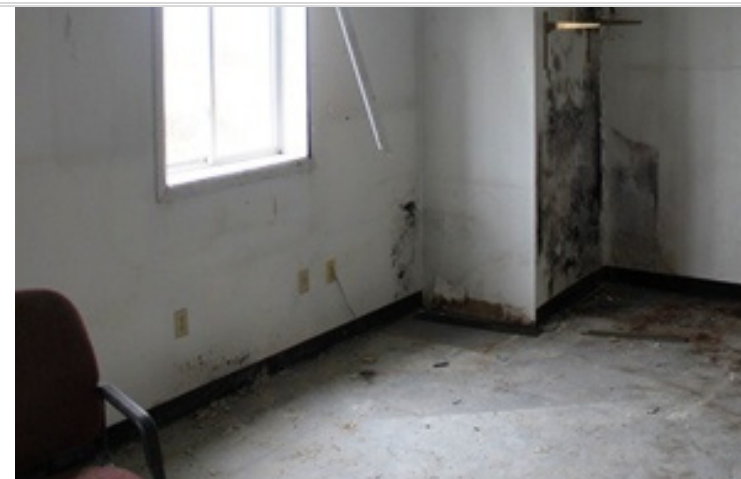
Photo 32 Office in southwest corner of building; mold on walls.

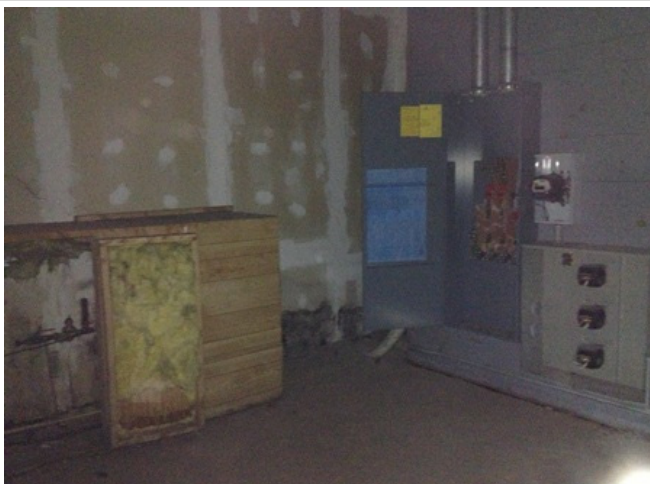
Photo 33 Utility Room near southwest corner of building. The electrical panels have been partially dismantled.

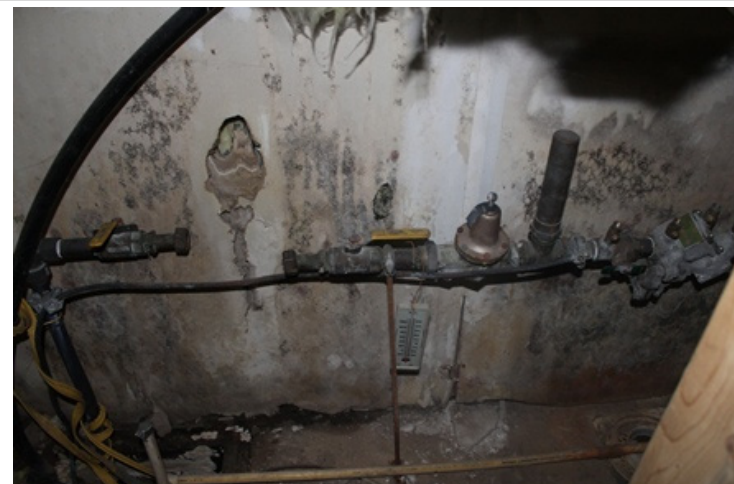
Photo 34 Utility Room water service connection with evidence of mold.

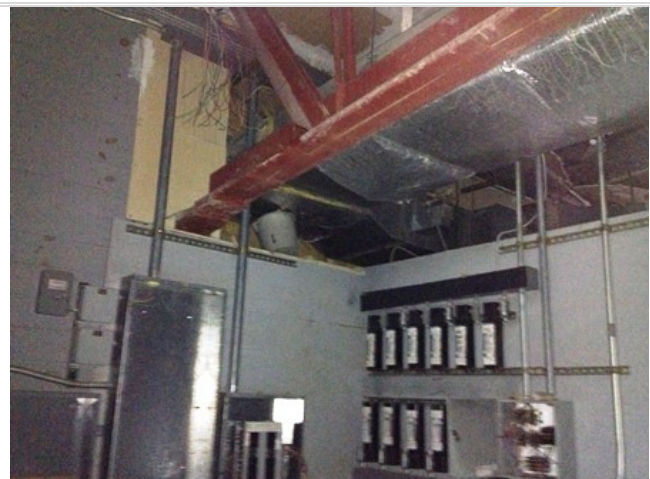
Photo 35 Electrical components on wall of Utility Room. Truss construction and partial insulation runs through the room and cut overhead wires remain in place.

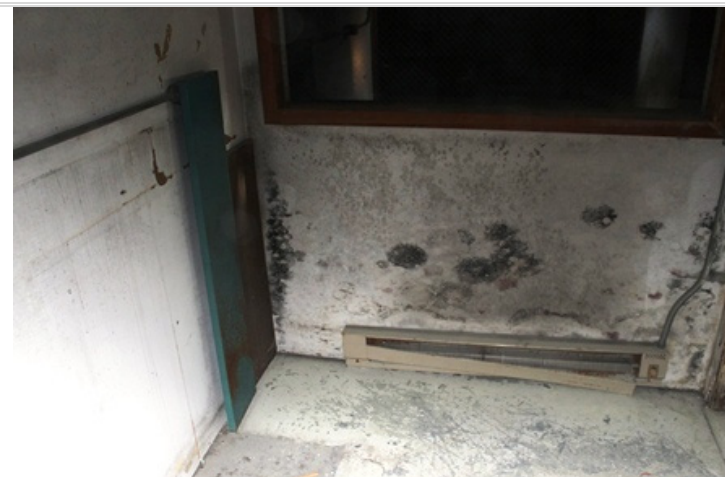
Photo 40 Mold in Laboratory.

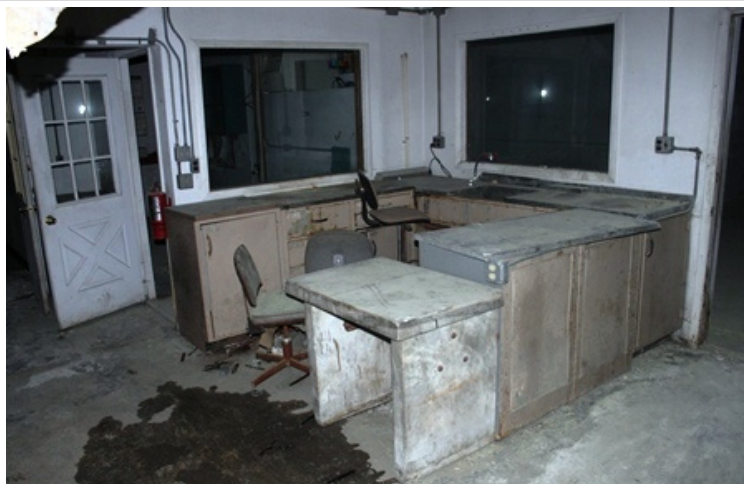
Photo 41 Office Supply Room with staining of floor.

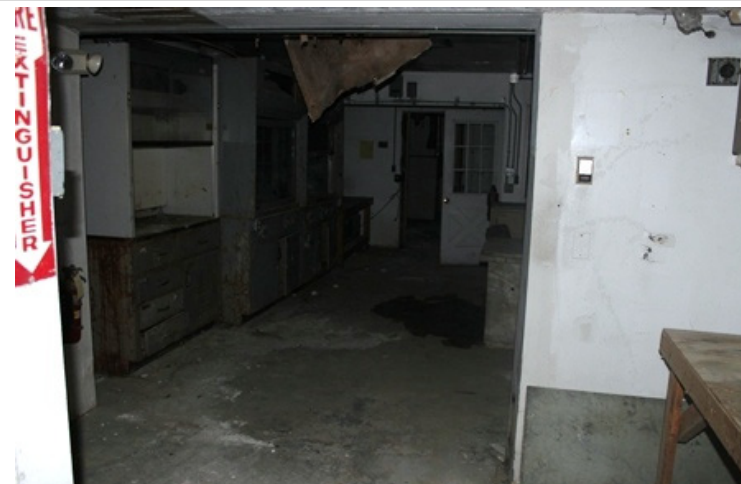
Photo 42 Office Supply Room with overhead wall deterioration.

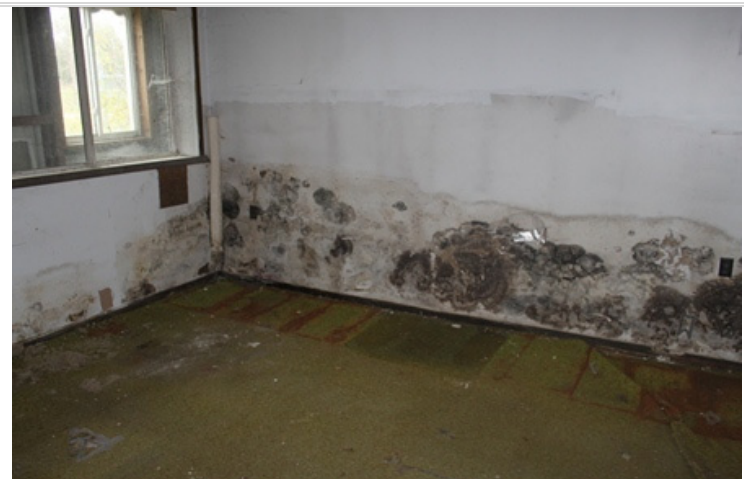
Photo 43 Office in southwest corner with mold on wall.

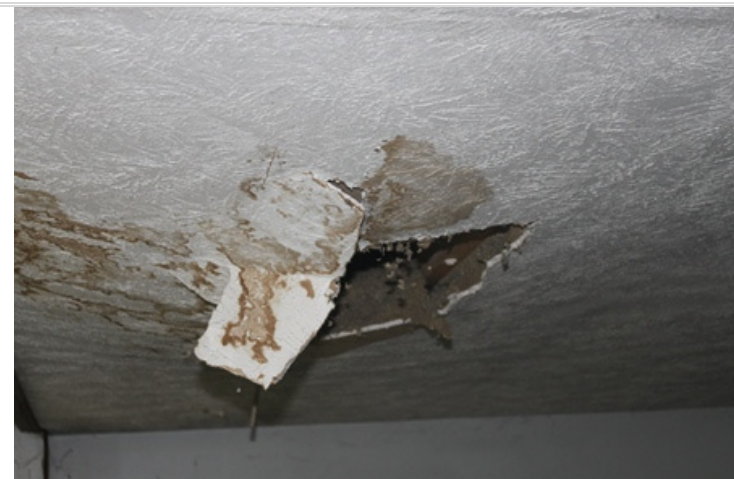
Photo 44 Office in southwest corner with ceiling deterioration.

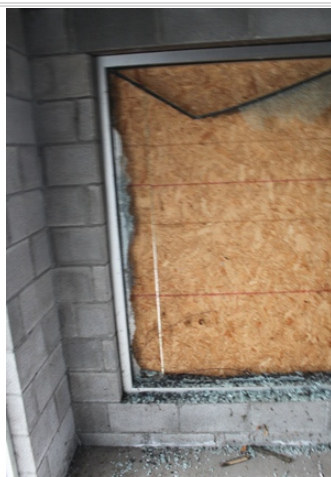
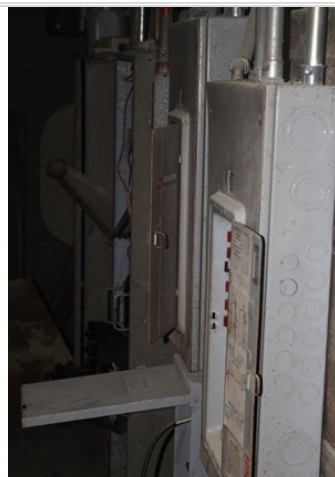
Photo 47 Left: Front entrance boarded, broken glass remains.
Right: Electrical panels on the exterior wall of wood frame of building near the Conference Room. Electrical boards contain asbestos.

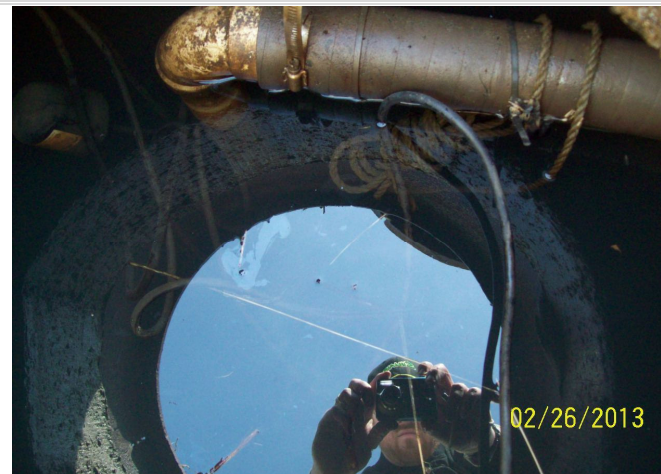
Photo 60 Unlabeled manhole interior containing standing water, an inoperable sump pump, and a 2-inch discharge pipe oriented toward the drainage ditch stormwater catch basin.
