November 6, 2018

Reference No. 8618809.36

**Re: Annual Site Inspection – 2018  
Former Crucible Specialty Metals Landfill – Inactive Hazardous Waste Disposal  
Site #734021**

EnPro Holdings, Inc.  
 Former Crucible Specialty Metals Landfill Site  
 2018 Annual Site Inspection

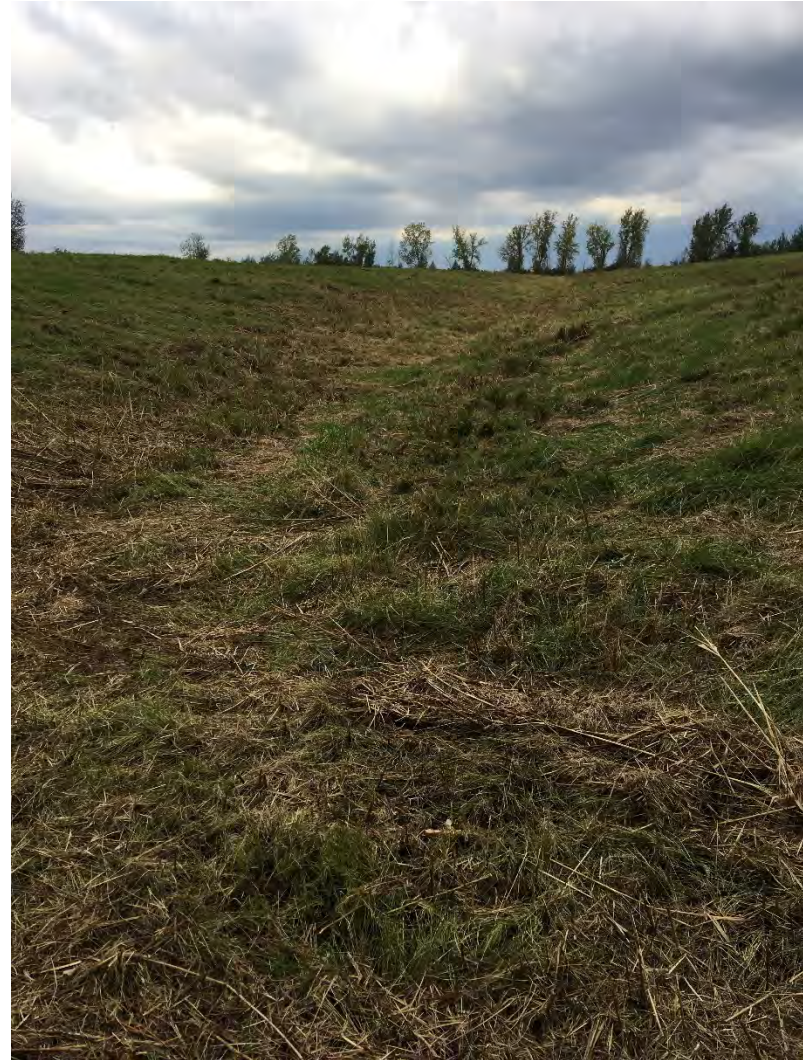
6. Representative view of landfill's interior drainage swales.

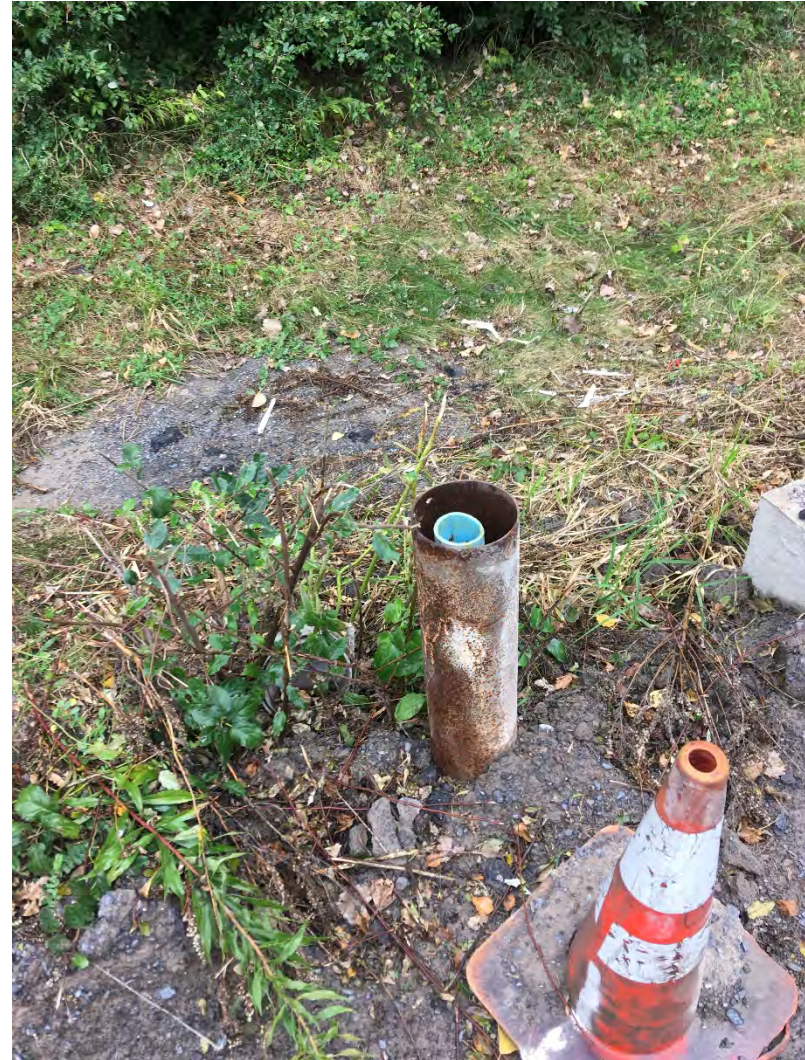
19. Does the survey benchmark for the site appear to be undisturbed?  
INC-2 cover needs to be replaced.

8. View of Inclinator 2 (interior pipe used as Site benchmark). Cover was found to be off and was loosely replaced.

2. Since the cover for INC-2 was only set back onto the protective casing, replacement setscrews should be brought to the Site during the next scheduled monitoring event (October 2019) to securely attach the cover to the protective casing.

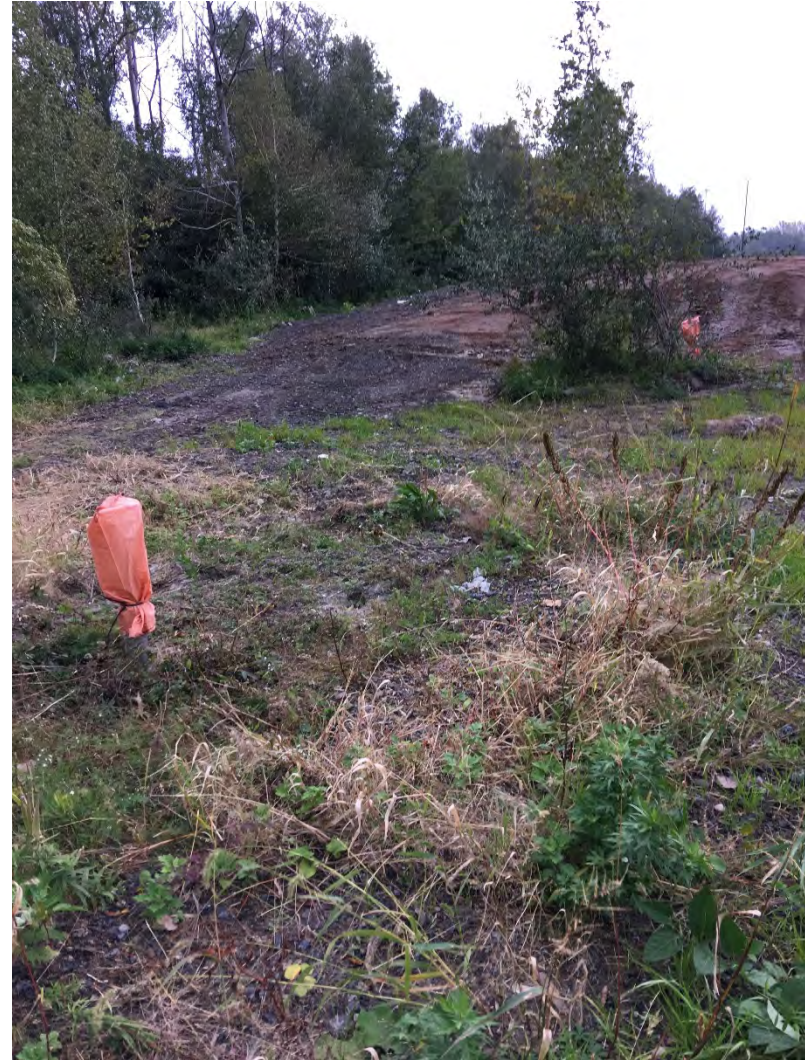
3. Off-site soils are being spread in the vicinity of piezometer cluster PZ-5 by others. These activities did not appear to be directly impacting PZ-5, but did extend up to the piezometer and appeared to be on-going at the time. The soil surface was not stabilized with vegetation at the time of the inspection.
4. Construction activities along the western perimeter roadway have resulted in bare soils in areas of the off-site perimeter stormwater swale. The bare soil areas were not stabilized with either temporary measures or vegetation at the time of the inspection.

16. View of W-5.6 groundwater monitoring well. Piezometer PZ-5 cluster in background.

3. The area adjacent to piezometer cluster PZ-5 should be observed during the next scheduled monitoring event (October 2019) to document that damage to PZ-5 has not occurred and that the area is stabilized such that impacts to PZ-5 are not likely to occur in the future.

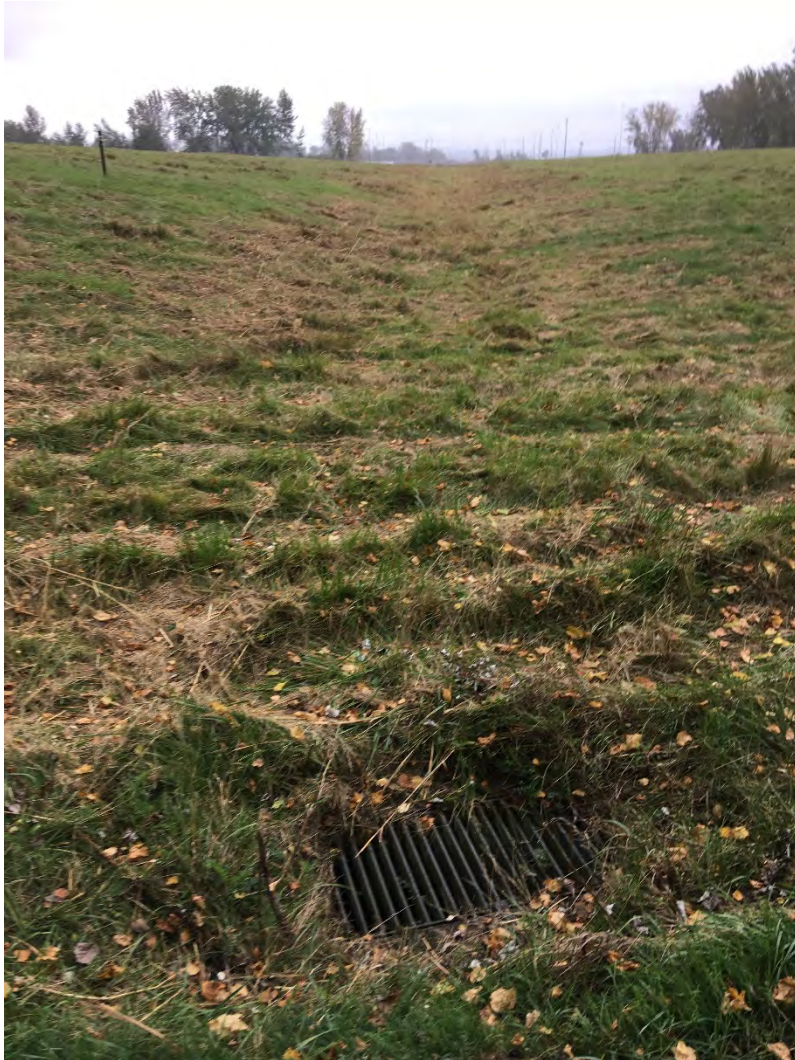
17. Representative view of stormwater catch basins along northwest side of Site.

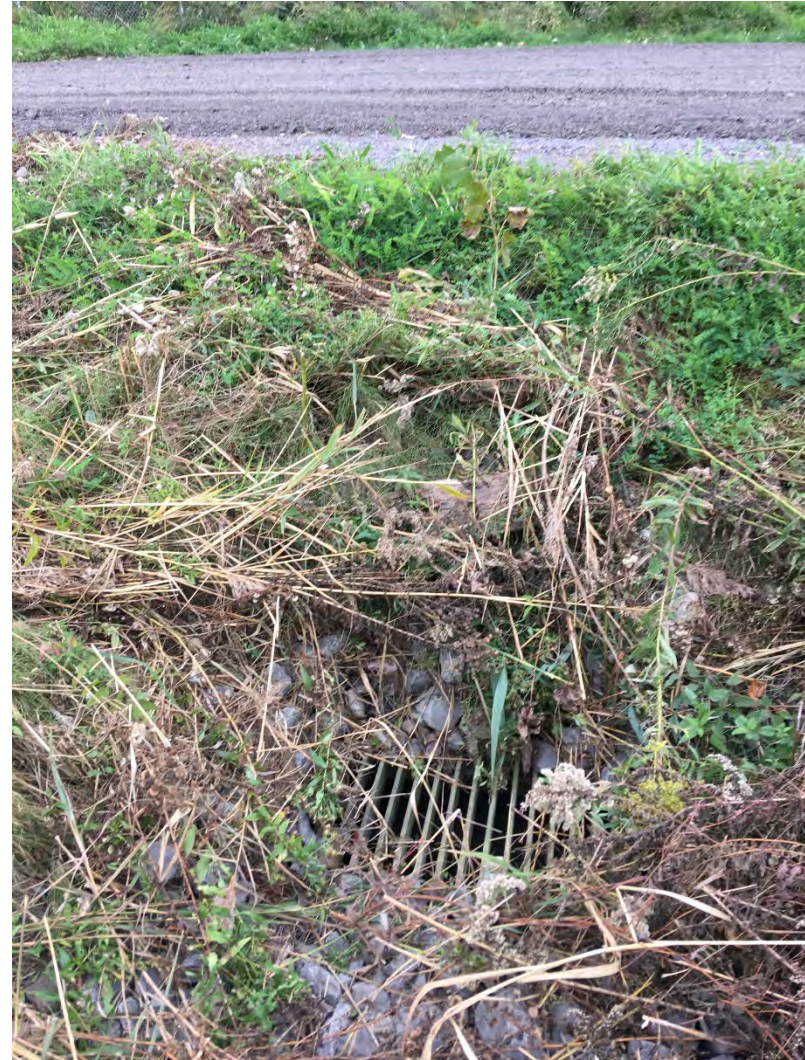
18. Representative view of stormwater catch basins along southeast side of Site

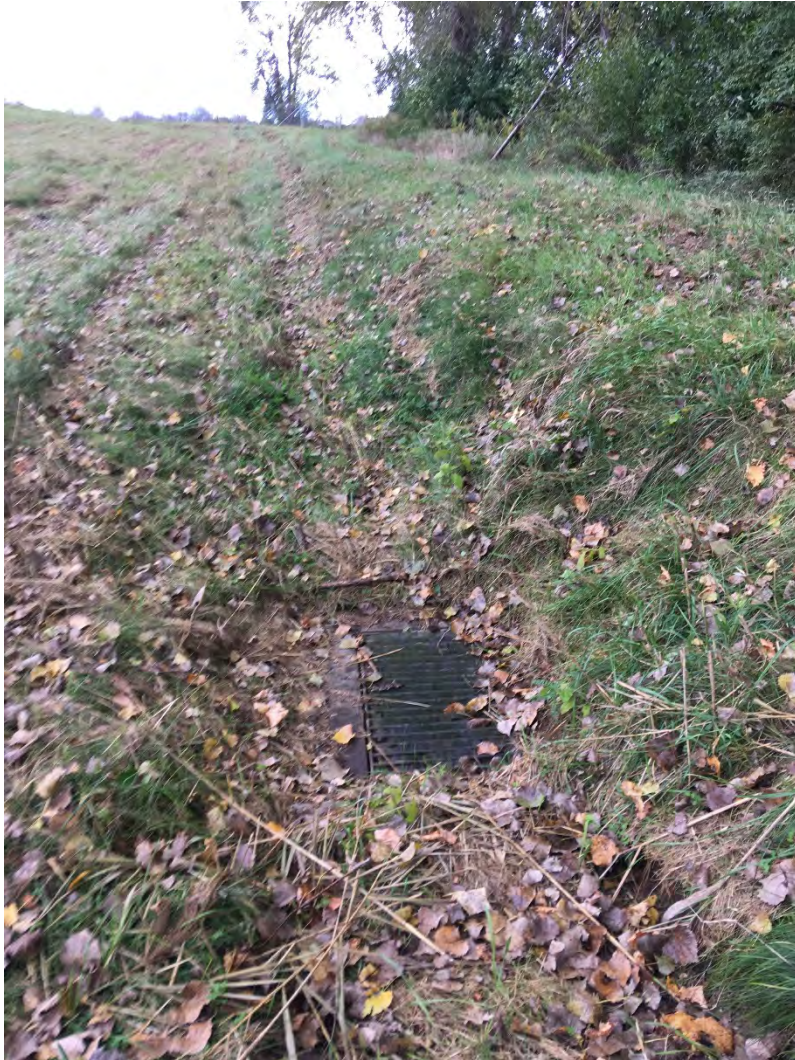
19. Representative view of stormwater catch basins along southwest side of Site.

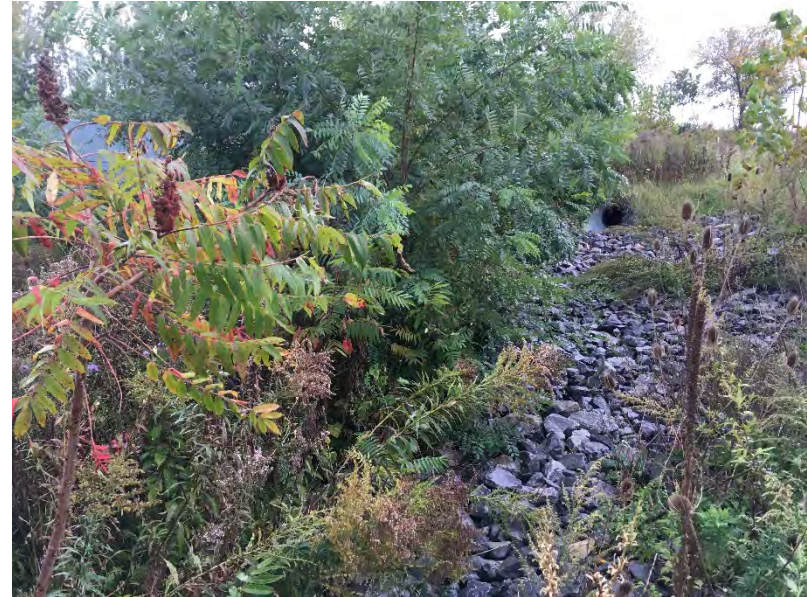
20. View of Site's stormwater outfall near Ninemile Creek.

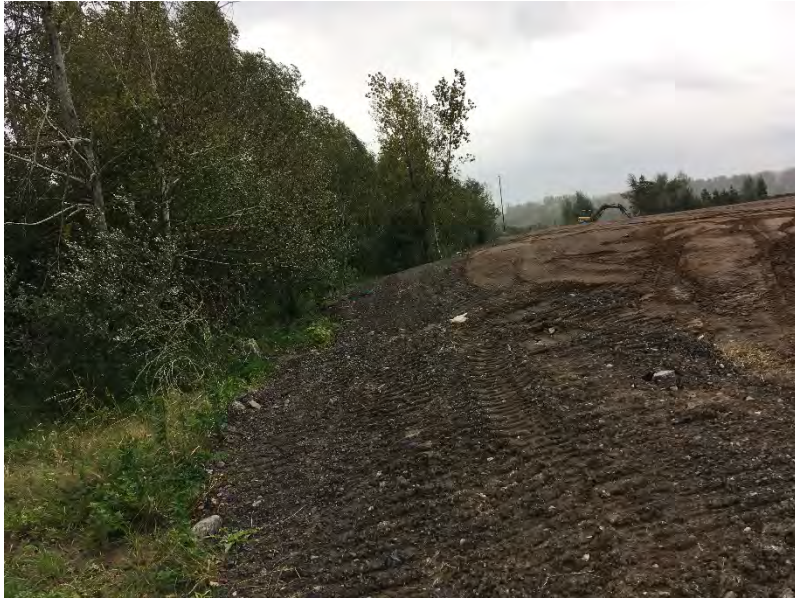
21. Material placement by others near northwest corner of landfill.

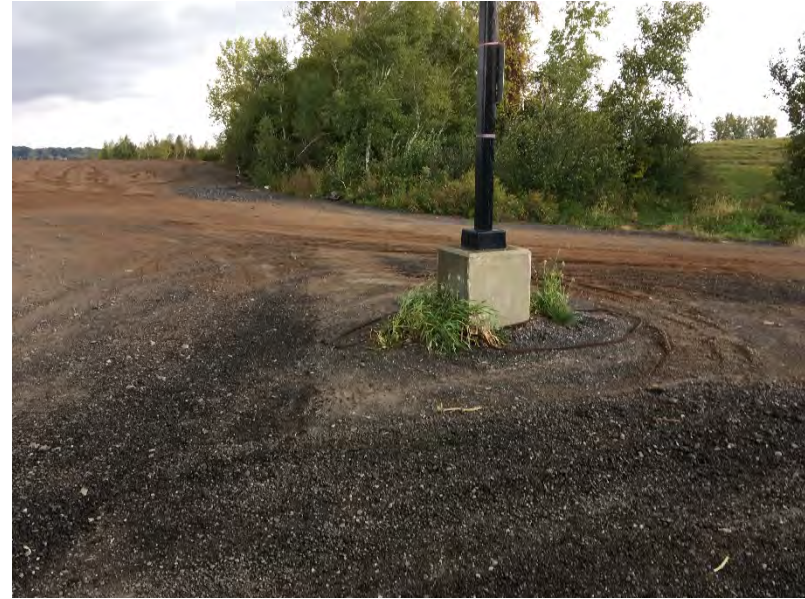
22. Material placement by others near northwest corner of landfill.

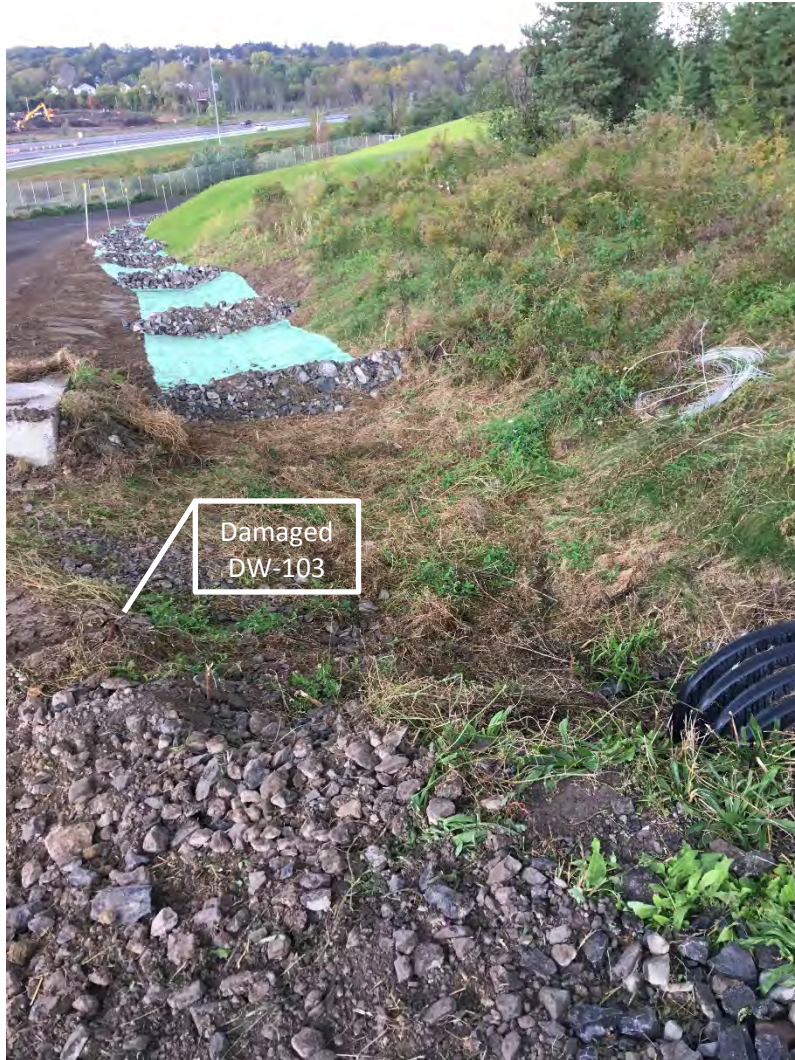
23. View of recent construction completed by others northwest of landfill.

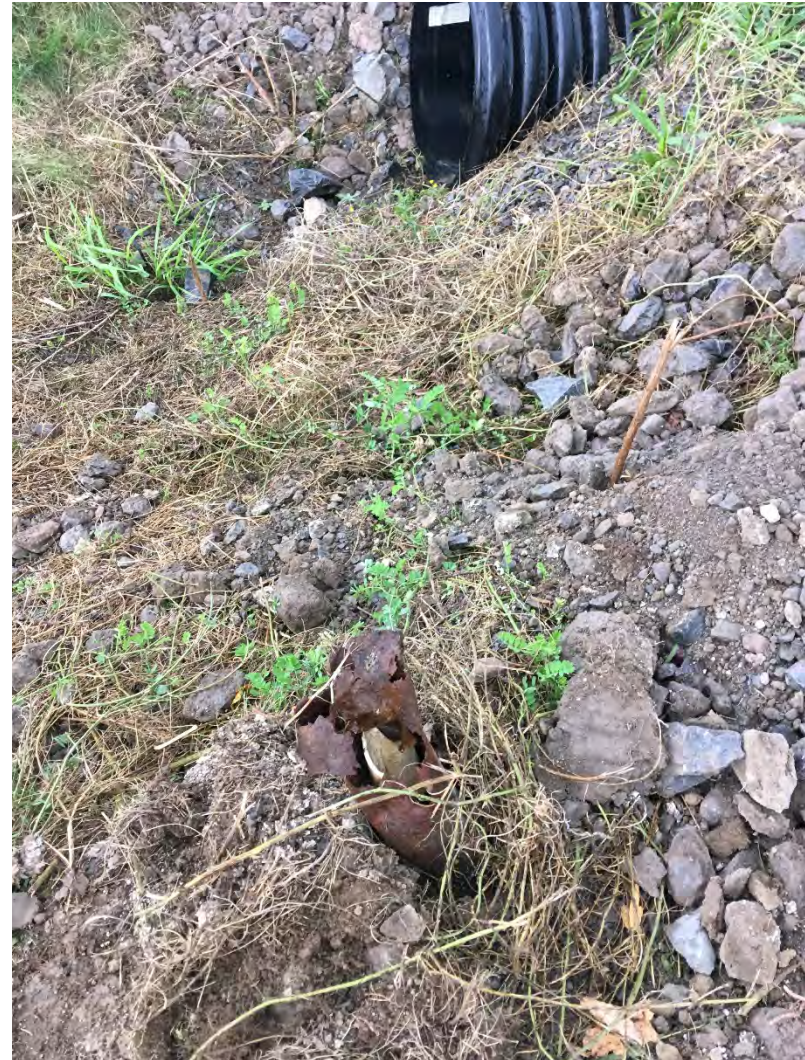
1. Groundwater monitoring well DW-103 near the northwestern corner of the landfill was destroyed at an unknown time, apparently due to construction activities completed in the area by others. This monitoring well was approximately 160-feet deep and was used for groundwater level measurements during groundwater monitoring events.
2. Inclinometer INC-2 was found with the surface casing cover knocked off and laying on the ground surface adjacent to the casing. The cover was placed back on top of the surface casing at the time of inspection; however, it could not be tightly attached at the time.

15. Is there evidence of trespassing or vandalism on the site?  
None observed. Monitoring well DW-103 destroyed, by possibly by construction activities by others.

24. View of damaged groundwater monitoring well DW-103 in vicinity of recent construction activities completed by others.

1. NYSDEC is coordinating with the New York State Department of Transportation (NYSDOT) in regards to destroyed groundwater monitoring well DW-103, since NYSDOT was reportedly completing construction activities in this area and may be responsible for the damage. GHD, on behalf of EnPro Holdings, Inc., recommended that DW-103 be abandoned since it is only used for groundwater elevation monitoring. As of the date of this report, NYSDEC has not made a decision on the abandonment of DW-103.
