**STAUFFER MANAGEMENT COMPANY
MAESTRI SITE
GEDDES, NEW YORK**

***POST GROUNDWATER COLLECTION /
TREATMENT SYSTEM SHUTDOWN***

SEMIANNUAL REPORT – DECEMBER 2009

Envirospec Engineering Project E07-102a

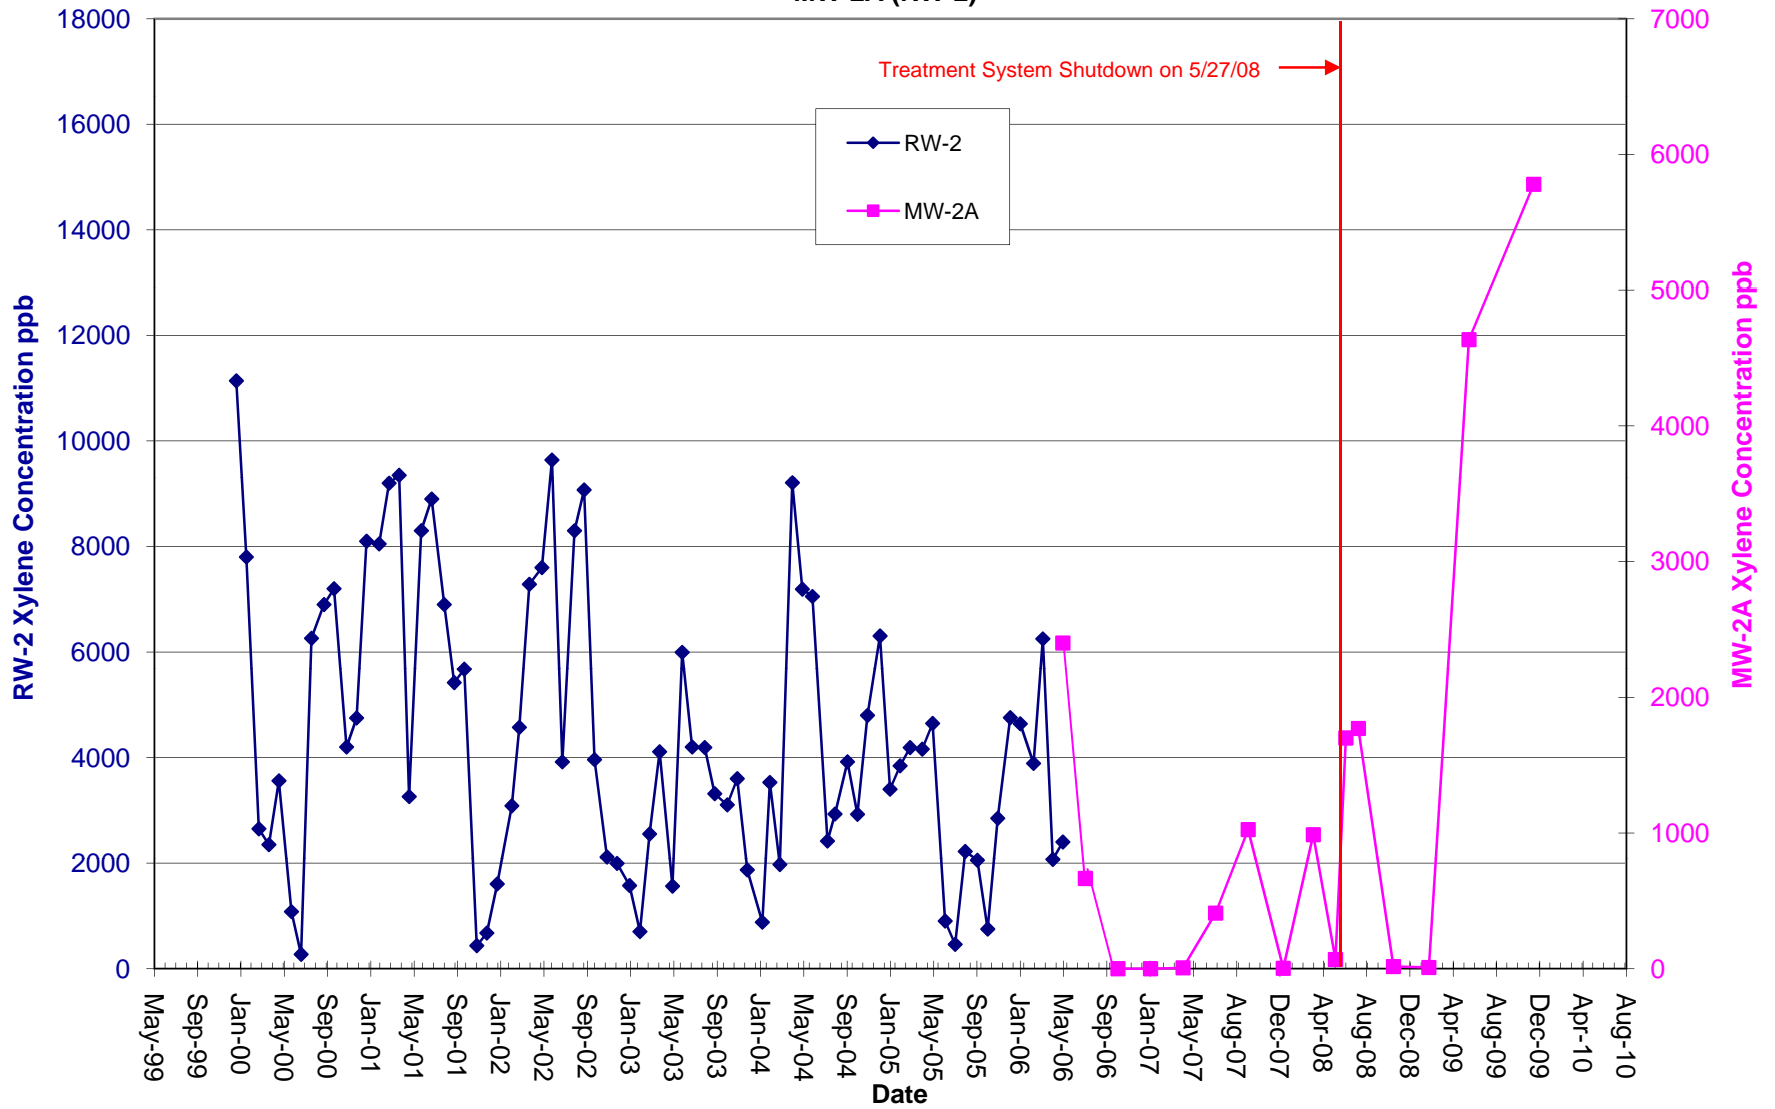
Figure 4
MW-2A (RW-2)

Figures 4 through 9 depict the xylene concentrations in recovery wells for this sampling event compared to levels noted during operation of the treatment system. In general, the xylene concentrations for this sampling round are in line with concentrations noted at the site for the past few years. Levels in MW-2A and RW-7 were slightly elevated as compared to past events while the elevated levels previously observed in RW-6 have decreased. These wells will continue to be monitored with the June 2010 sampling event.
