**MAESTRI SITE  
904 State Fair Boulevard  
Geddes, NY  
NYSDEC Site: 7-34-025**

**PERIODIC REVIEW REPORT**

**January 2011**

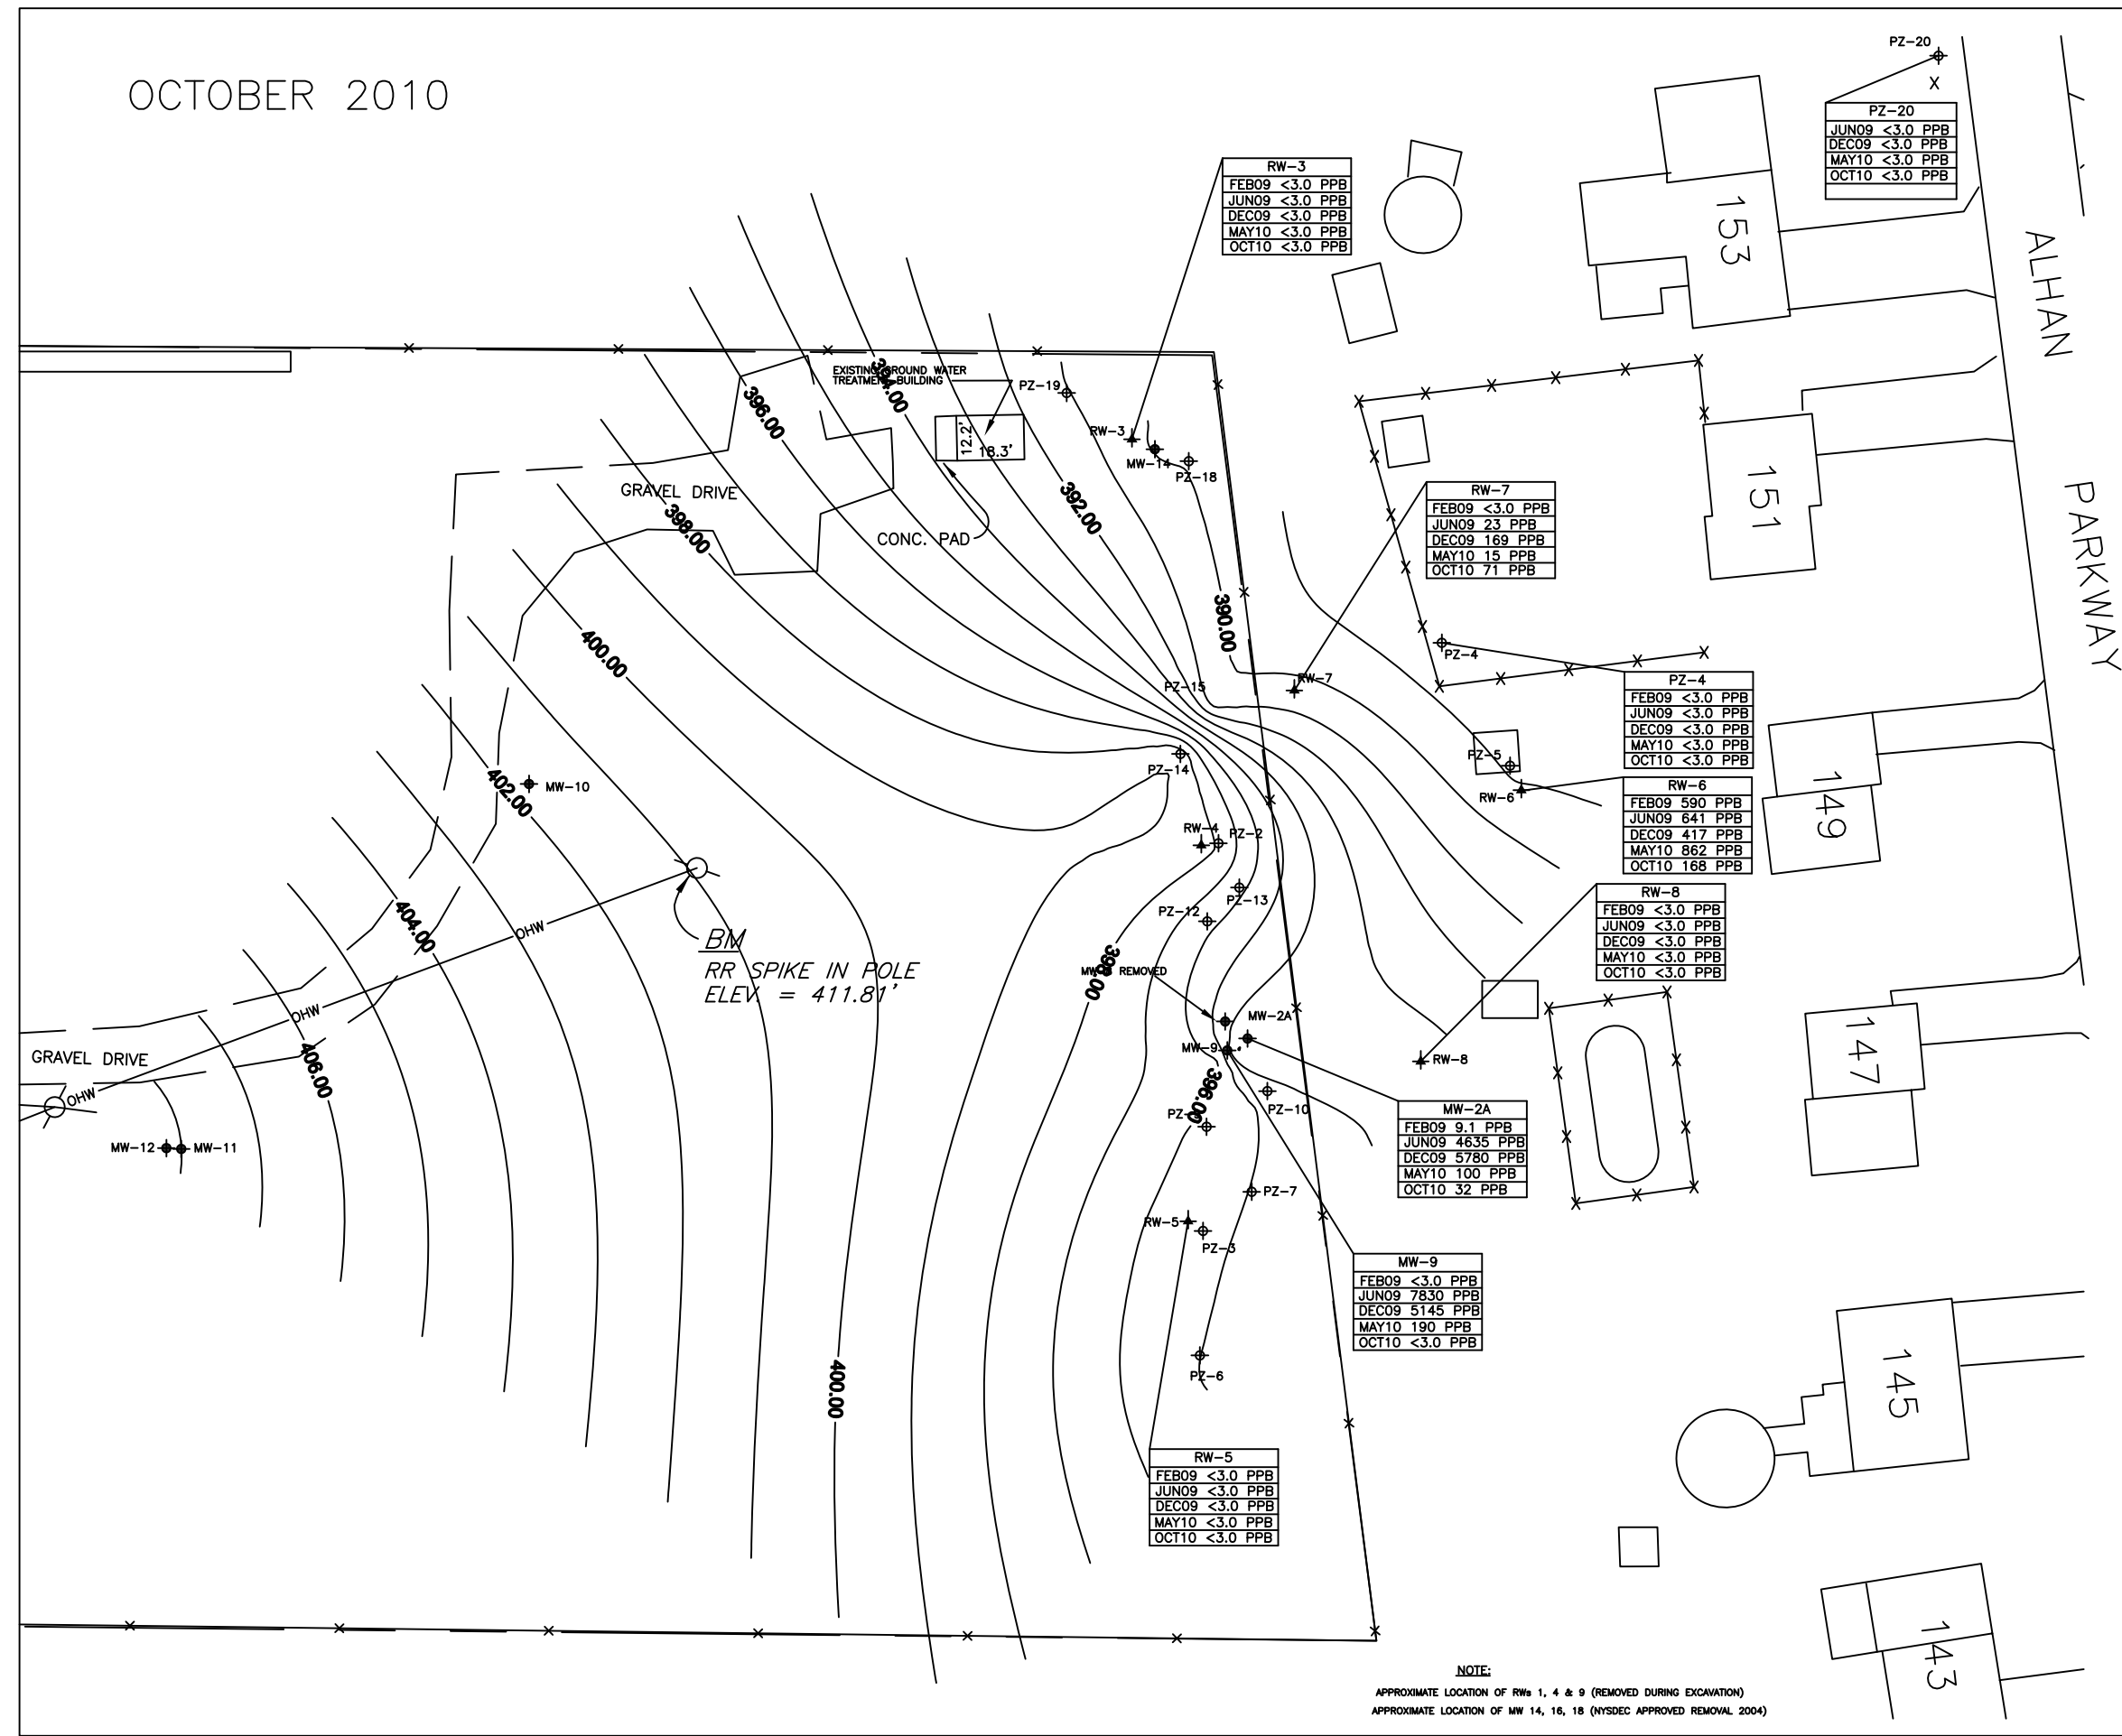
ATTACHMENT B  
 GROUNDWATER CONTOURS  
 WITH XYLENE CONCENTRATION SUMMARY  
 MAESTRI SITE—OCTOBER 2010  
 904 STATE FAIR BLVD.  
 GEDDES, NEW YORK

Groundwater monitoring is in place to ensure that residual groundwater contamination is not migrating off-site and to analyze the remaining levels of contamination in the groundwater, which is required for compliance with remedial goals. Of the nine (9) wells that are sampled at the site, six (6) were non-detect for xylene during the October 2010 sampling event. These results are consistent with previous sampling events. The offsite well continues to be non-detect, indicating that the plume is not migrating offsite.

Appendix B contains a summary of the results of groundwater monitoring, including a drawing with the locations of the wells and their concentrations from the past five (5) sampling events, a table with historical results from the past five (5) years, graphical representations of xylene levels in the recovery wells over the past 10 years, graphical representation of the xylene level in MW-9 since its re-installation, and graphical representations of xylene in the piezometers since their installations. Groundwater sampling reports have been previously submitted and contain additional discussion of groundwater at the site.
