**Stauffer Management Company**

**MAESTRI SITE  
904 State Fair Boulevard  
Geddes, NY  
NYSDEC Site: 7-34-025**

**PERIODIC REVIEW REPORT**

**January 2015**

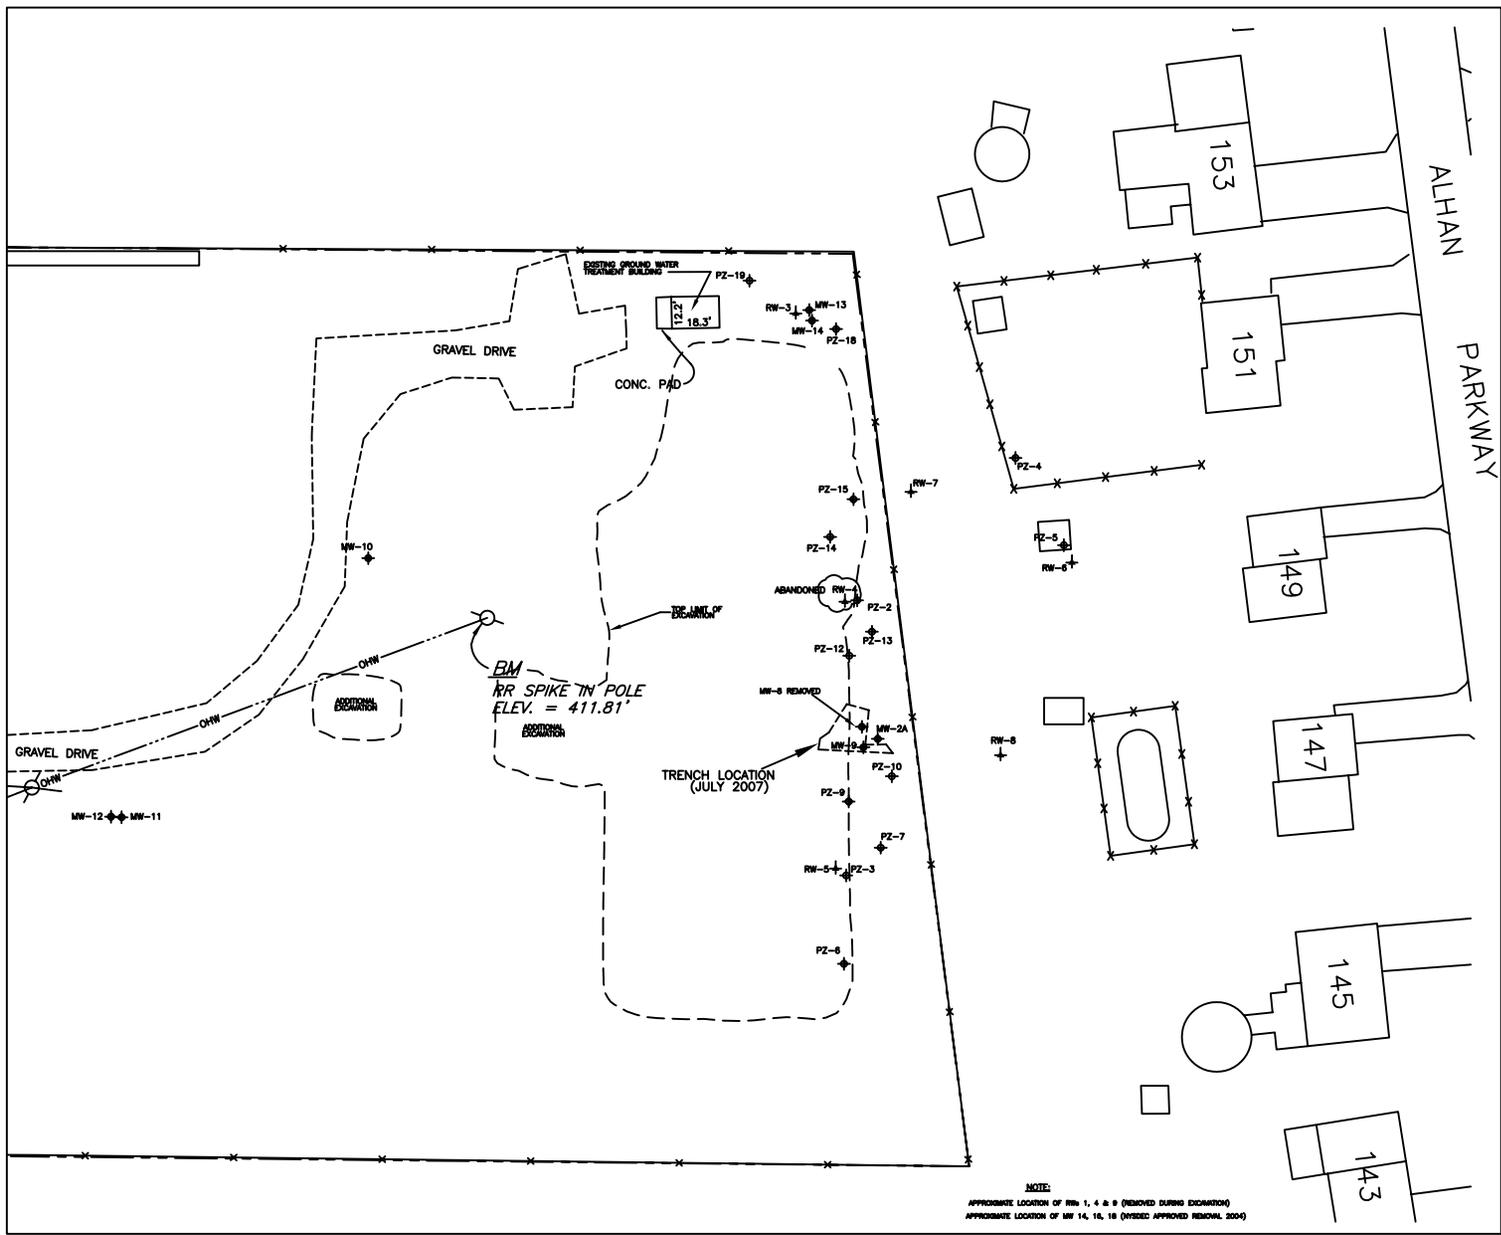
FIGURE 1  
SITE PLAN  
2008  
MAESTRI SITE  
904 STATE FAIR BLVD.  
GEDDES, NEW YORK

The Site is located at 904 State Fair Boulevard, Geddes, NY, approximately three (3) miles west of Syracuse. The portion of the Site that is still actively monitored is approximately 2.5 acres. The Site is bordered by State Fair Boulevard to the southwest and residences along Alhan Parkway to the northeast. Vacant, wooded lots border the Site to the northwest and the southeast. This area is fenced as shown in Figure 1.

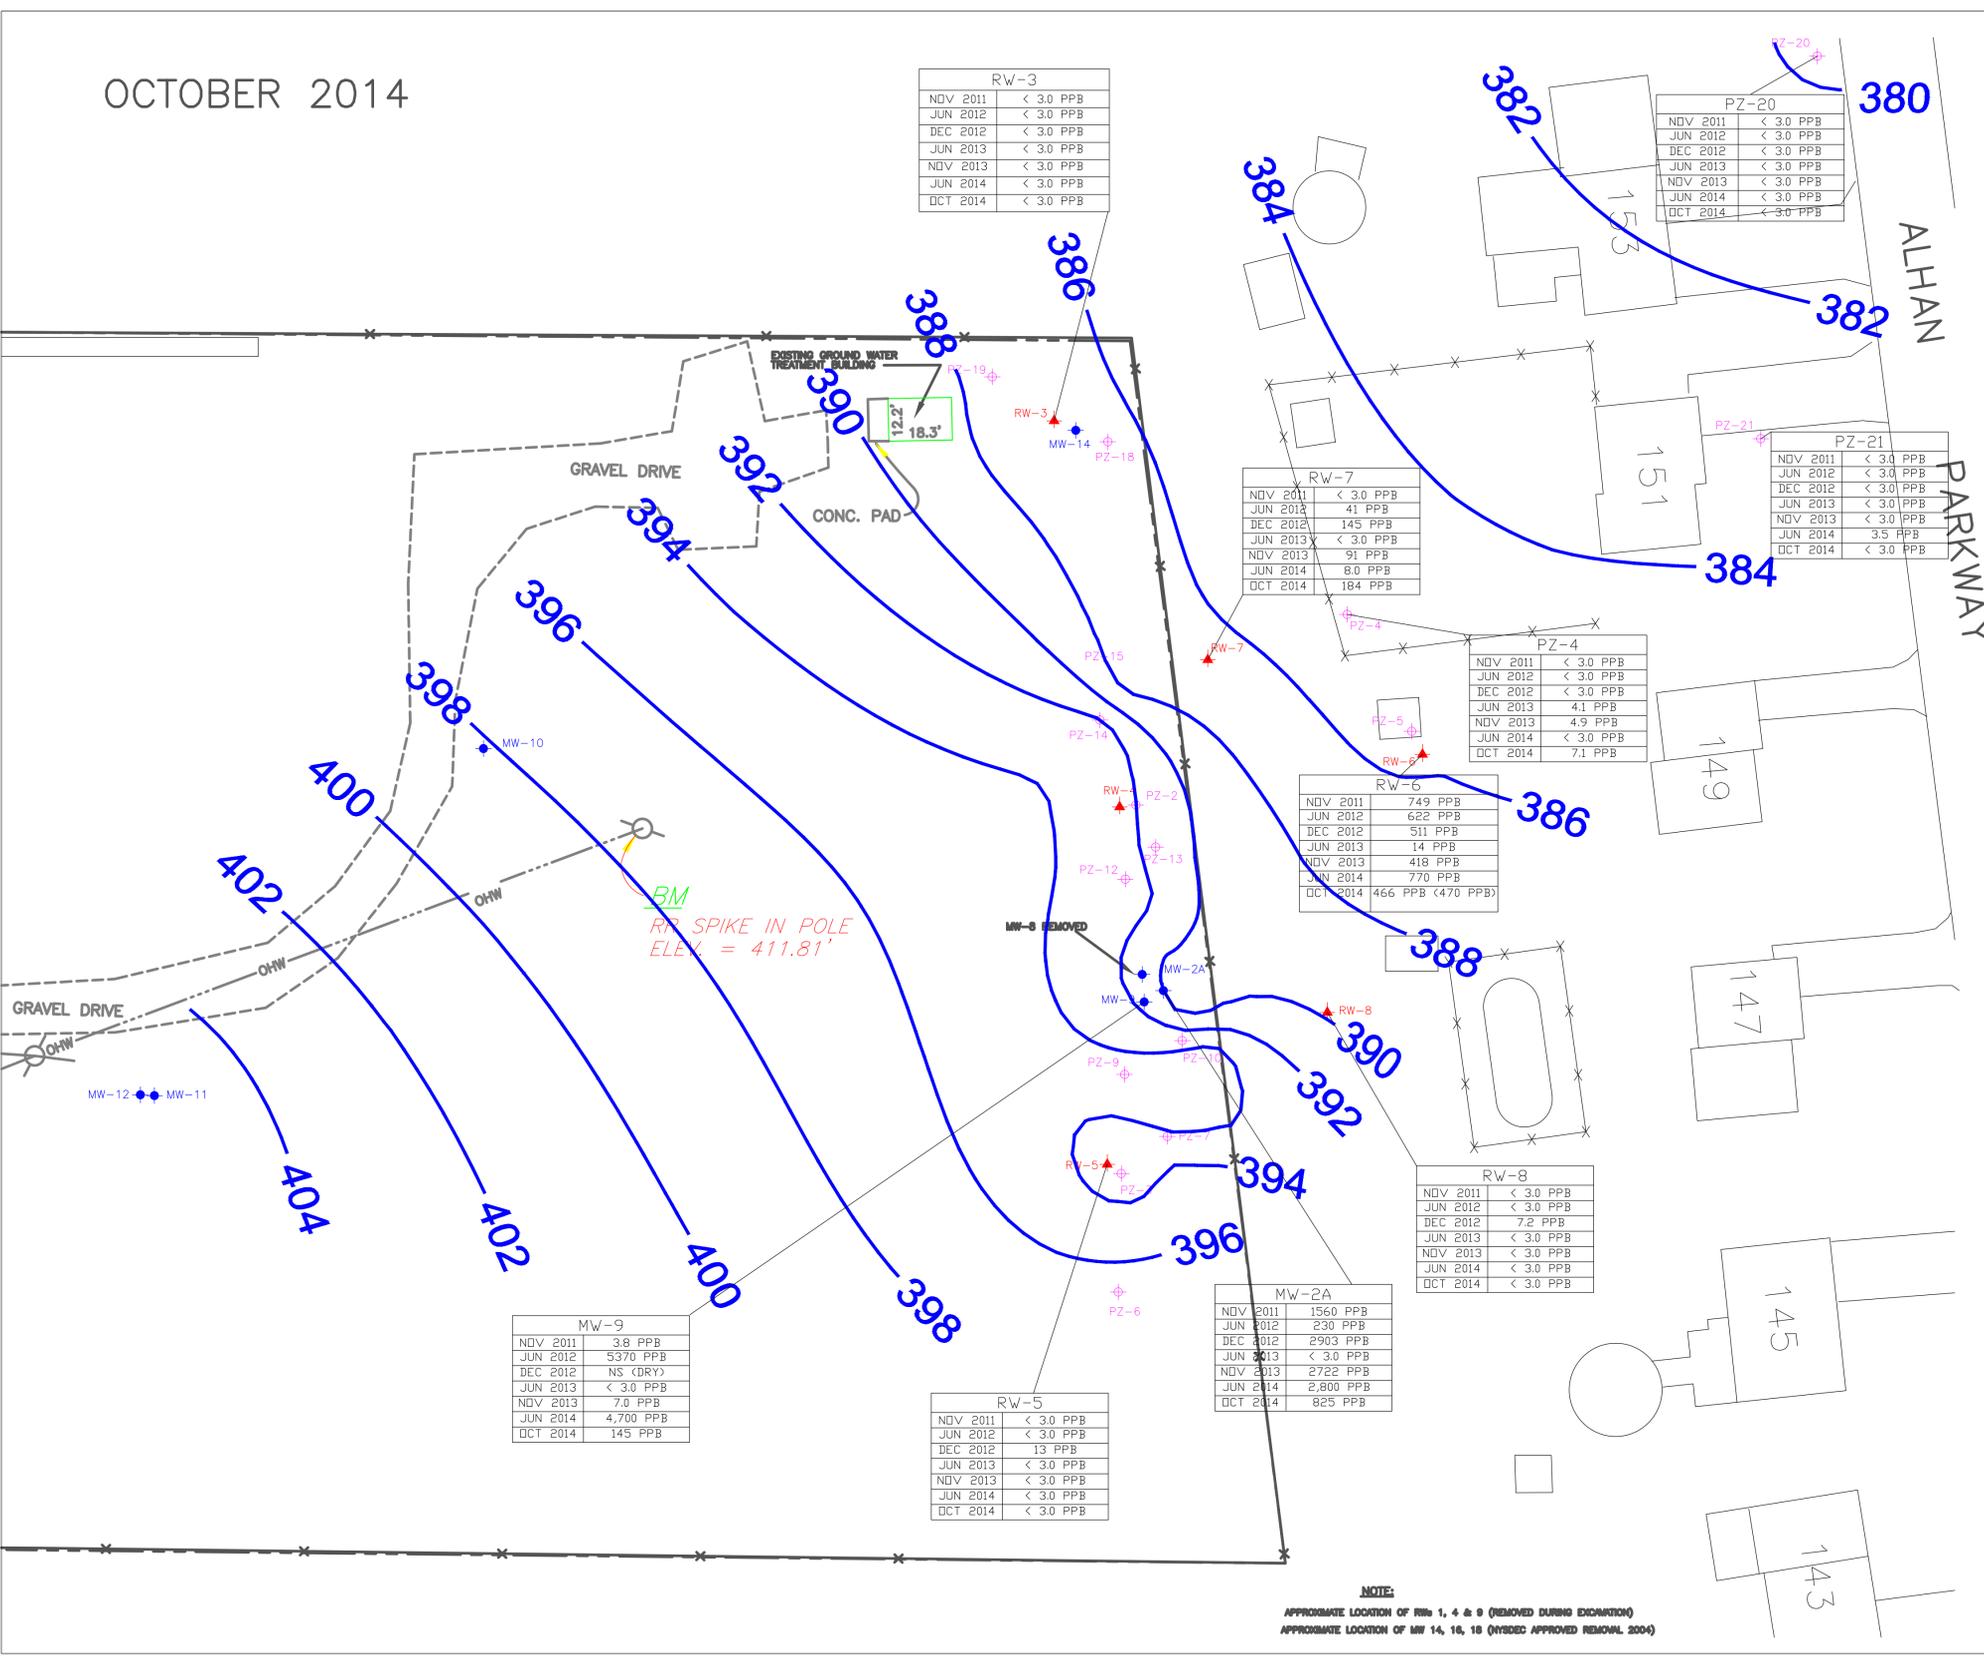
FIGURE 2B  
 GROUNDWATER CONTOURS  
 WITH XYLENE CONCENTRATION SUMMARY  
 MAESTRI SITE—OCTOBER 2014  
 904 STATE FAIR BLVD.  
 GEDDES, NEW YORK

Mw-9	
NOV 2011	3.8 PPB
JUN 2012	5370 PPB
DEC 2012	NS (DRY)
JUN 2013	< 3.0 PPB
NOV 2013	7.0 PPB
JUN 2014	4,700 PPB
OCT 2014	145 PPB

Mw-2A	
NOV 2011	1560 PPB
JUN 2012	230 PPB
DEC 2012	2903 PPB
JUN 2013	< 3.0 PPB
NOV 2013	2722 PPB
JUN 2014	2,800 PPB
OCT 2014	825 PPB

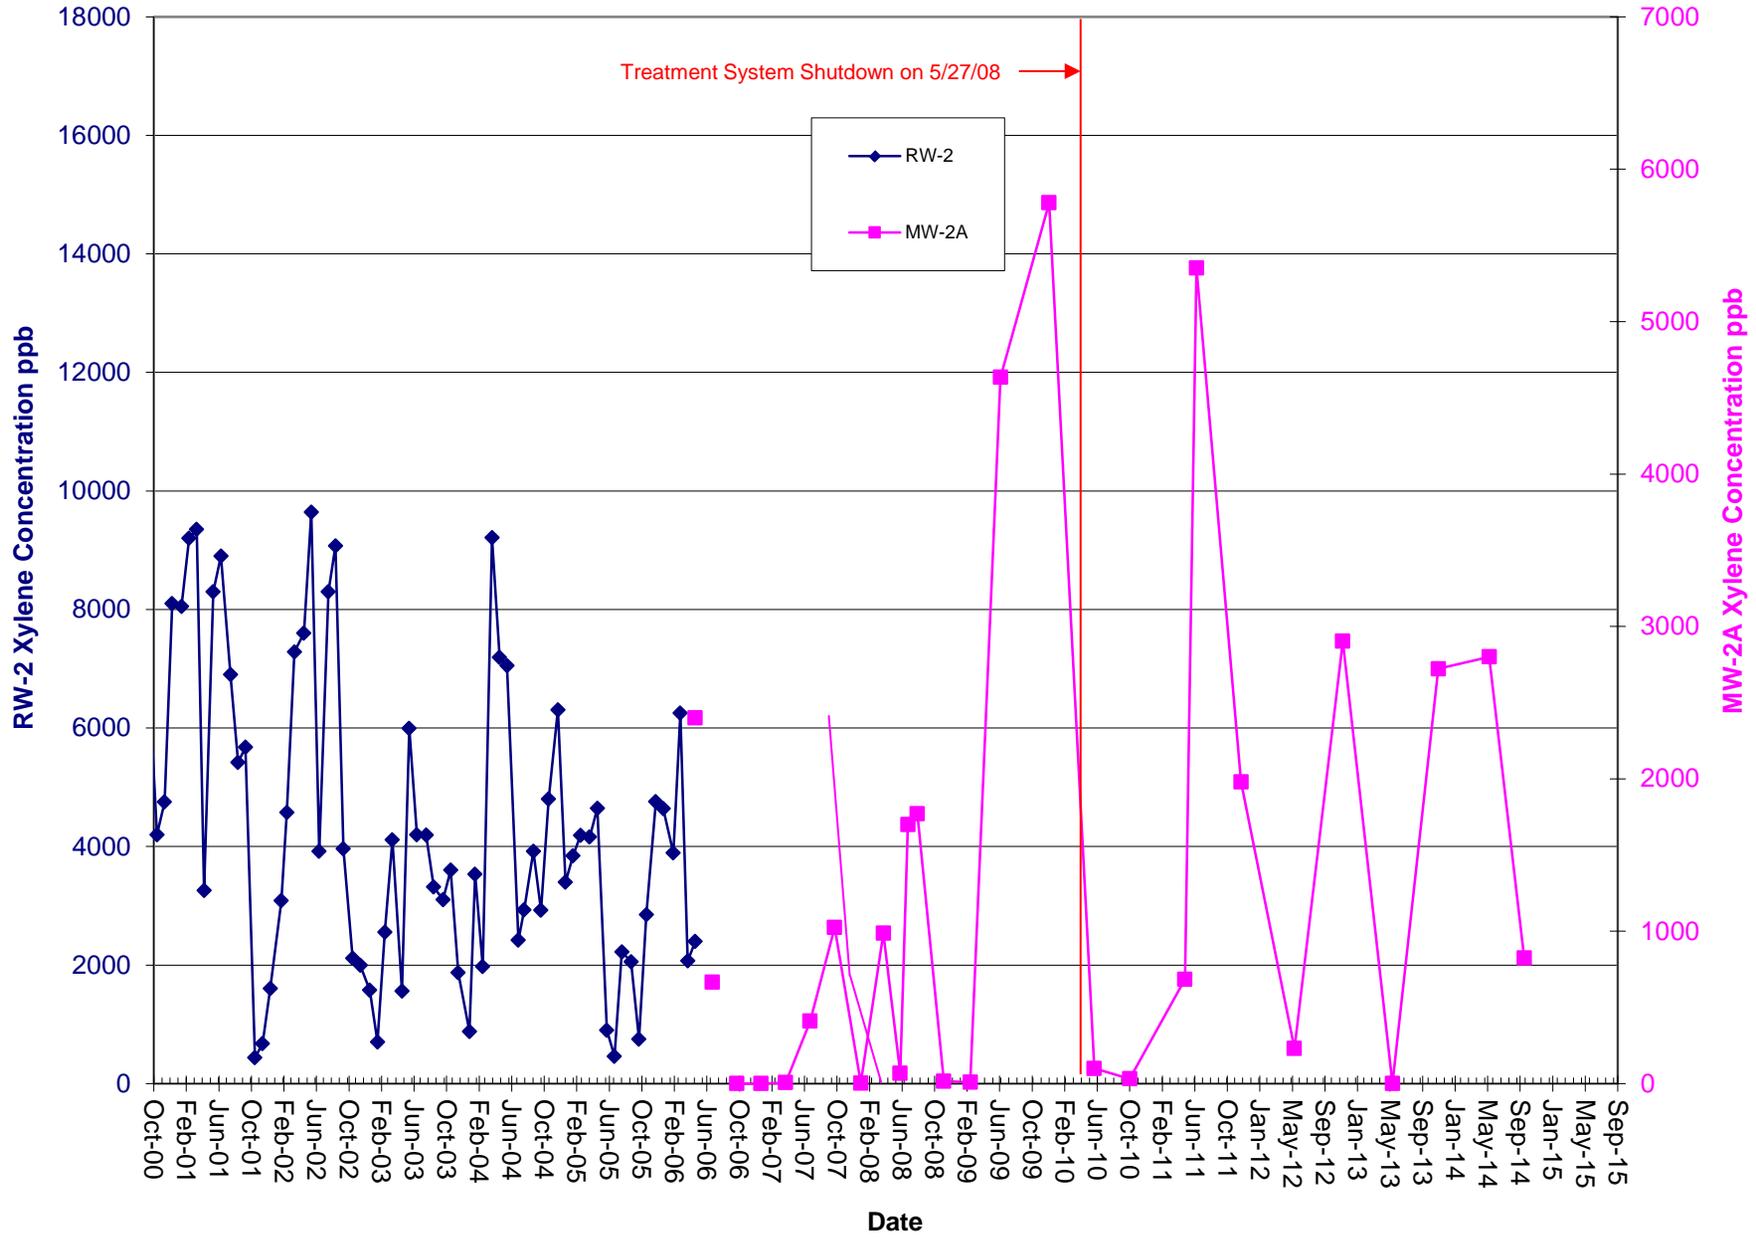
### MW-2A Xylene Concentration

Groundwater monitoring is in place to ensure that residual groundwater contamination is not migrating off-site and to analyze the remaining levels of contamination in the groundwater, which is required for compliance with remedial goals. Of the ten (10) wells that are sampled at the site, five (5) were non-detect for xylene during the October 2014 sampling event. Xylene concentrations remain consistent with historical data patterns.

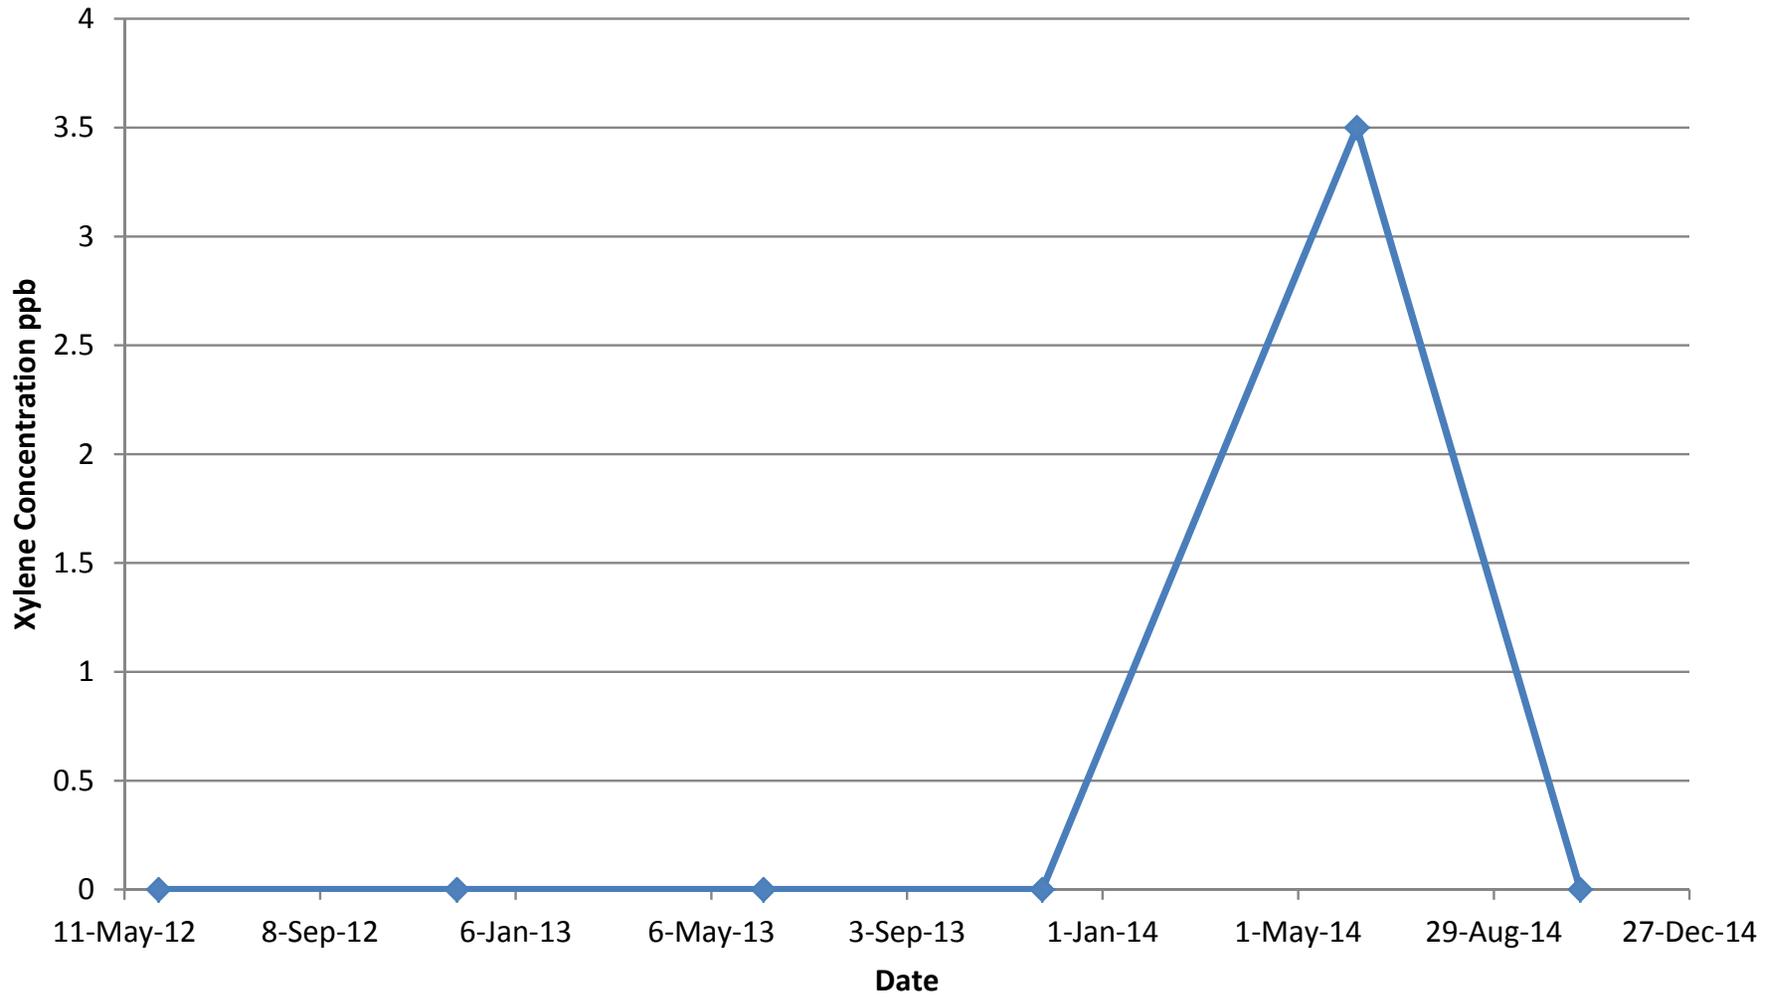
**PZ-21 Xylene Concentration**

Offsite monitoring well PZ-21 had a xylene concentration of 3.5 ppb during the June 2014 sampling event, but has returned to non-detect concentrations during the October 2014 sampling event, consistent with historical sampling events. The 3.5 ppb xylene concentration did not exceed the groundwater cleanup objective of 5 ppb for xylene. Offsite well PZ-20 remained non-detect. The offsite well PZ-21 will continue to be monitored to ensure that the plume does not migrate.
