2019 ANNUAL POST-CLOSURE MONITORING REPORT

Town of Clay Landfill Oak Orchard Road Town of Clay, Onondaga County, New York Site #734034

C&S ENGINEERS, INC.

MAY 2021

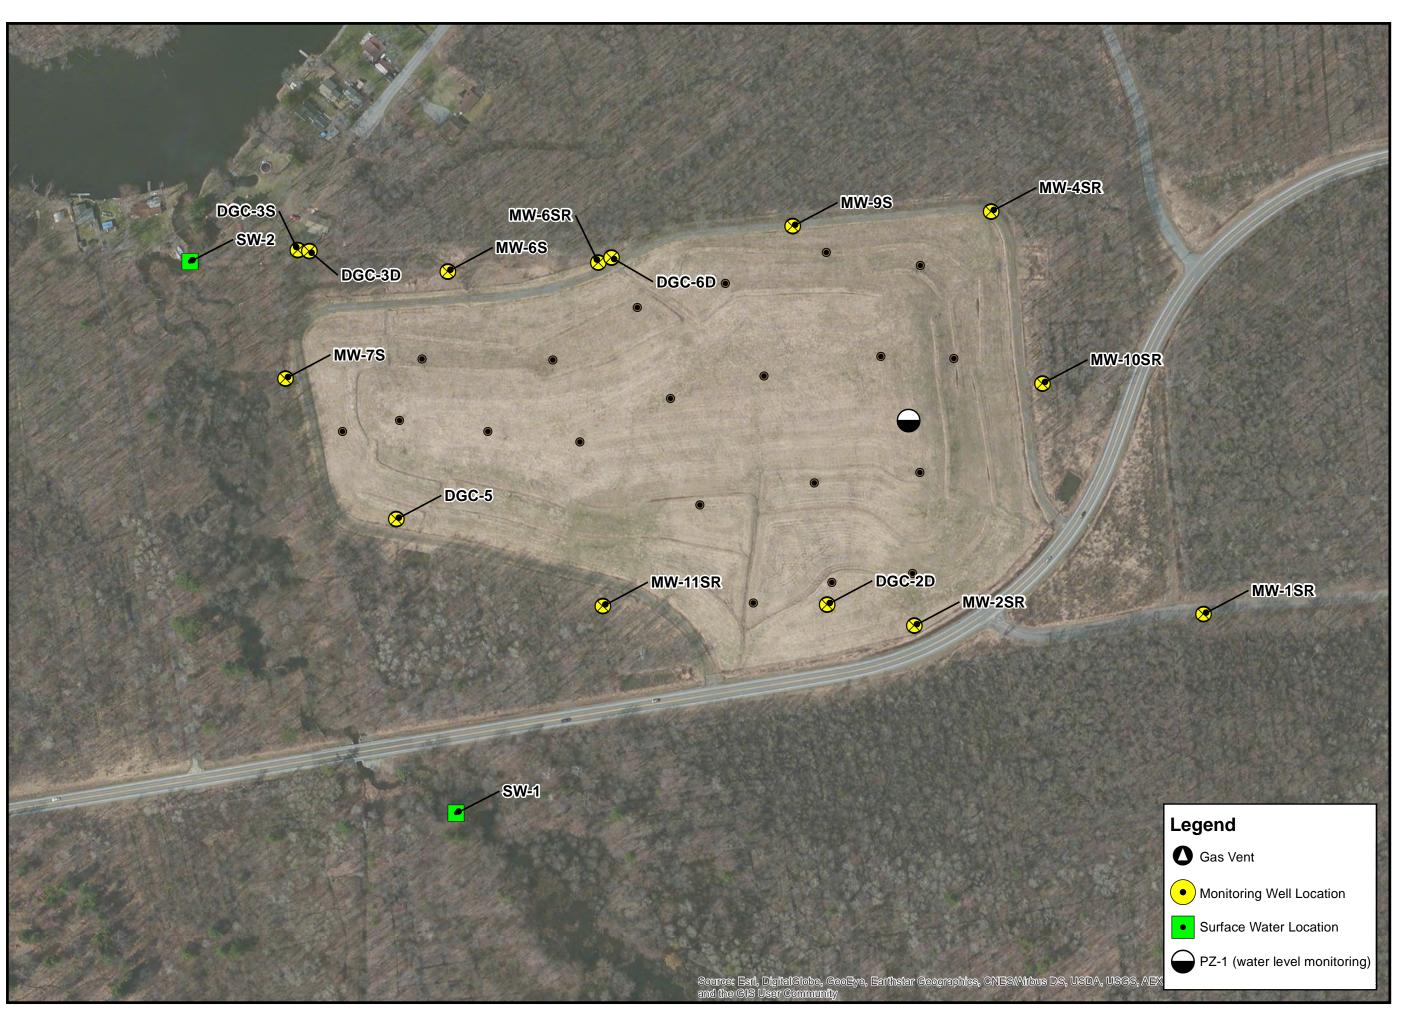
FIGURE 2

A landfill reconnaissance and combustible gas survey (landfill gas vents as well as perimeter monitoring) was completed at the site on a quarterly basis. A total of 22 gas vents are incorporated into the gas venting trench system across the landfill. Perimeter monitoring was completed at four locations along the access road surrounding the landfill. The gases released from each gas vent as well as perimeter gas monitoring were field screened utilizing a multi-gas monitor and a MiniRAE Photo Ionization Detector (PID) with 3-D sensor. Combustible gas measurements were completed for parameters including percent lower explosive limit (%LEL), carbon monoxide (CO), and hydrogen sulfide (H₂S), while total volatile organic vapor concentrations were measured at each vent using the PID. The locations of the landfill gas vents are shown on Figure 2.
