TR-18 Storm Sewer Line Cleaning Summary

**Carrier Corporation
Thompson Road Facility
Syracuse, New York**

**EnSafe Project No.
3133-057**

April 9, 2004

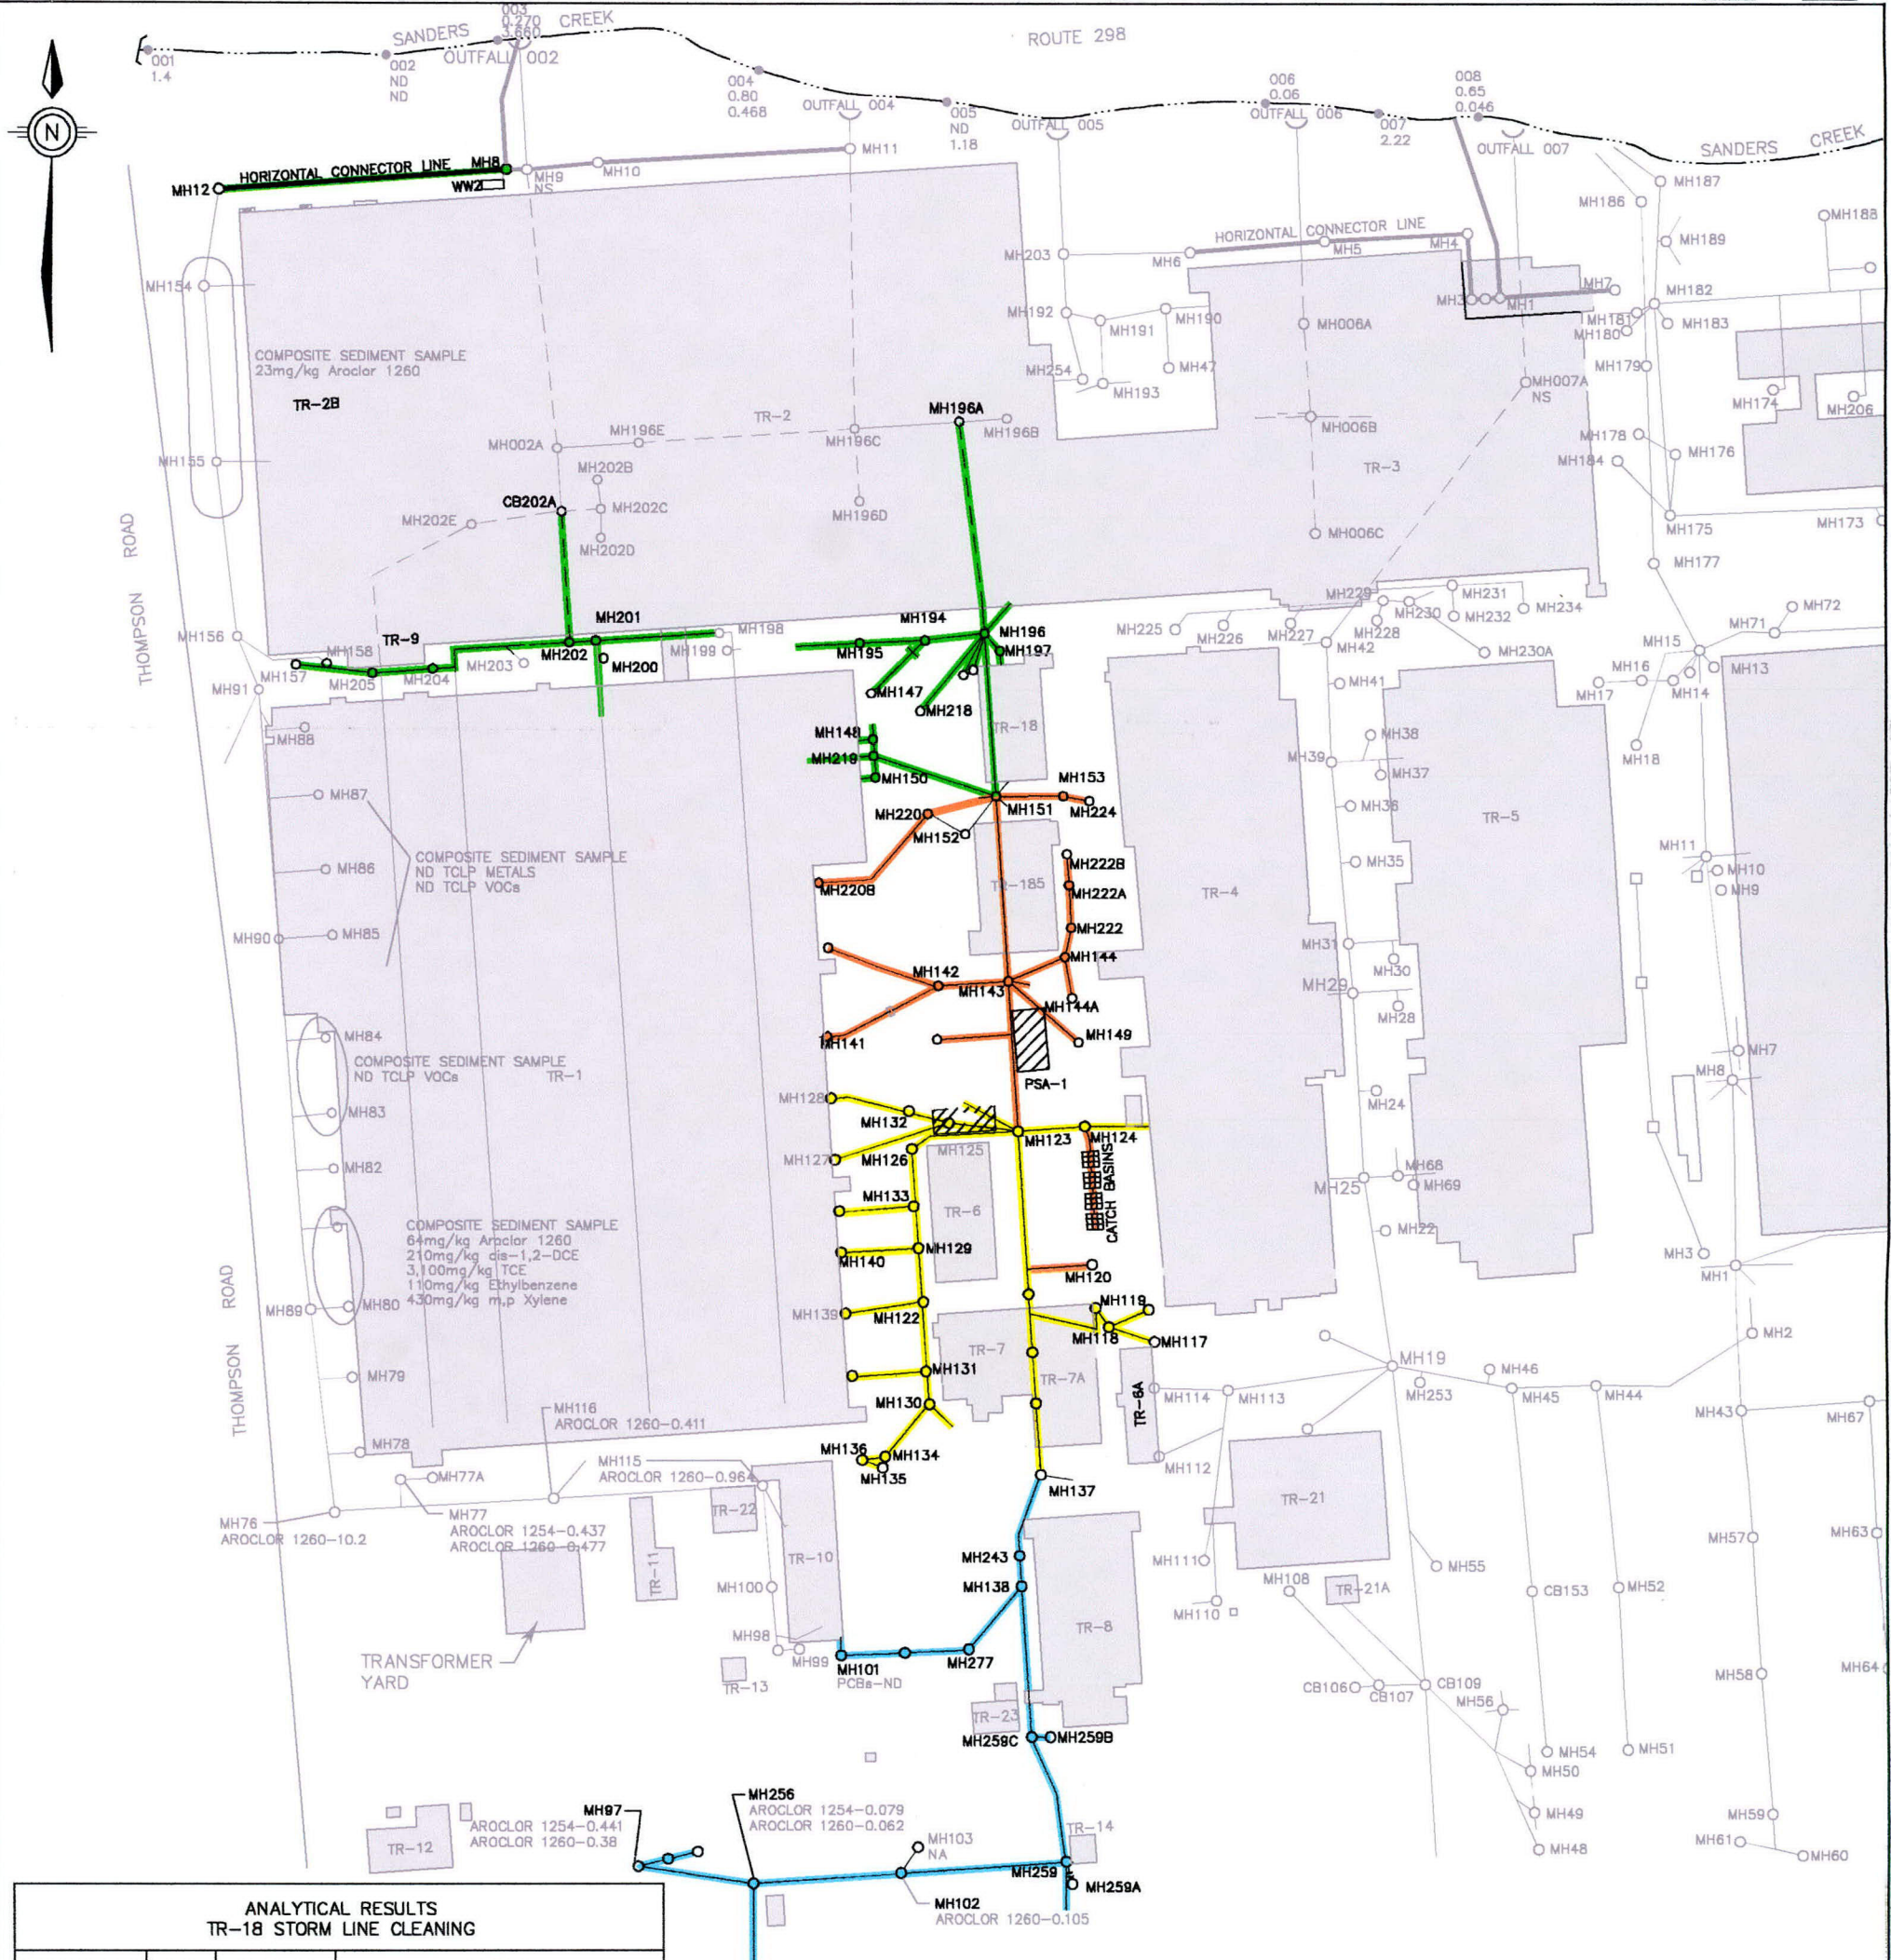
FIGURE 1
CENTRAL STORM SEWER SECTION CLEANED
FOR PCB ABATEMENT NOV/DEC 2003
CARRIER CORPORATION
SYRACUSE, NEW YORK

ANALYTICAL RESULTS TR-18 STORM LINE CLEANING

PARAMETER	MEDIA	RESULT	ORIGIN
TCE	Water	<30 µg/L	Tank 2060 (1st use)
Aroclor 1260	Water	3.1 µg/L	
Aroclor 1260	Solid	140 mg/kg	Tank 2034 & 2067 composite
TCLP TCE	Solid	0.07 mg/L	
Aroclor 1260	Solid	7.9 mg/kg	Tank 2060 & 2061 composite
TCE	Water	5 µg/L	Tank 2061
Aroclor 1260	Water	2.0 µg/L	
TCE	Water	200 µg/L	Tank 2034 & 2067 composite
TCE	Water	<30 µg/L	Tank 2060
Aroclor 1260	Water	5.8 µg/L	(2nd use, Detergent Wash)
TCE	Water	80 µg/L	Tank FADWH800L (detergent wash)
Aroclor 1260	Water	3.7 µg/L
