**Re: Carrier Corporation, Thompson Road Facility, Syracuse, New York
Corrective Action Order — Index No. CO 7-20051118-4
Site Registry Number: 734043
Former Building TR1 Sub-Slab Free Product Evaluation, Bail Down Testing 2014**

**FORMER BUILDING TR-1 SUB-SLAB
FREE PRODUCT EVALUATION
BAIL DOWN TESTING**

**CARRIER THOMPSON ROAD FACILITY
CARRIER PARKWAY
SYRACUSE, NEW YORK**

**EnSafe Project Number
0888814866**

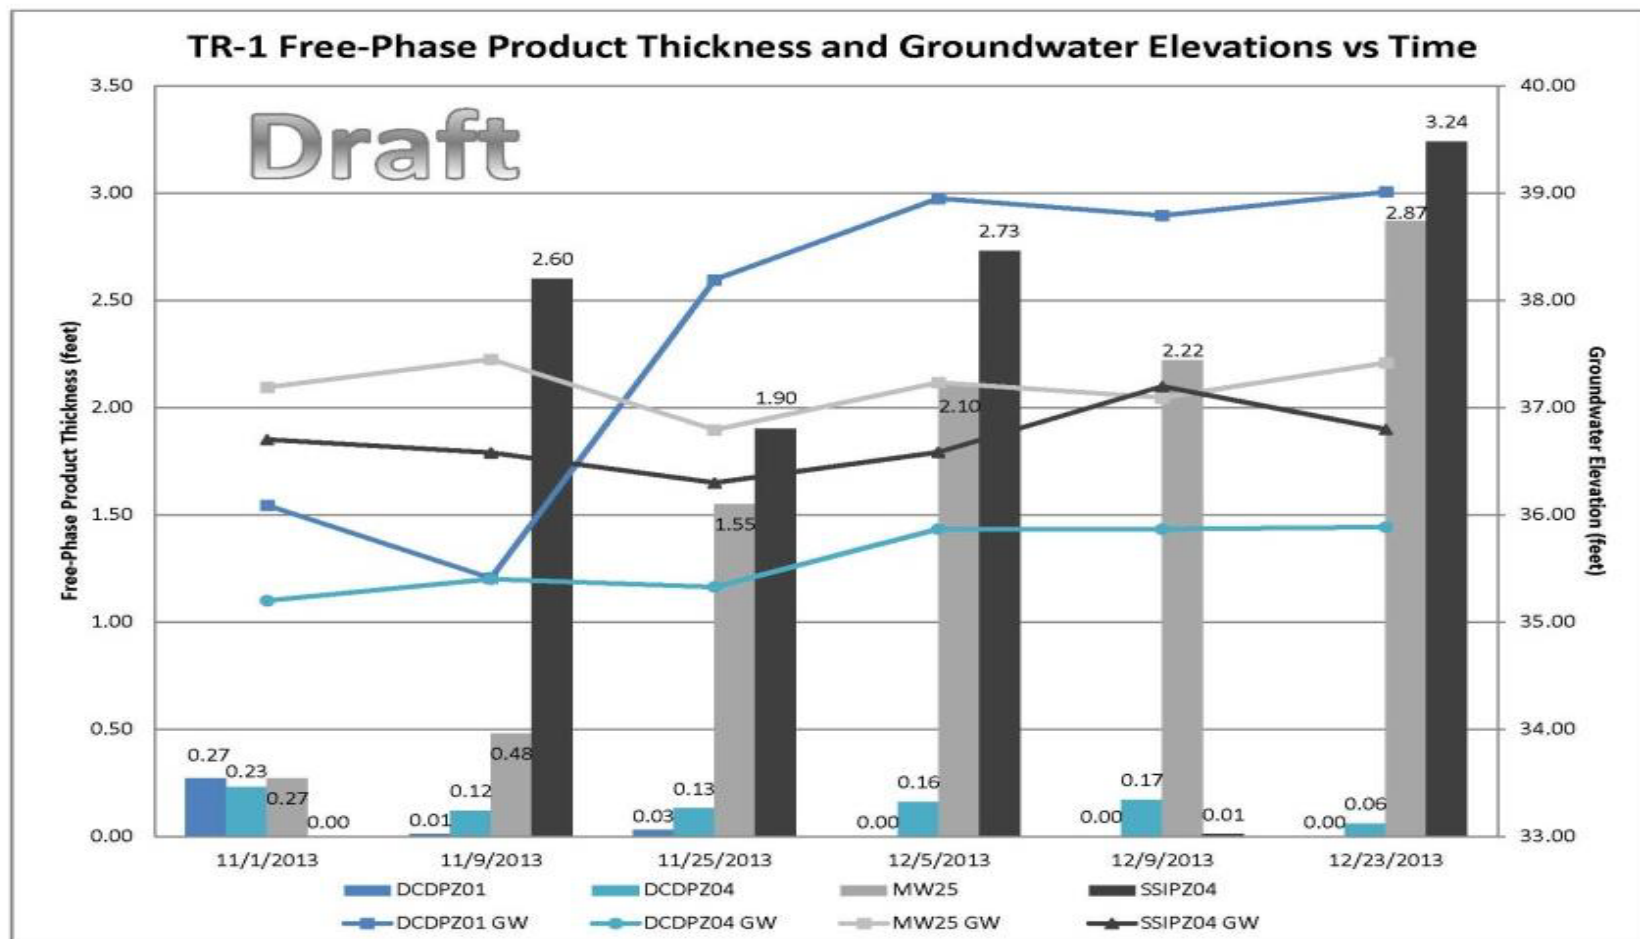
- Relatively immobile LNAPL mass beneath former building TR-1
- Slow LNAPL recharge, low transmissivity, remediation by recovery well extraction not effective/efficient
- Use OWS to capture LNAPL in storm sewers
- Monitoring & Manual Removal of LNAP in wells
