Subject: Carrier Corporation, Thompson Road Facility, Syracuse, New York
Corrective Action Order — Index CO 7-20051118-4
Site Registry No.: 734043
Interim Corrective Measure Construction Completion Report
TR-8 Floor Vault Sealing

**TR-8 Floor Vault Sealing
Interim Corrective Measure
Carrier Corporation Site
ONONDAGO COUNTY, NEW YORK**

Construction Completion Report

NYSDEC Site Number: 734043

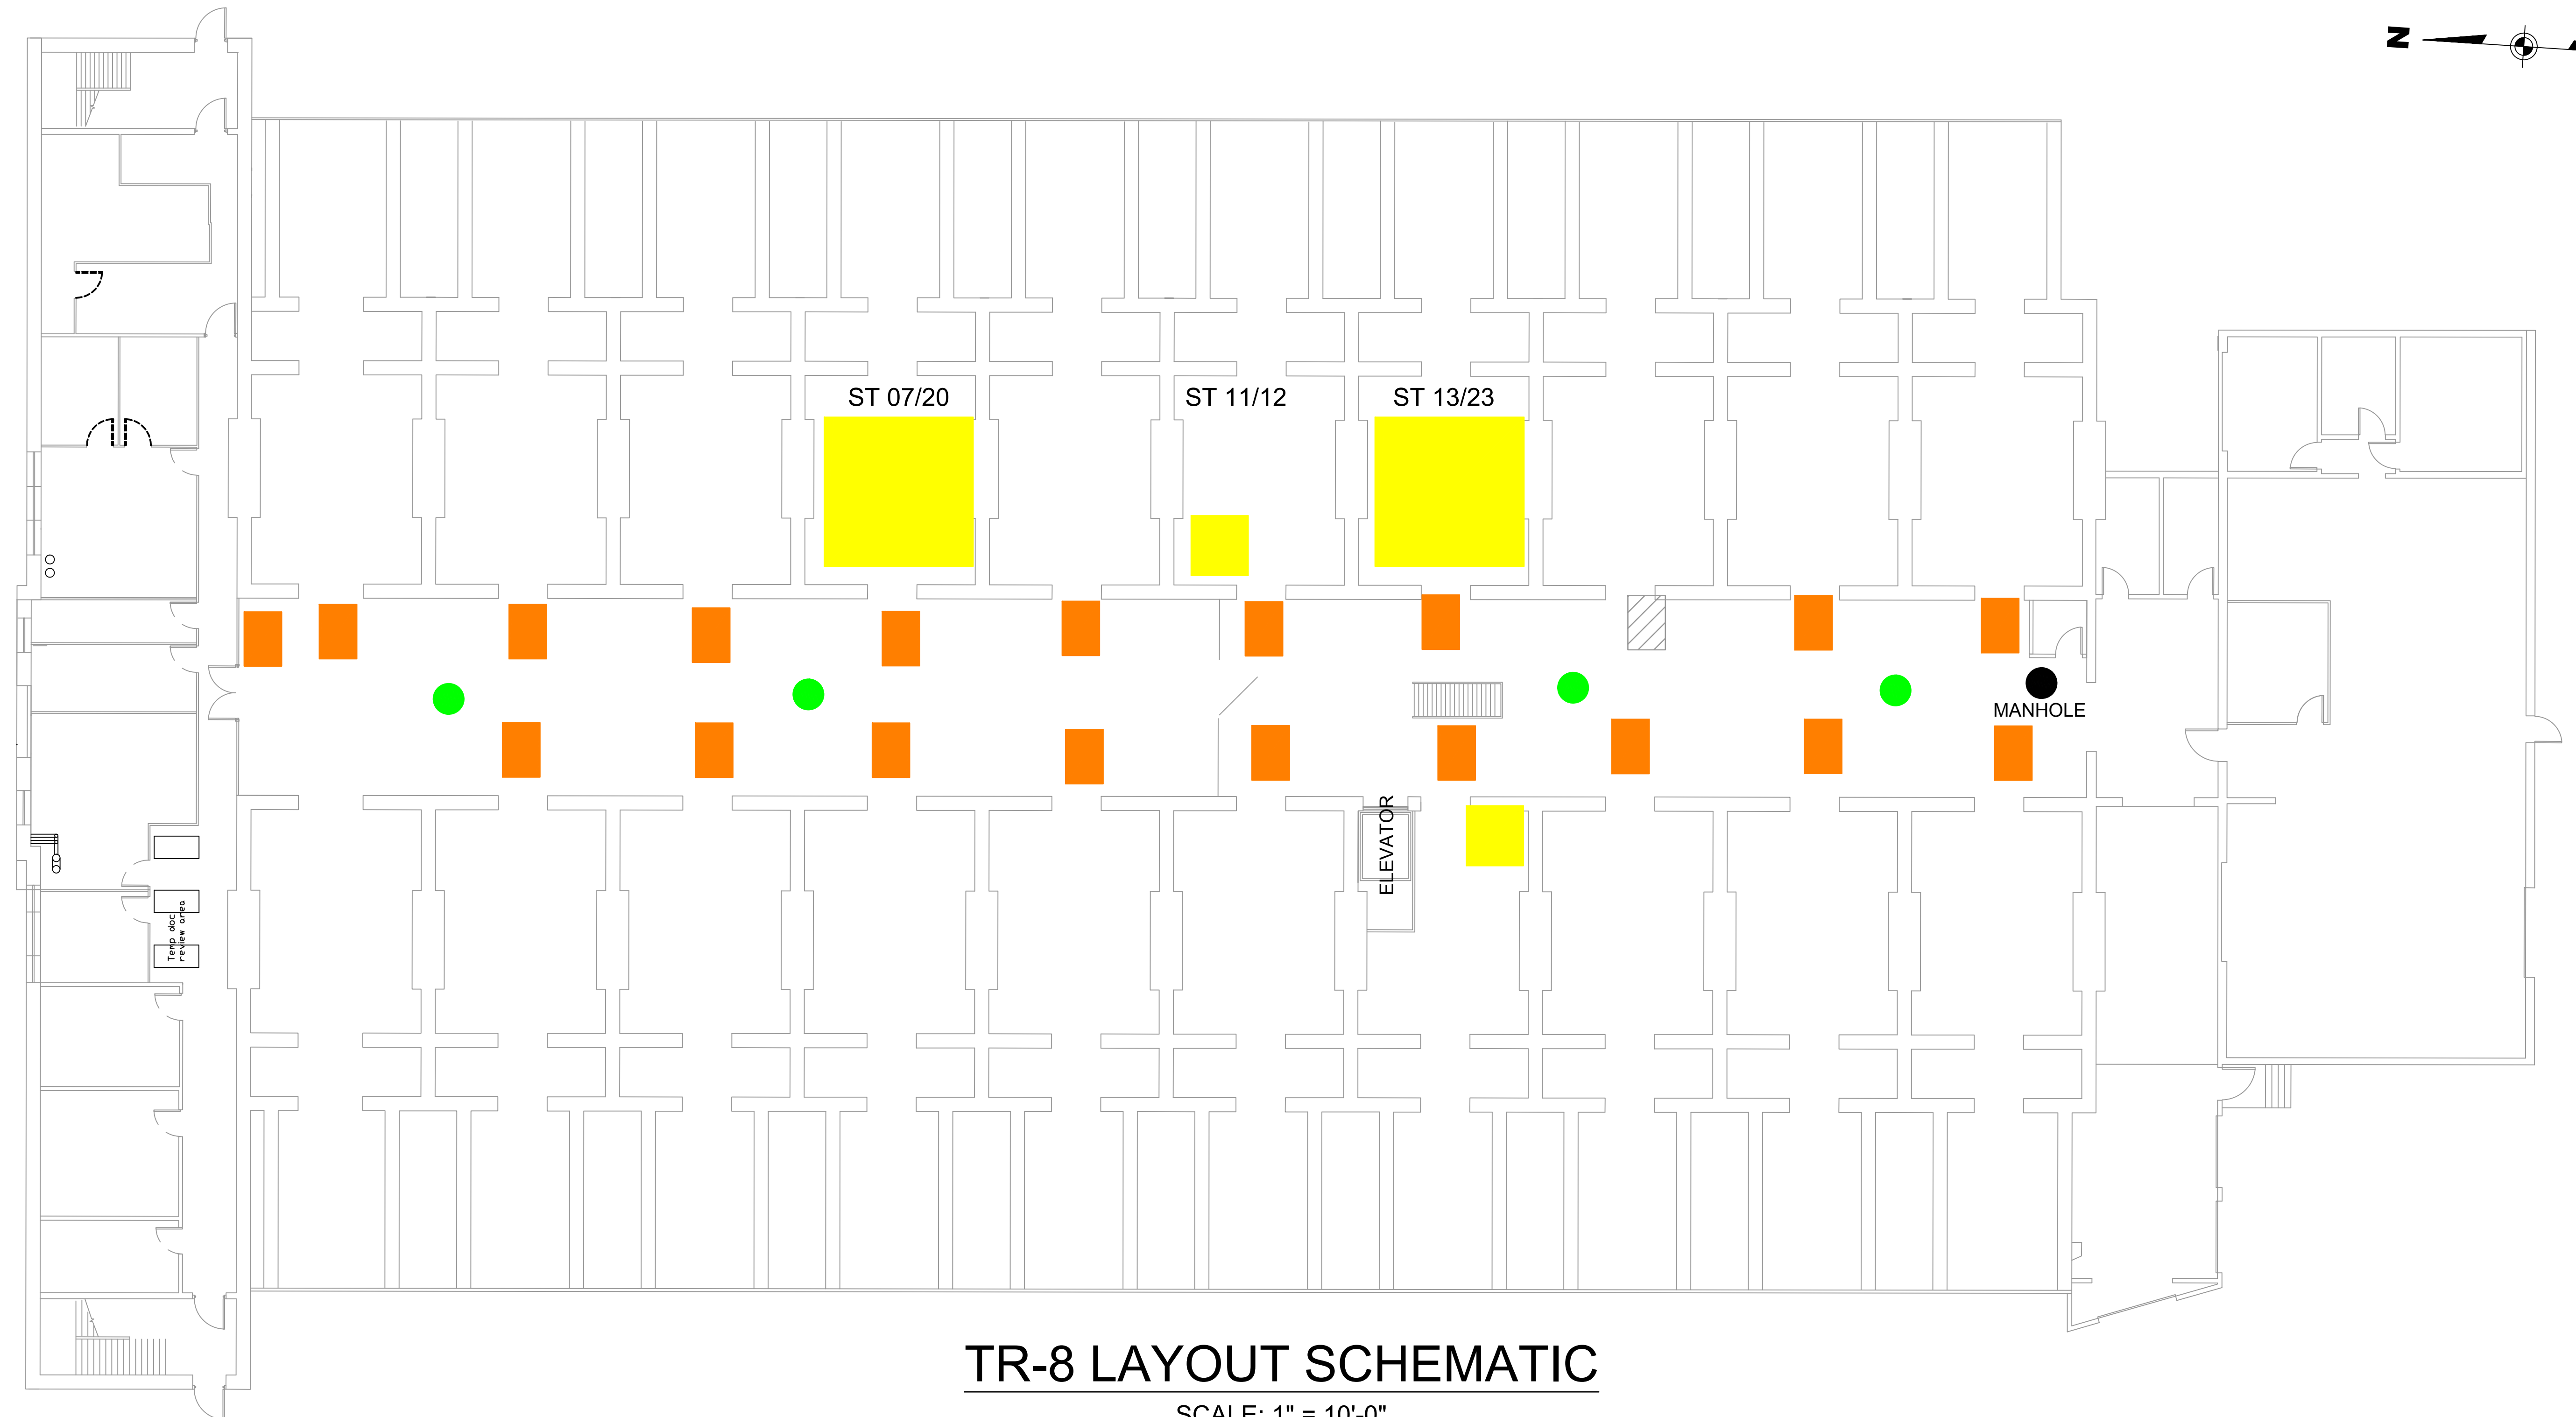
FIGURE 2

In addition to the vaults, four floor drains were identified and sealed. The approximate locations of the vaults and floor drains are shown in **Figure 2**.

LARGER FLOOR VAULTS IN STORAGE BAYS SEALED WITH CONCRETE AND EPOXY/PAINT SEAL AT THE FLOOR SURFACE
-

FLOOR VAULTS SEALED WITH CONCRETE AND EPOXY/PAINT SEAL AT THE FLOOR SURFACE
-

NO ACTION - VAULT PREVIOUSLY SEALED WITH CONCRETE
-

FLOOR DRAINS SEALED WITH CONCRETE. EPOXY/PAINT SEAL AT THE FLOOR SURFACE.

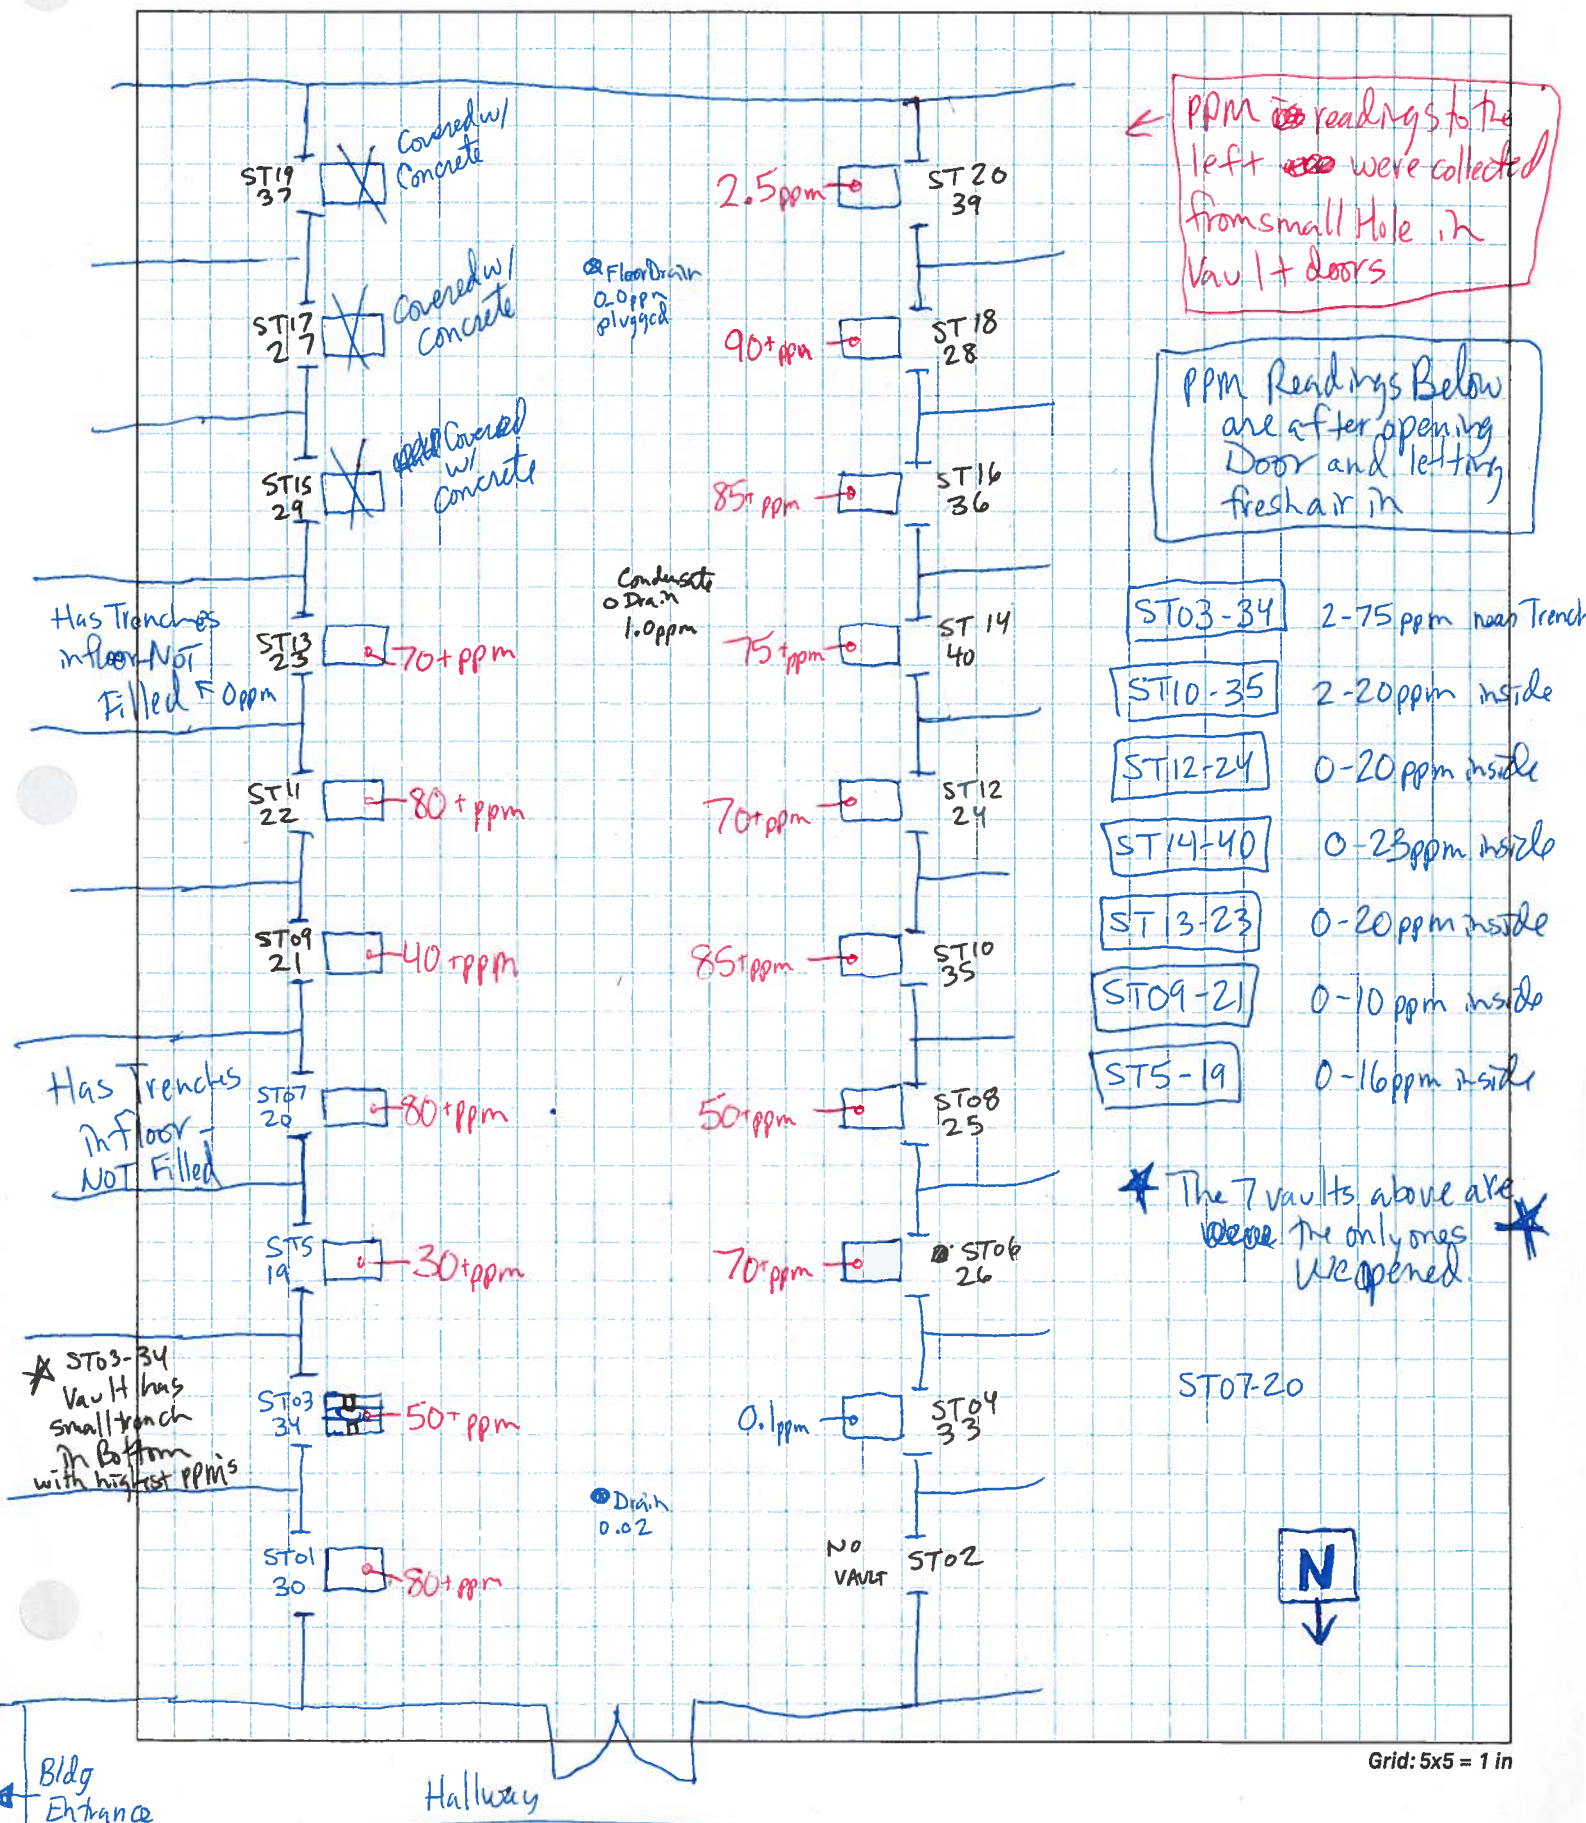
Appendix B – Field Sketch of PID Readings – April 13, 2018

On April 13, 2018, AECOM visually inspected the vaults and floor drains as well as screened the air inside the vaults and floor drains using a photoionization detector (PID) for those that were accessible. No visual staining or other indications of potential vapor sources (other than general debris) was observed. The PID readings ranged from as low as 0.1 parts per million (ppm) to as high as 90 ppm in the vaults. Fourteen of the readings exceeded 30 ppm with the vault lids closed. The floor drain PID readings ranged from 0.0 – 1.0 ppm. No elevated PID readings were observed outside the vaults (i.e., breathing zone). A field sketch of the PID readings and other observations is provided in **Appendix B**. Based on elevated photoionization detector readings from the vaults, the lids were sealed with adhesive tape along holes/gaps as a temporary mitigation measure on April 13, 2018. Permanent sealing of the vaults by filling with concrete started on June 11, 2018 and was completed on August 22, 2018.

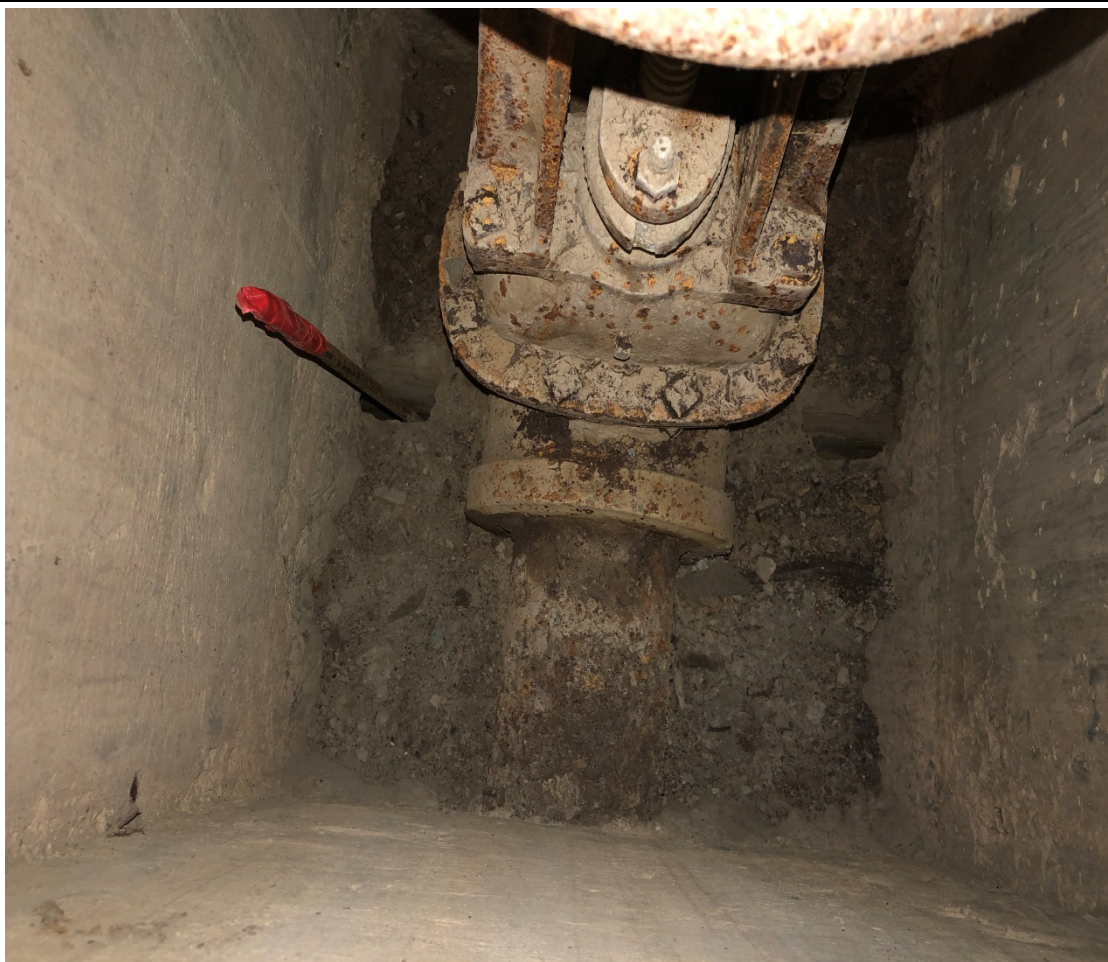
1. Nineteen approximately 2 feet x 2 feet concrete vaults within the main corridor room that contained inactive steel piping with valves. Deteriorated concrete was observed in the bottom of some of the vaults.
2. One larger vault located near the elevator which did not contain piping/valves.
3. One larger vault in storage bay ST11/22 which did not contain piping/valves.
4. Two larger vaults in storage bays ST07/20 and ST13/23 which contained floor scales.

Typical vault with
valve/piping and non-
competent concrete at
bottom.

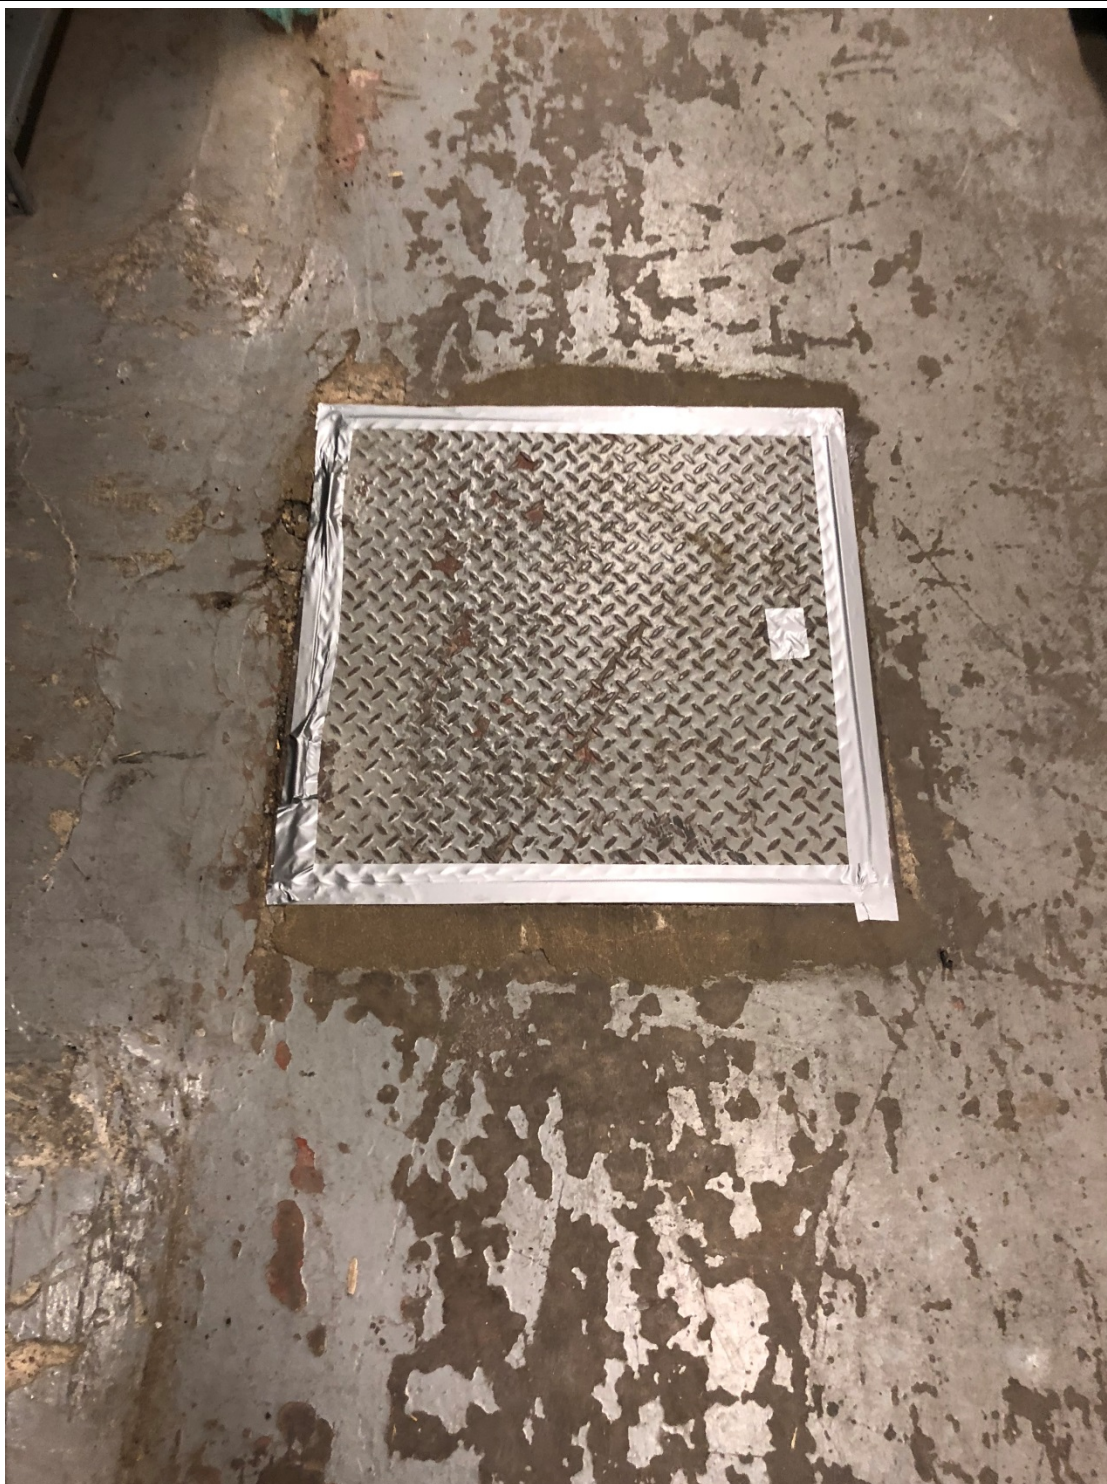
Temporary mitigation
measure of sealing vault
lid joints/holes with
adhesive tape.

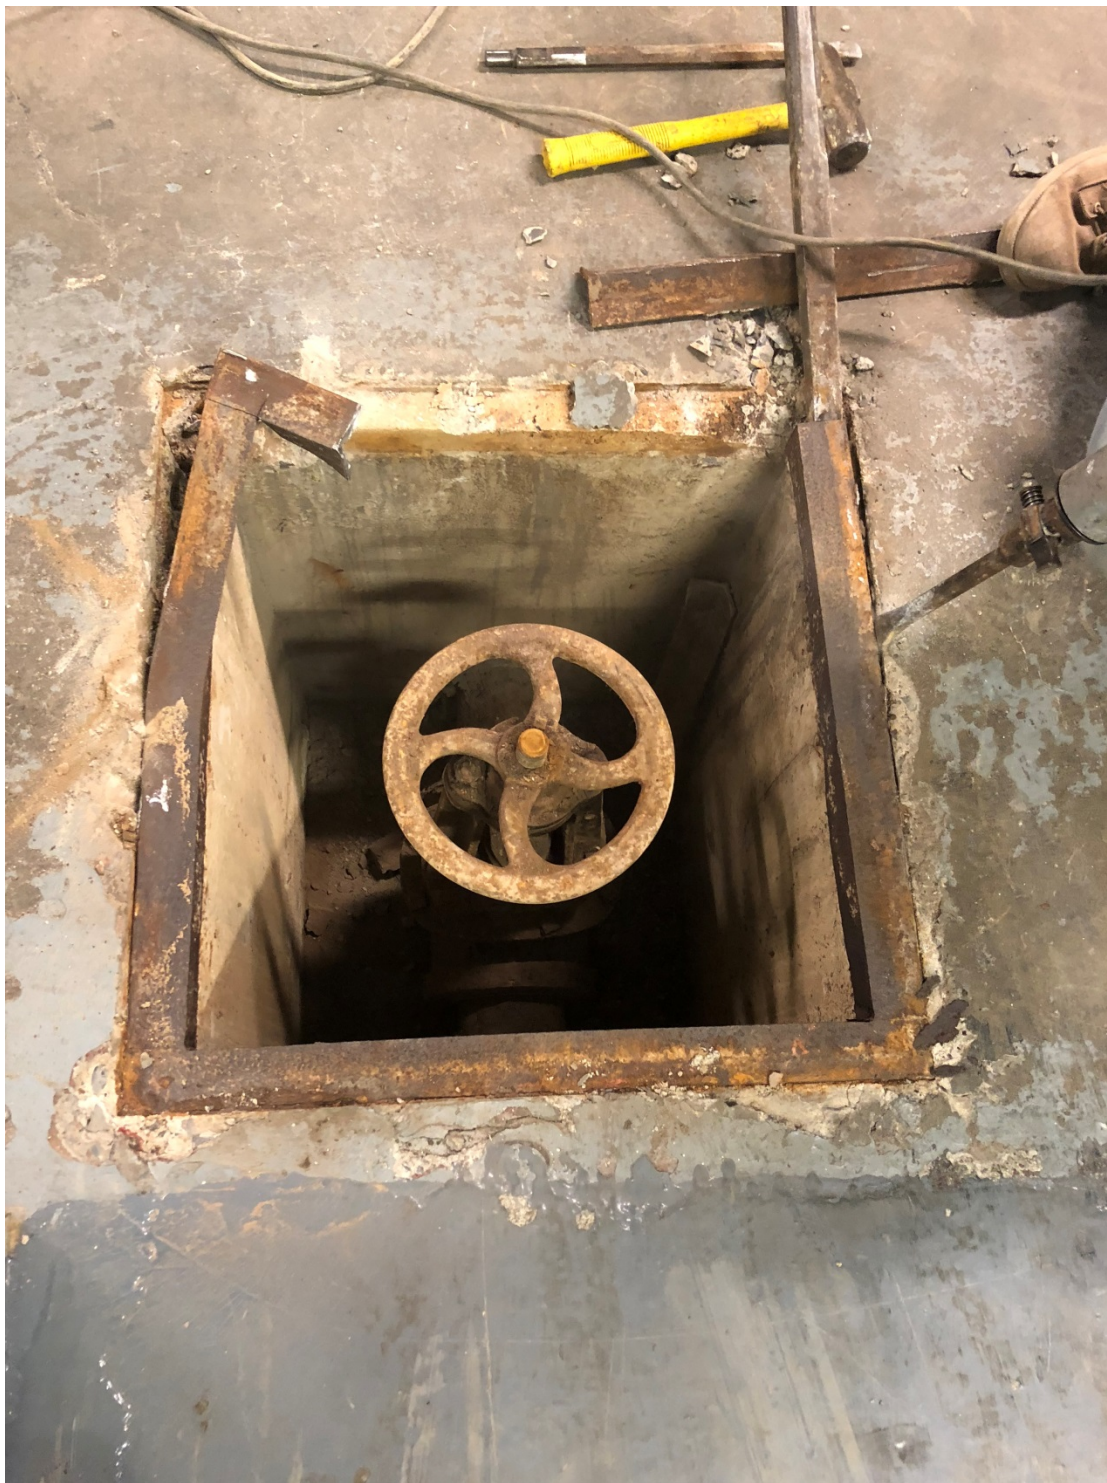
Typical vault with
valve/piping and steel
frame.

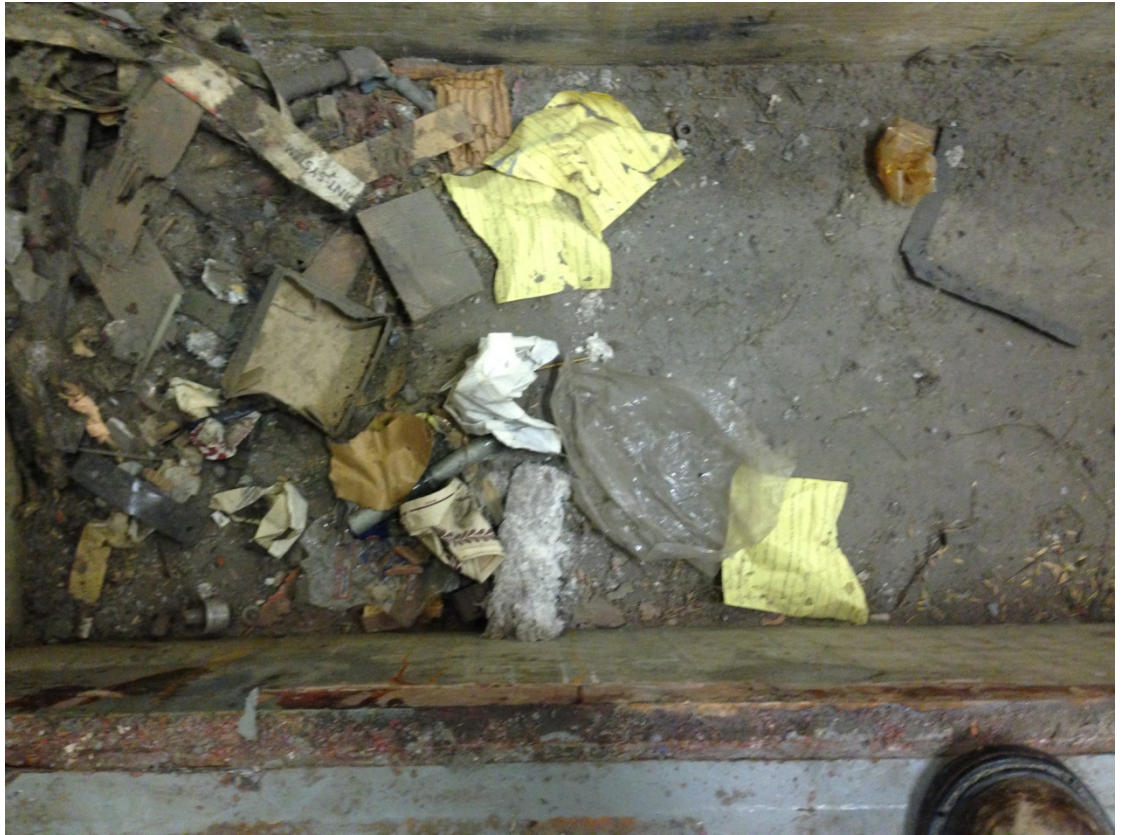
Typical debris found
inside vaults prior to
cleaning.

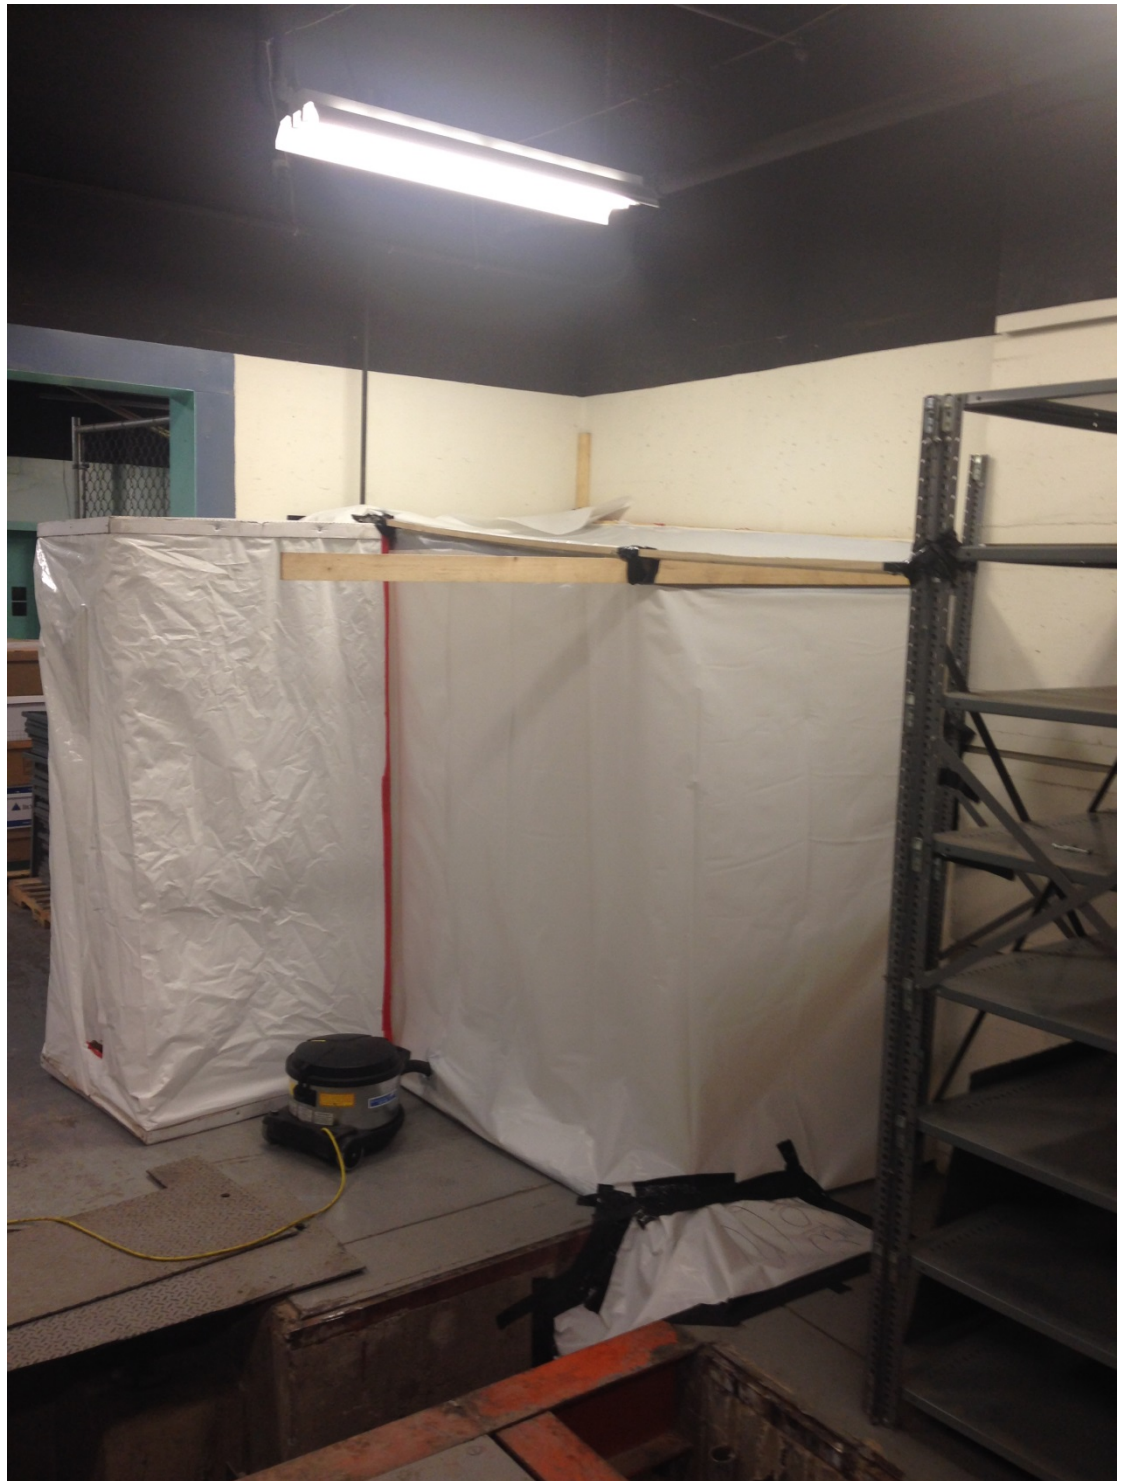
Typical setup for asbestos abatement.

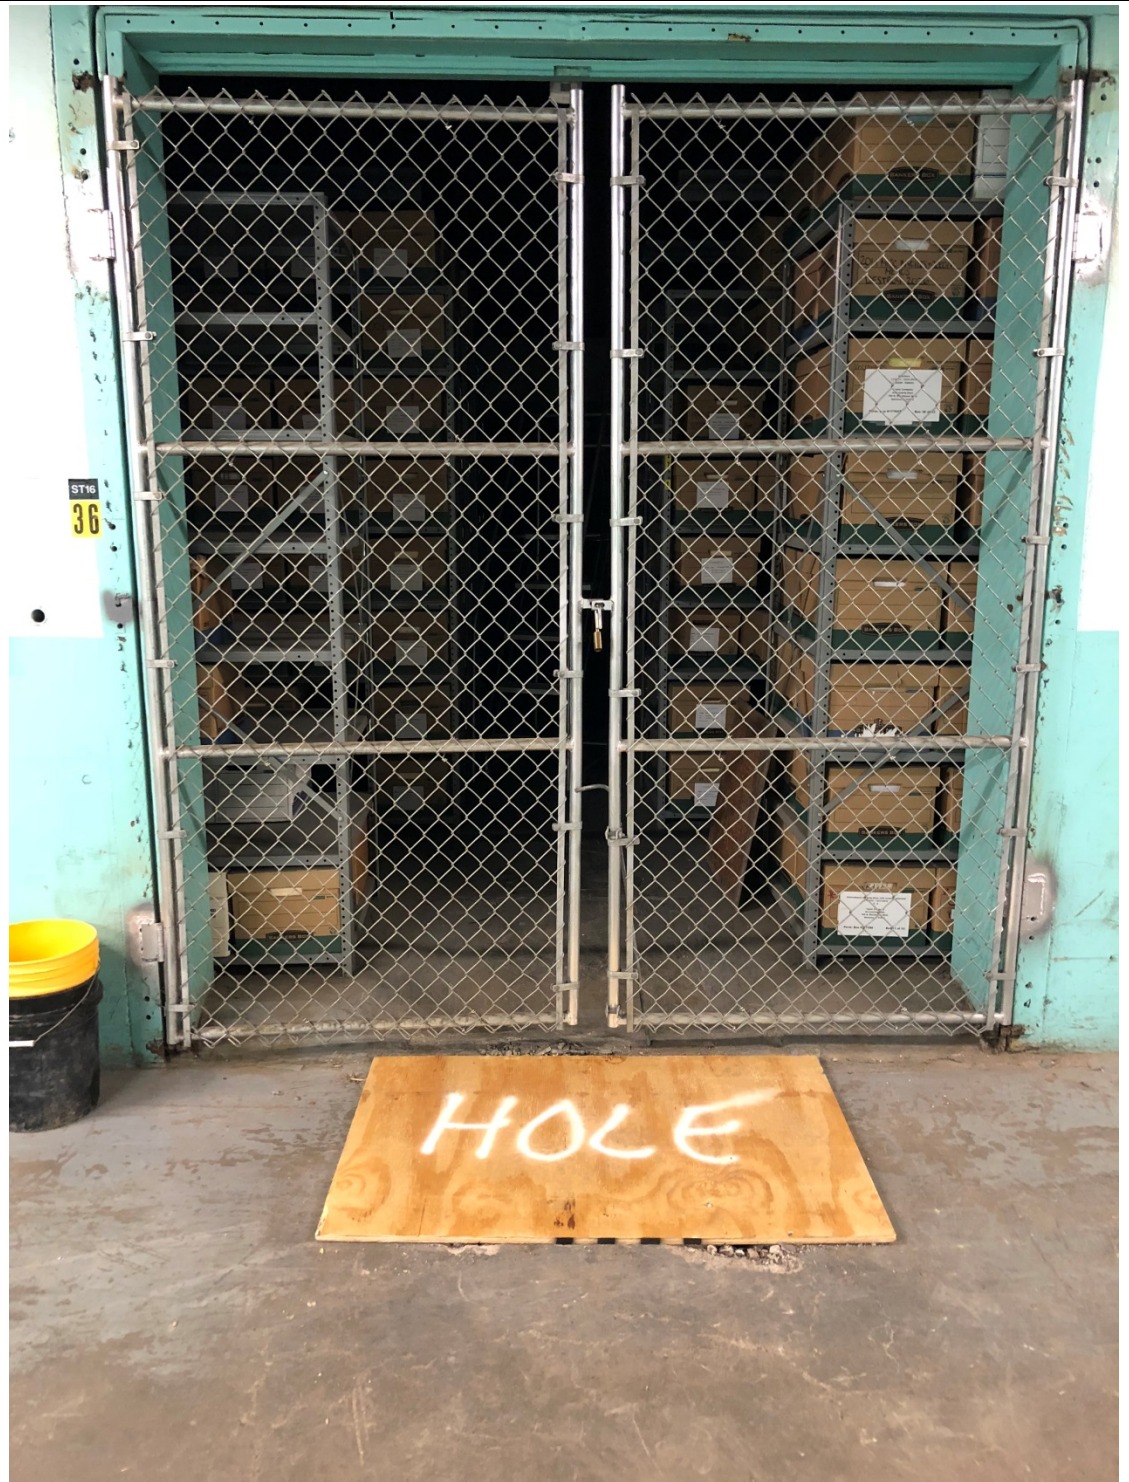
Description:
Typical temporary cover
of vault when lid was
removed.

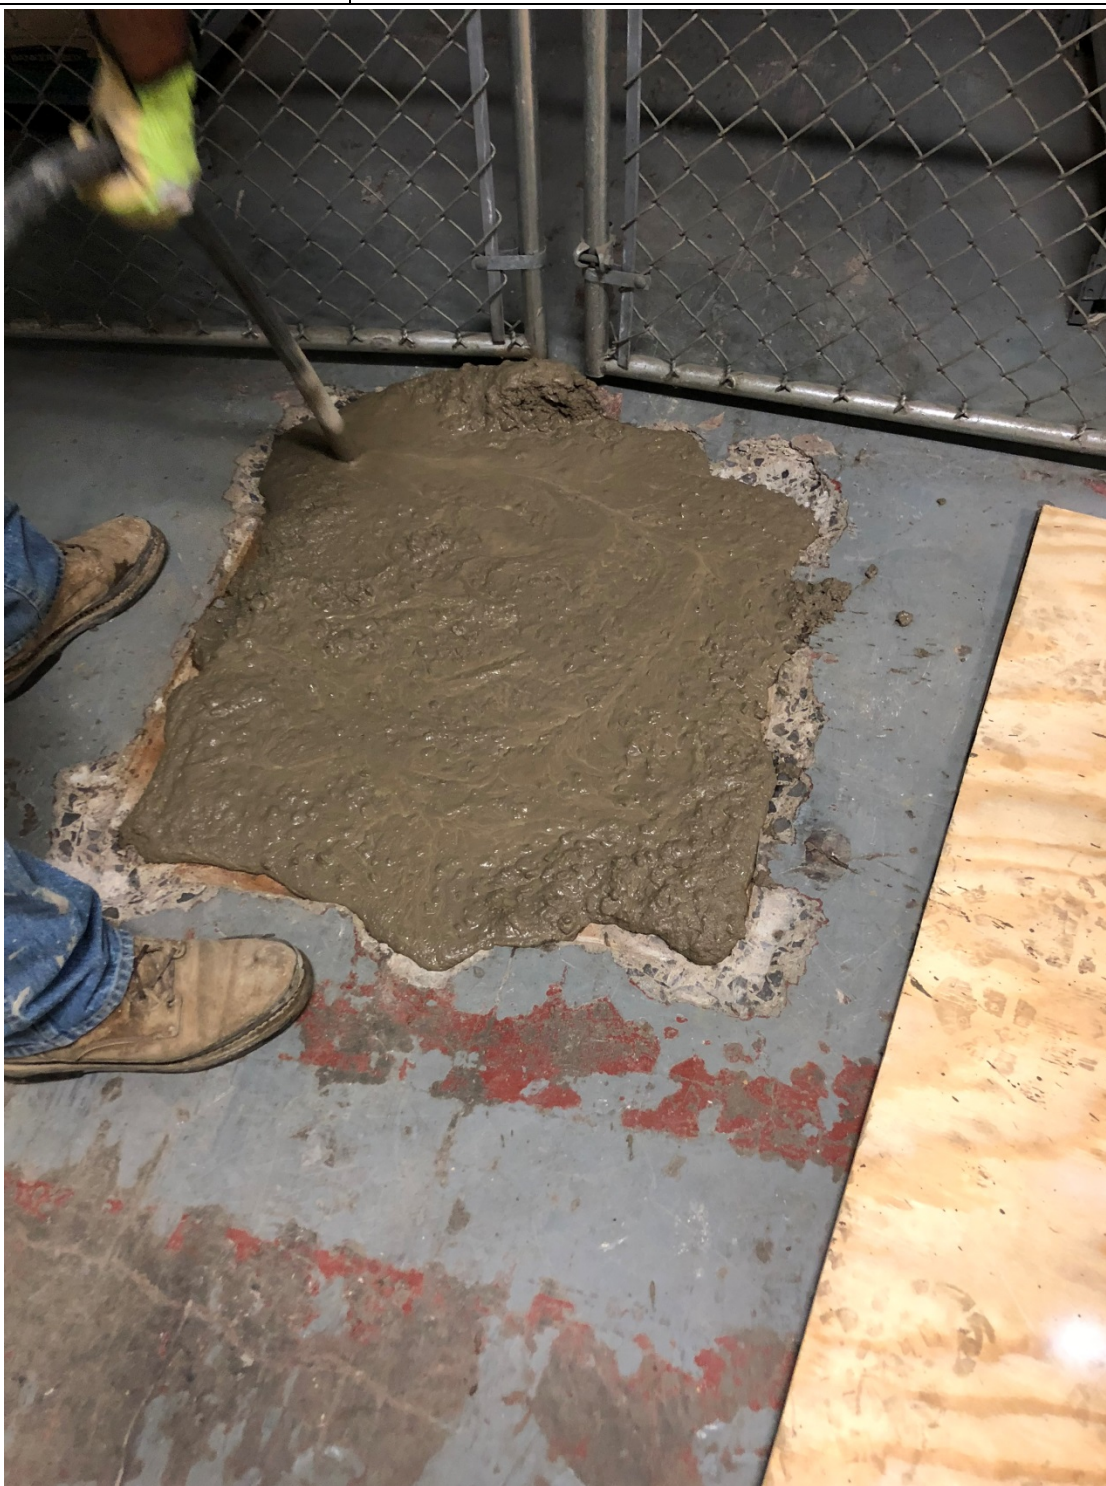
Typical filling of vault with
concrete.

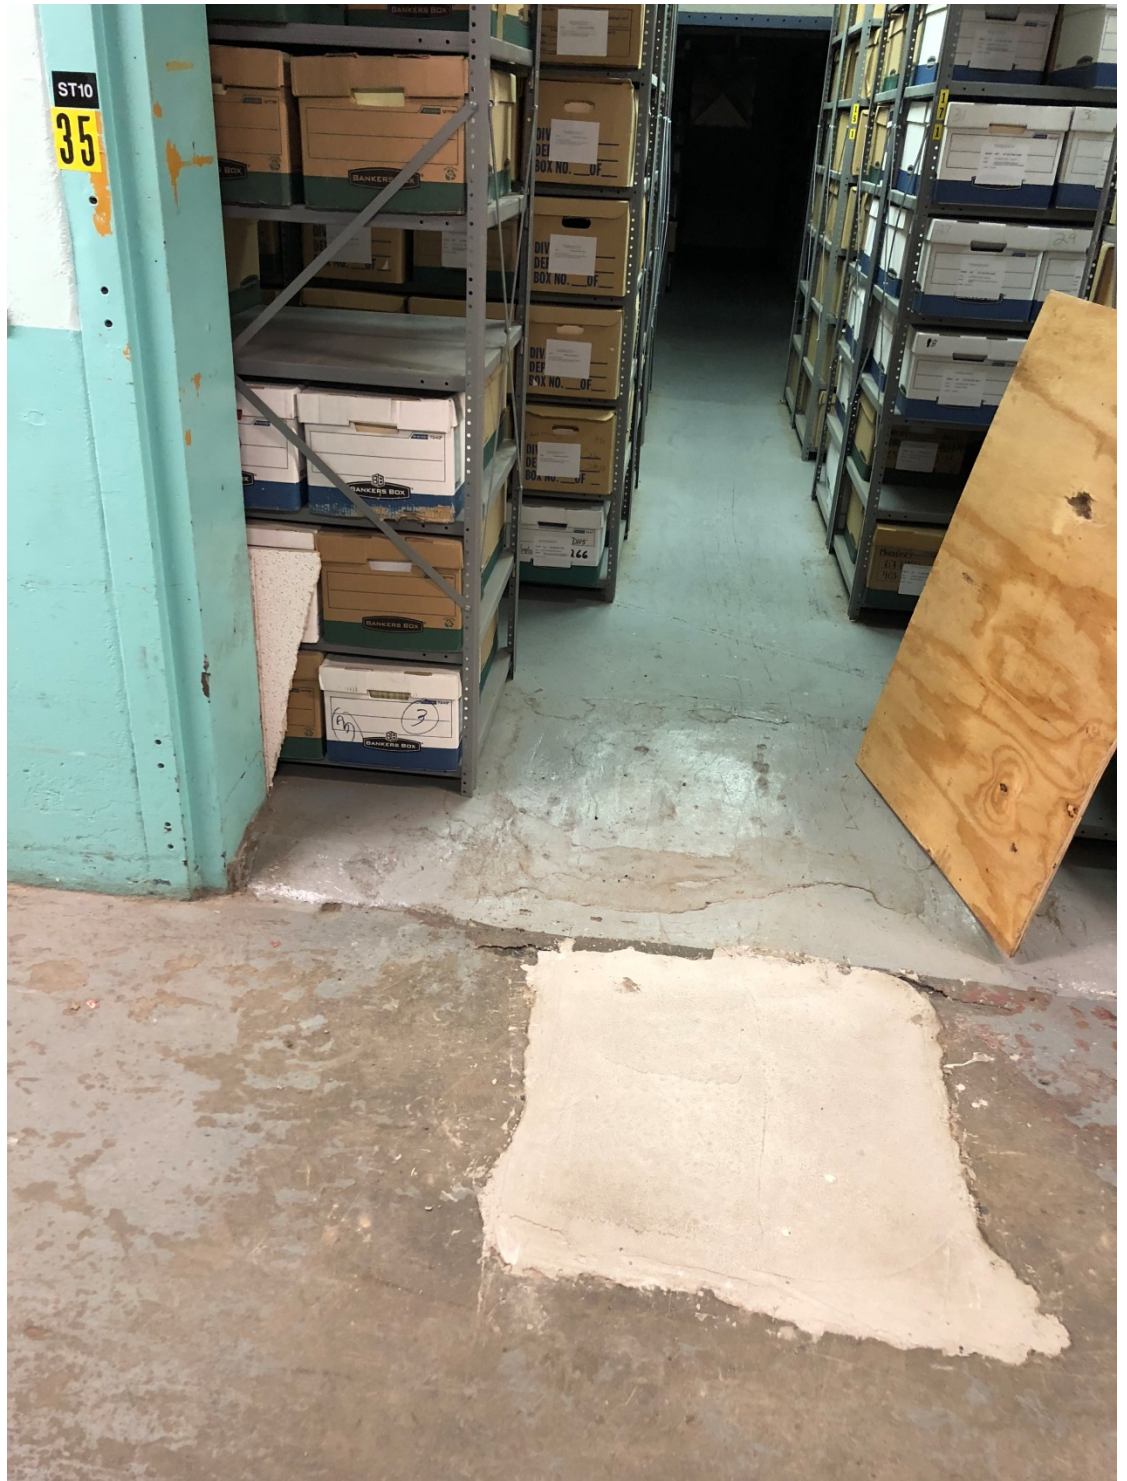
Typical vault filled with
concrete after allowing the
concrete to cure.

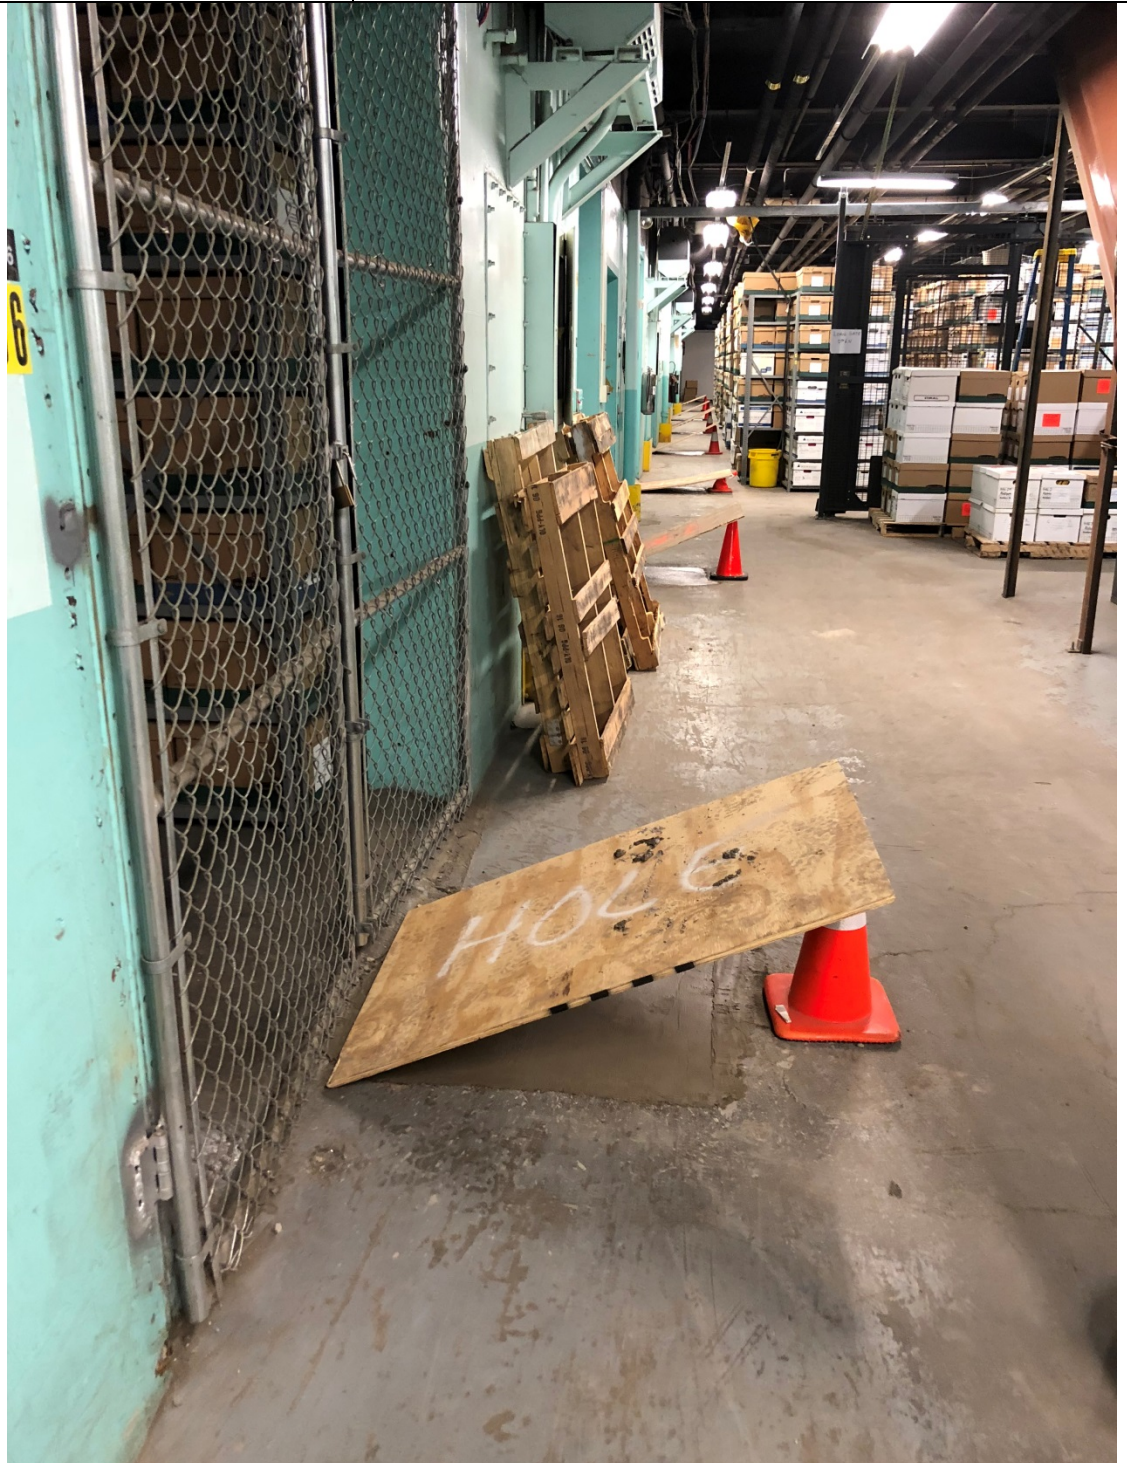
Vaults in the main corridor
after being filled with
concrete.

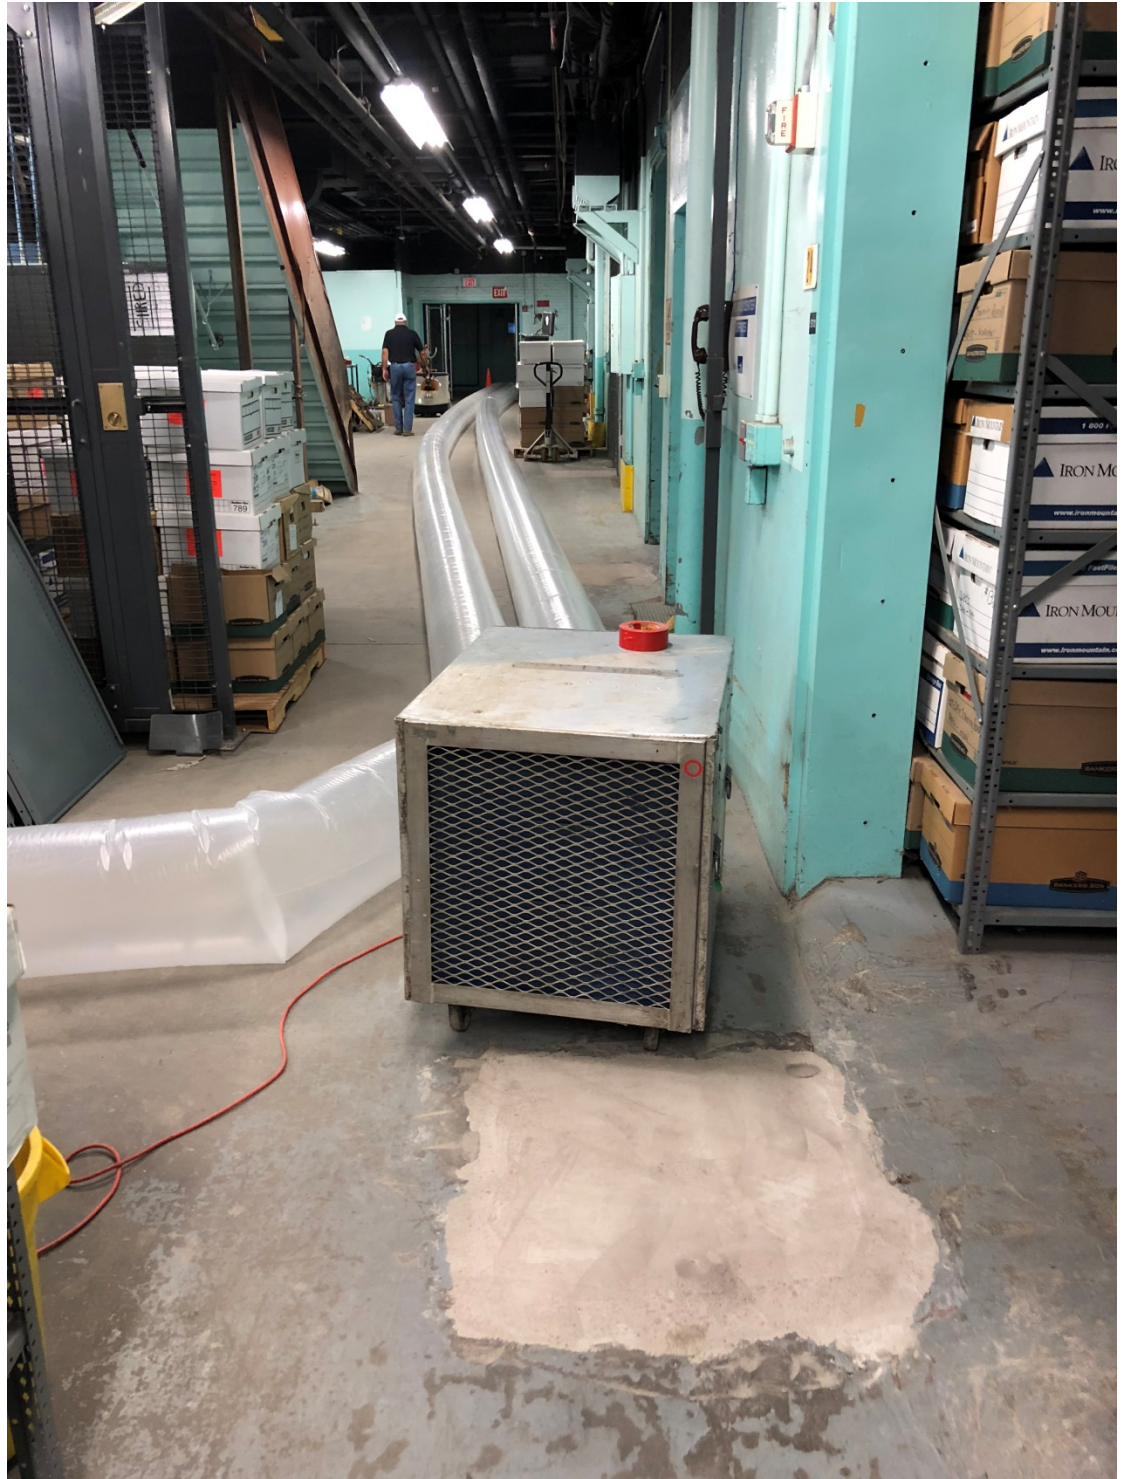
Temporary ventilation system when applying epoxy and paint over the concrete.
