Subject: Carrier Corporation, Thompson Road Facility, Syracuse, New York
Corrective Action Order — Index CO 7-20051118-4
Site Registry No.: 734043
Interim Corrective Measure Construction Completion Report
TR-8 Floor Vault Sealing

**TR-8 Floor Vault Sealing
Interim Corrective Measure
Carrier Corporation Site
ONONDAGO COUNTY, NEW YORK**

Construction Completion Report

NYSDEC Site Number: 734043

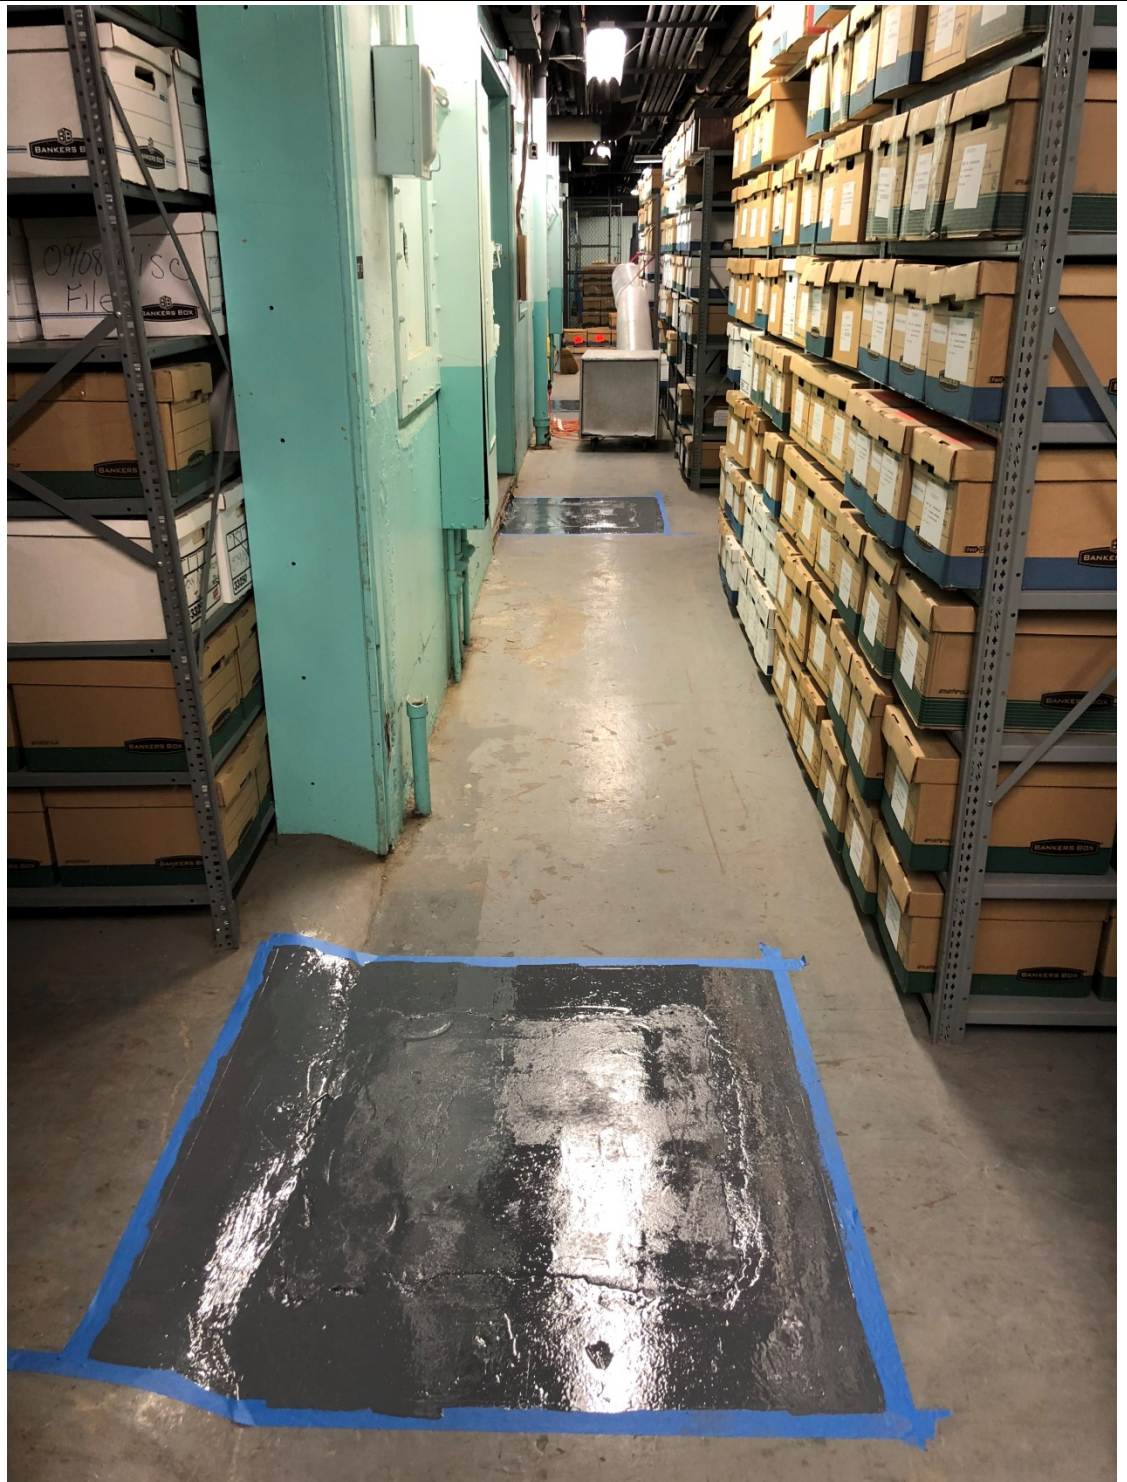
Vaults after being sealed
at the surface with
epoxy/paint.

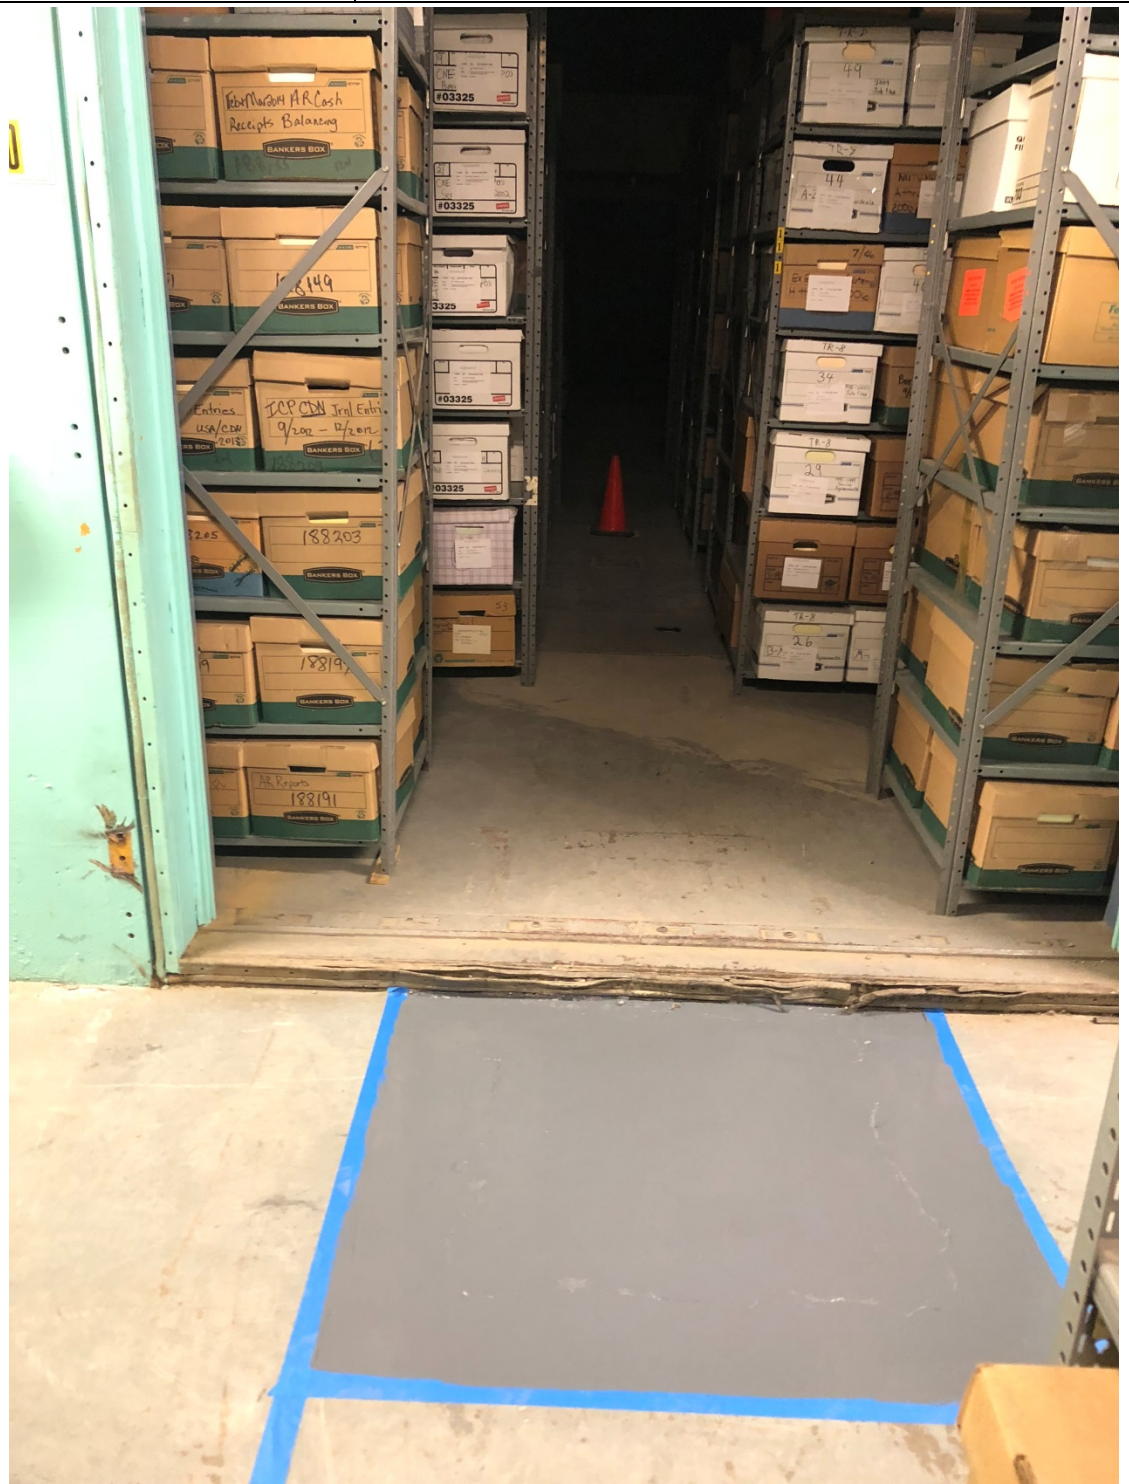
Vault after being sealed at
the surface with
epoxy/paint.

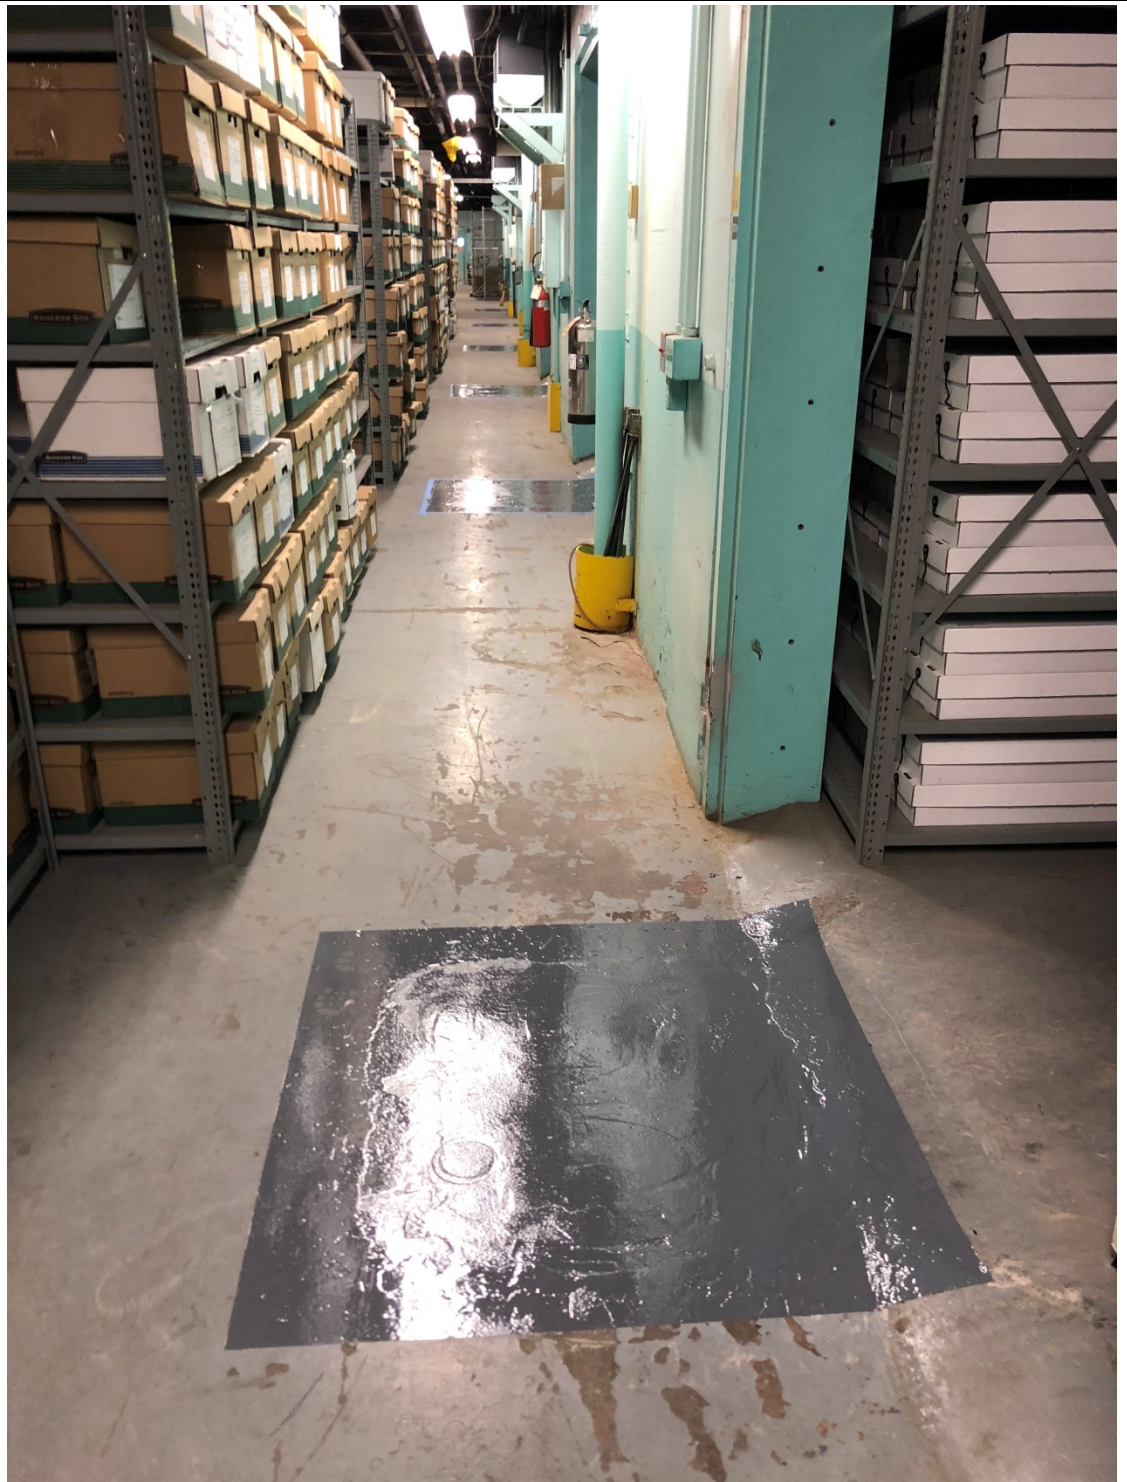
Vaults after being sealed
at the surface with
epoxy/paint.

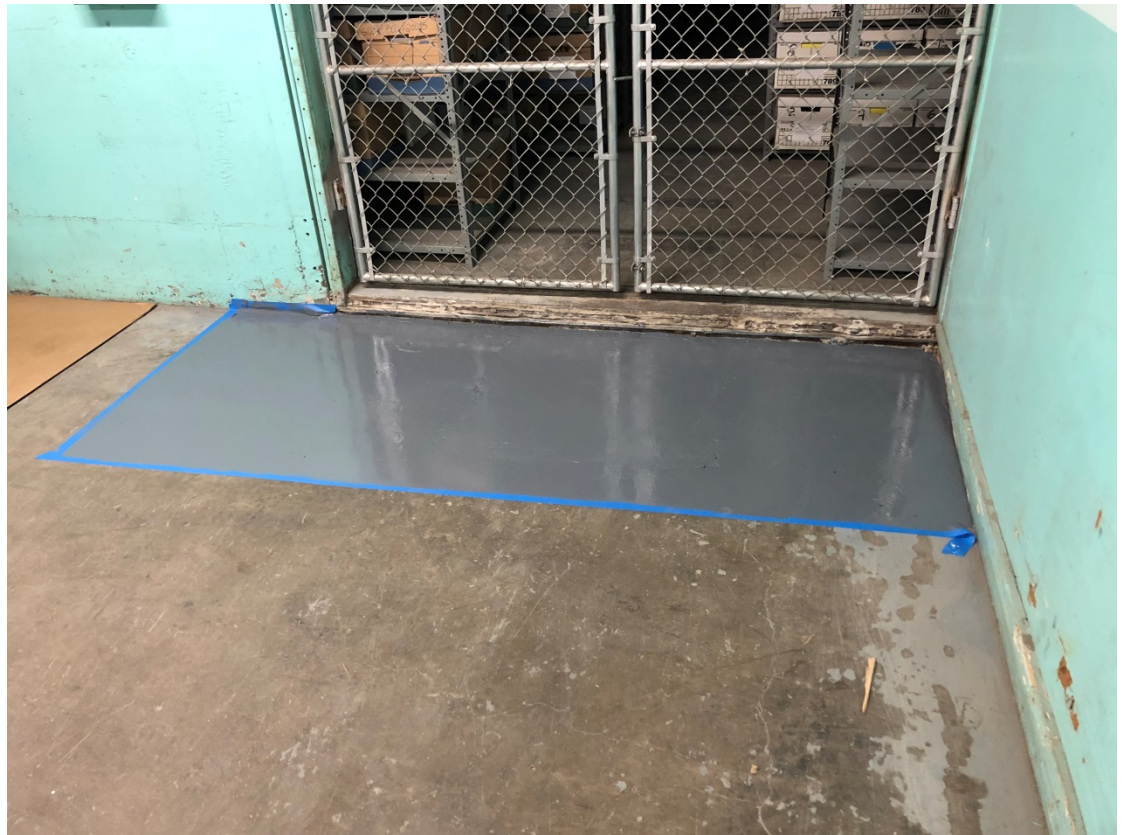
Vault after being sealed at
the surface with
epoxy/paint.

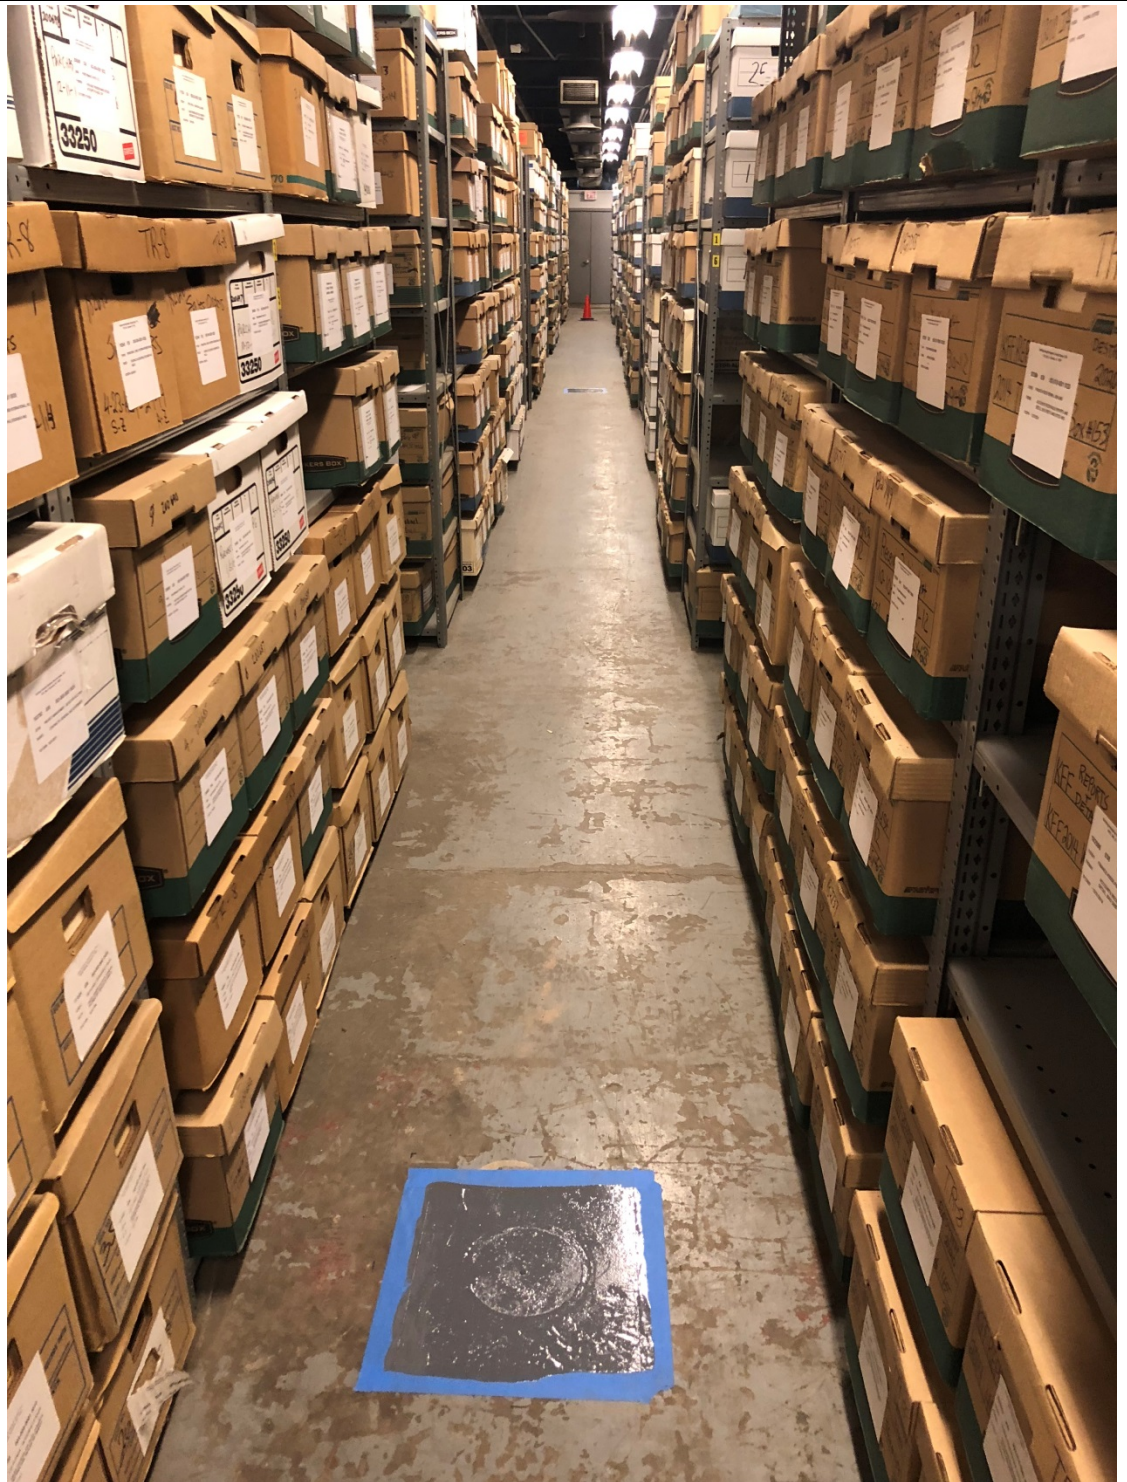
Floor drains after being
seal at the floor surface
with epoxy/paint.

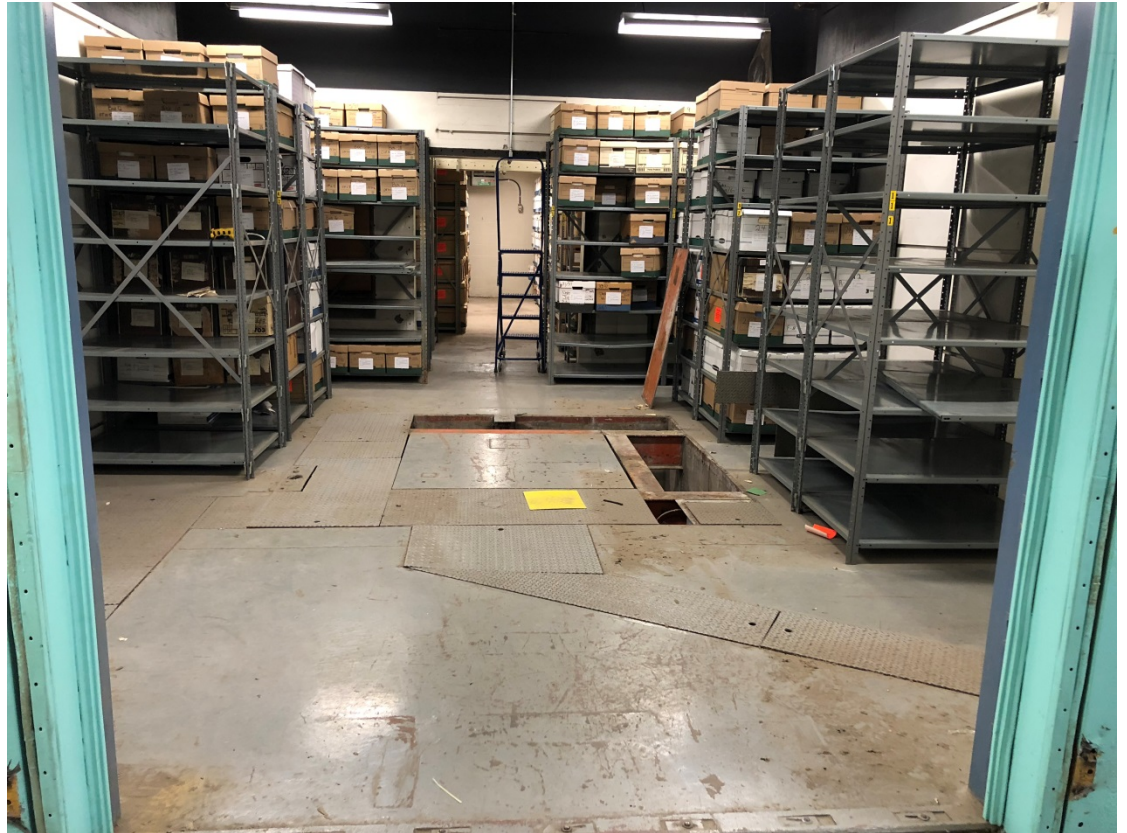
Larger vault in bay
ST13/23 prior to cleaning
out the vault. Floor scale
is visible.

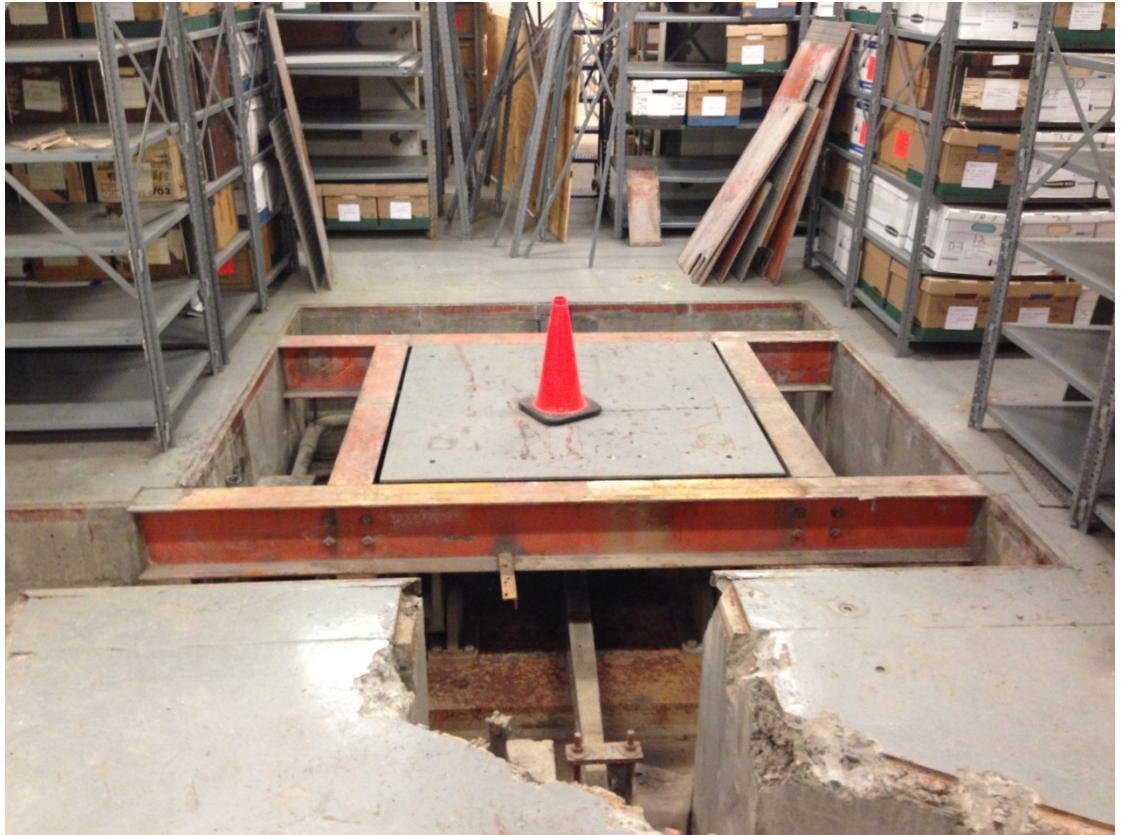
Larger vault in bay
ST13/23. Floor scale is
visible.

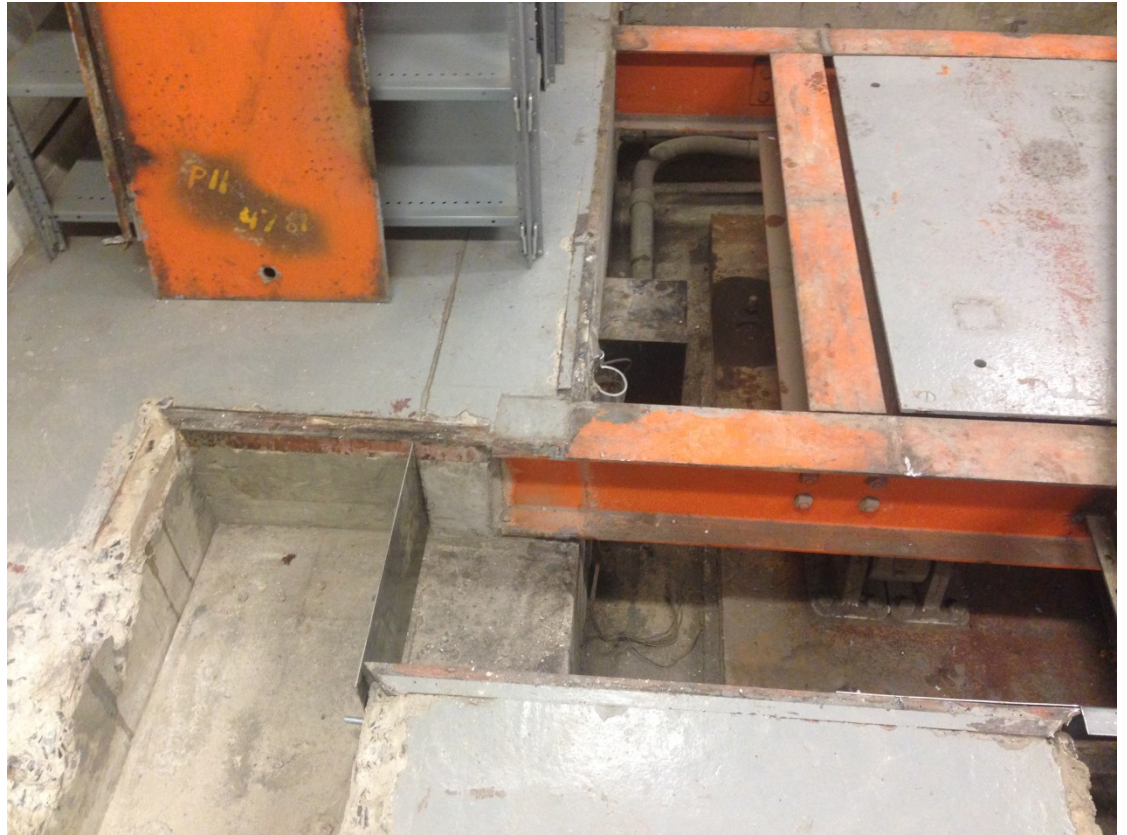
Larger vault in bay
ST13/23 after cleaning.

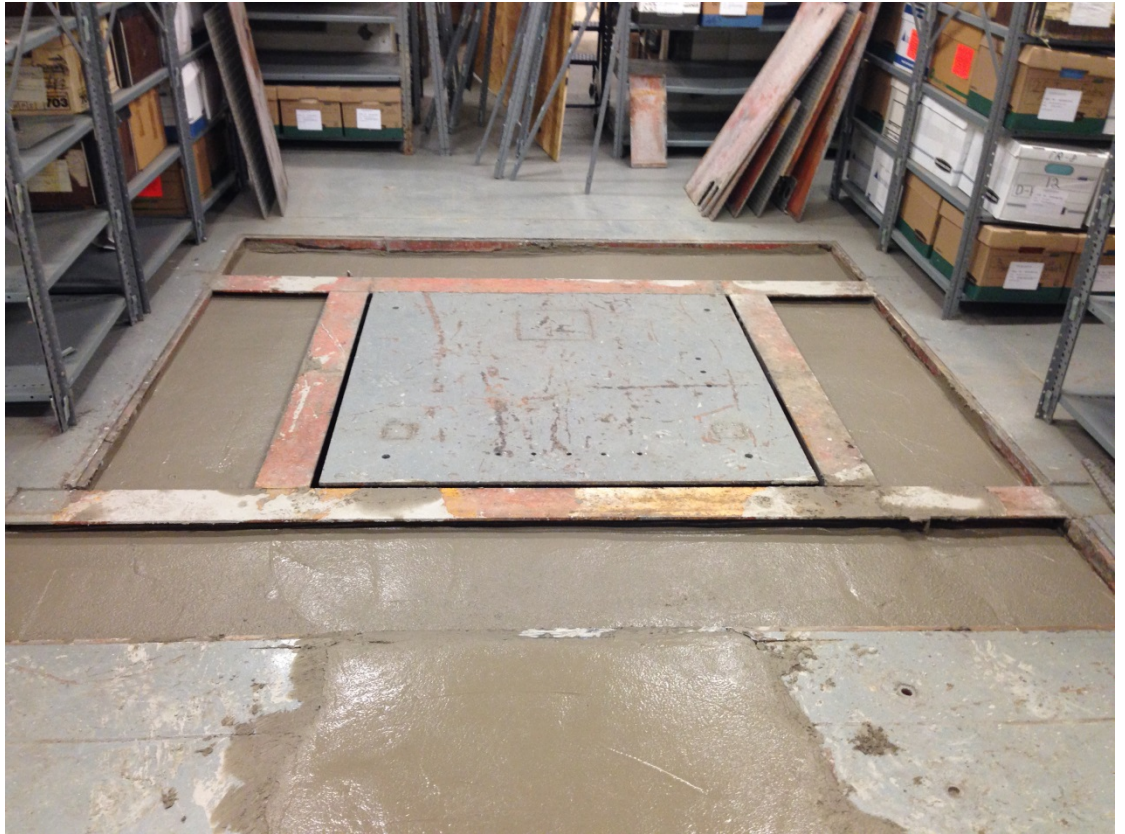
Larger vault in bay
ST13/23 after filling with
concrete.

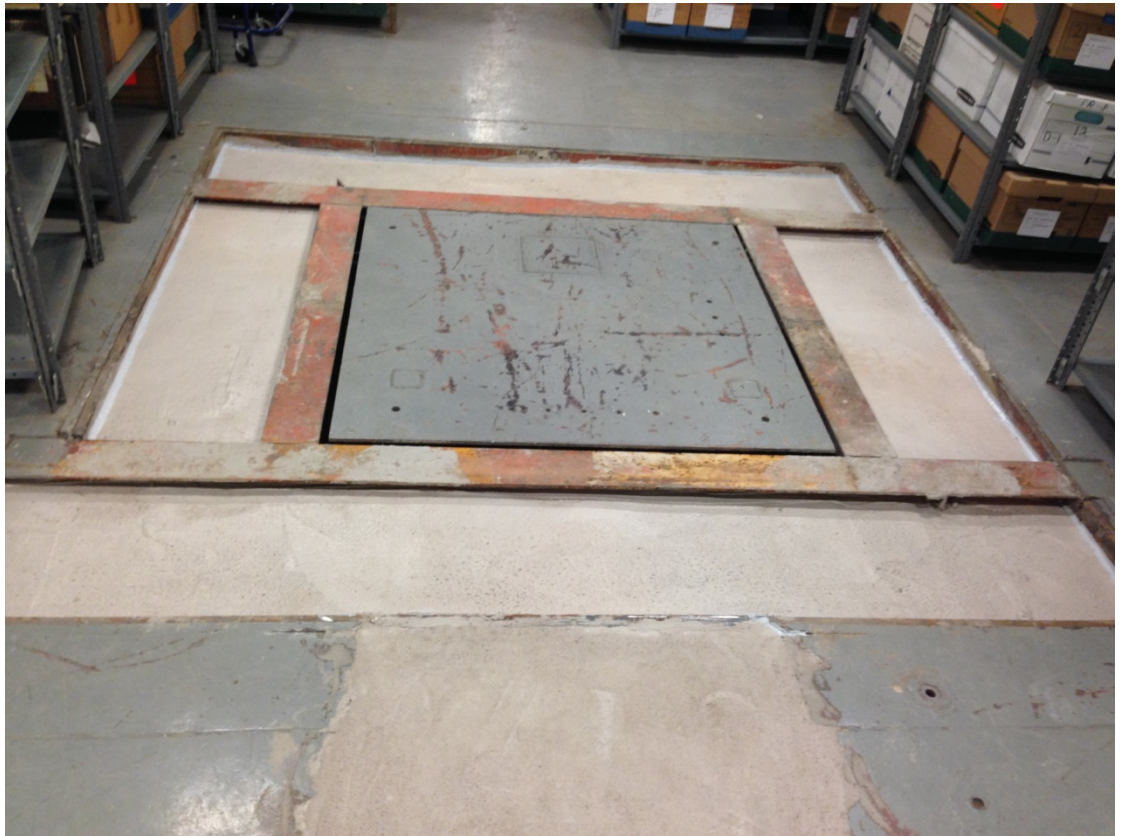
Larger vault in bay
ST13/23 after allowing
concrete to setup.

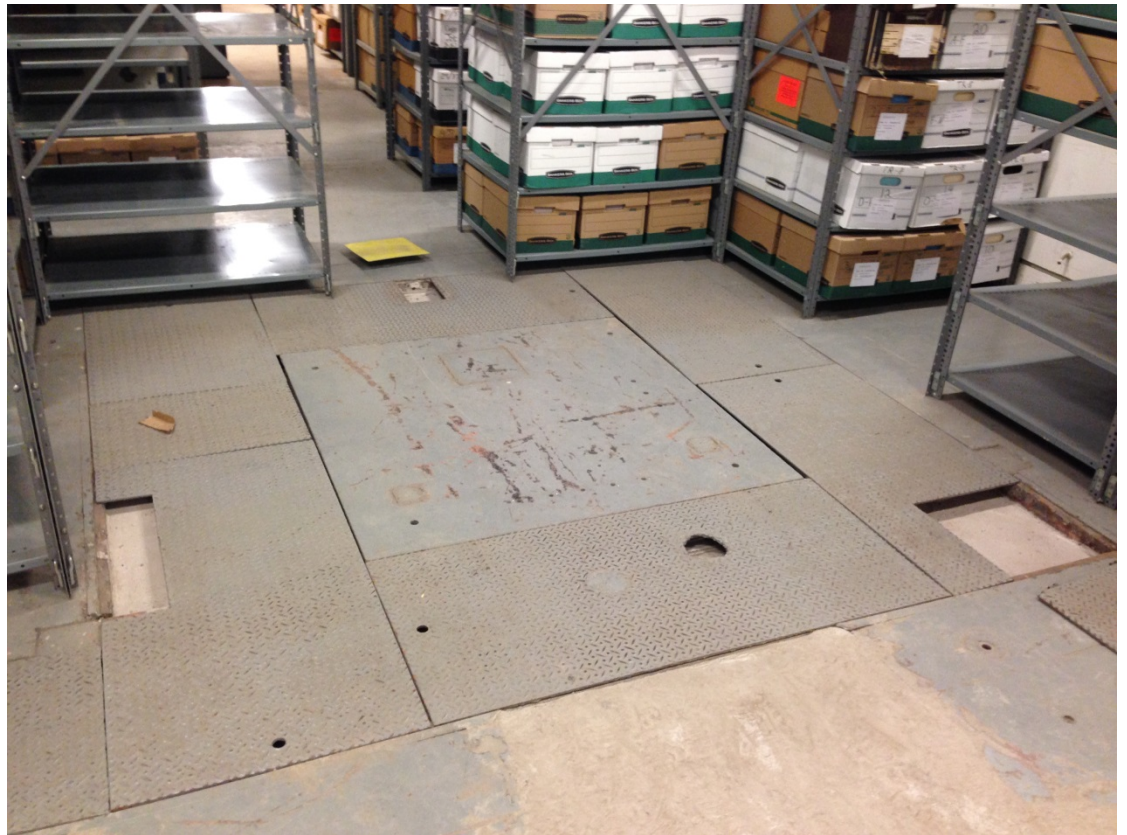
Larger vault in bay
ST13/23 with steel plates
back in place.

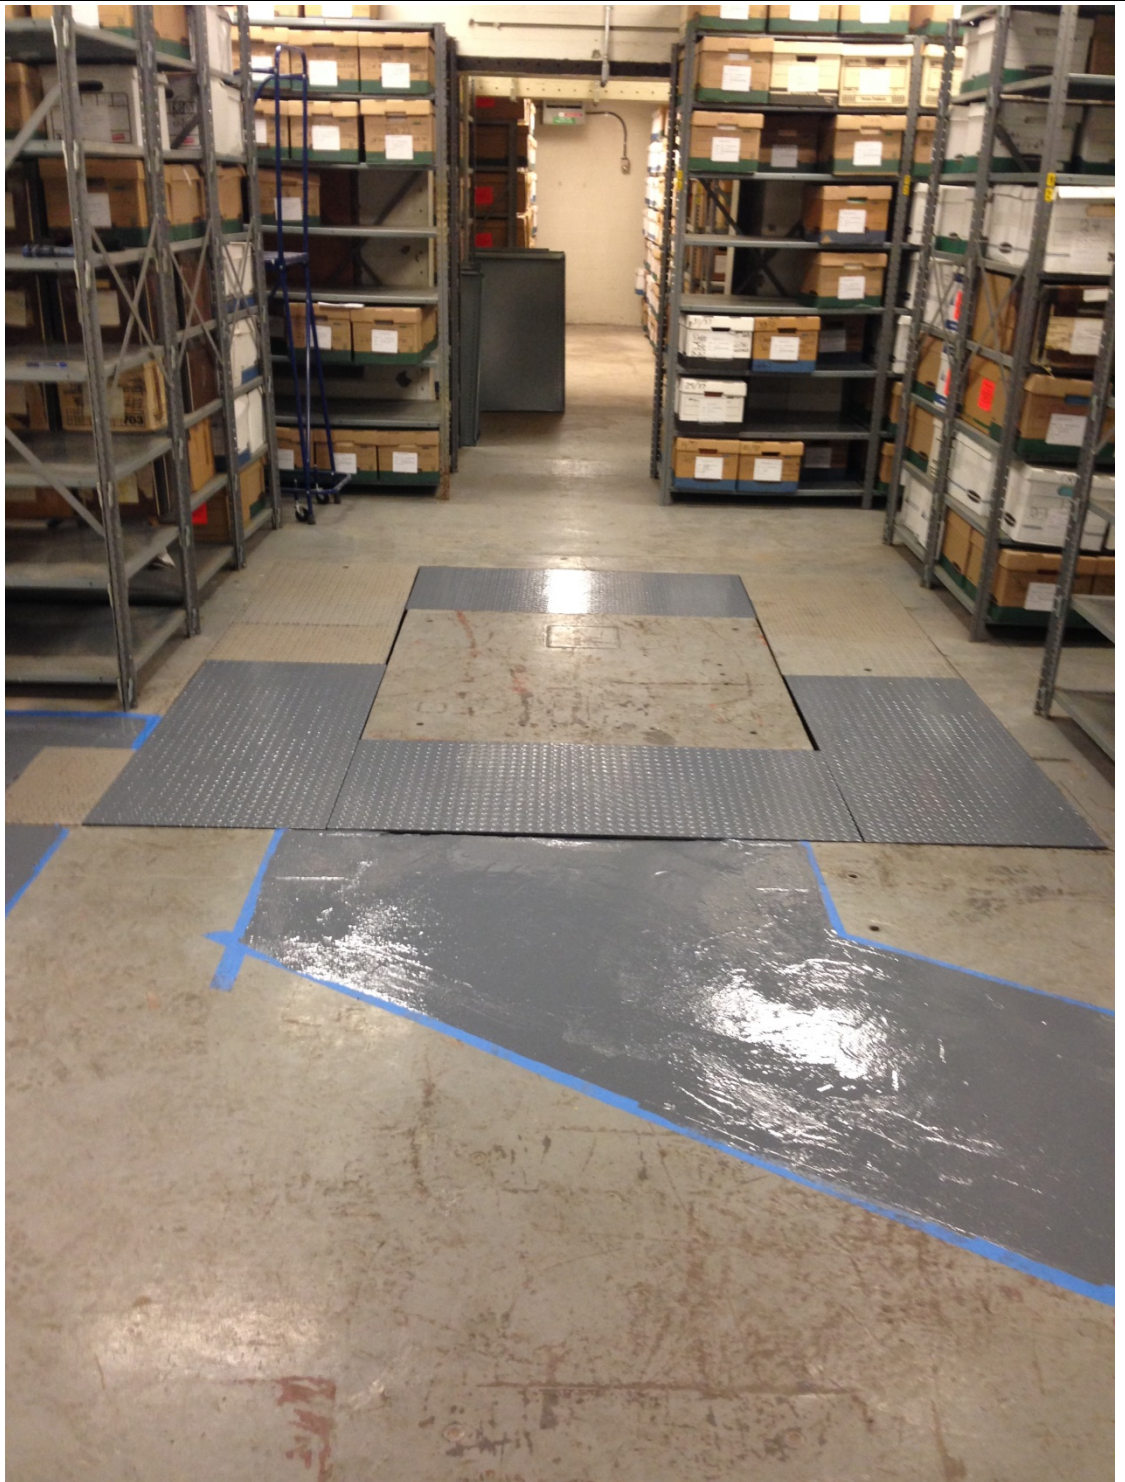
Larger vault in bay
ST13/23 with steel plates
back in place and surface
sealed with epoxy/paint.

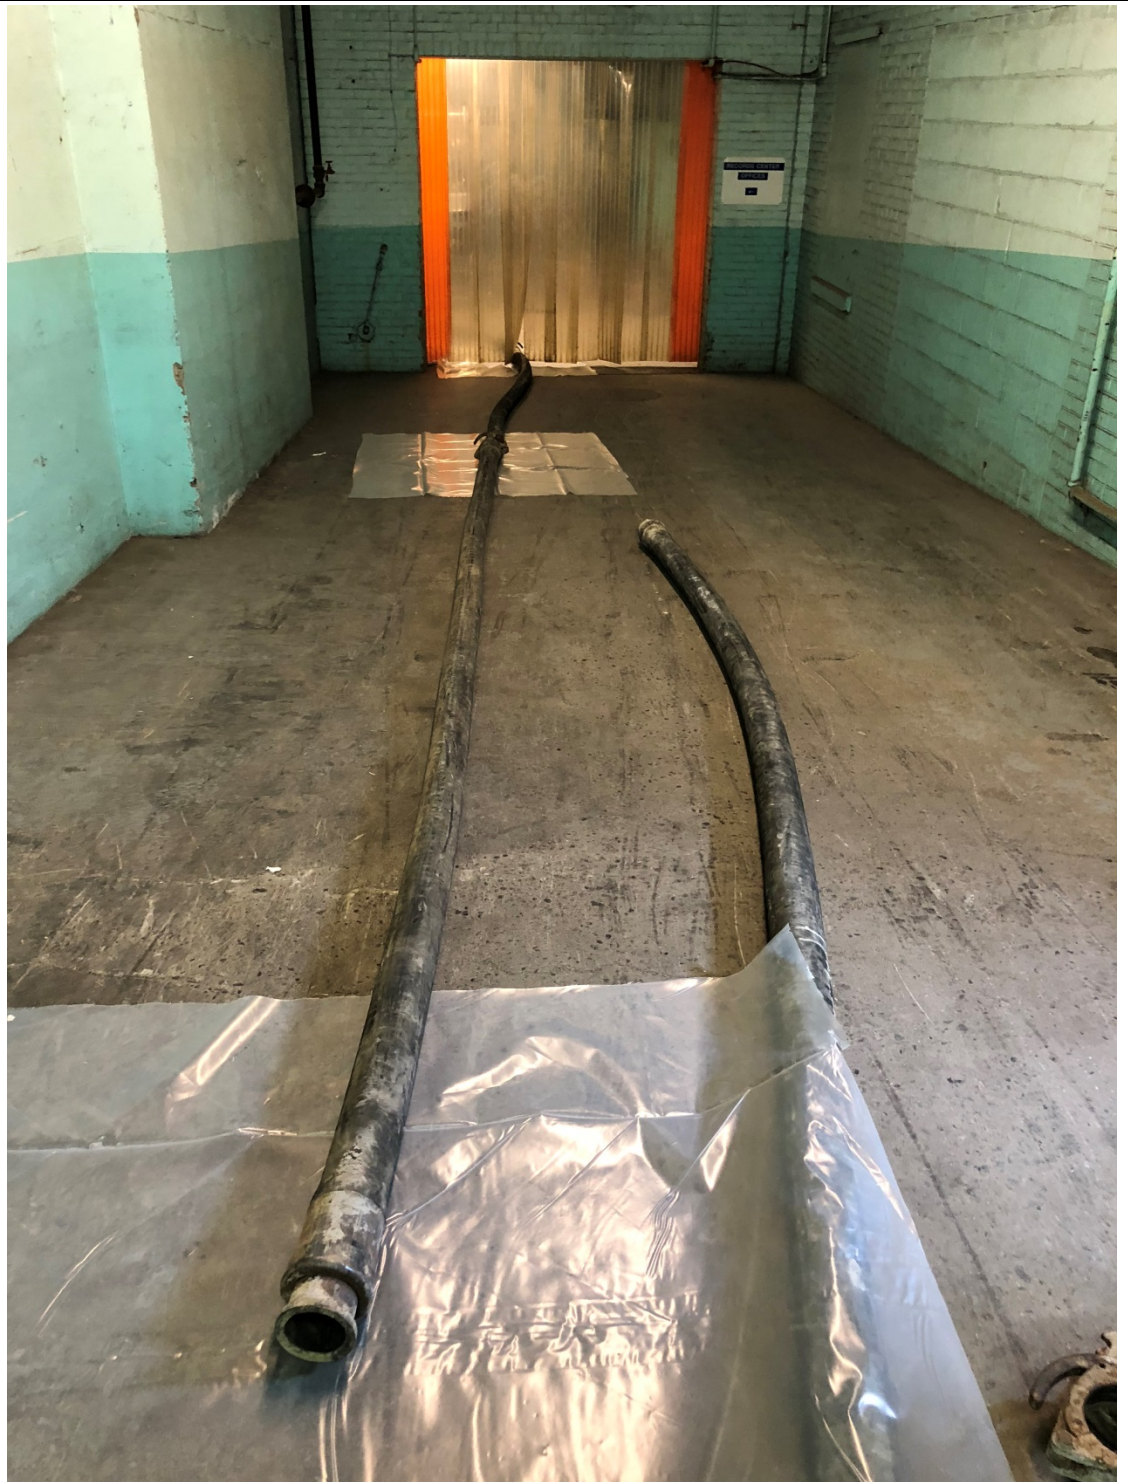
Typical hosing used to convey the concrete to the vaults.
